ASBESTOS INVESTIGATION REPORT
STUDEBAKER CORRIDOR PROJECT
SOUTH BEND, IN
JANUARY 10, 1991
ATEC PROJECT NO. 21-09340

DEPARTMENT OF ECONOMIC DEVELOPMENT
COUNTY-CITY BUILDING
SOUTH BEND, IN 46601

Re: Asbestos Investigation
Studebaker Corridor Project
South Bend, IN
ATEC Project No. 21-09340

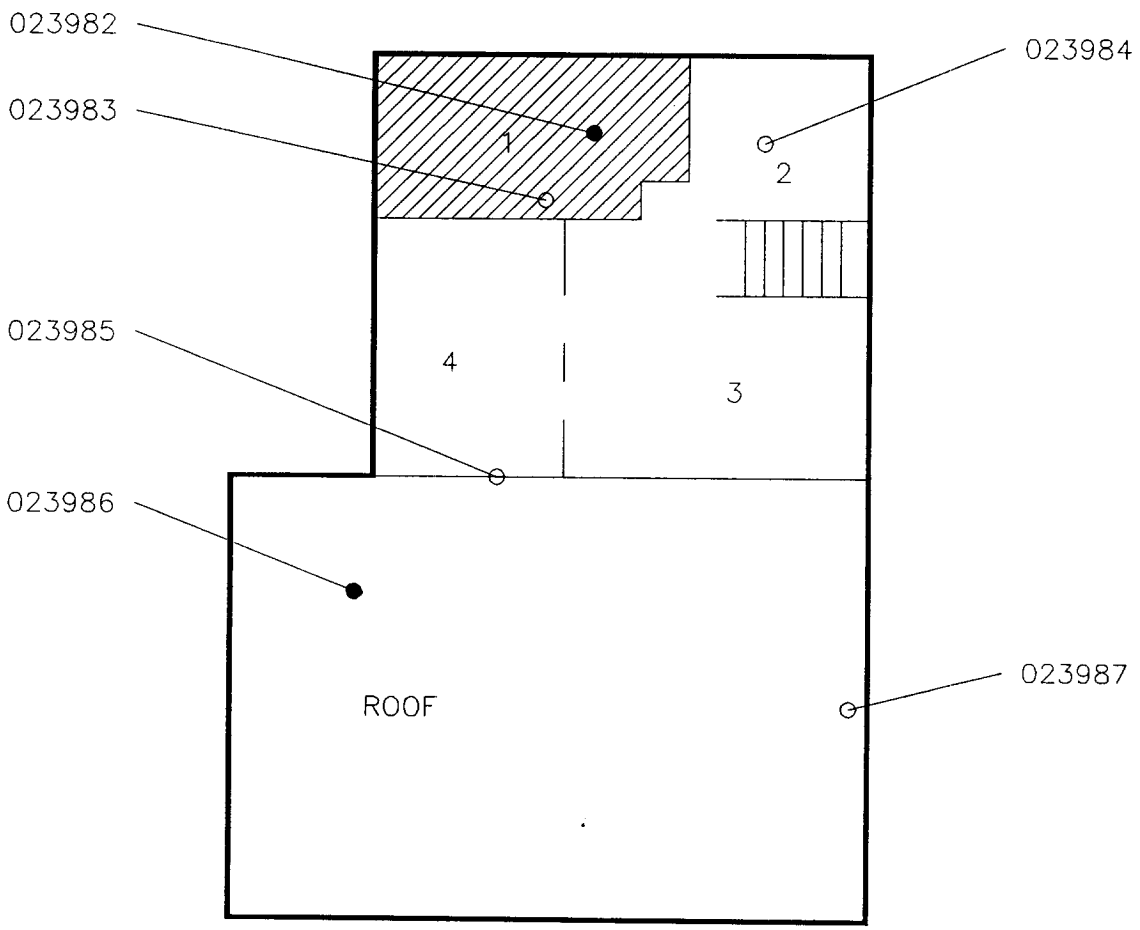
FIGURE NO.
 5A

One sample was taken from the loose-fill insulation (HA 15) located above the plaster ceilings. The sample tested negative for asbestos content. (Figure 5A, Photograph G-4)

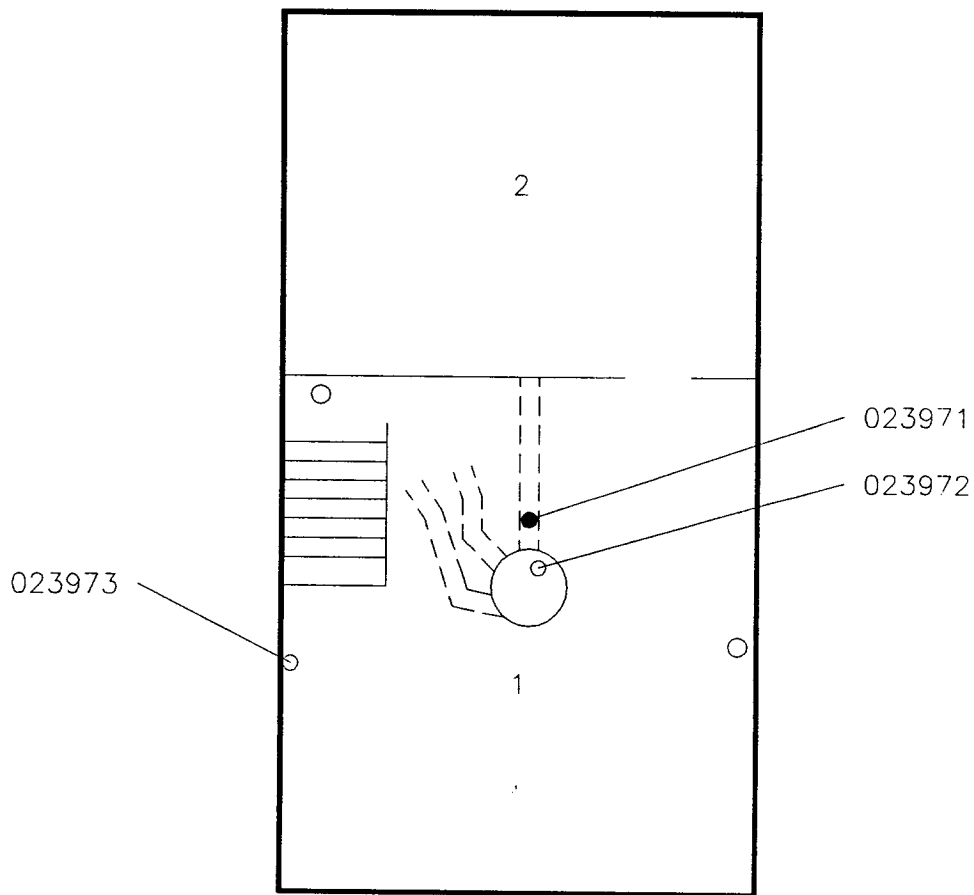
FIGURE NO.
 5B

One sample was taken from the linoleum (HA 7) located in the kitchen area of the second floor. The linoleum was found to contain 5-10% chrysotile asbestos. (Figure 5B, Photograph G-1)

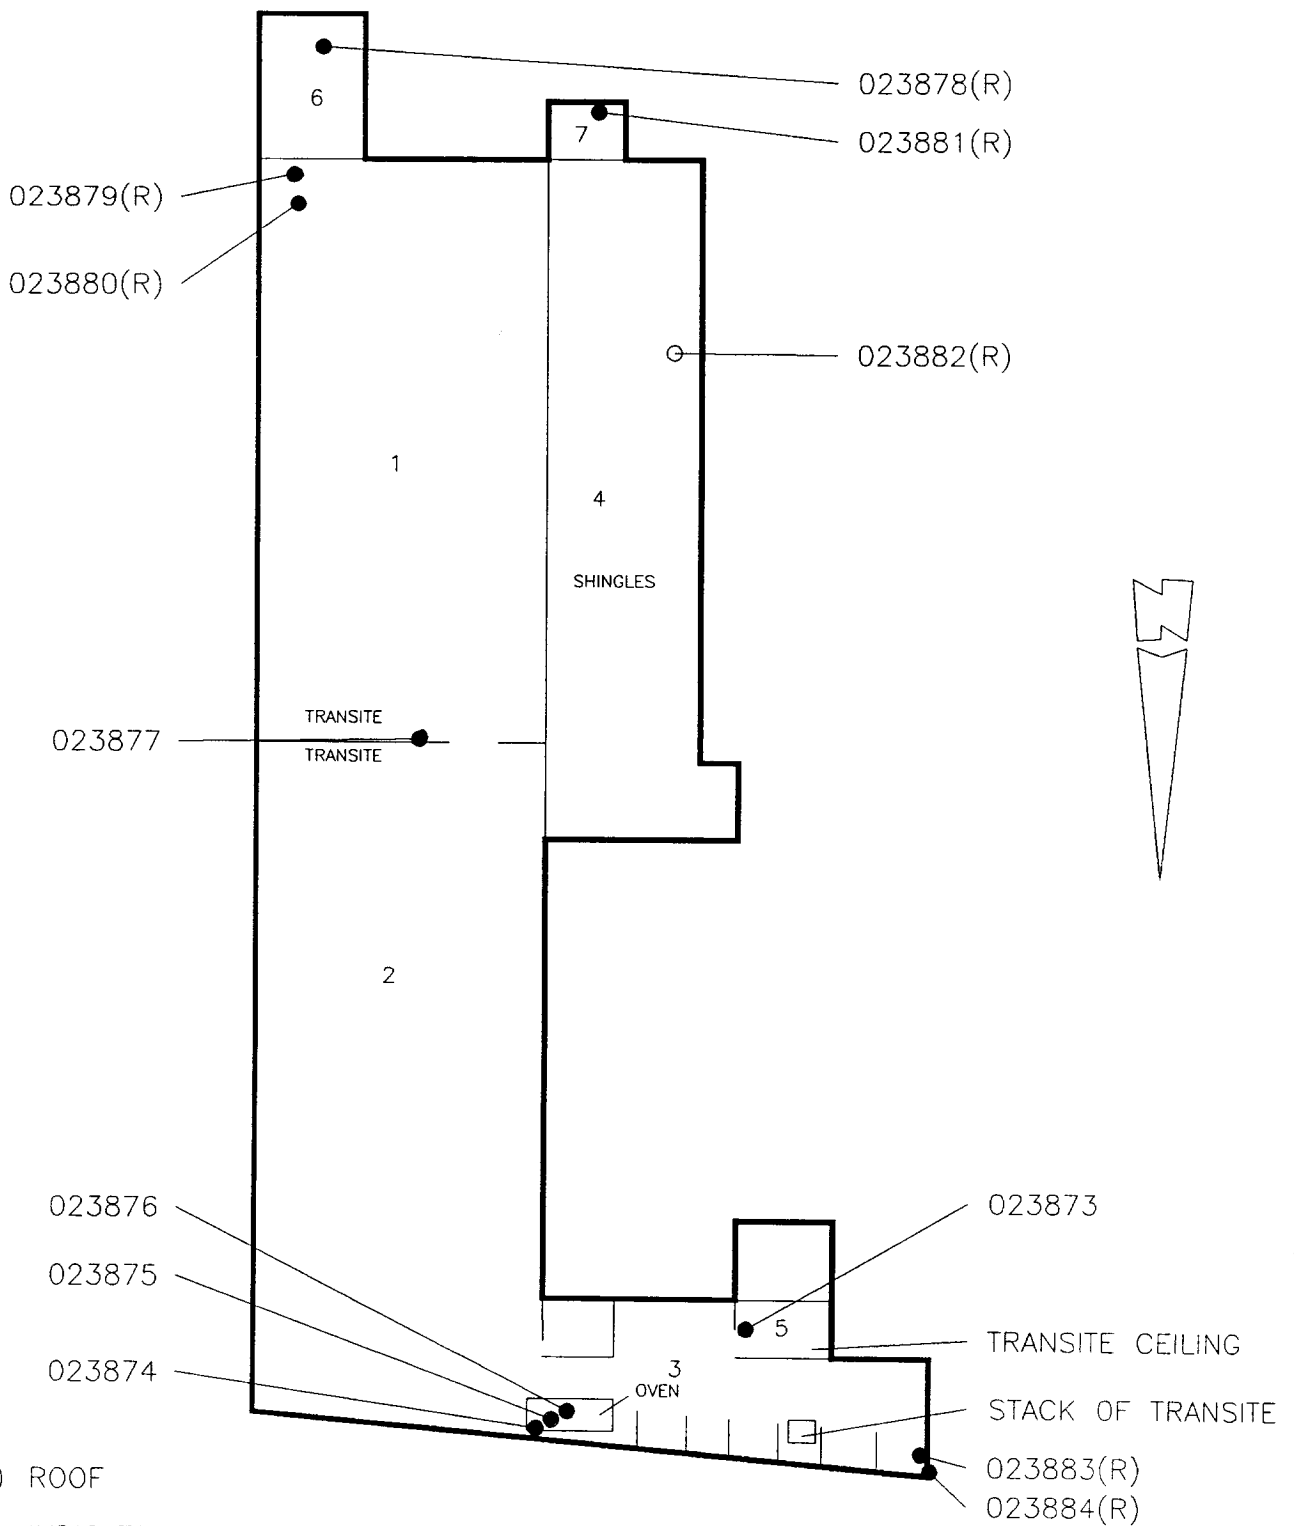
FIGURE NO.
6E

Building 4 (Figure 6E) was constructed of brick, with a built-up gravel/asphalt roof. The interior walls are brick, and the floors are concrete. No thermal system insulation was observed in the building. Building 4 is a one-story structure without a basement, and covers approximately 3,750 square feet in area.
