City of South Bend, Indiana

***Post-Flooding Investigation of Four Neighborhoods
Along the St. Joseph River***

August 16, 2018

LAWSON-FISHER ASSOCIATES P.C.
CONSULTING ENGINEERS

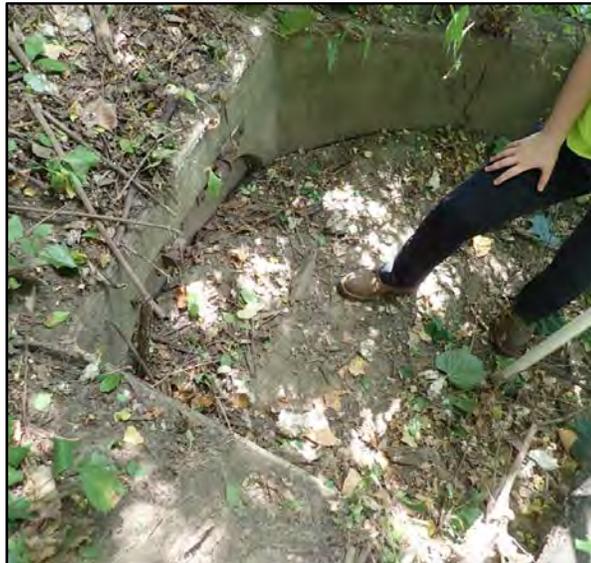
Photo 4-1
View of CSO 5 Outfall

This location was selected due to its proximity to combined sewer outfall (CSO) 5 and river crossing 5. The 54" diameter combined sewer trunk line brings flow into the structure. It also appeared that a 24" diameter combined pipe was actively conveying flow into the structure as well. Additionally, it is assumed that this 24" diameter combined pipe is connected to Location 8. There are two gate valves installed within the structure. One gate valve is aligned with the 36" diameter CSO 5 outfall pipe and the other is aligned with the 54" diameter river crossing 5 pipe. The CSO 5 outfall, located along the east bank of the St. Joseph River, was significantly buried by sediment, impeding its ability to open and relieve the sewer network (See Photo 4-1). The outfall structure had a steel flap gate installed to help prevent the backflow of river water into the sewer network.

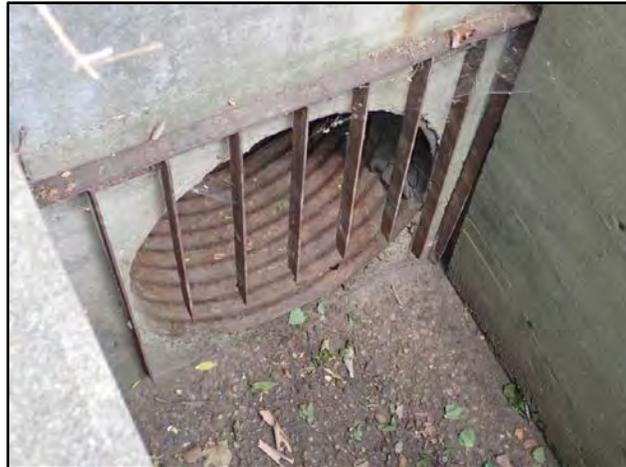
Photo 4-2
View of Storm Outfall

discharges out of the storm outfall into the St. Joseph River. The headwall and outfall appear to be functional and in good condition. The structure and sewer configuration matched the as-built data. This outfall was not outfitted with a backflow prevention device.

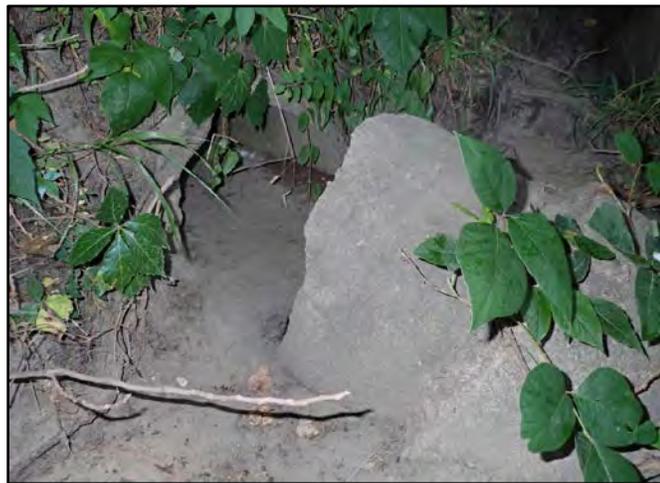
Photo 4-3
View of abandoned CSO 24 Outfall

According to the GIS, CSO 24 has been abandoned and is no longer in use. It appeared that a backflow preventer had been installed on the 24" diameter inlet pipe, but appeared to have been removed. The 24" diameter outlet pipe appeared to convey flow to the 84" diameter combined trunk line that runs parallel to the St. Joseph River. The second structure, 4-2 in Appendix B, was located along the 84" diameter combined sewer trunk line. There were two inflow pipes, an 84" diameter combined and a 24" diameter combined, along with two outflow pipes, an 84" diameter combined and a 24" diameter combined, observed within the structure. The 24" diameter outflow pipe appeared to be the old connection to the CSO 24 outfall structure. However, the old CSO outfall structure was broken into two separate pieces and did not appear to be functional.

Based on visual inspection, it could not be confirmed that the 24" diameter outlet pipe has been plugged to prevent flow from exiting the structure and discharging into the river. There was evidence of debris along the rim of the structure indicating that the water level has been high in the past at this location.

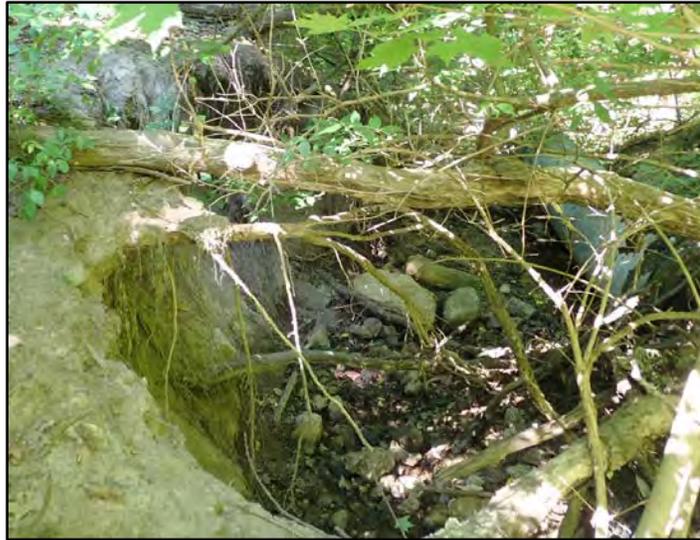
Photo 4-4
View of Erosion near 24" Diameter CMP Pipe

After 500 feet, a 24" diameter CMP pipe sits on the surface and appeared to have been installed to help direct flow within the channel. The channel showed signs of severe erosion around the pipe and appeared to have bypassed the pipe in the present condition.
