STAFF REPORT CONCERNING APPLICATION FOR A CERTIFICATE OF APPROPRIATENESS

Date: July 3, 2019

Application Number:2019-0703AProperty Location:629 CarrollArchitectural Style/Date/Architect or Builder:Neo-Classical/1924Property Owner:David Steinberg/Bingo Properties LLCLandmark or District Designation:Taylors Field, Ordinance #8952-98Rating:Contributing

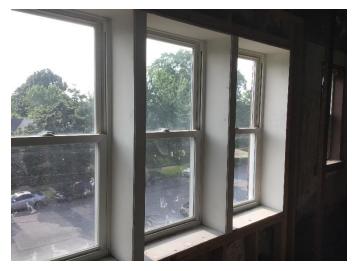
I did not find any sashes that were deteriorated beyond repair. However, the main concerns with these windows are the jambs and sills. The weight pockets are flat trim construction with the "sides" being used as the interior stop. The play in the sashes is quite severe and without the addition of an additional interior stop on each side and top, I do not see a feasible solution for the air gap. I did not find a single set of windows that completely had ropes as most lower sashes were without.

Secondly, the majority of the sills are dry-rotted or deteriorated beyond repair. Especially those closest to the northwest corner. At least a dozen of the sills are soft enough to put my finger into.

I would ask that a clear plan on how replacements would be installed be presented. At the front of the building a bank of three windows were replaced. The original jams were removed and the new windows were installed with a minor setback from the brick face rather than centered in the frame. This left an interior "shelf" to compensate for the distance from exterior to interior walls. See photograph #106. I fear that a centered installation would leave too much of the limestone sill exposed and result in water infiltration though the walls.

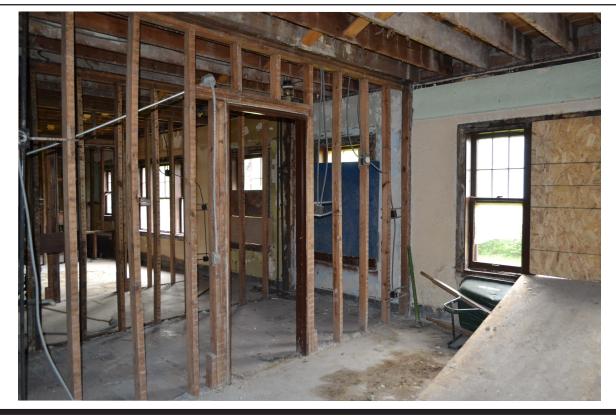
WINDOWS - Picture of interior of windows, photo provided

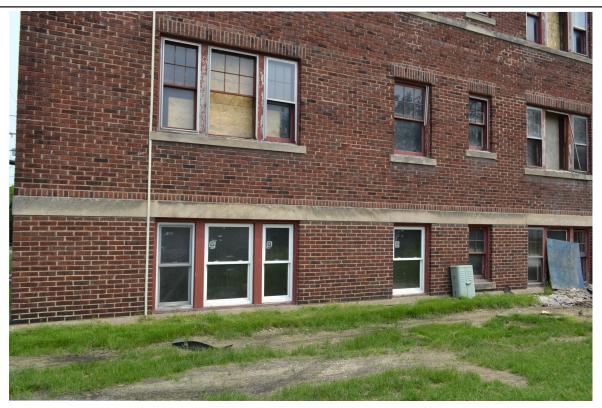
WINDOWS - Picture of windows, photo provided

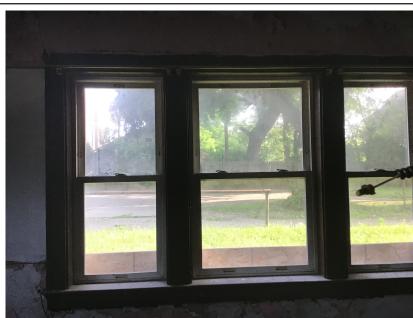
WINDOWS - Picture of interior of windows

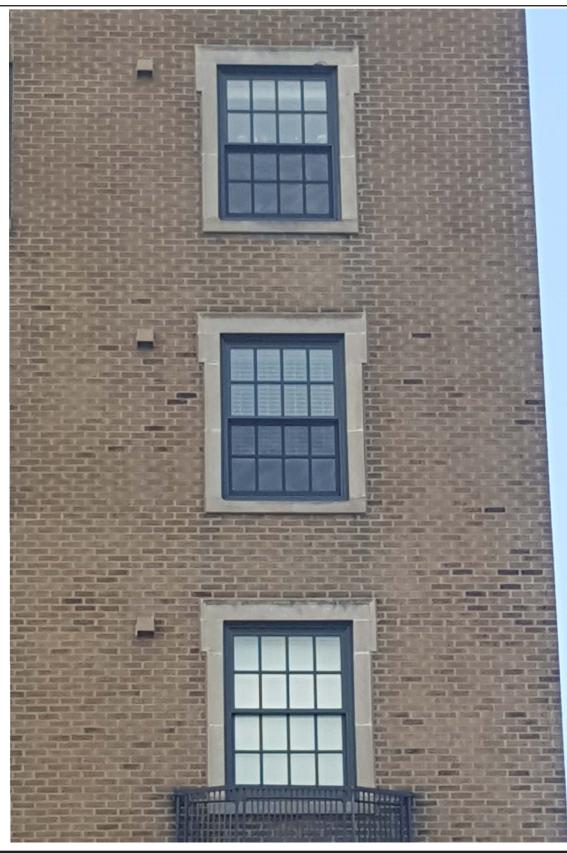
Thru-wall bathroom vents, see elevation, will be painted sheet metal units, approximately 6" square, similar to those on the brick facade of the historic LaSalle Hotel in downtown South Bend, see picture.

EXAMPLE OF VENTS: Pictures of new vents on LaSalle Hotel, for example

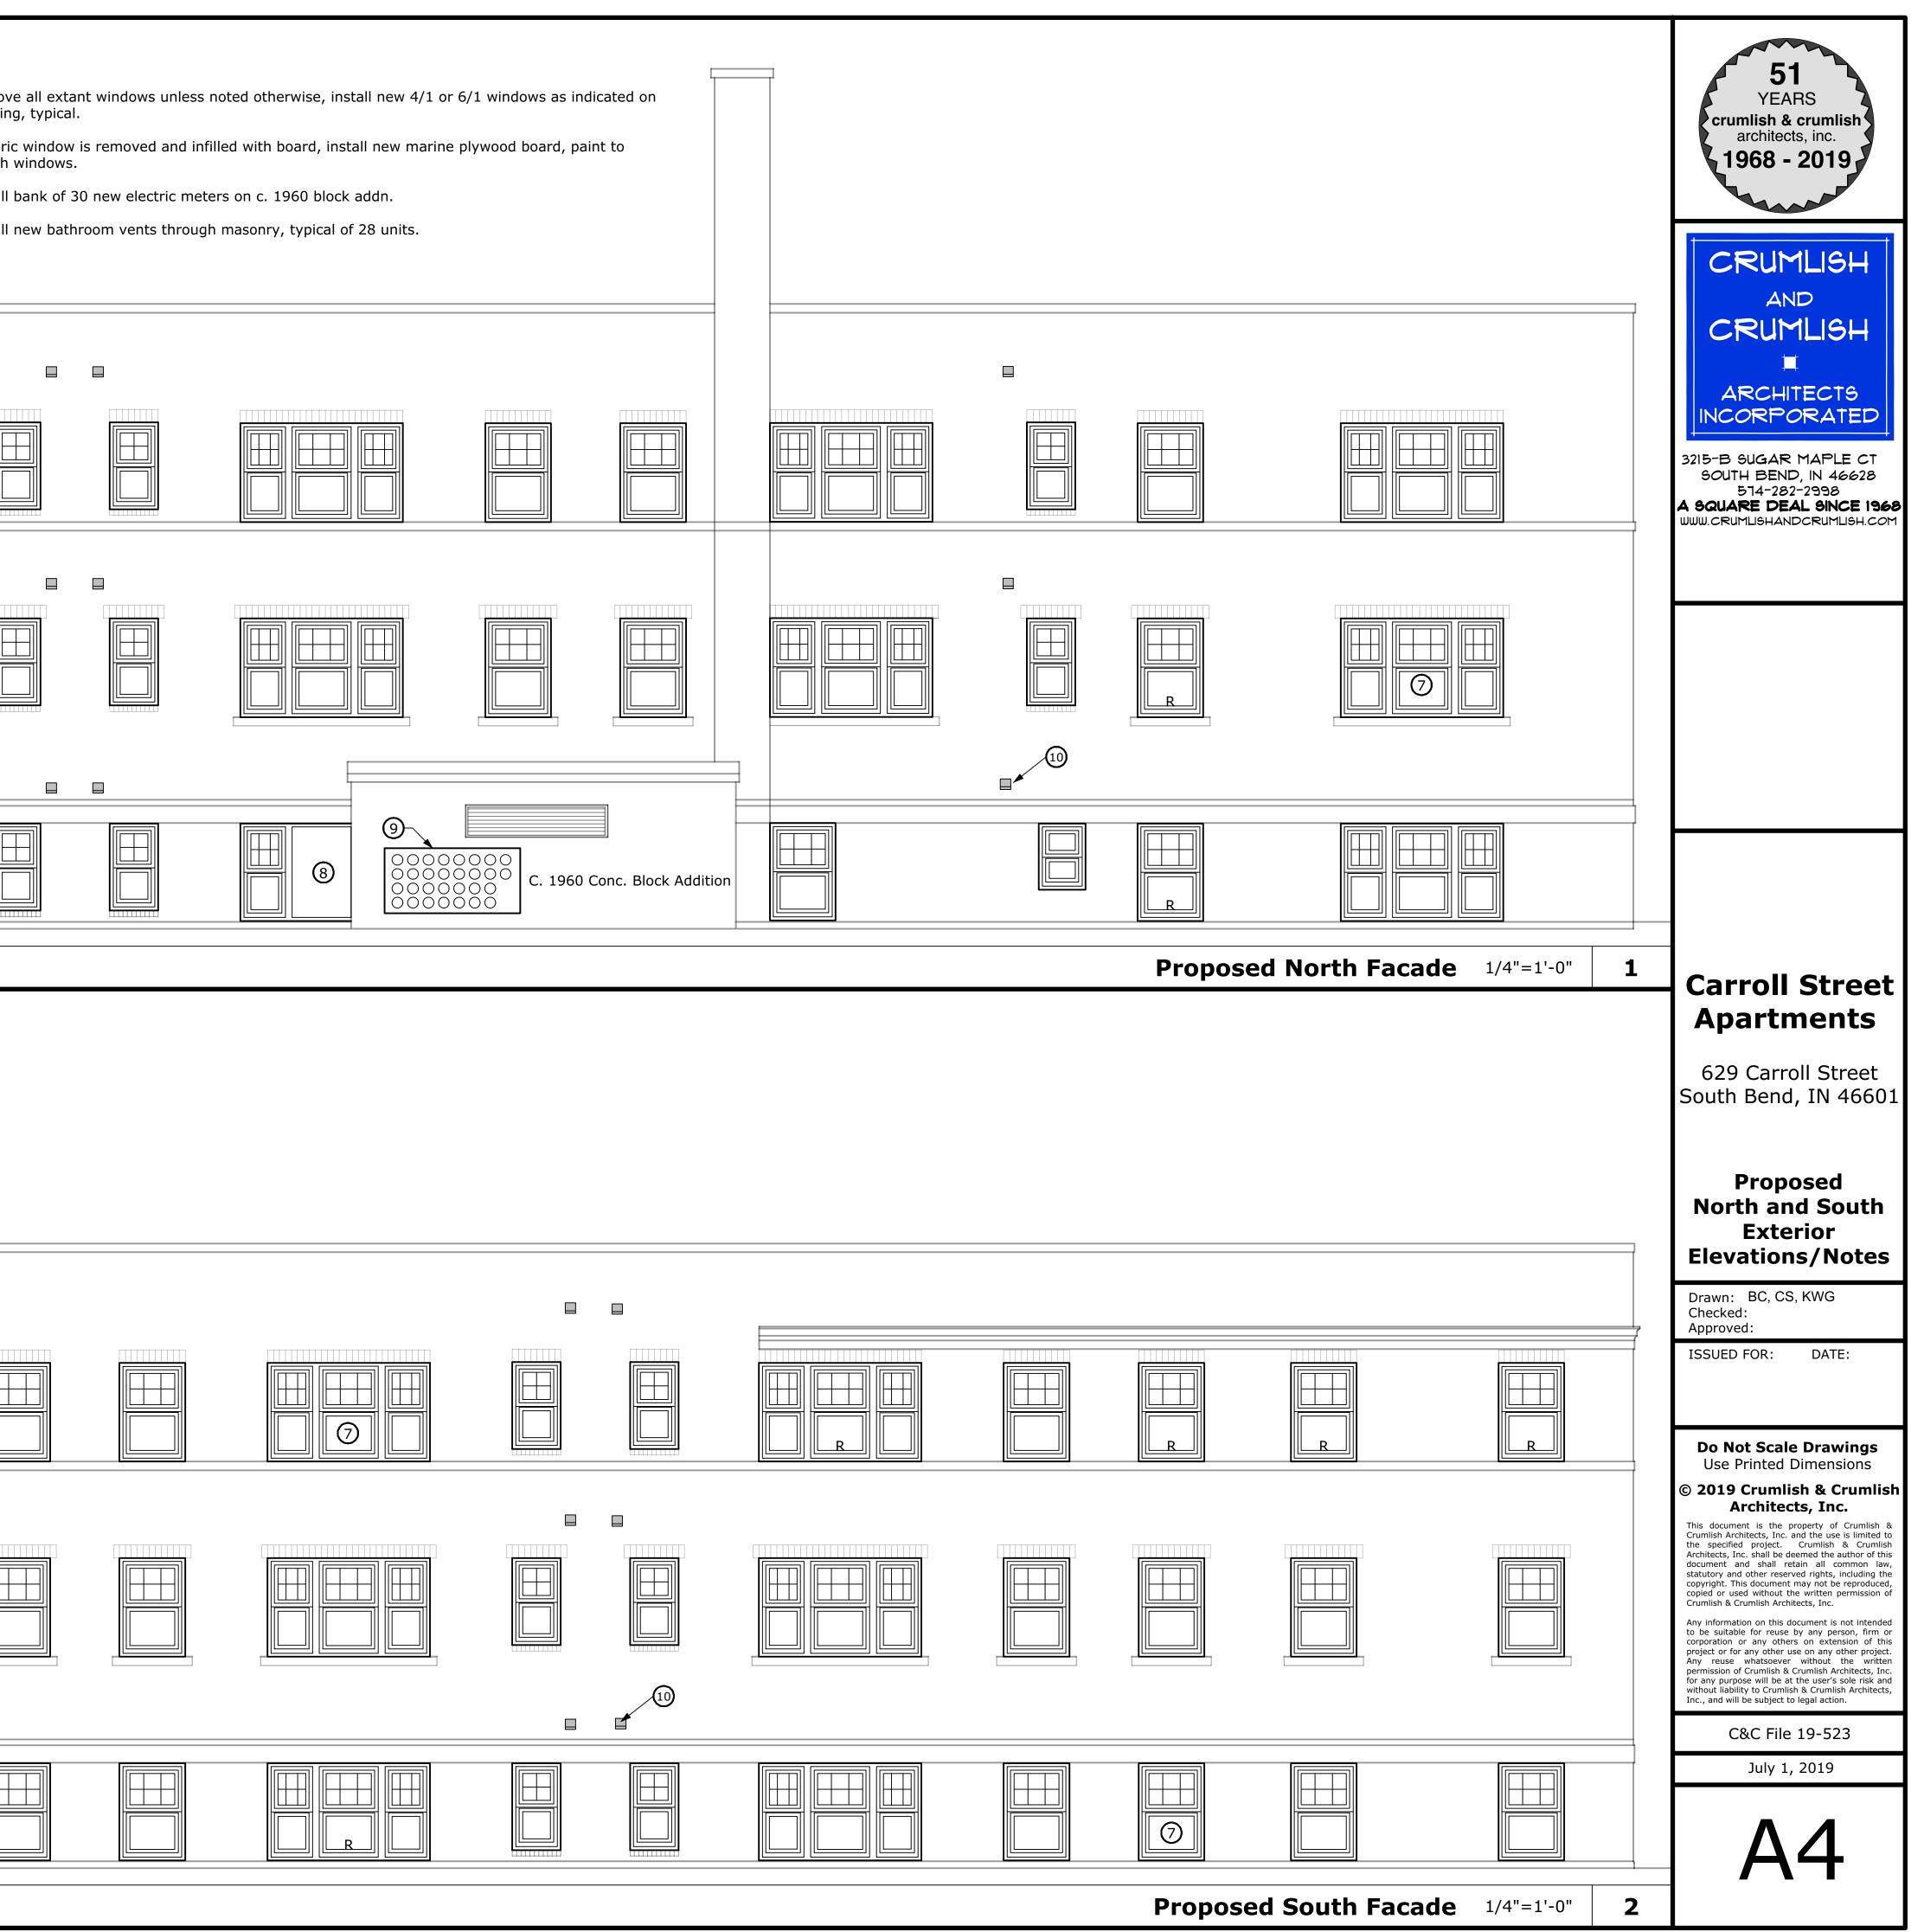
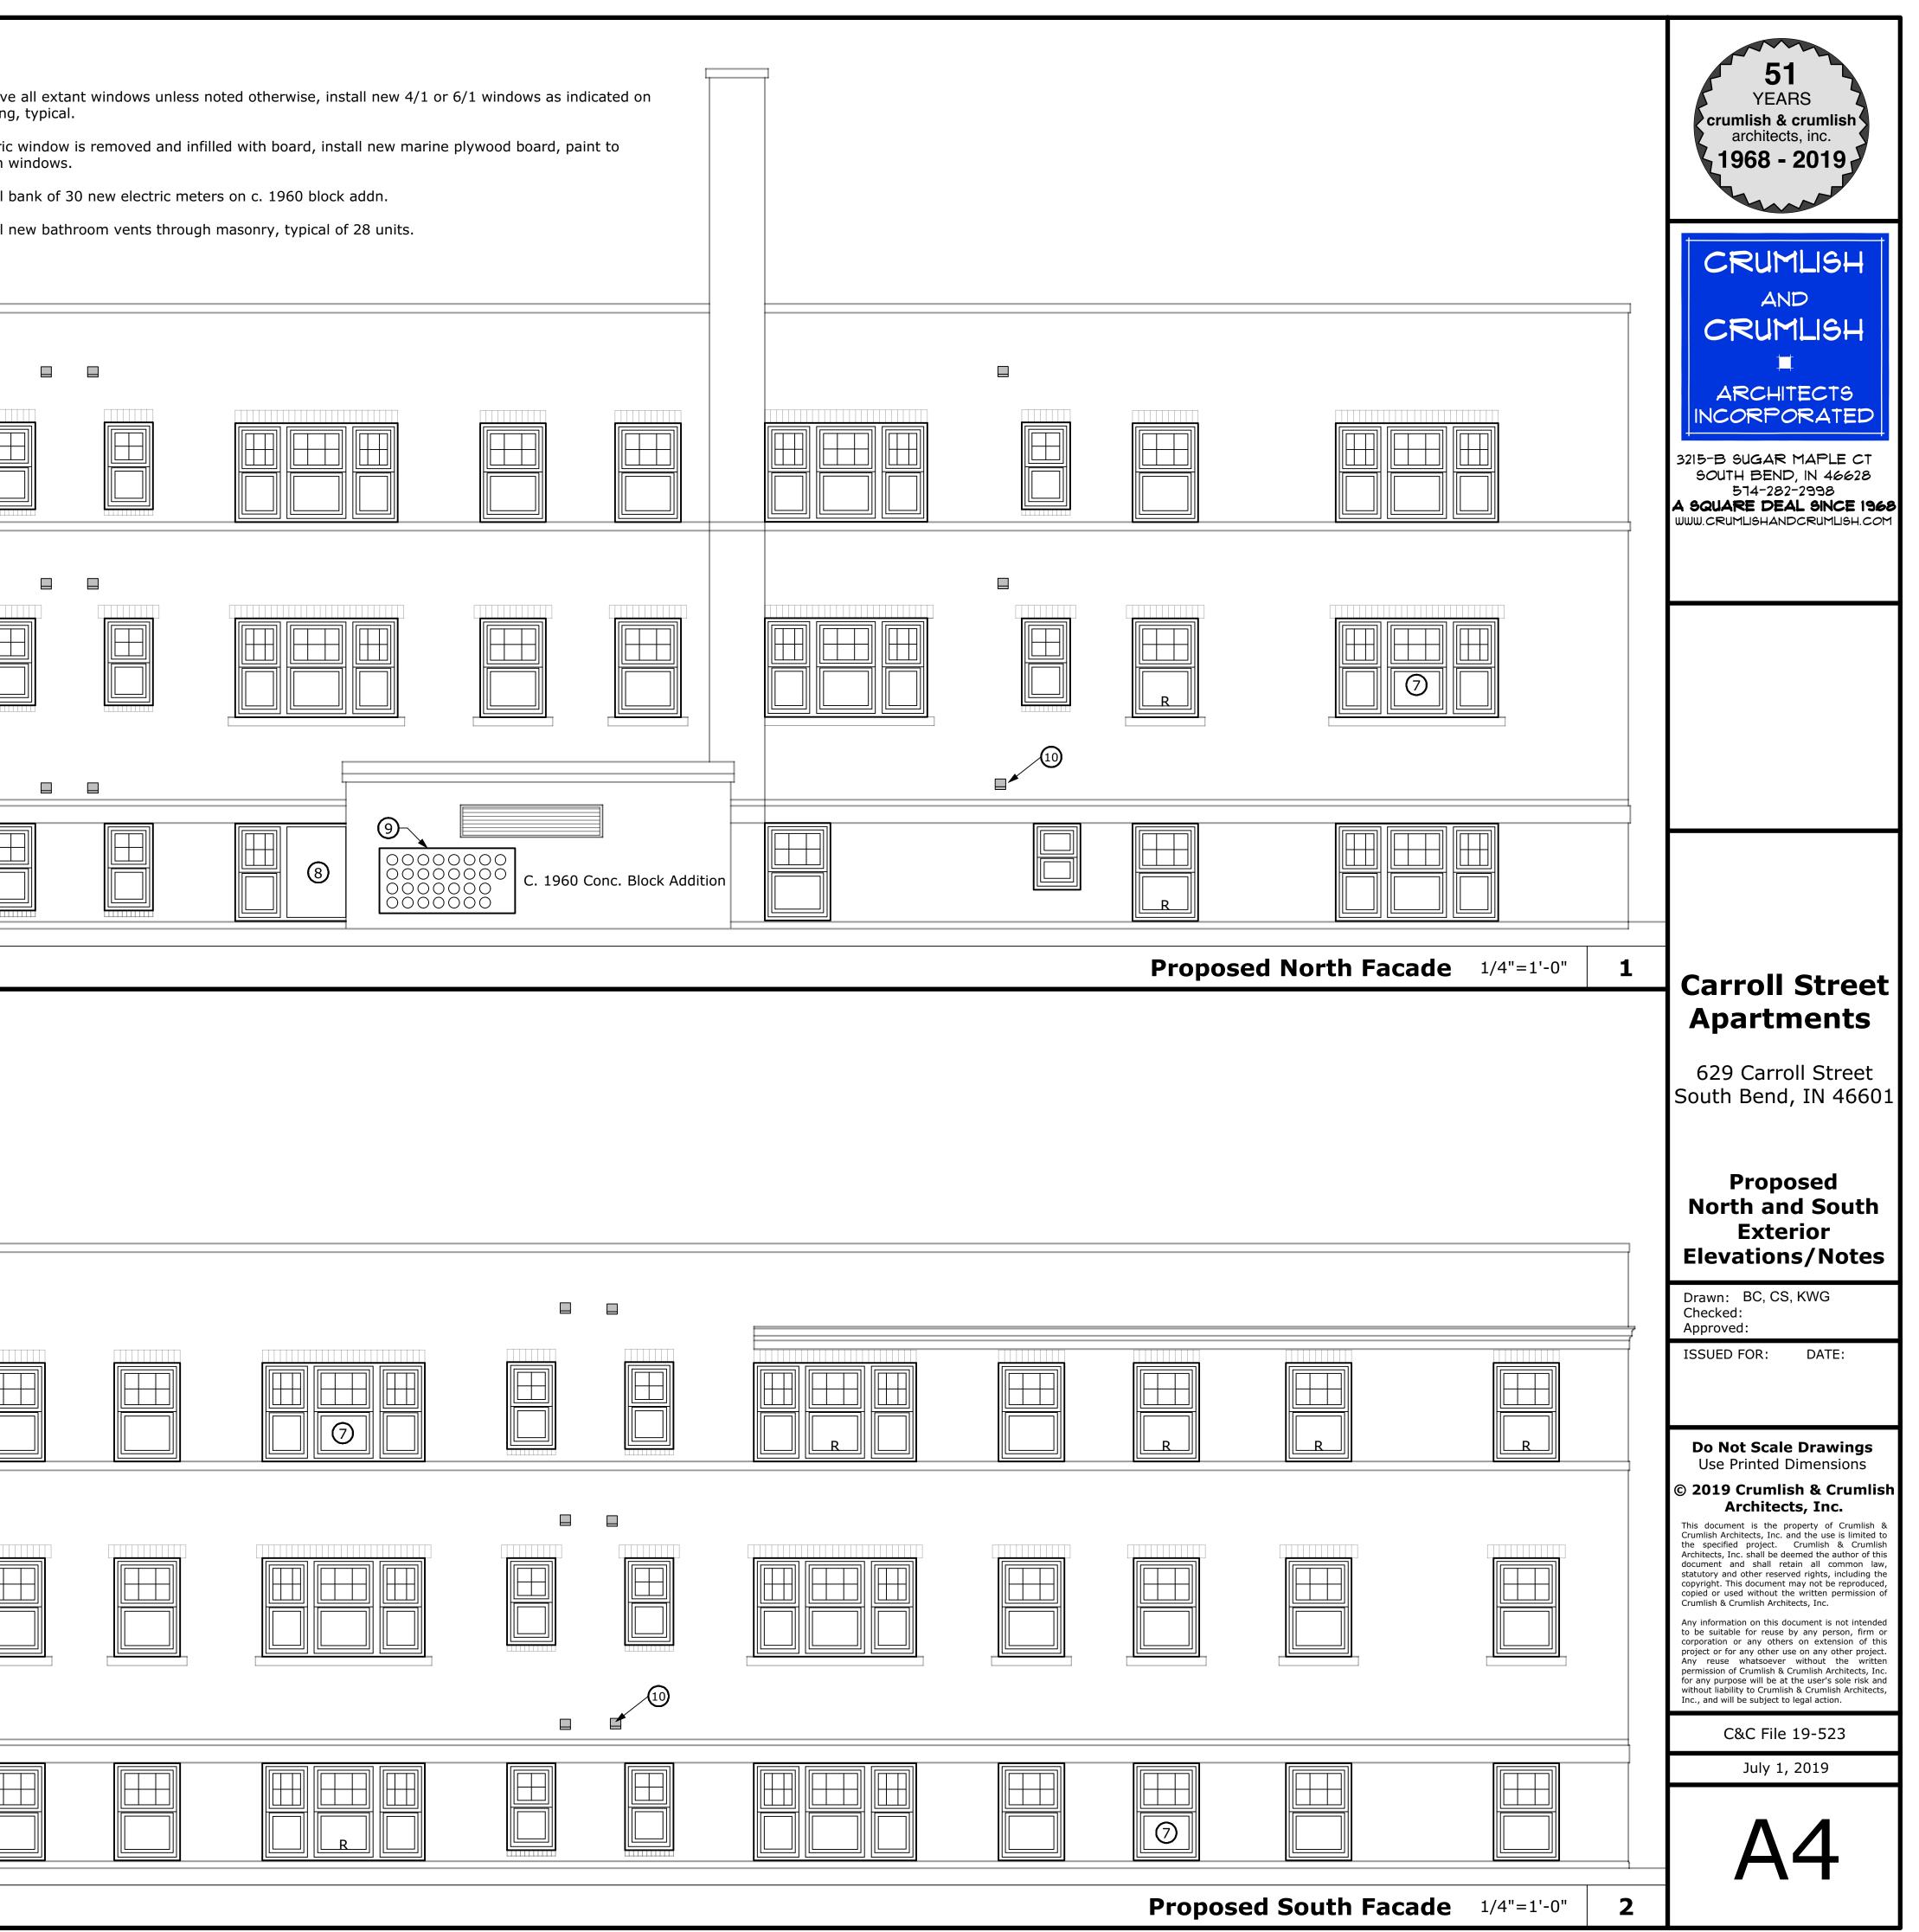
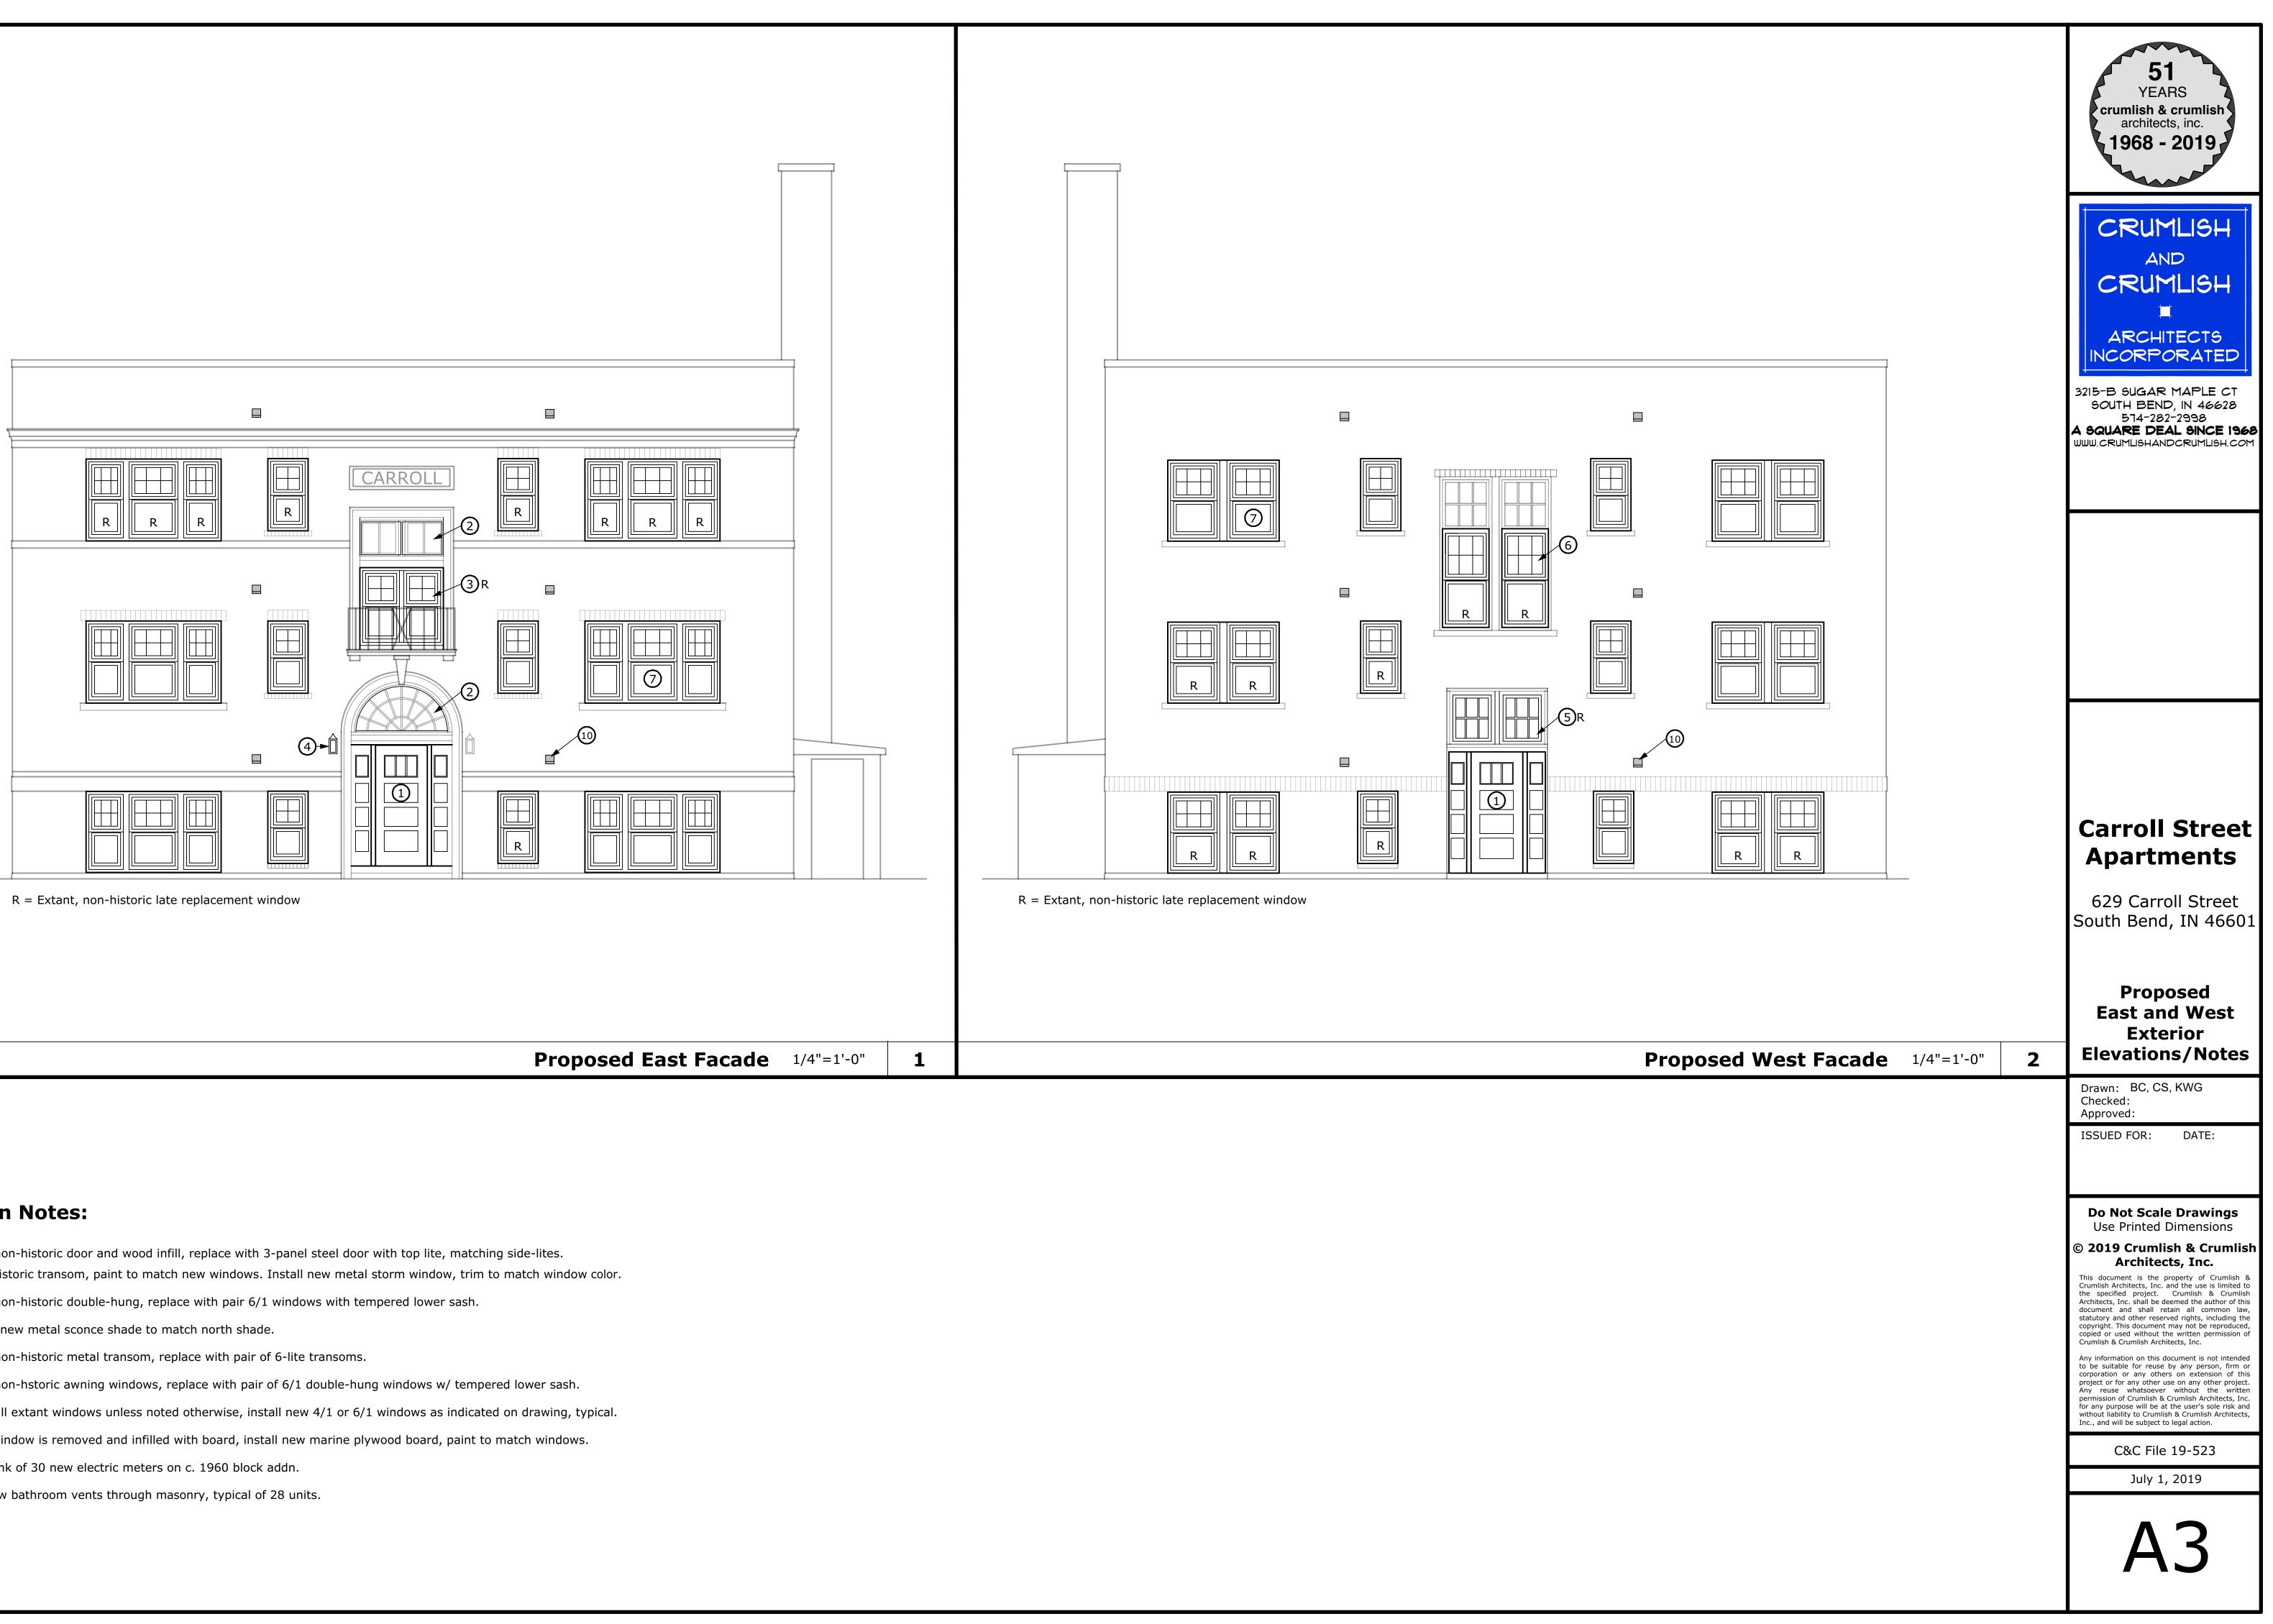
R = Extant, non-historic late replacement window

- 1. Remove non-historic door and wood infill, replace with 3-panel steel door with top lite, matching side-lites.
- 2. Restore historic transom, paint to match new windows. Install new metal storm window, trim to match window color.

- 3. Remove non-historic double-hung, replace with pair 6/1 windows with tempered lower sash.
- 4. Fabricate new metal sconce shade to match north shade.

- 5. Remove non-historic metal transom, replace with pair of 6-lite transoms.
- 6. Remove non-hstoric awning windows, replace with pair of 6/1 double-hung windows w/ tempered lower sash.

- 7. Remove all extant windows unless noted otherwise, install new 4/1 or 6/1 windows as indicated on drawing, typical.
- 8. Historic window is removed and infilled with board, install new marine plywood board, paint to match windows.

- 9. Install bank of 30 new electric meters on c. 1960 block addn.
- 10. Install new bathroom vents through masonry, typical of 28 units.
