LEAD BASED PAINT SURVEY

**TEAM MERCHANDISE STORE
420 S. William Street
South Bend, Indiana 46601**

Project No. 2011-5108

March 9, 2012

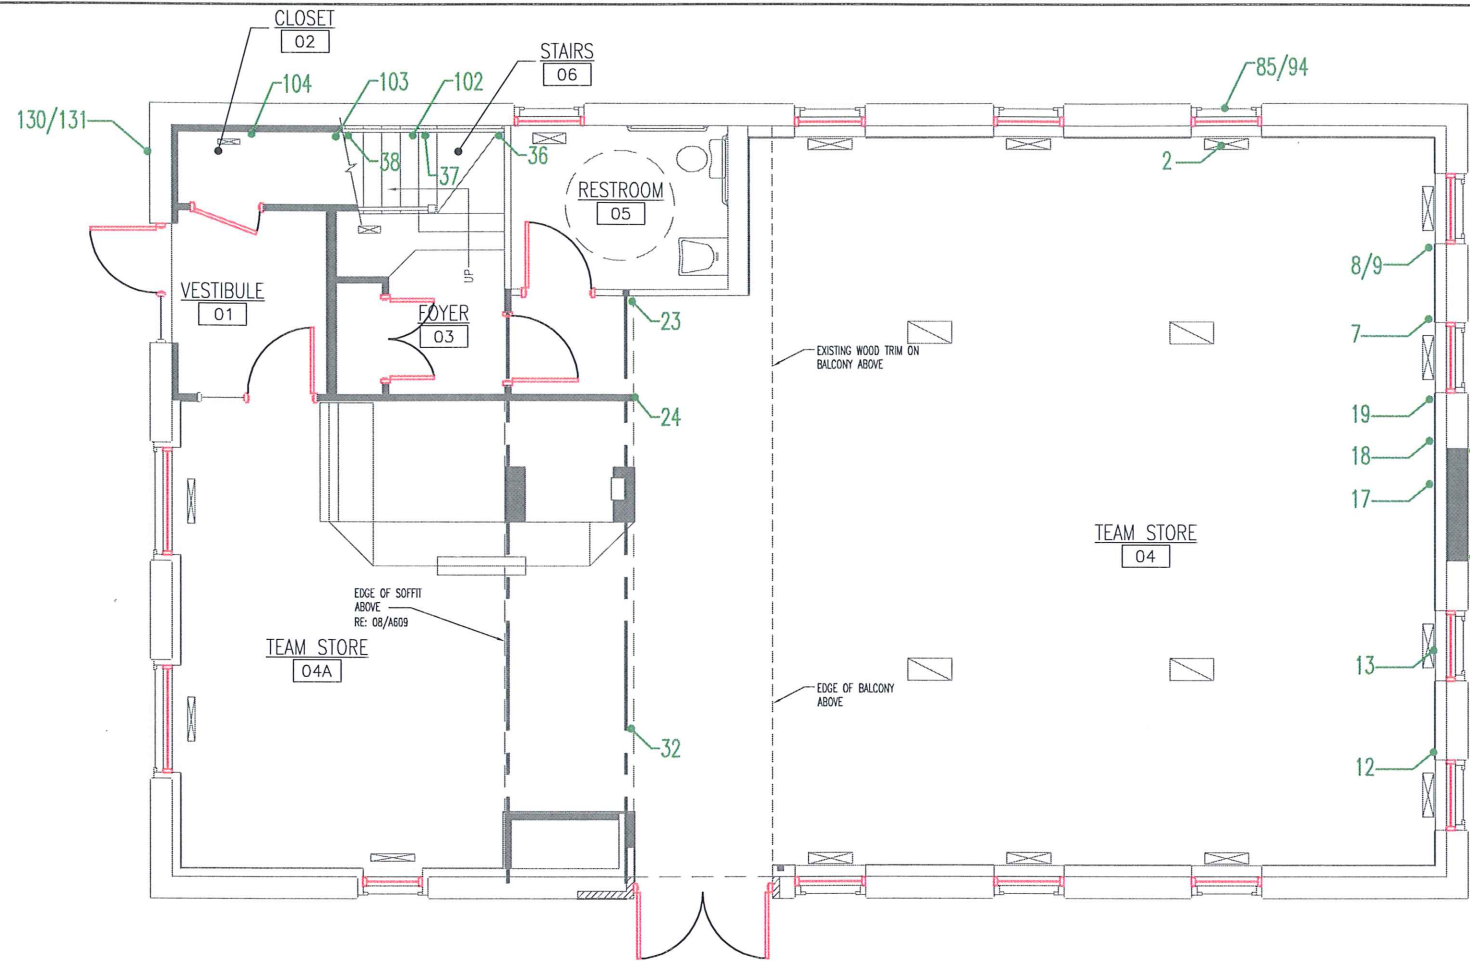
01 FIRST FLOOR PLAN
SCALE: 1/4" = 1'-0"

LEAD PAINT POSITIVE TEST LOCATIONS LEGEND

NO.	STRUCTURE	PAINT COND.	COLOR	LEAD (mg/cm ²)
2	WINDOW	F	BLUE	1.0
7	WALL	P	GREEN	9.9
8	WALL	P	GREEN	9.9
9	WALL	P	GREY	9.9
12	WALL	P	GREEN	9.9
13	WALL	P	GREEN	9.9
17	CLOSET	P	WHITE	6.2
18	CLOSET	P	WHITE	5.9
19	CLOSET	P	WHITE	9.6
23	DOOR	P	BROWN	5.3
24	DOOR	P	BROWN	1.4
32	DOOR	P	BROWN	1.4
37	WALL	P	GREEN	3.0
38	WALL	P	GREEN	1.5
39	WALL	P	BLUE	9.9
43	WALL	F	WHITE	3.3
44	WALL	F	WHITE	4.2
50	WALL	P	WHITE	9.9
51	WALL	P	WHITE	9.9
52	WALL	P	BLUE	9.9
56	WALL	P	BLACK	2.9
57	WALL	P	WHITE	3.9
85	WINDOW	F	BLUE	1.0
94	WINDOW	F	BLUE	2.2
102	WALL	P	GREEN	9.9
103	WALL	P	GREEN	2.4
104	WALL	P	GREEN	1.0
111	WALL	P	DARK BLUE	9.9
112	WALL	P	DARK BLUE	8.1
130	CEILING	F	WHITE	1.6

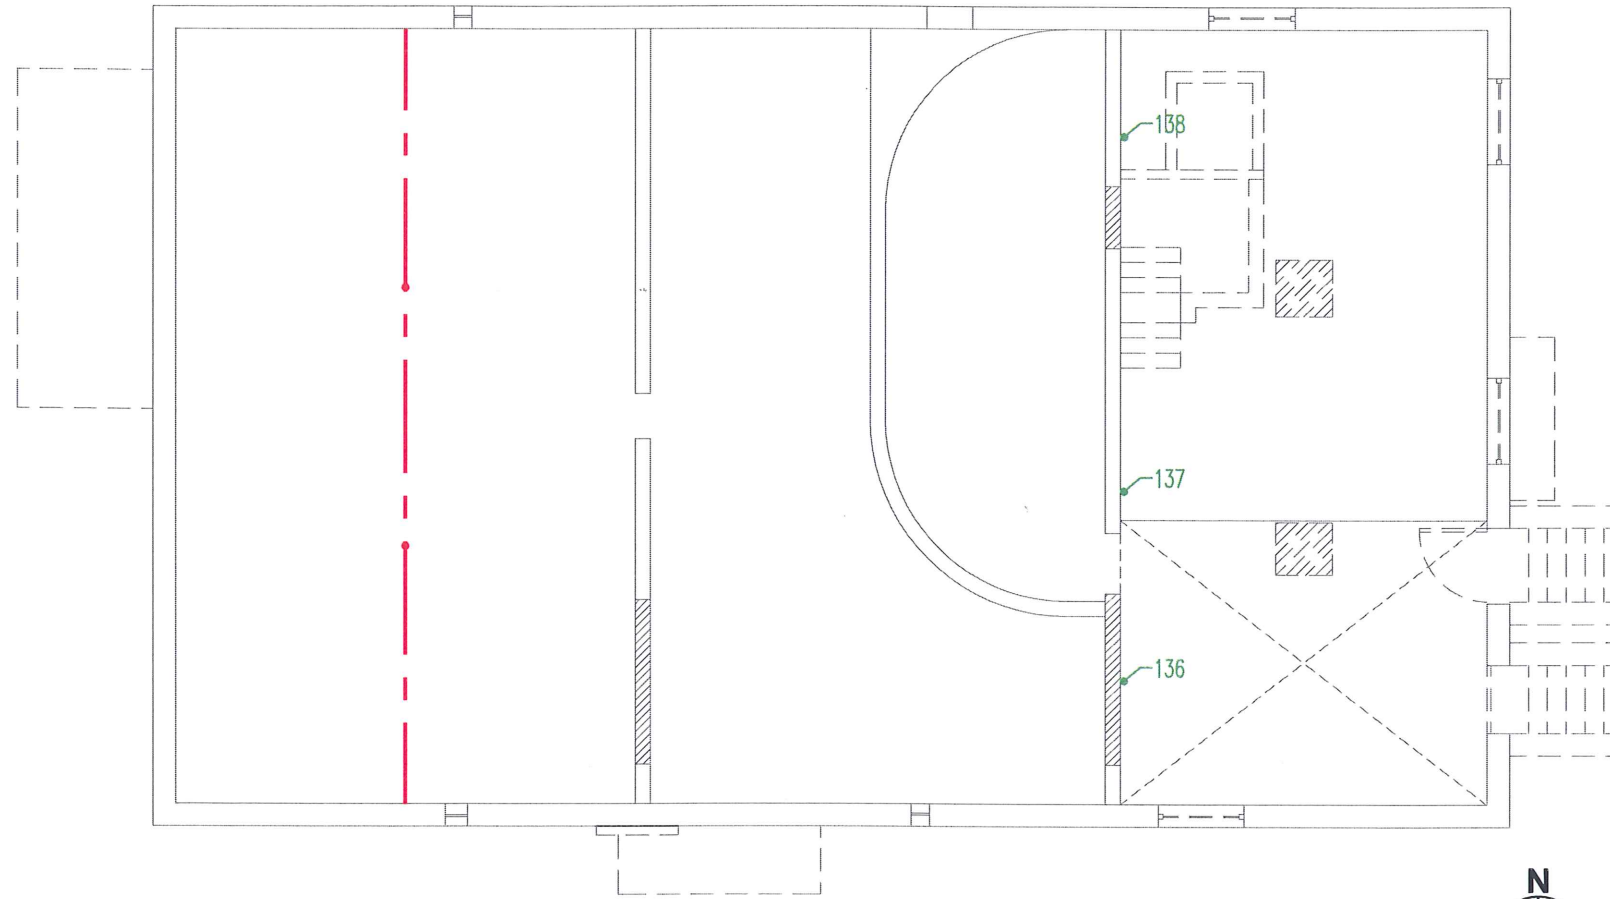
TEAM STORE BASEMENT - LEAD PAINT POSITIVE TEST LOCATIONS

LEAD PAINT POSITIVE TEST LOCATIONS LEGEND

NO.	STRUCTURE	PAINT COND.	COLOR	LEAD (mg/cm ²)
136	WALL	P	BLUE	2.1
137	WALL	P	BLUE	2.0
138	WALL	P	BLUE	1.4
