LEAD BASED PAINT SURVEY

**IVY TOWER CORPORATION FACILITY
635 S. Lafayette Boulevard and 600 Prairie Avenue
South Bend, Indiana**

Project No. 2012-5001

March 21, 2012

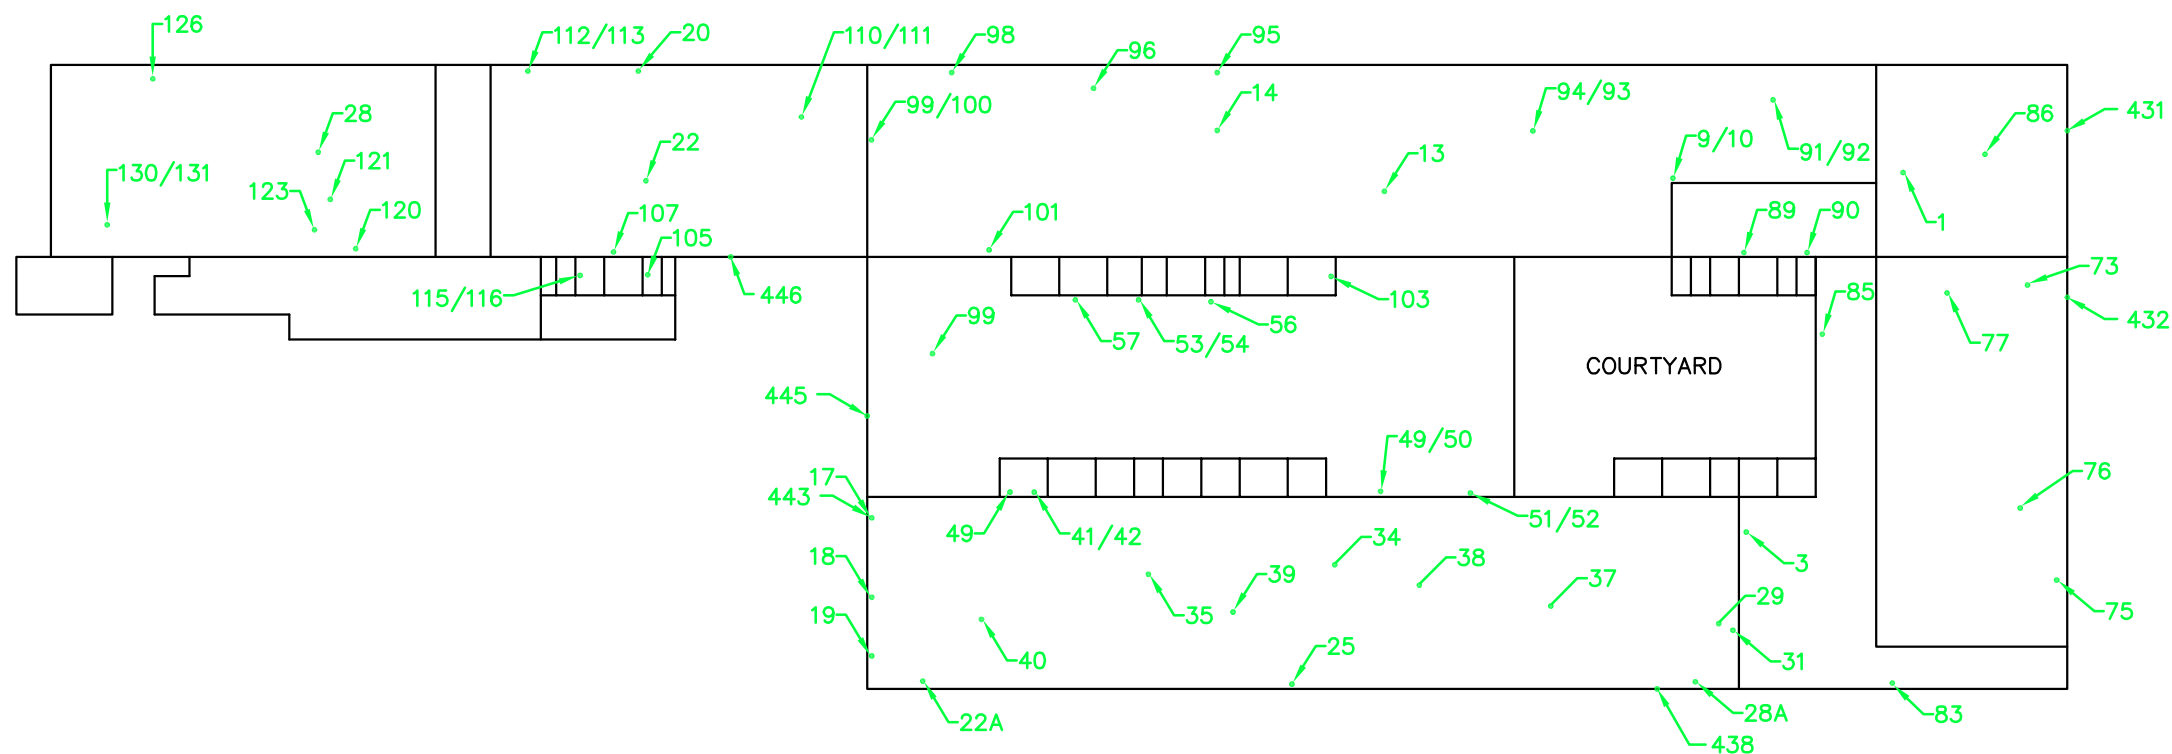
FLOOR 1 – POSITIVE LEAD BASED PAINT LOCATIONS
SCALE 1" = 100'

NO.	STRUCTURE	COLOR	LEAD (MG/CM ²)	COND	NO.	STRUCTURE	COLOR	LEAD (MG/CM ²)	COND	NO.	STRUCTURE	COLOR	LEAD (MG/CM ²)	COND
1	PILLAR	WHITE	1.3	P	45	WALL	GREEN	1.0	P	98	WALL	GREEN	1.0	P
3	CEILING	WHITE	1.0	P	49	I BEAM	GREEN	5.9	P	99	PILLAR	GREEN	1.0	P
9	CEILING	WHITE	1.0	P	50	I BEAM	WHITE	4.9	P	100	PILLAR	WHITE	2.4	P
10	PIPE	RED	1.8	P	51	I BEAM	WHITE	7.0	P	101	PILLAR	GREY	1.7	P
13	PIPE	RED	1.0	P	52	I BEAM	GREEN	4.8	P	103	WALL	GREEN	1.8	P
14	PIPE	WHITE	1.0	P	53	I BEAM	GREEN	5.8	P	105	DOOR	GREEN	1.0	P
20	DUCT	BLUE	1.0	P	54	I BEAM	WHITE	6.3	P	107	WALL	GREEN	1.0	P
22	PIPE	RED	1.0	P	56	WALL	GREEN	1.0	P	110	PILLAR	RED	1.0	P
28	CEILING	WHITE	1.0	P	57	WALL	GREY	1.0	P	111	PILLAR	GREEN	1.0	P
17	WALL	WHITE	1.0	P	59	I BEAM	YELLOW	5.7	I	112	WALL	GREEN	1.8	P
18	WALL	WHITE	1.0	P	73	PILLAR	WHITE	1.0	P	113	WALL	WHITE	1.6	P
19	WALL	WHITE	1.0	P	75	DOOR	RED	1.0	I	115	STAIRS	RED	1.9	I
22A	WALL	WHITE	1.0	P	76	PILLAR	WHITE	1.0	P	116	STAIRS	RED	1.0	I

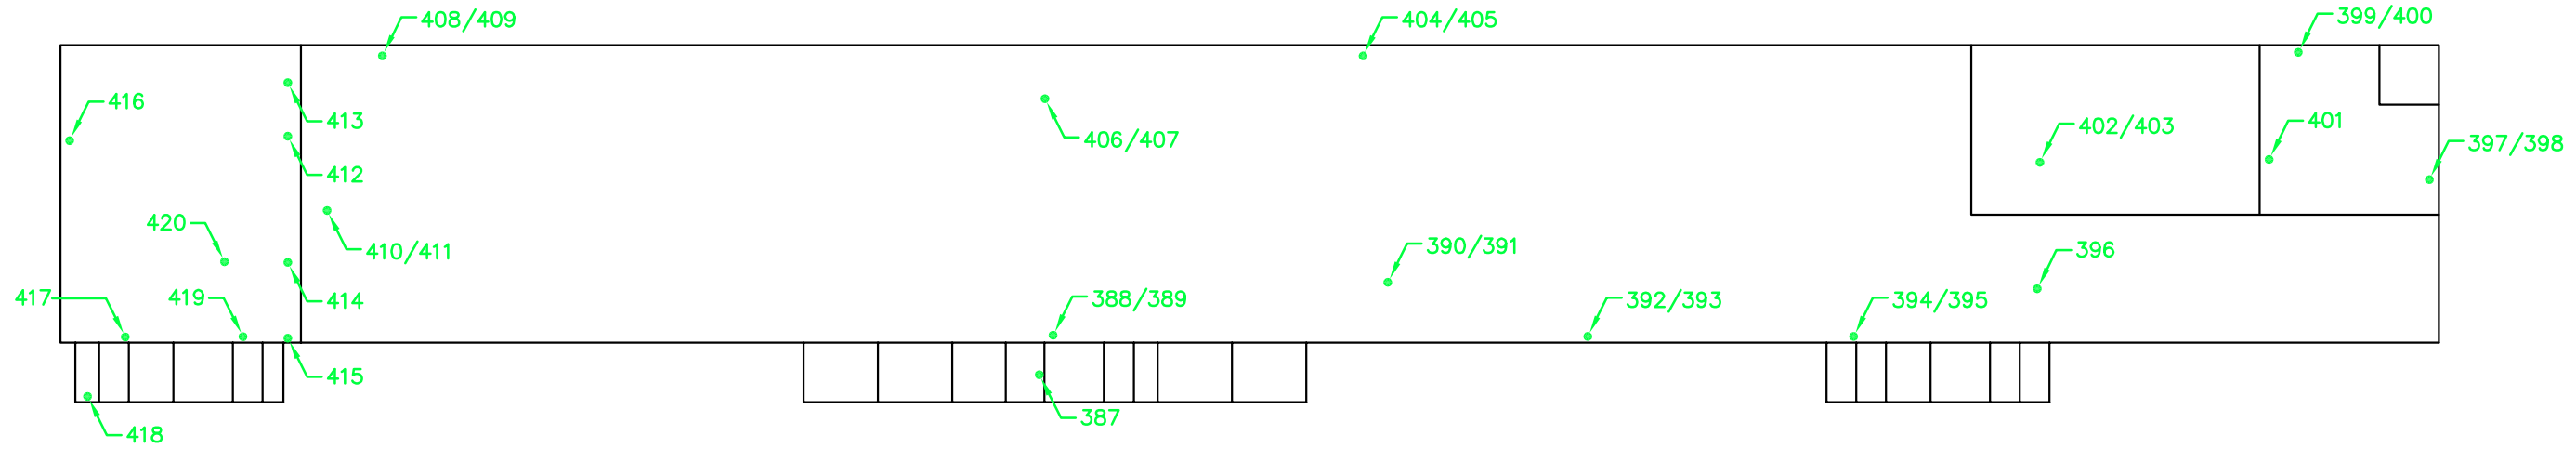
FLOOR 4 – POSITIVE LEAD BASED PAINT LOCATIONS

NO.	STRUCTURE	COLOR	LEAD (MG/CM ²)	COND
389	WALL	GREEN	6.1	P
392	WALL	WHITE	1.7	P
393	WALL	GREEN	1.0	P
394	WALL	GREEN	7.6	P
396	PILLAR	WHITE	1.0	P
397	WALL	GREEN	1.0	P
399	WALL	WHITE	1.6	P
400	WALL	GREEN	2.0	P
401	DOOR	RED	6.3	P
402	PILLAR	WHITE	1.4	P
406	PILLAR	WHITE	1.0	P
407	PILLAR	GREEN	1.0	P
408	WALL	GREEN	1.0	P
409	WALL	WHITE	1.0	P
410	PILLAR	N/A	1.0	P
411	PILLAR	GREEN	1.8	P
417	WALL	WHITE	3.3	P
419	WALL	WHITE	6.8	P
420	PILLAR	WHITE	9.9	P

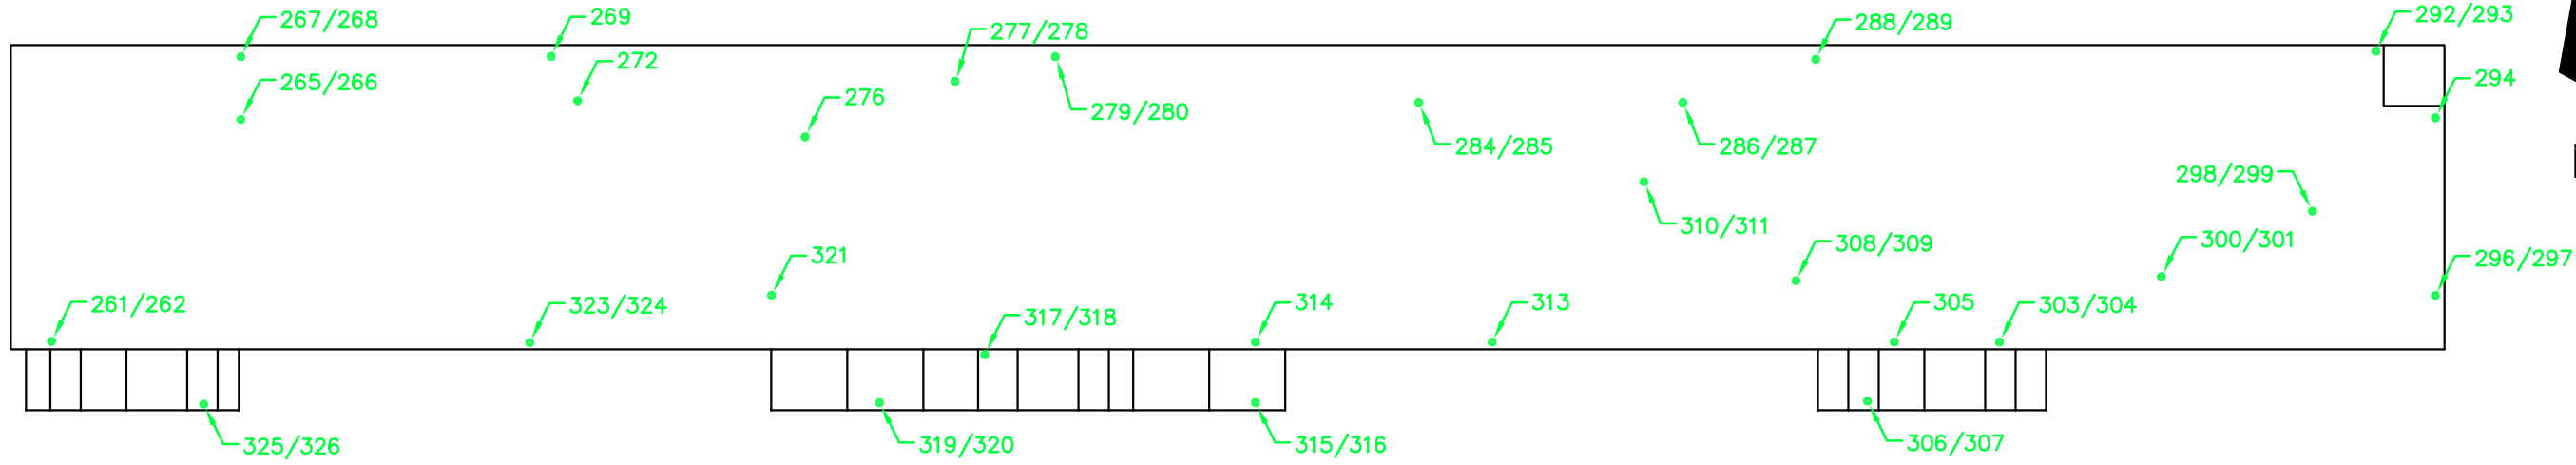
FLOOR 5 – LEAD BASED PAINT LOCATIONS
SCALE 1" = 60'

NO.	STRUCTURE	COLOR	LEAD (MG/CM ²)	COND	NO.	STRUCTURE	COLOR	LEAD (MG/CM ²)	COND
261	WALL	WHITE	5.7	P	298	PILLAR	GREEN	6.7	P
262	WALL	GREEN	6.3	P	299	PILLAR	WHITE	3.9	P
265	PILLAR	WHITE	3.4	P	300	PILLAR	WHITE	3.0	P
266	PILLAR	GREEN	4.6	P	301	PILLAR	GREEN	7.0	P
267	WALL	GREEN	6.8	P	303	WALL	WHITE	8.8	P
268	WALL	WHITE	3.6	P	304	WALL	GREEN	4.7	P
269	WALL	WHITE	4.2	P	305	DOOR	RED	2.3	P
272	PILLAR	RED	1.6	P	306	WALL	WHITE	4.2	P
273	WALL	WHITE	3.8	P	307	WALL	GREEN	6.1	P
274	WALL	GREEN	4.9	P	308	PILLAR	GREEN	1.8	P
276	PILLAR	WHITE	3.0	P	309	PILLAR	WHITE	1.6	P
277	PILLAR	WHITE	5.3	P	310	PILLAR	WHITE	1.0	P
278	PILLAR	GREEN	5.4	P	311	PILLAR	WHITE	1.4	P
279	WALL	GREEN	3.5	P	313	WALL	GREEN	1.4	P
280	WALL	WHITE	2.9	P	314	DOOR	GREEN	1.0	P
284	PILLAR	WHITE	4.3	P	315	WALL	GREEN	1.6	P
285	PILLAR	GREEN	3.5	P	316	WALL	WHITE	1.0	P
286	PILLAR	GREEN	1.4	P	317	WALL	WHITE	2.6	P
287	PILLAR	ORANGE	2.0	P	318	WALL	GREEN	3.1	P
288	WALL	WHITE	1.0	P	319	WALL	GREEN	1.0	P

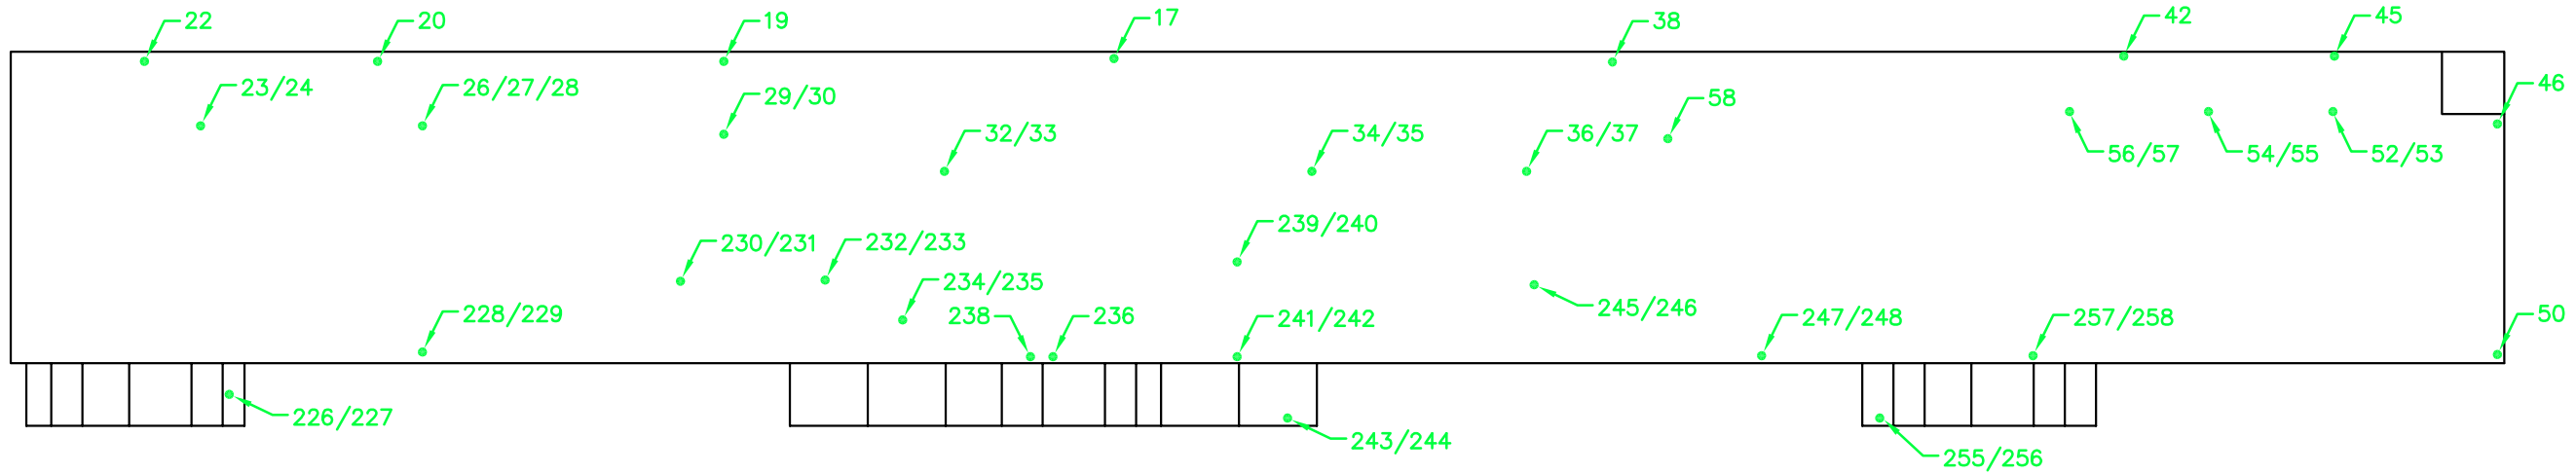
FLOOR 6 – POSITIVE LEAD BASED PAINT LOCATIONS
SCALE 1" = 60'

NO.	STRUCTURE	COLOR	LEAD (MG/CM ²)	COND	NO.	STRUCTURE	COLOR	LEAD (MG/CM ²)	COND	NO.	STRUCTURE	COLOR	LEAD (MG/CM ²)	COND
17	WALL	GREEN	1.0	P	45	WALL	GREEN	1.0	P	201	WALL	WHITE	3.9	P
19	WALL	GREEN	1.0	P	46	WALL	GREEN	1.0	P	202	WALL	GREEN	4.5	P
20	WALL	GREEN	1.0	P	50	WALL	GREEN	1.0	P	203	DOOR	RED	1.0	P
22	WALL	GREEN	1.0	P	52	I BEAM	WHITE	1.7	P	206	WALL	GREEN	1.0	P
23	PILLAR	GREEN	1.0	P	53	I BEAM	GREEN	1.7	P	207	PILLAR	GREEN	1.0	P
24	PILLAR	RED	1.0	P	54	I BEAM	GREEN	1.8	P	208	PILLAR	WHITE	1.3	P
26	PILLAR	WHITE	2.4	P	55	I BEAM	WHITE	1.0	P	210	PILLAR	GREEN	1.8	P
27	PILLAR	ORANGE	2.0	P	56	PILLAR	WHITE	1.0	P	211	PILLAR	WHITE	1.5	P
28	PILLAR	GREEN	1.0	P	57	PILLAR	GREEN	1.4	P	212	WALL	GREEN	1.6	P
29	PILLAR	GREEN	1.0	P	58	PILLAR	GREEN	1.0	P	213	WALL	WHITE	1.4	P
30	PILLAR	ORANGE	1.0	P	182	PILLAR	WHITE	1.0	P	214	WALL	WHITE	1.5	P
32	I BEAM	WHITE	1.9	P	183	PILLAR	GREEN	1.0	P	215	WALL	GREEN	1.4	P
33	I BEAM	GREEN	2.4	P	186	DOOR	GREEN	1.0	P	218	DOOR	GREEN	1.7	P
