UNDERGROUND STORAGE TANK REMOVAL  
INITIAL SITE CHARACTERIZATION  
ALLIED AUTOMOTIVE  
BENDIX AUTOMOTIVE BRAKE SYSTEMS  
NORTH AMERICA  
SOUTH BEND, INDIANA

28 February 1990

PROJECT # ASBSNA SBIN 001

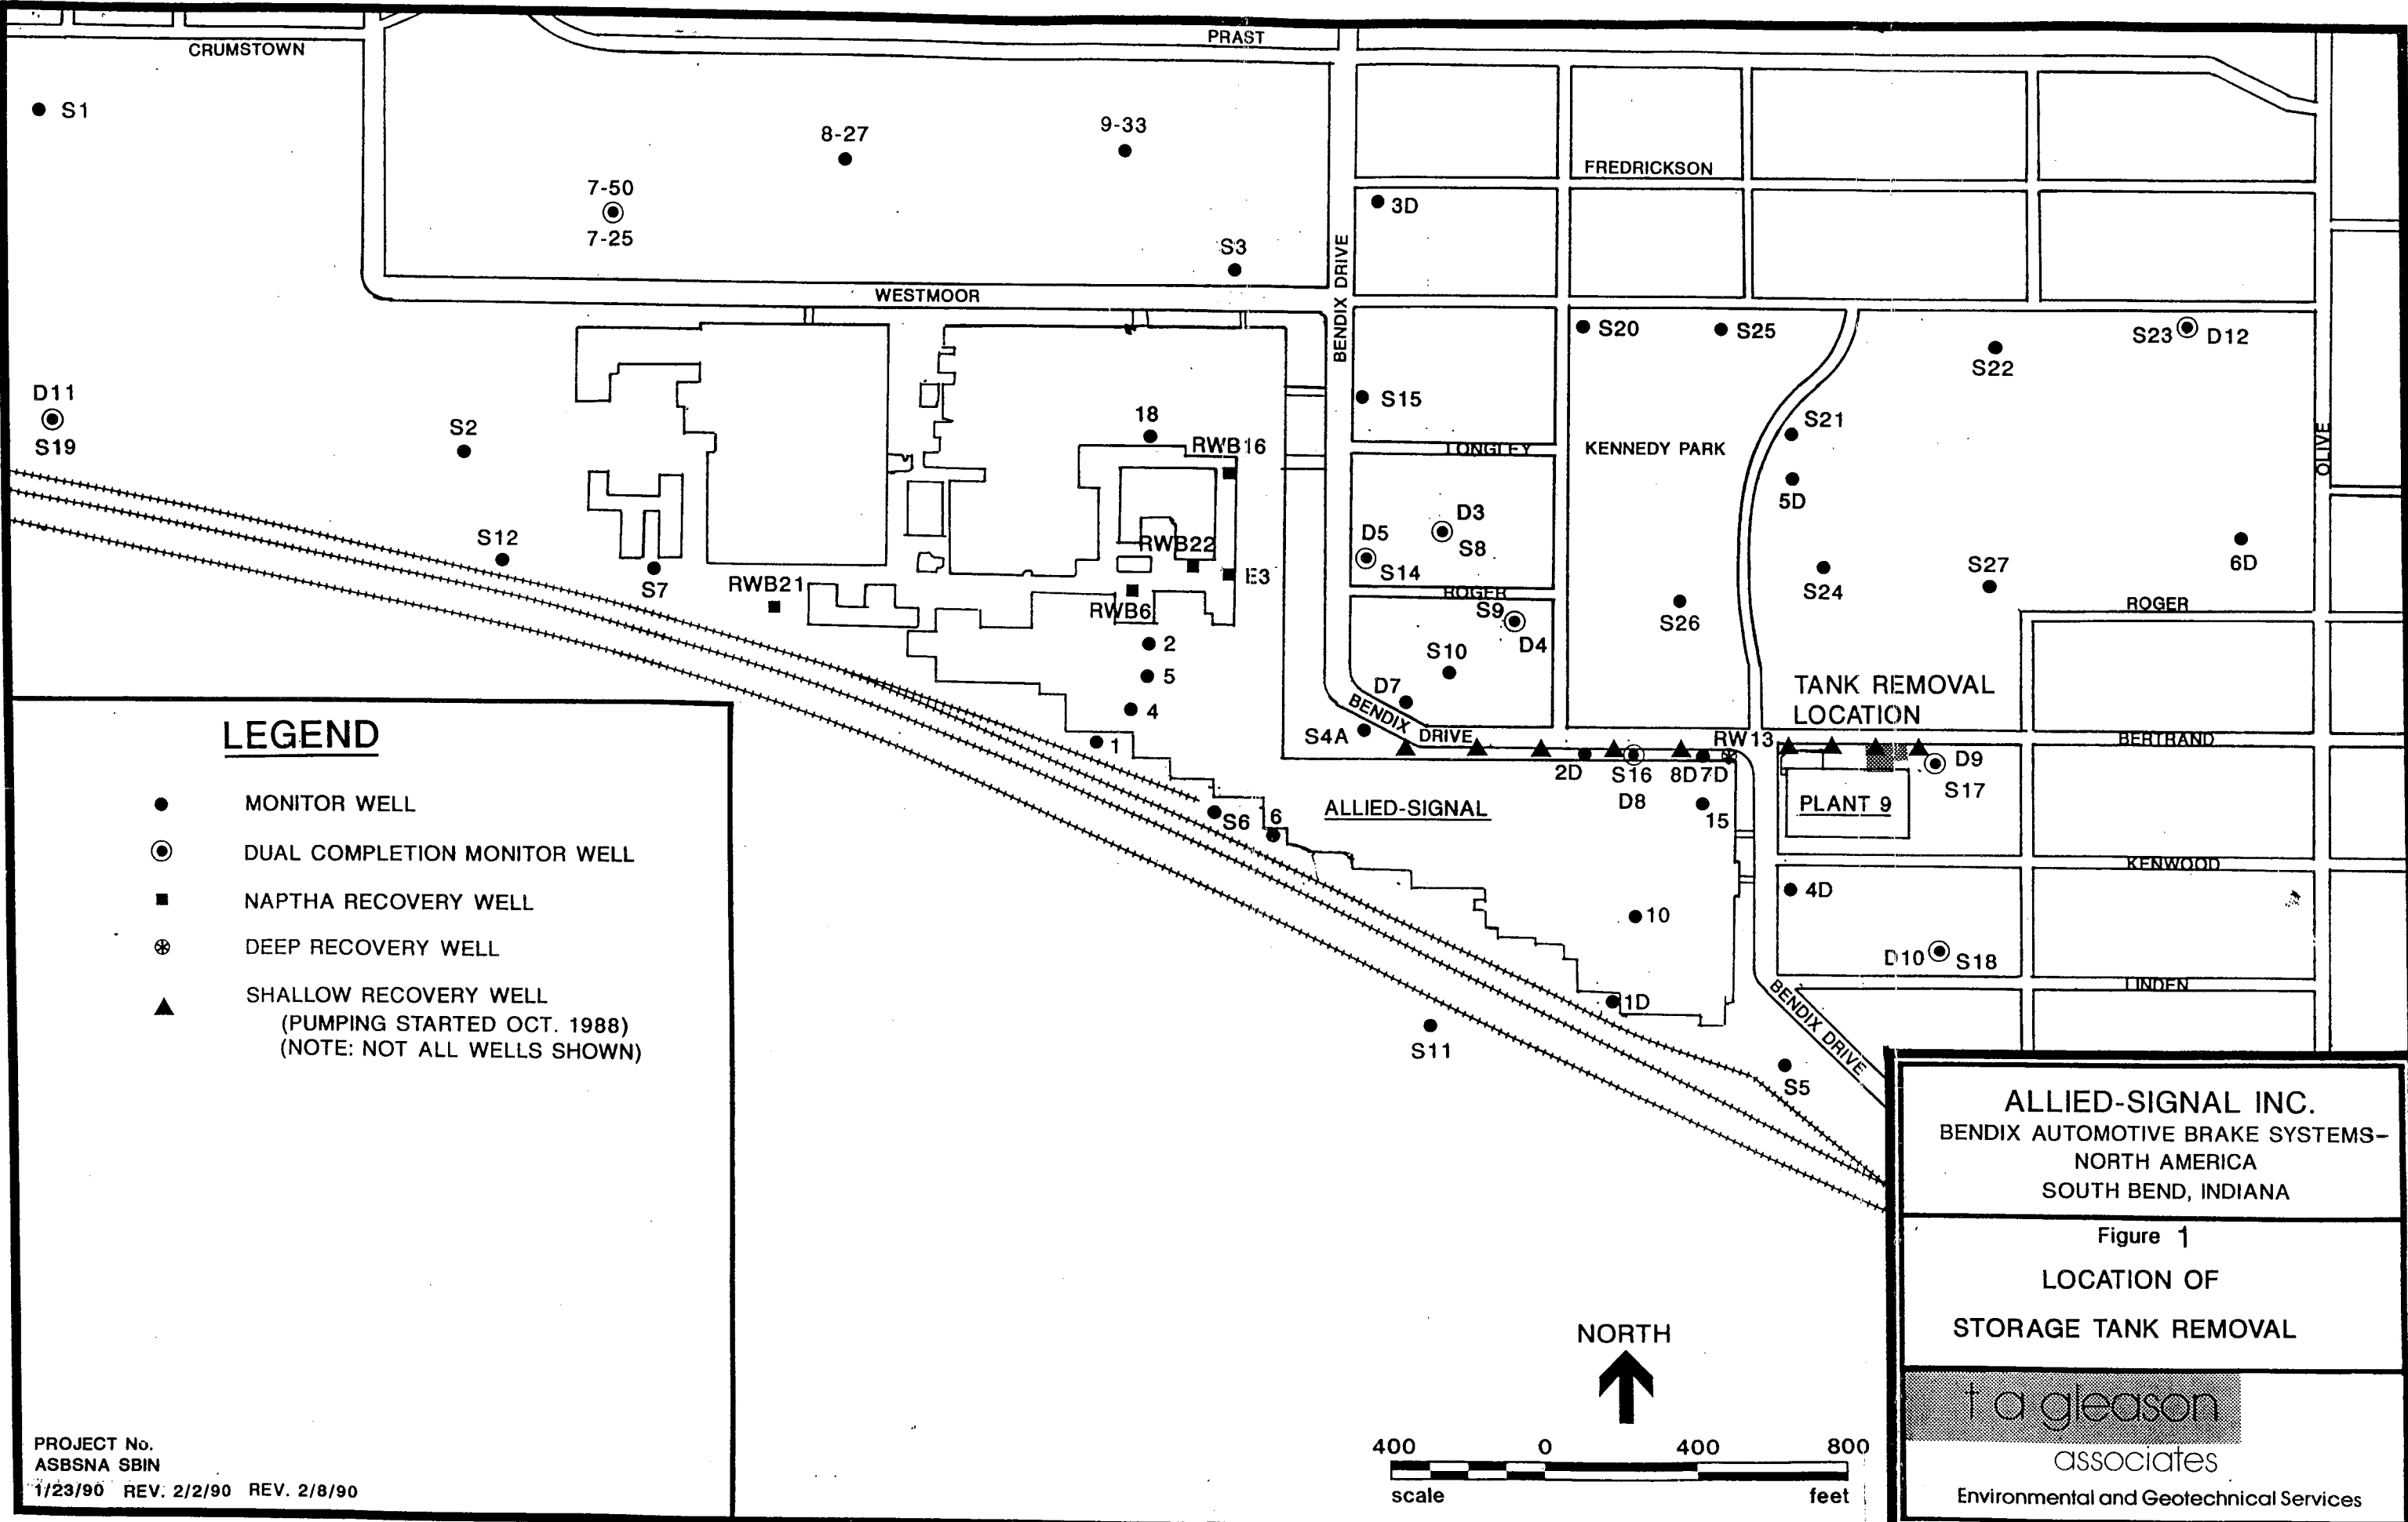
Figure 1  
 LOCATION OF  
 STORAGE TANK REMOVAL

The tank was located in an industrial and residential area. To the north of the tank location is Bertrand street and a city park (Bendix Park). North of Bendix Park is residential and the area east of the tank location is residential. The Bendix facility is located immediately south and west of the tank location (see Figure 1).

There are no known drinking water wells within 1/4 mile of the tank location. There are numerous groundwater monitor wells (see Figure 1) within 1/4 mile of the tank facility. These wells have been installed as part of previous investigations at the Bendix facility. Several of these wells are being sampled on a quarterly basis for volatile organic compounds (VOC) using EPA method 8240. Additionally, there are several groundwater recovery wells located along Bertrand street immediately downgradient from the tank location which are also sampled and analyzed for VOC method 8240 on a quarterly basis. Analytical results show no evidence of gasoline contamination in any of the monitor wells or recovery wells in the proximity of the tank. The most recent sampling of these wells was conducted in December 1989. The sampling results were reported to Bendix in TAGA's 4th Quarter 1989 Monitoring Report.

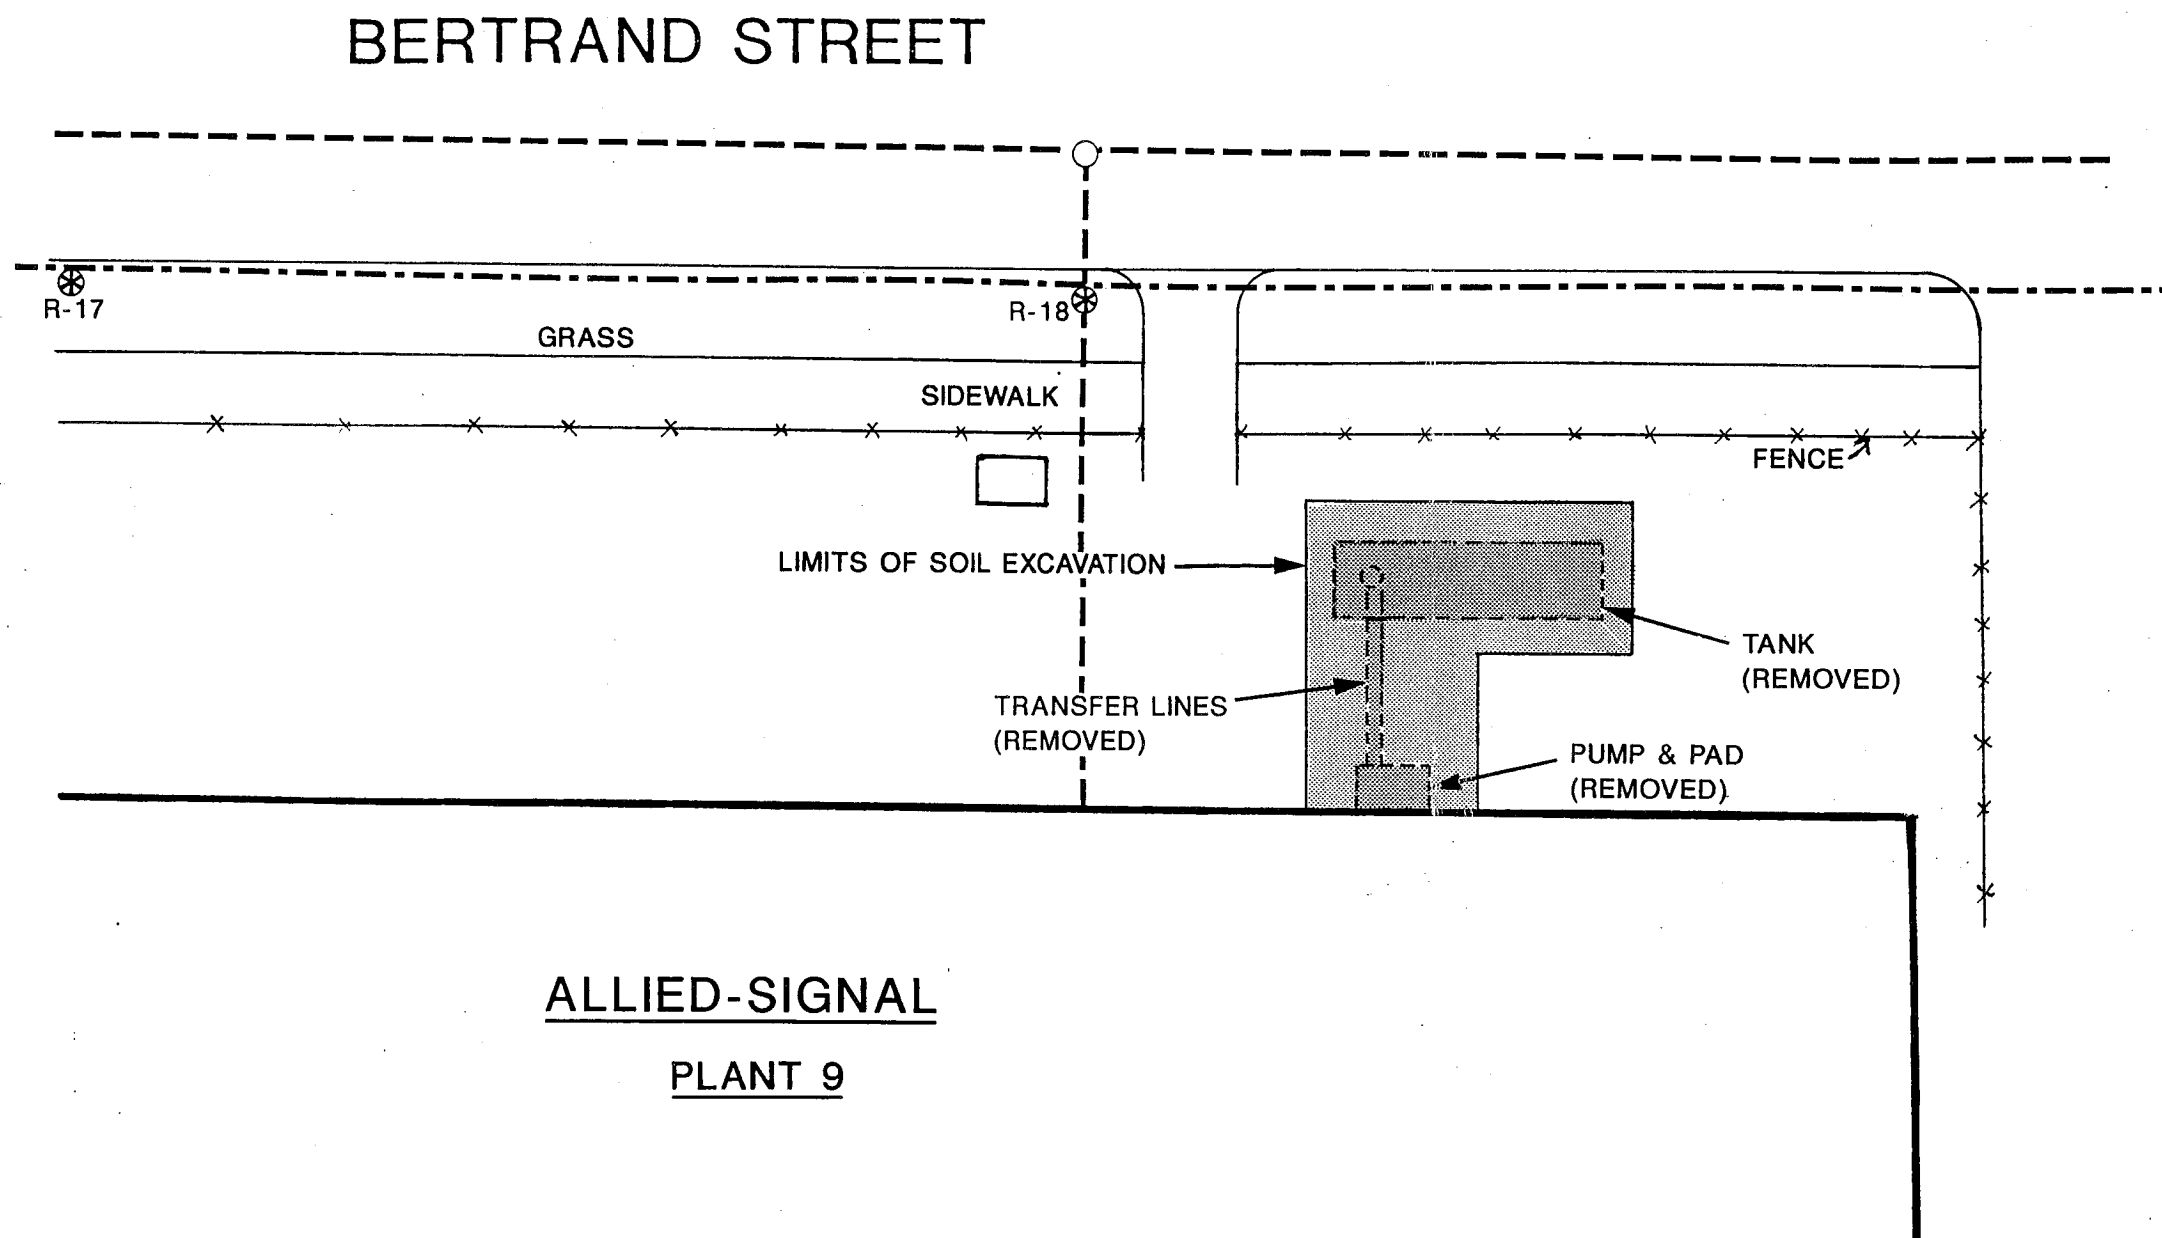
Figure 2  
DETAIL OF STORAGE  
TANK REMOVAL

A 12 inch underground city sewer line is located beneath Bertrand Street approximately 50 ft north of the tank location. The sewer line flows west to east. Additionally, a sewer lateral from Plant 9 is located 20 ft west of the tank. This line services Plant 9 and flows south to north into the city sewer line located under Bertrand Street (see Figure 2).

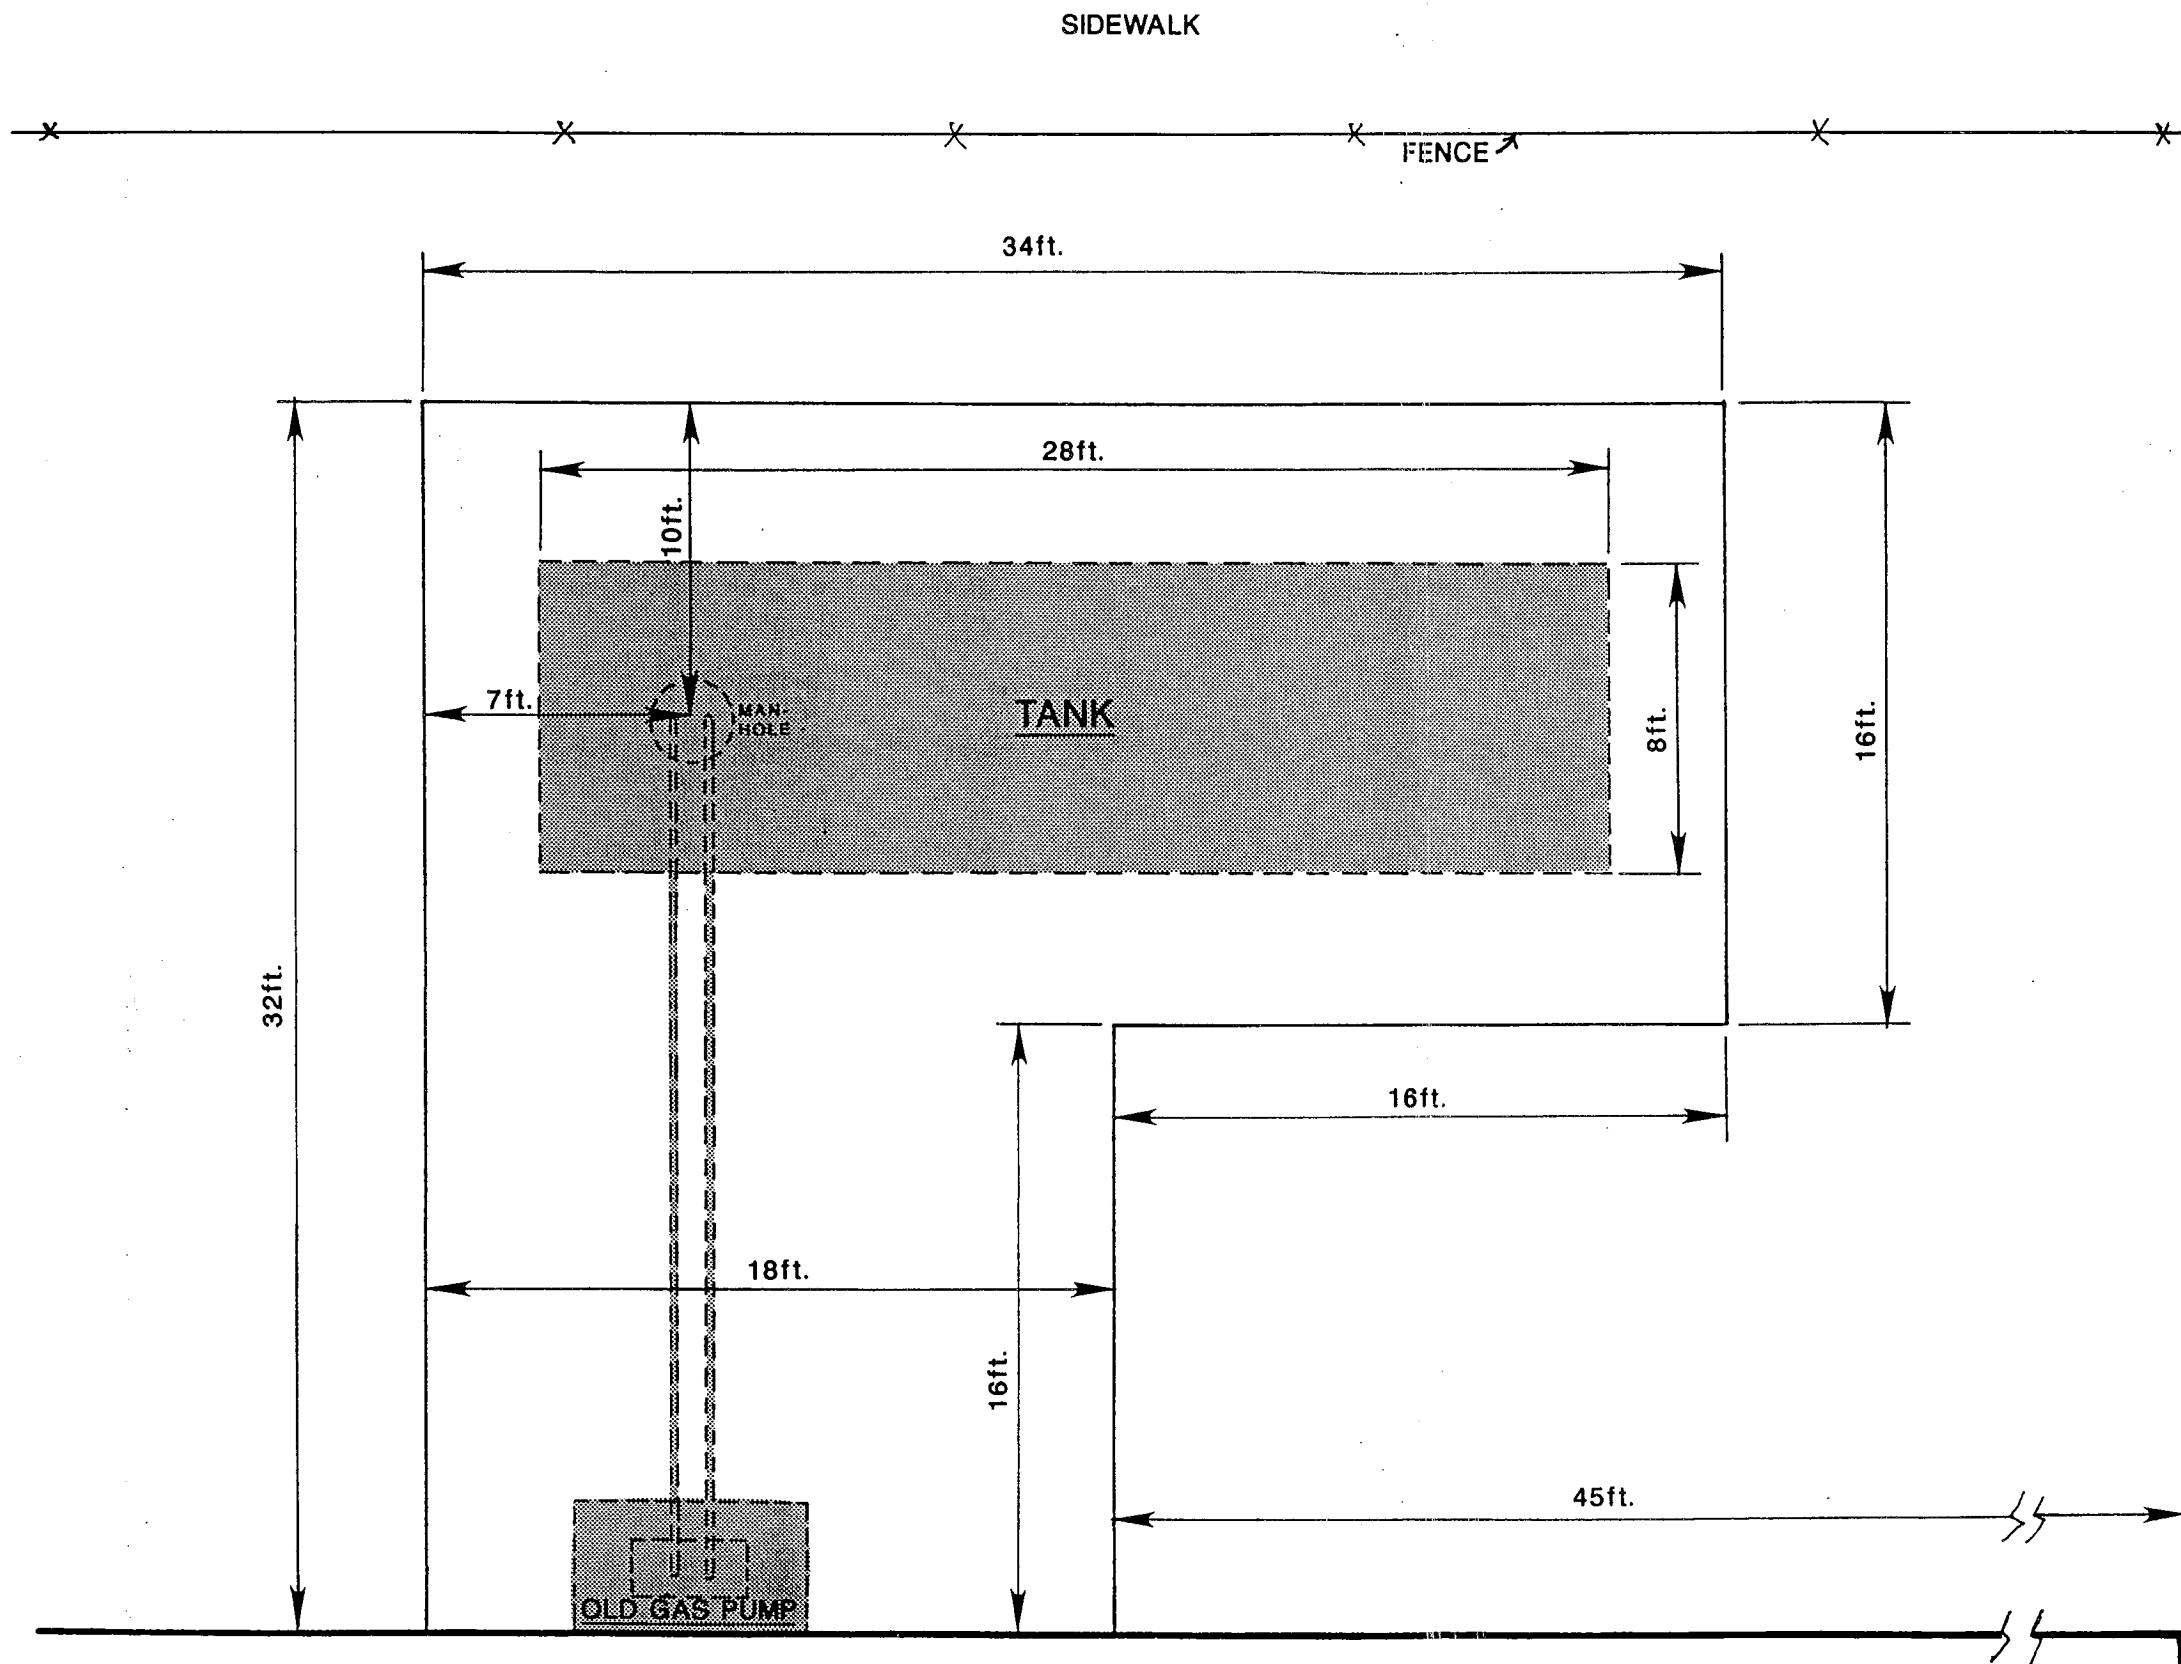
Figure 3  
TANK AND EXCAVATION  
MEASUREMENTS

After the tank was removed and placed on the flatbed trailer, a visual inspection of the tank was made. The tank appeared to be in good condition and no obvious evidence of holes or leakage was found. The tank size was measured and found to be 8 ft in diameter and 28 ft long, with an estimated capacity of 10,500 gallons (see Figure 3).

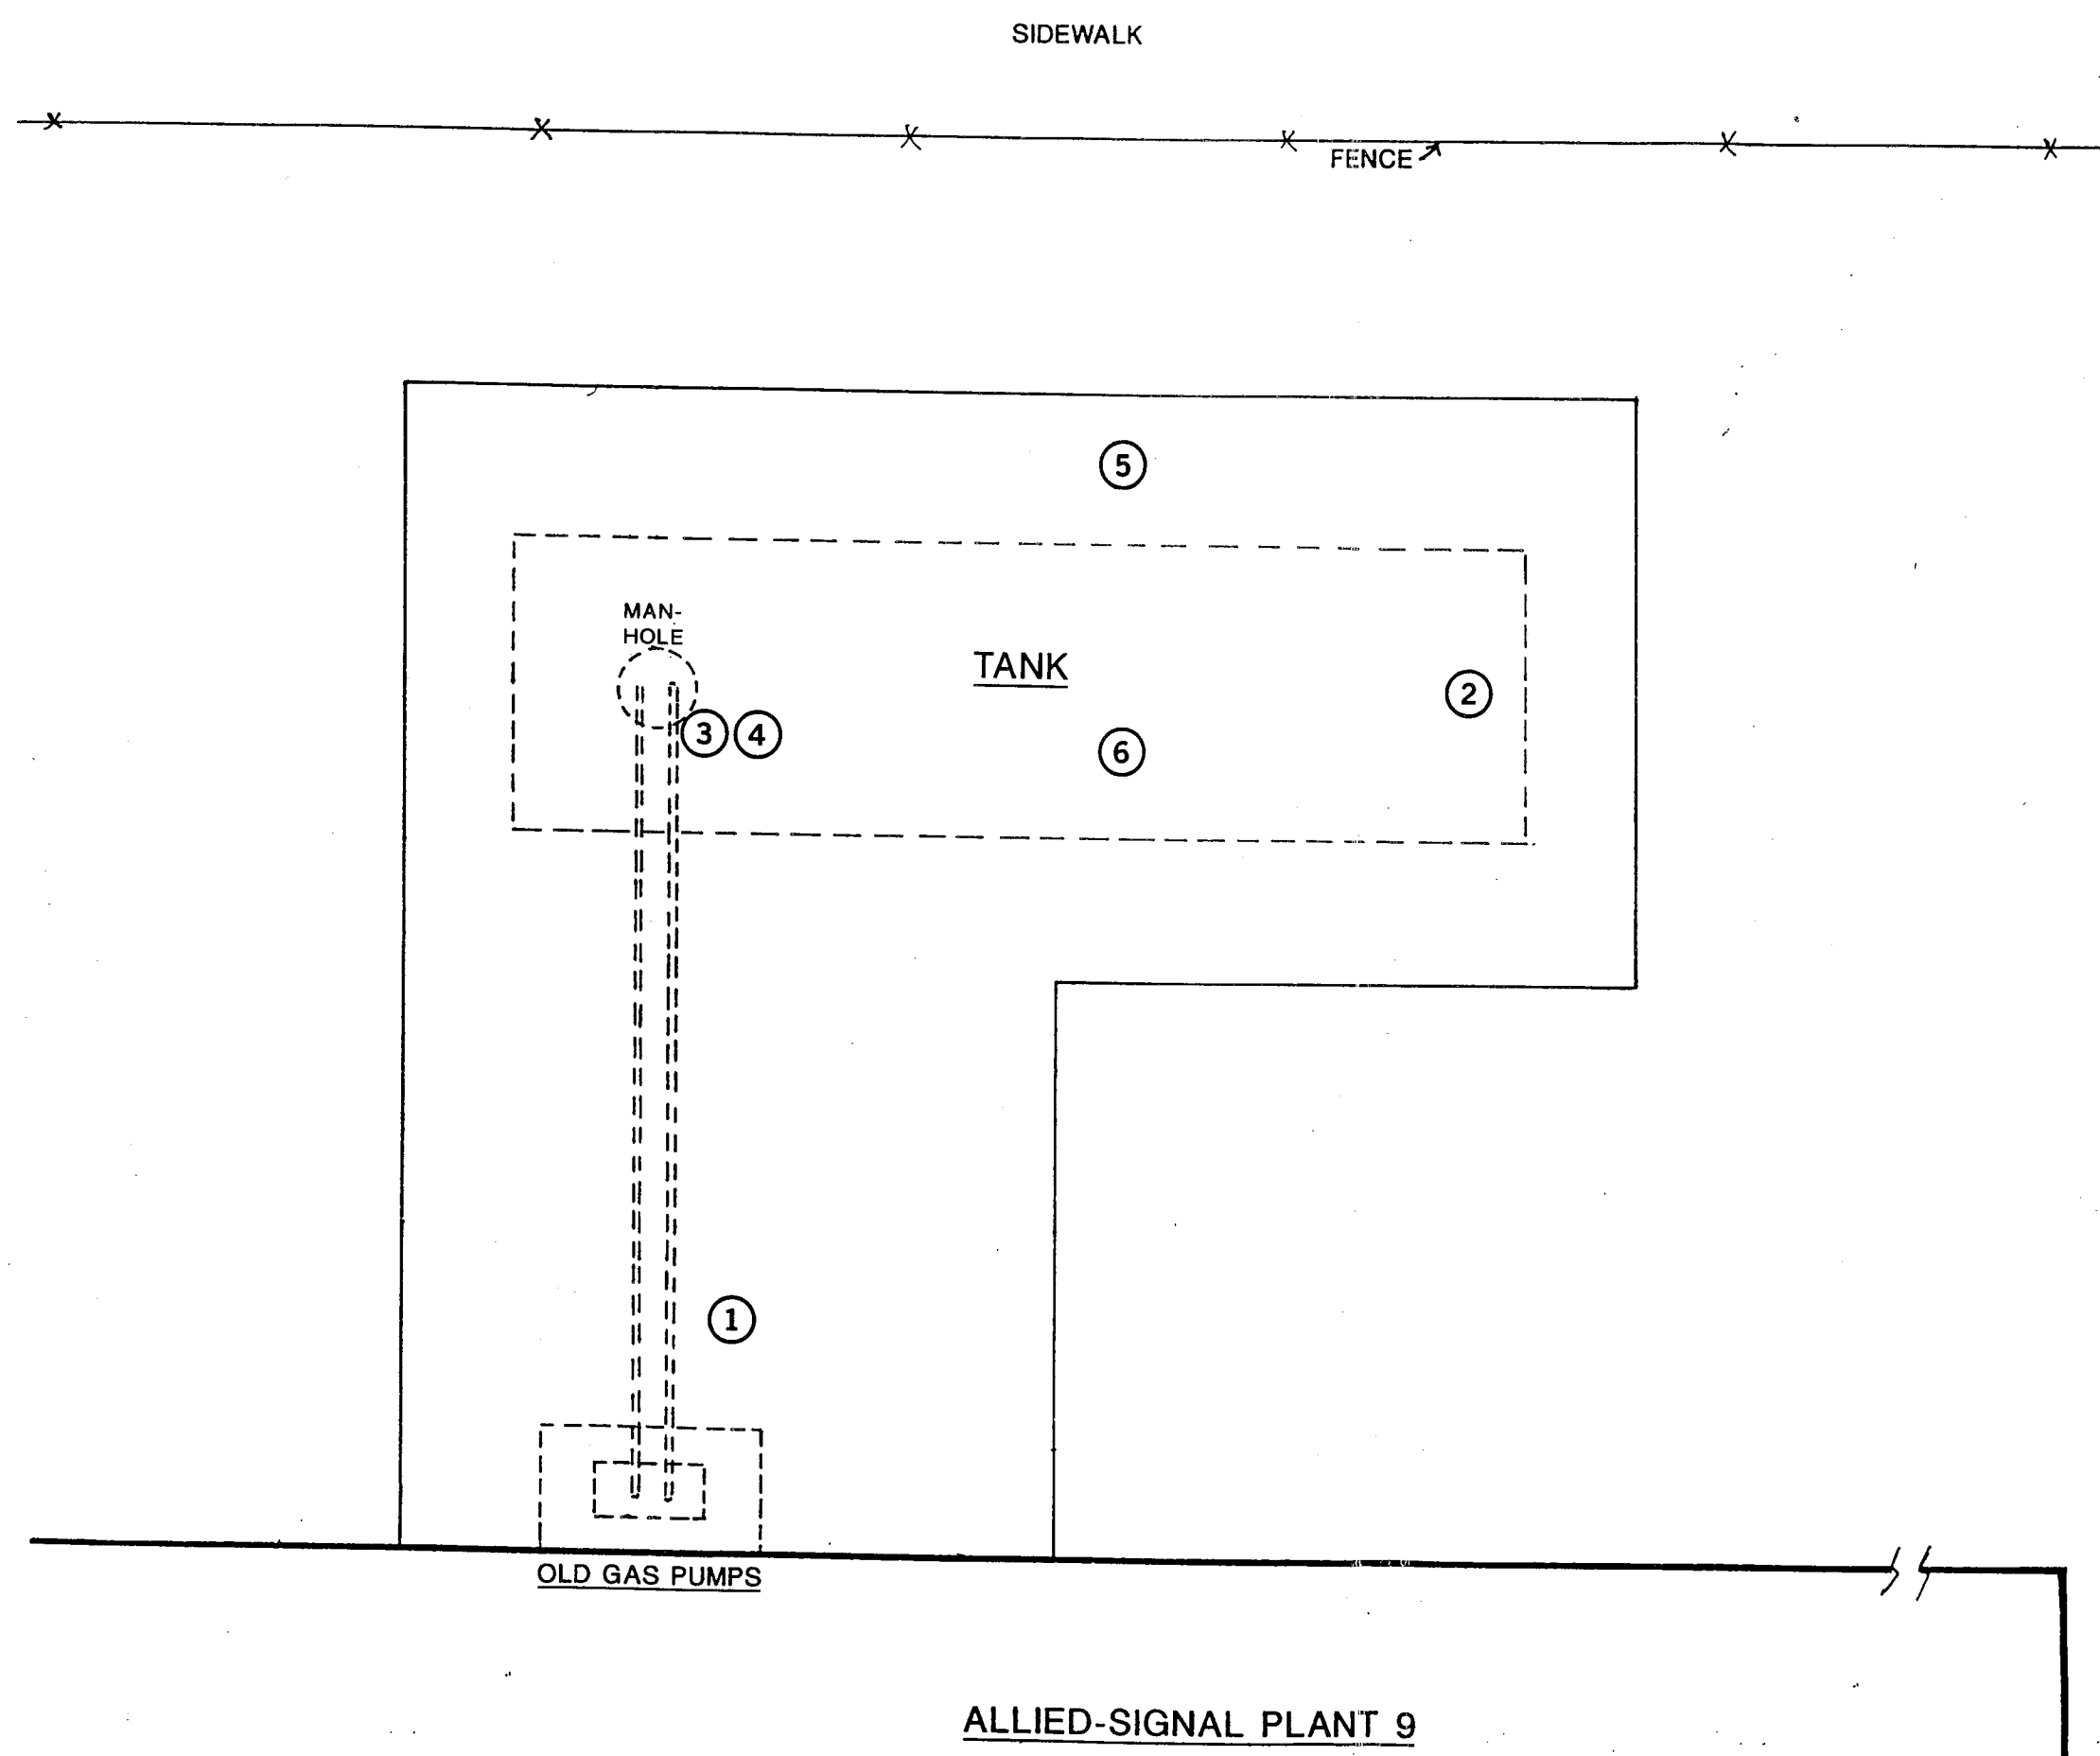
shown on Figure 4 and sample results show that TPH was below laboratory detection limits in all of the samples (see Table 1). All samples were analyzed for TPH using a GC/PID method. All sampling procedures were in accordance with current EPA guidelines and performed in compliance with TAGA's Quality Assurance Procedure Plan (QAPP) and Standard Operating Procedures.
