STAFF REPORT

CONCERNING APPLICATION FOR A CERTIFICATE OF APPROPRIATENESS

Application Number: 2019-0109B

Property Location: 815 Leland Avenue

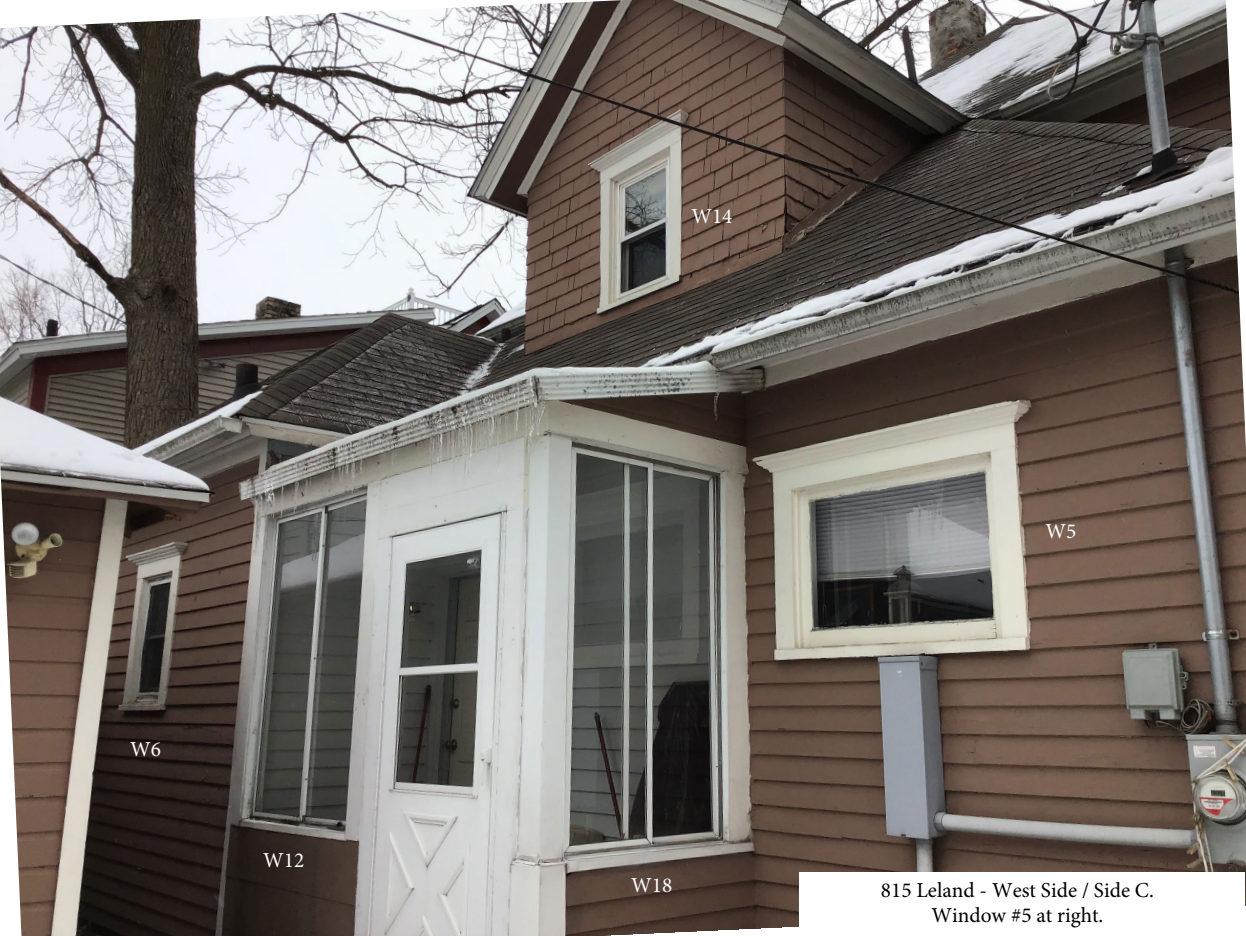
815 Leland - West Side / Side C.
Window #5 at right.

- a. The exterior wood frame will be covered as above with aluminum,
7. Remove and replace window (referenced as ground floor window #5 on side C) with a *“white, vinyl, double hung, replacement style, Energy Star Rated, Argon filled, Low E coated glass, one-over-one window,”*

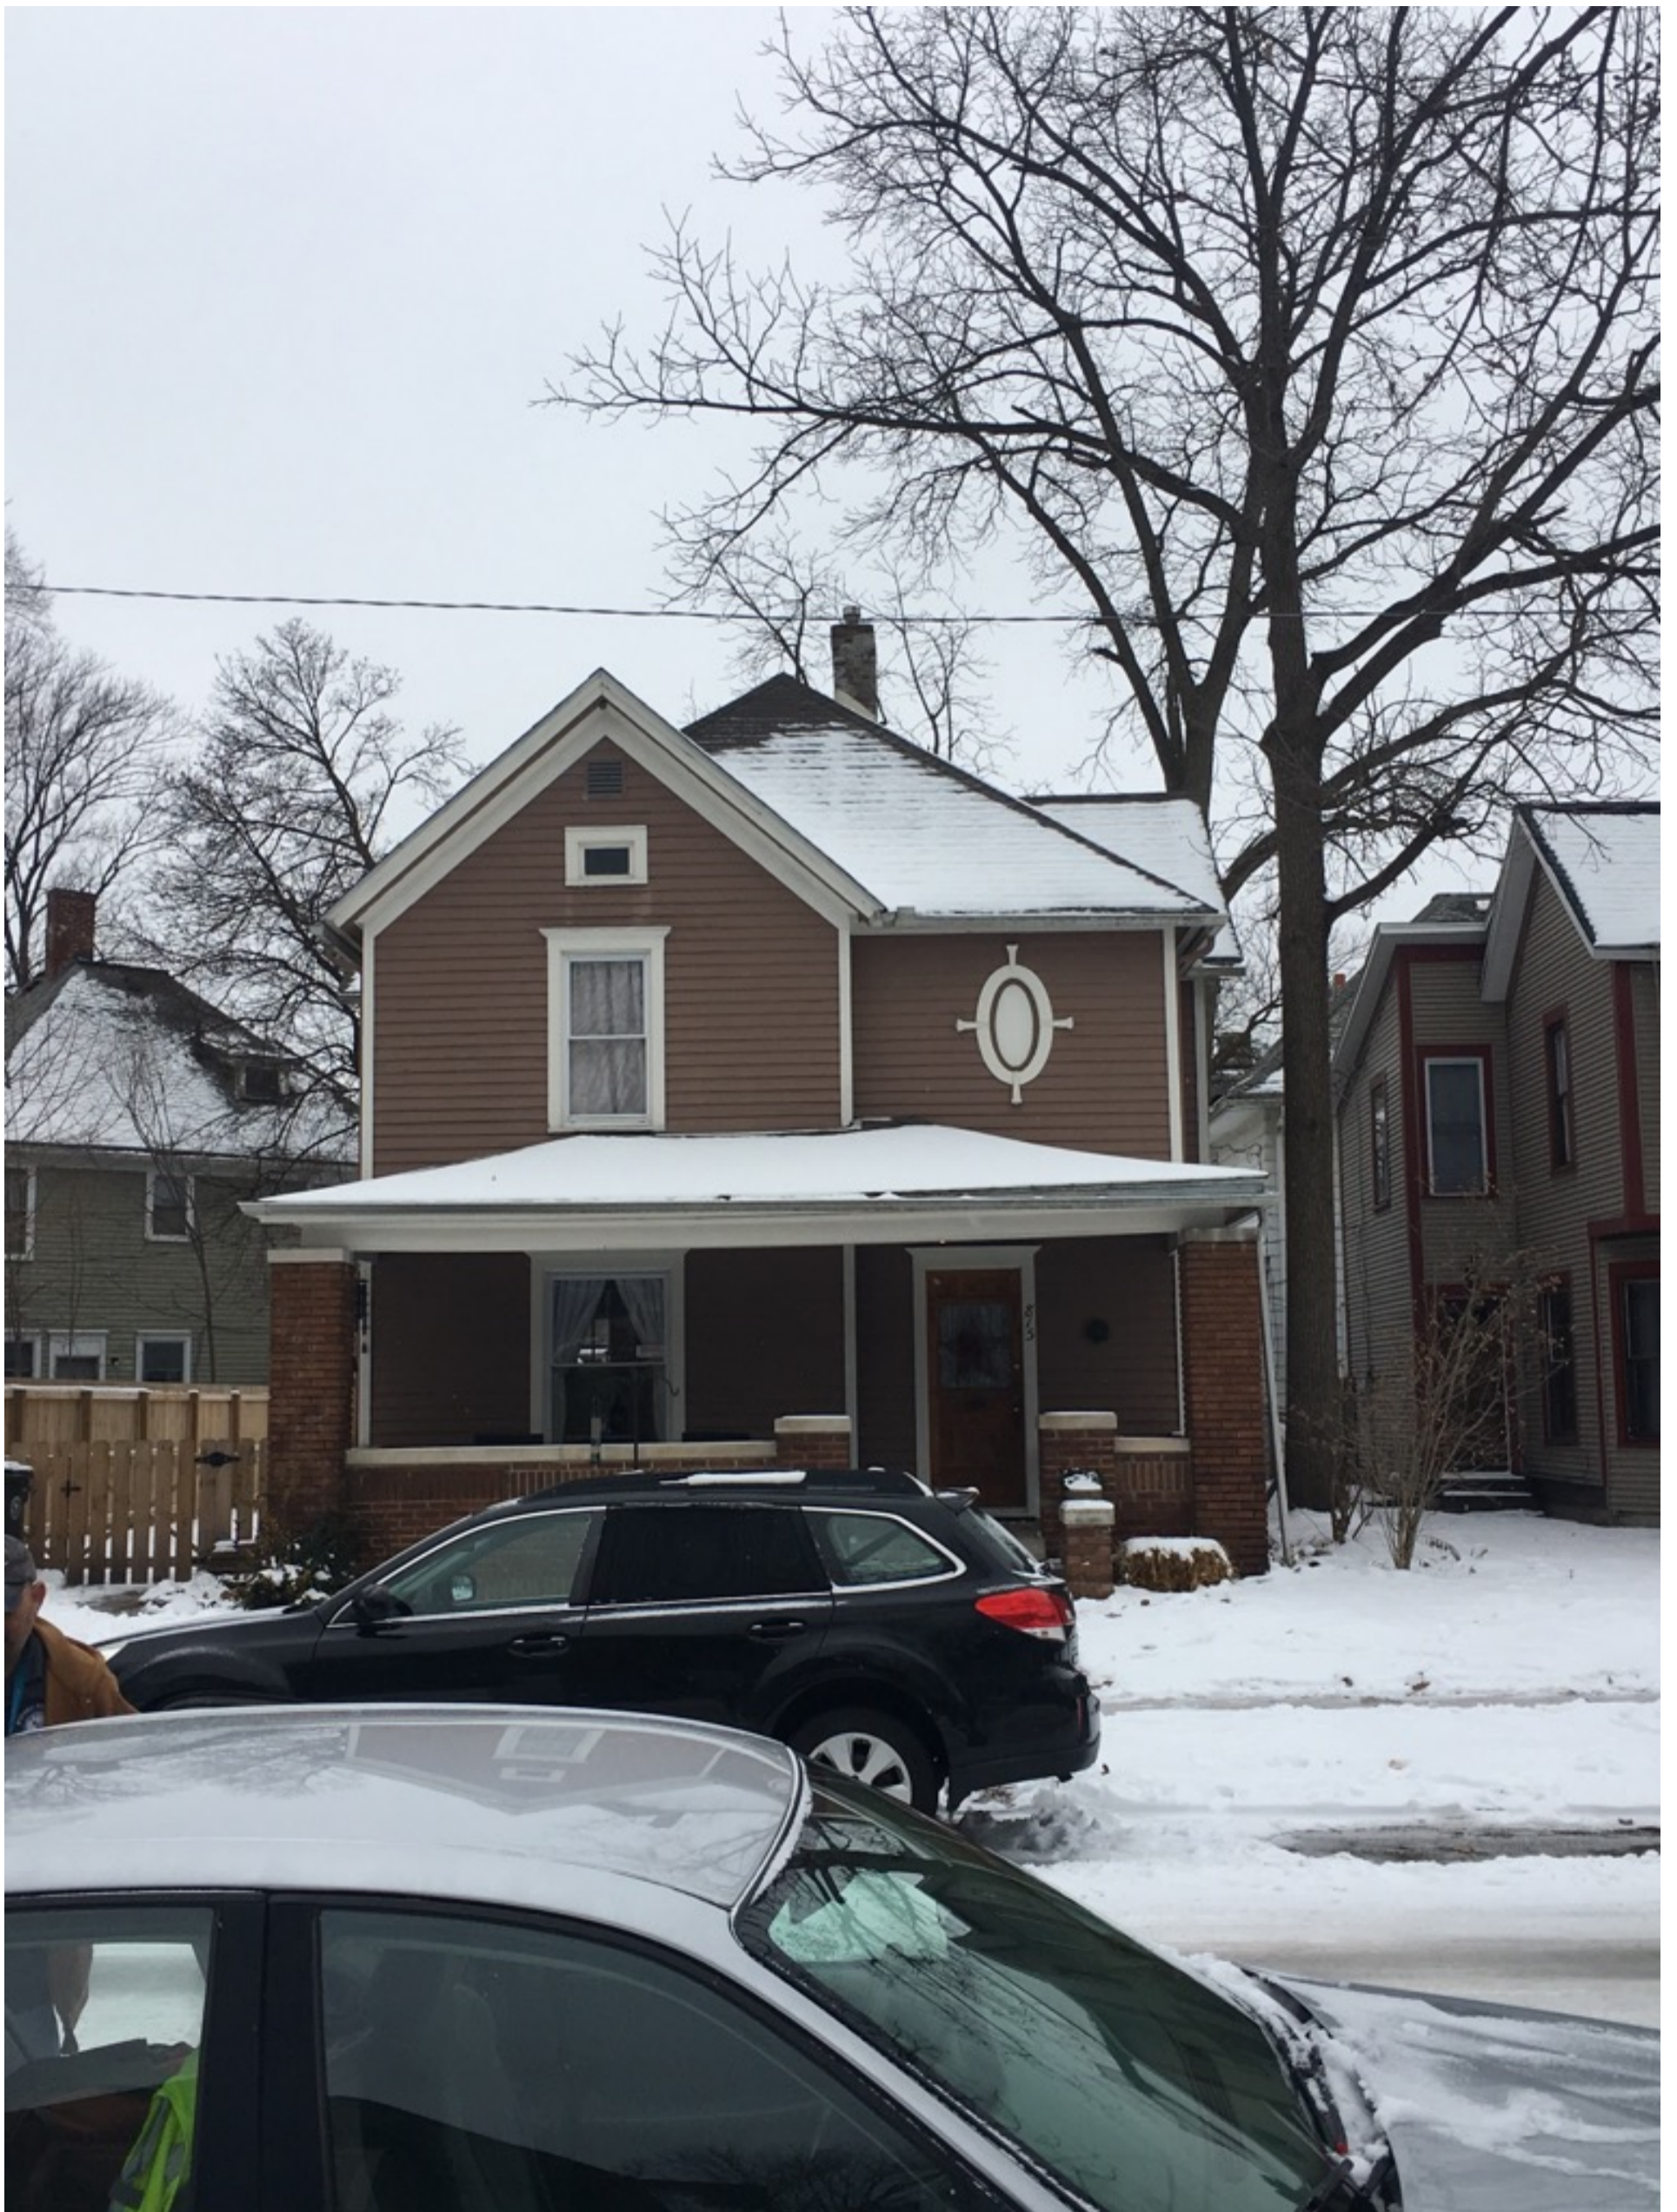
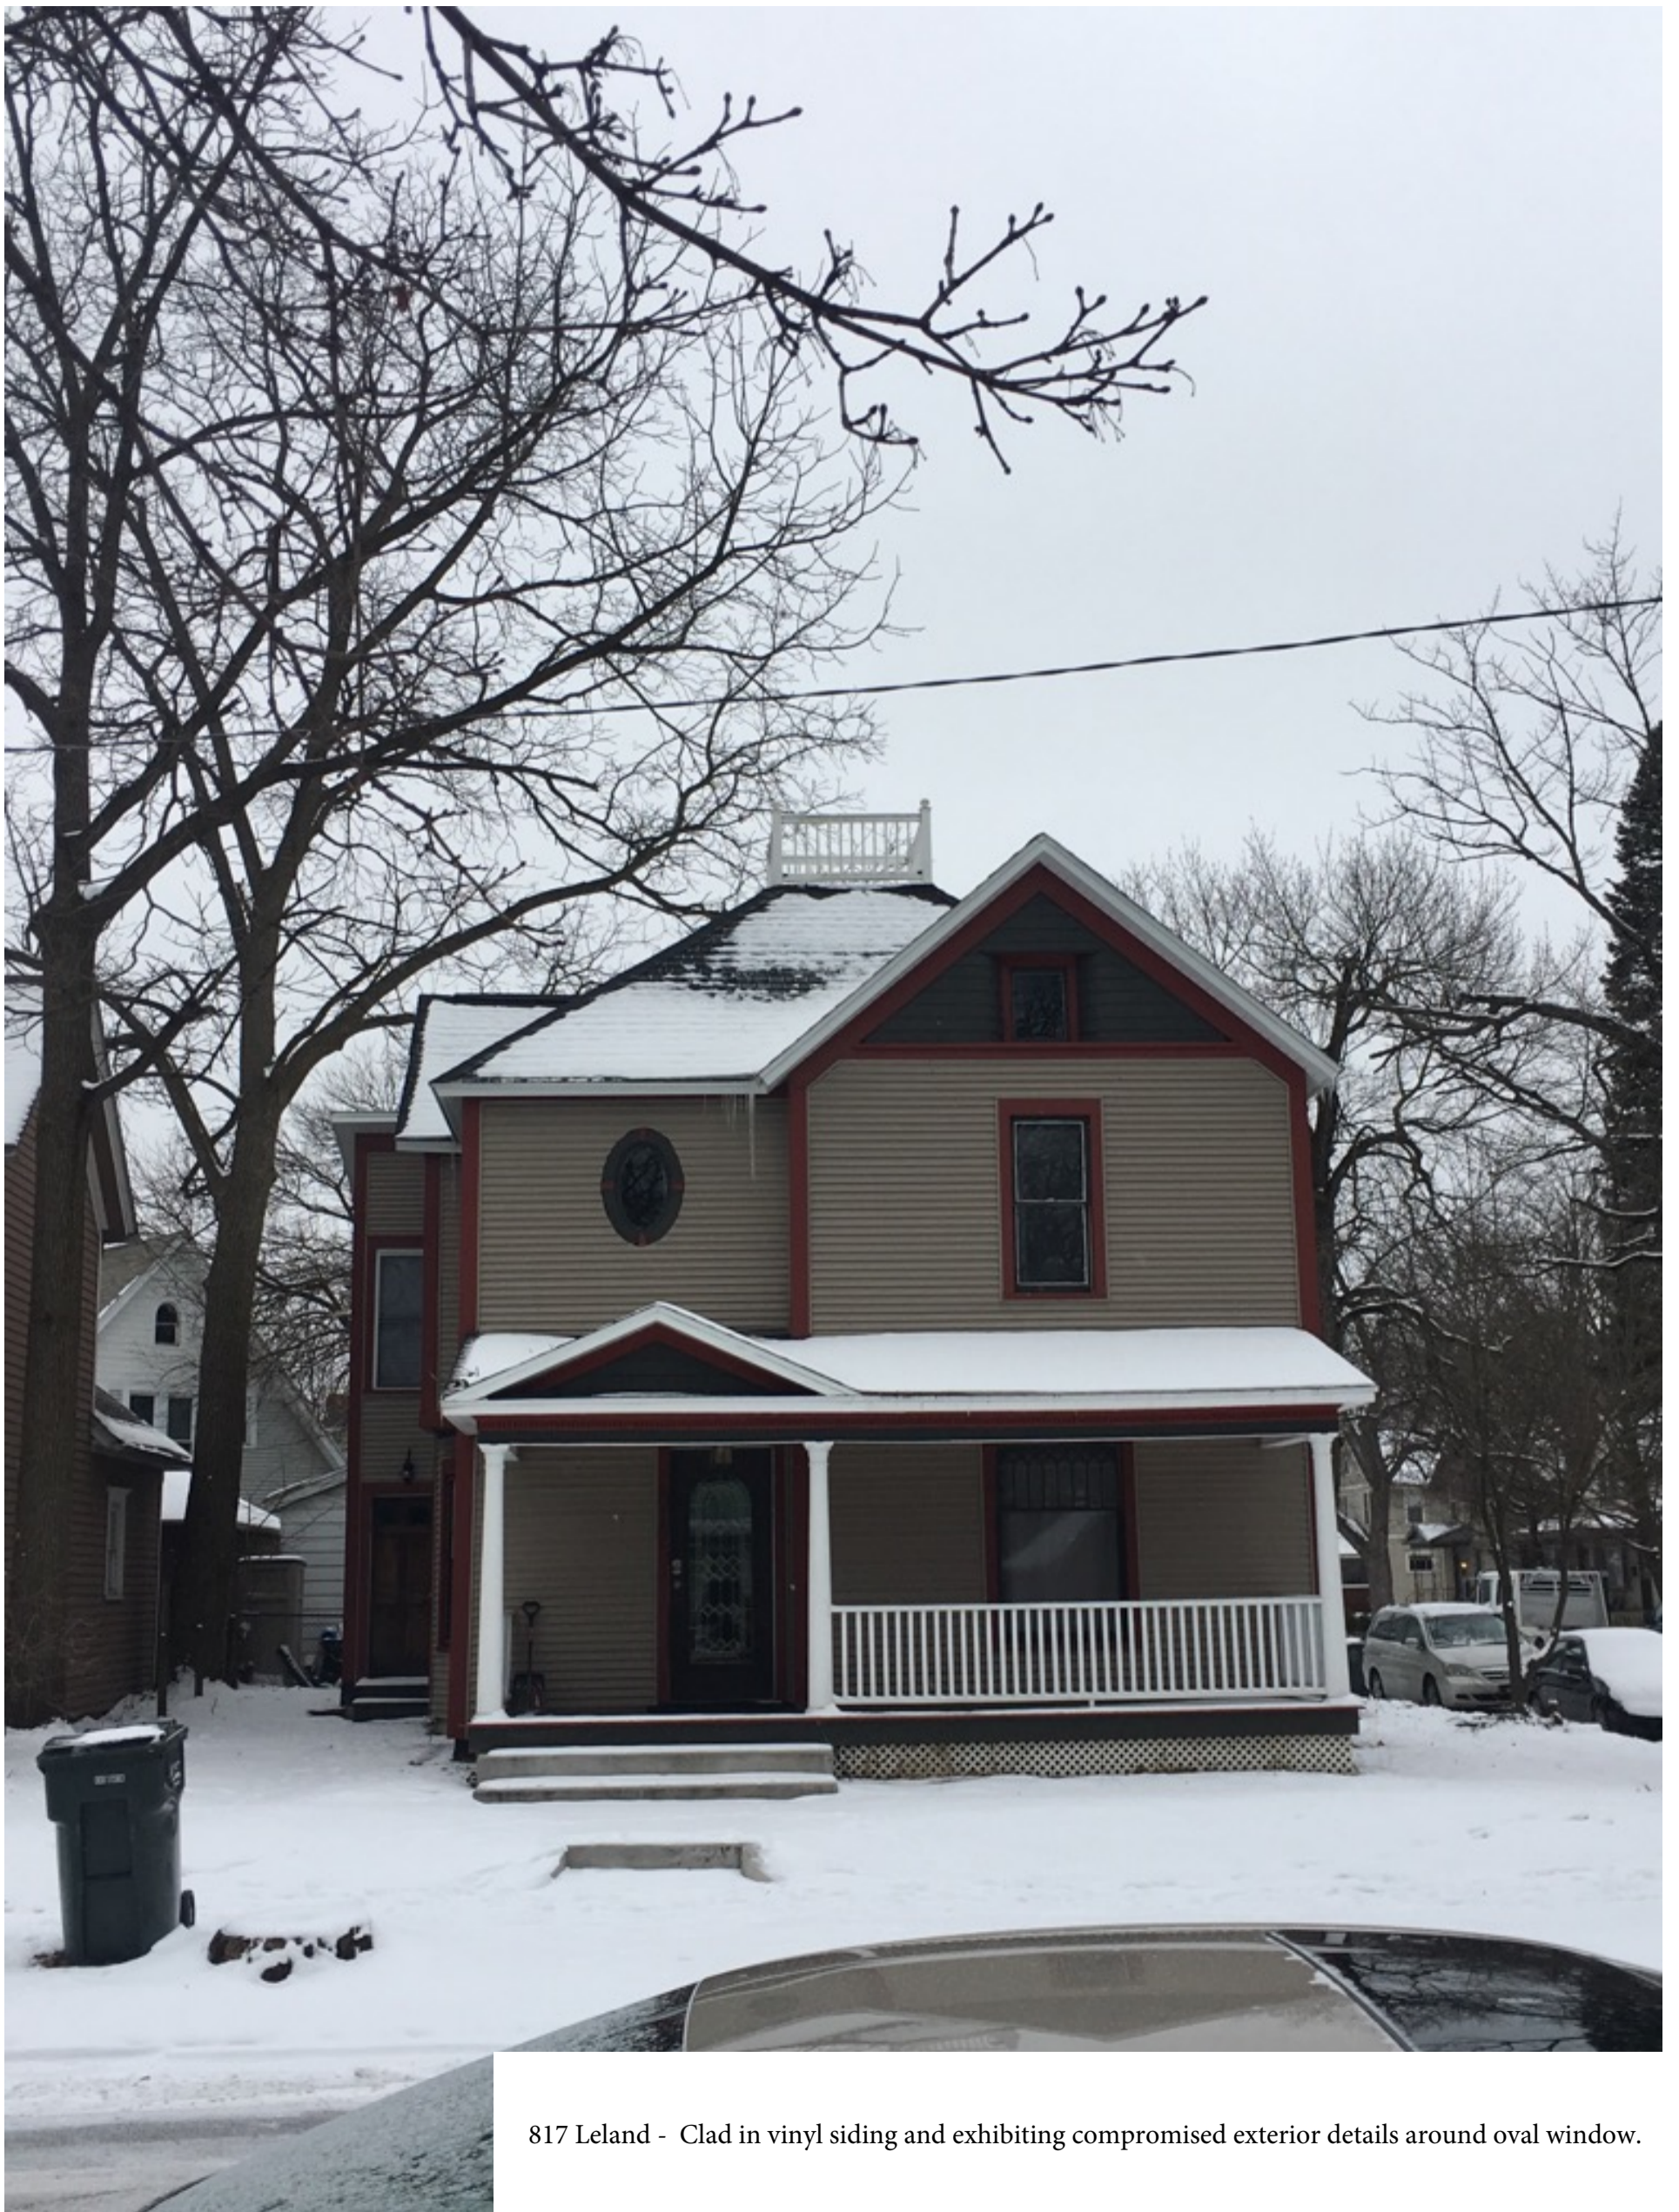
817 Leland - Clad in vinyl siding and exhibiting compromised exterior details around oval window.
