# STAFF REPORT

## CONCERNING APPLICATION FOR A CERTIFICATE OF APPROPRIATENESS

**Application Number:** 2019-0211  
**Property Location:** 508 S St Joseph  
**Architectural Style/Date/Architect or Builder:** American Foursquare / 1894  
**Property Owner:** The Entrust Group FBO Lisa H McKnight  
**Landmark or District Designation:** Taylor's Field, Ordinance #8952-98  
**Rating:** *Contributing*

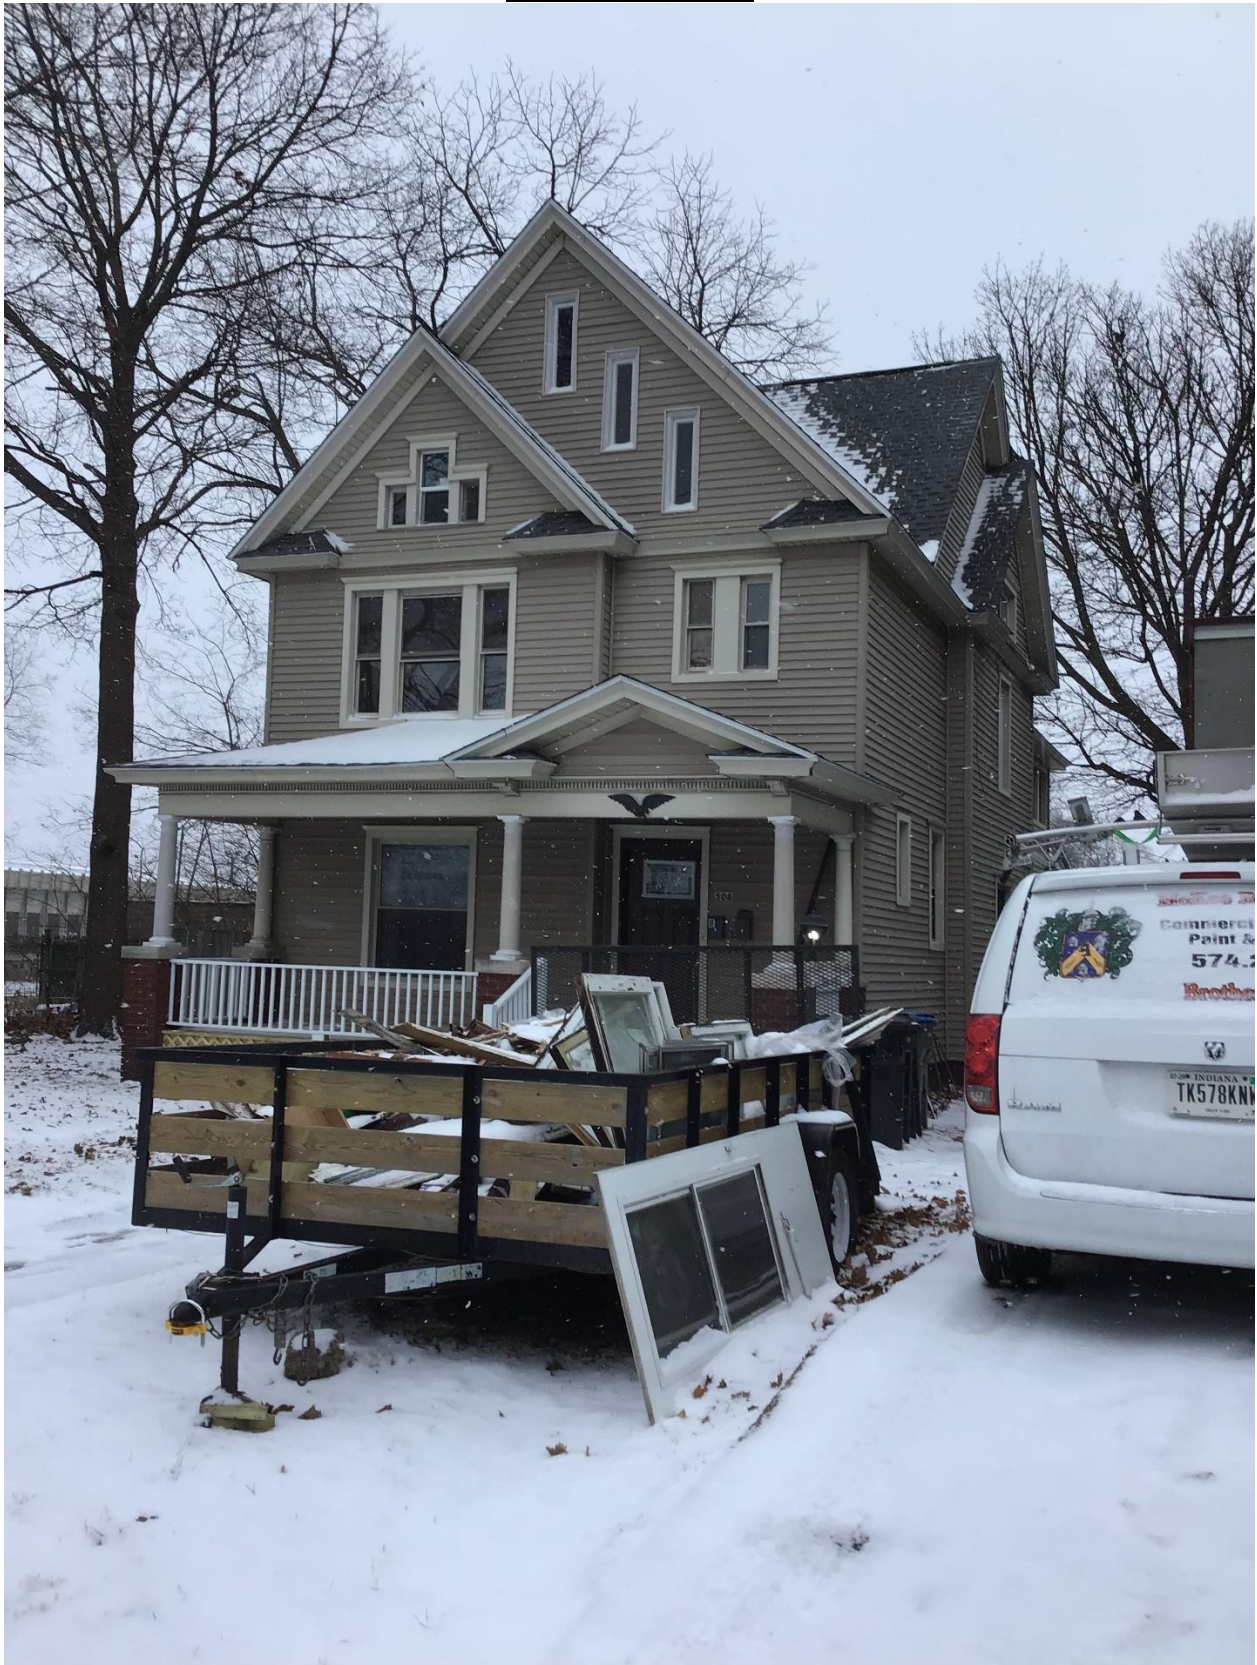
*Figure 1 - 508 S St. Joseph from the street, looking east.*

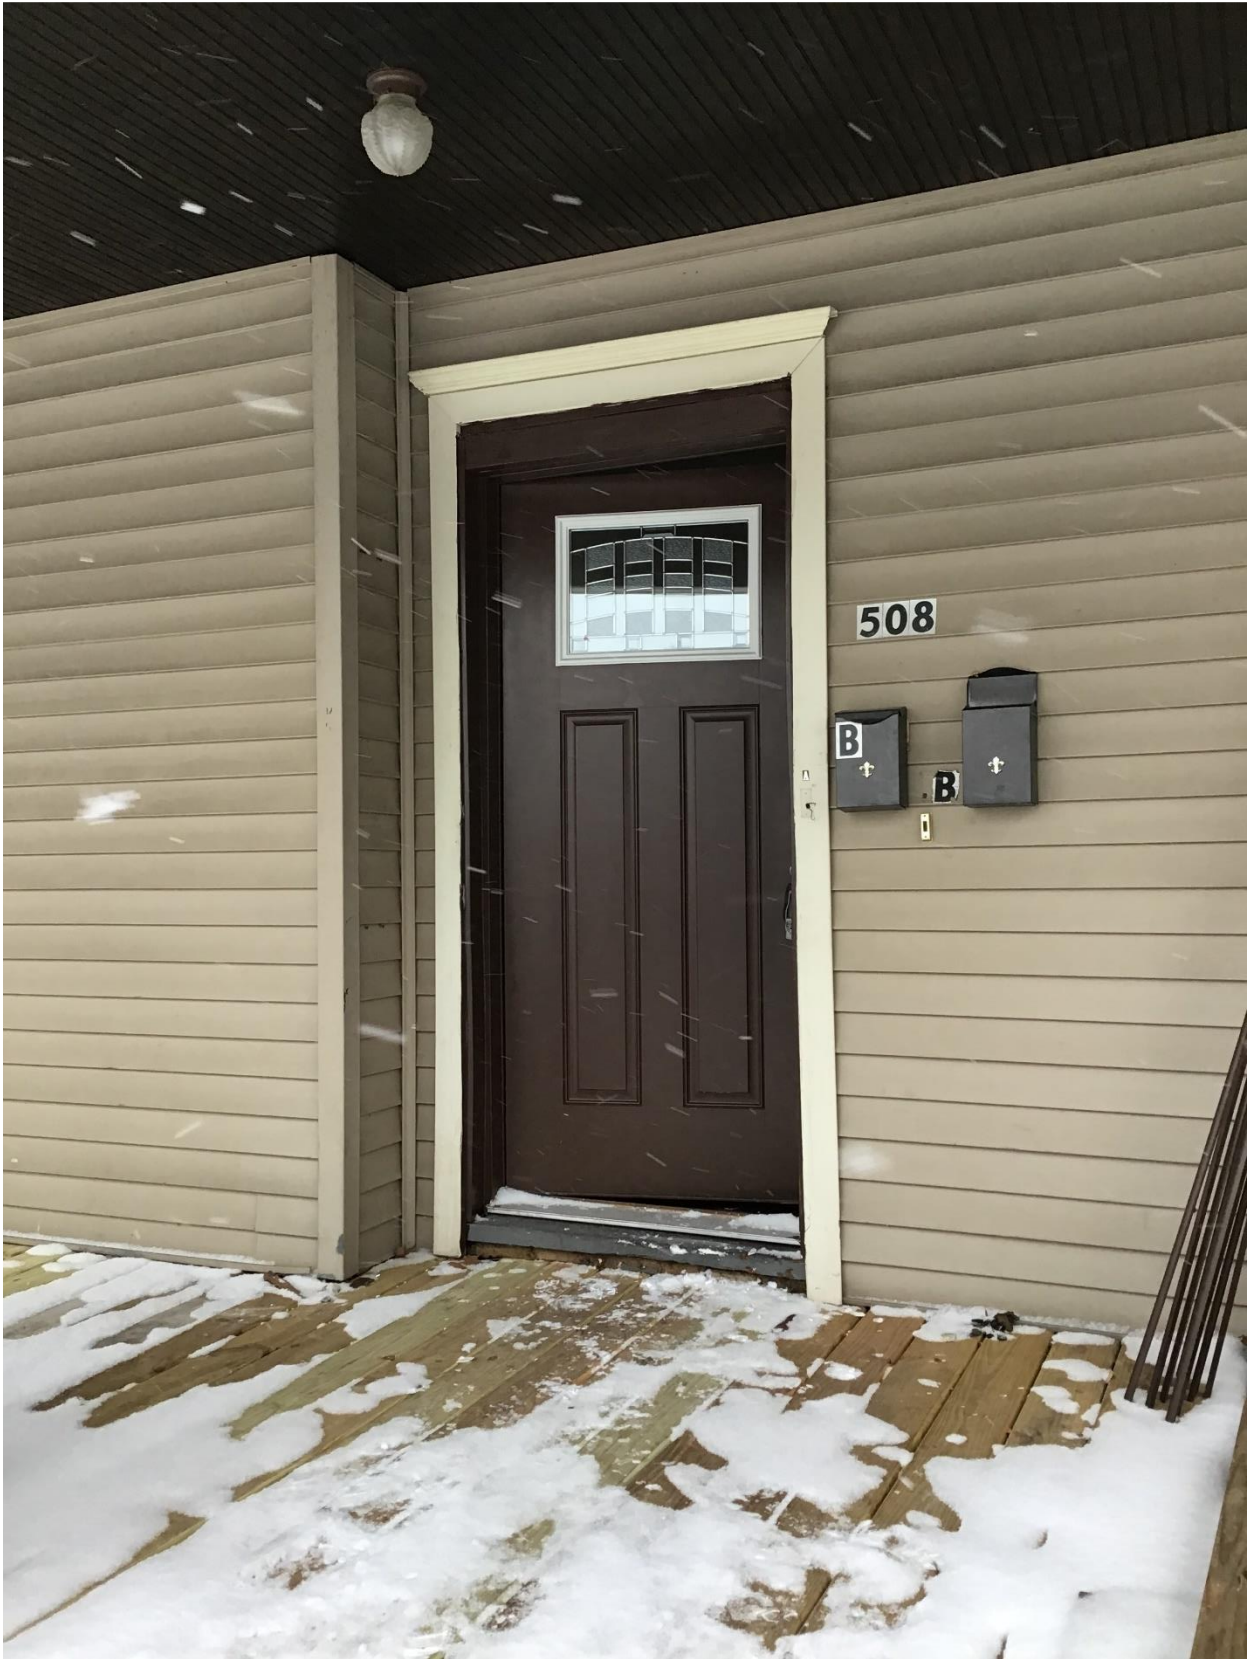
**STAFF RECOMMENDATION:** Regarding the retroactive replacement of the front door, staff would have preferred the original door and storm door would have been retained. The fiberglass replacement door is a departure from the original material and format; Staff would like to see a new wooden storm door installed to conceal the fiberglass door.

*Figure 2 - Close-up of the entrance.*
