# STAFF REPORT

## CONCERNING APPLICATION FOR A CERTIFICATE OF APPROPRIATENESS

**Application Number:** 2019-0211A

**Property Location:** 510 S St Joseph

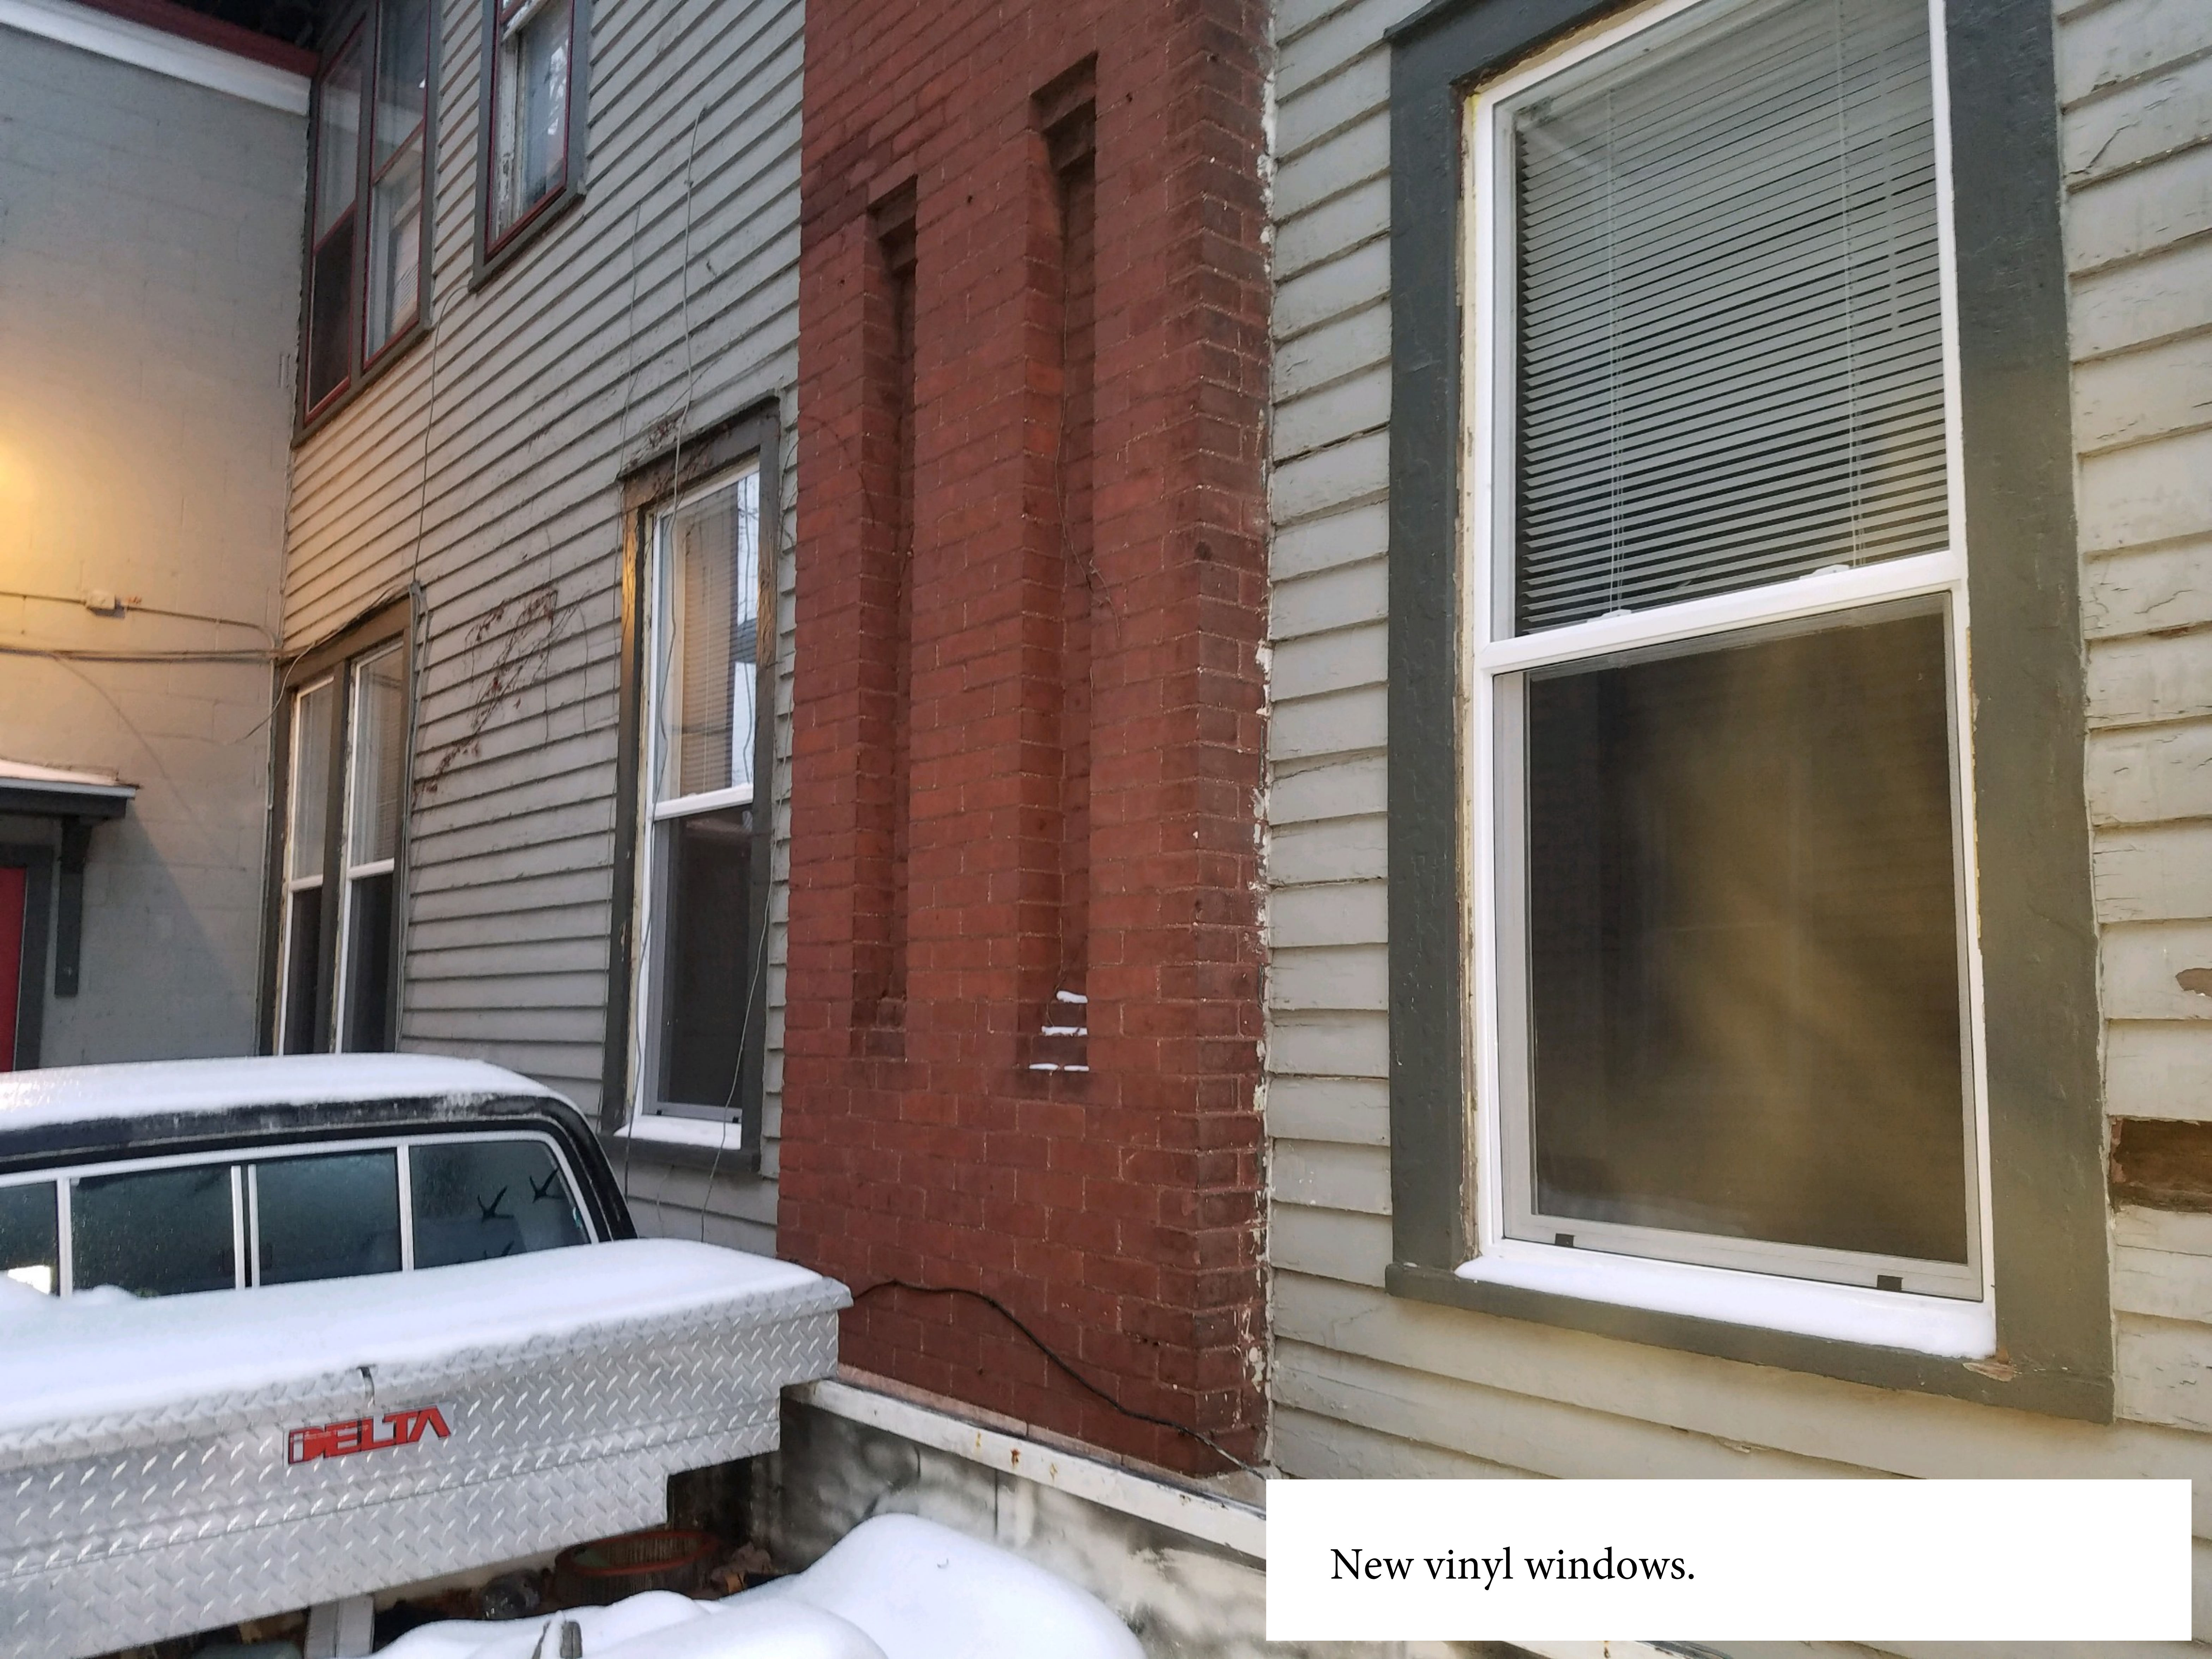
Regarding the retroactive replacement of the front doors, staff would have preferred the original door and storm door would have been retained. The fiberglass replacement door is a departure from the original material and format; Staff would like to see new wooden storm doors installed to conceal the new fiberglass doors.

Replacement Doors

Also at 510 the front door was replaced, the door is set right but the trim work around and above it is not proper. Above the door I will tear out the scab and install a transit, the transit I am using came out of the house it will be painted and installed. Also the trim boards will be replaced if needed to ensure the period appearance.

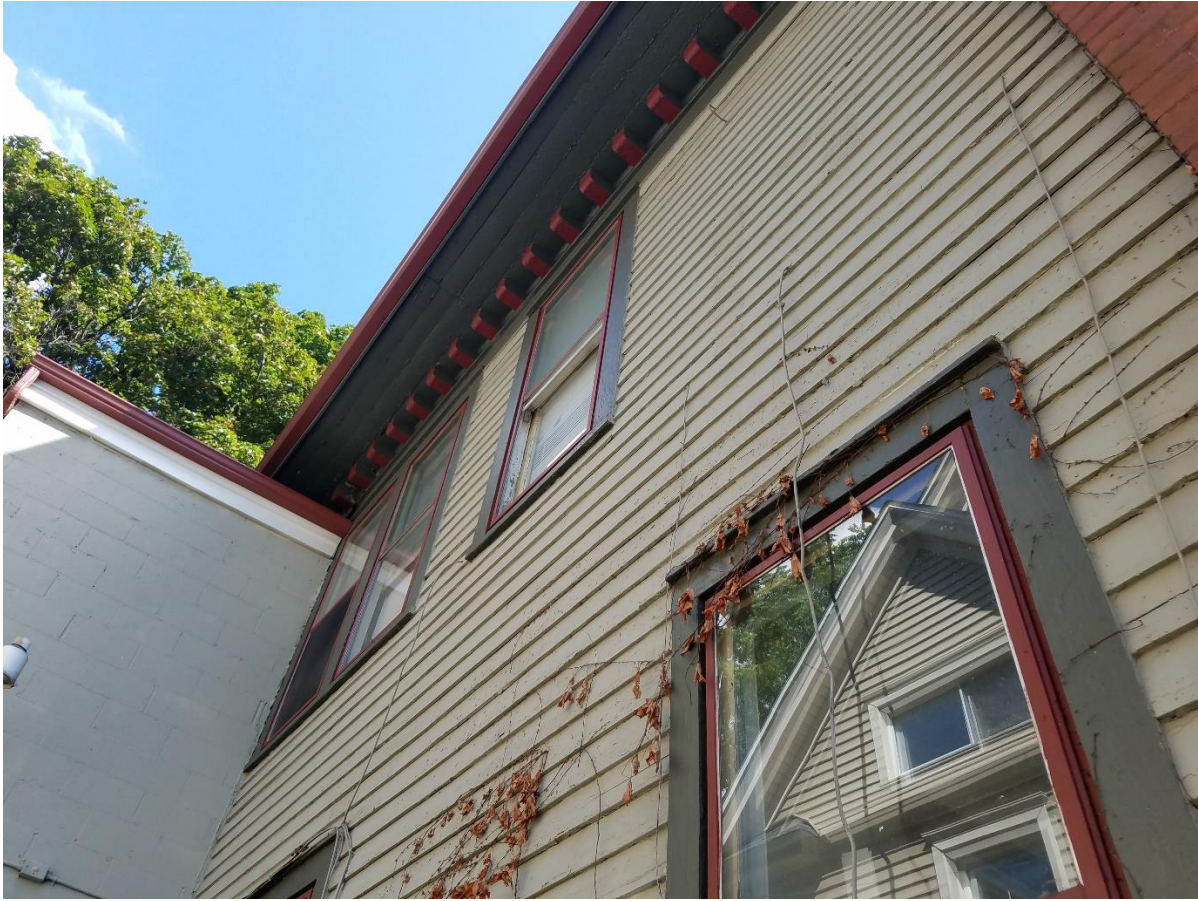
*"Windows: The owner has proposed the replacement of 7 original wood double-hung windows. I was unable to inspect the windows in the second floor as the apartment is occupied and the renter was not home. The four on the first level all have lower sashes that are broken and each have metal angle brackets holding the sashes together. These sashes are missing ropes and are not rotted, but rather are structurally damaged beyond repair. The metal storm windows are missing screens but have kept the original sashes and sills safely out of the elements. The upper sashes are painted and nailed in place."*

*Figure 1 - North face, upper three windows to be replaced. – Photos from September.*

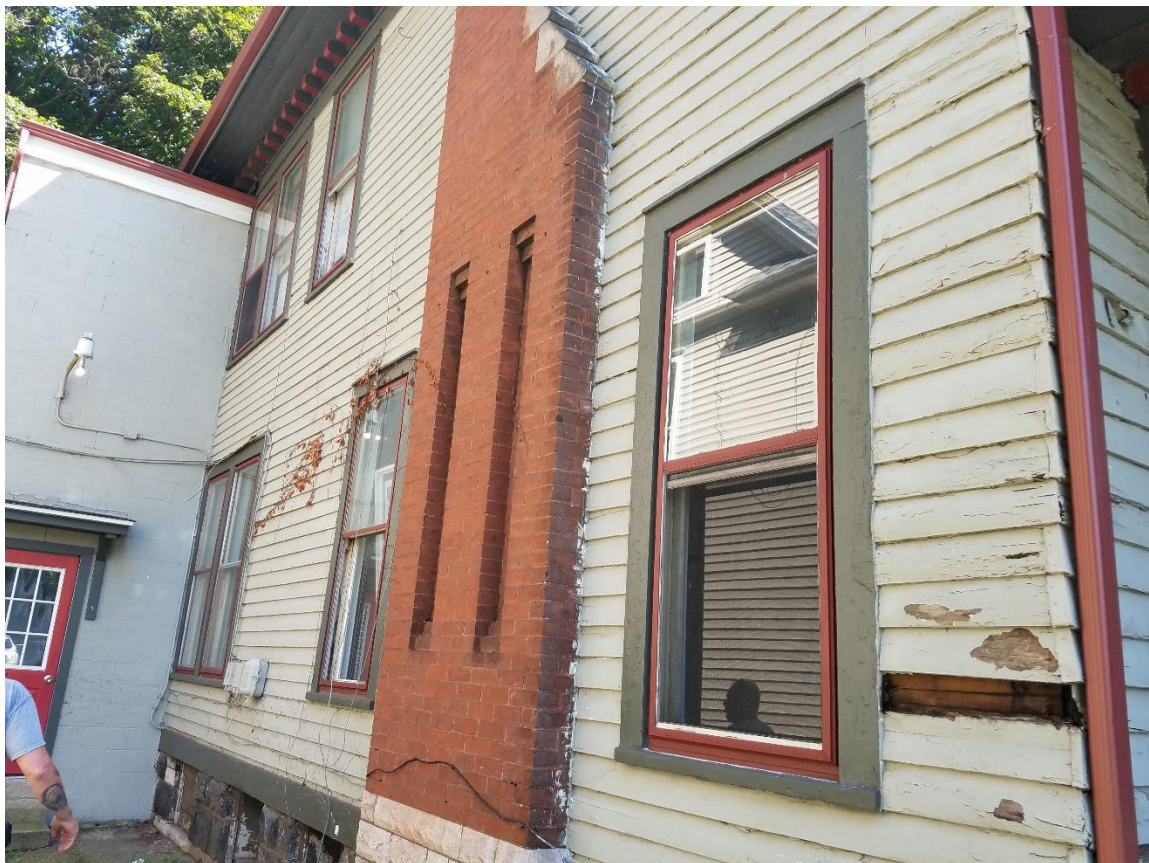
*Figure 2 - North face, all windows to be replaced. – Photos from September.*

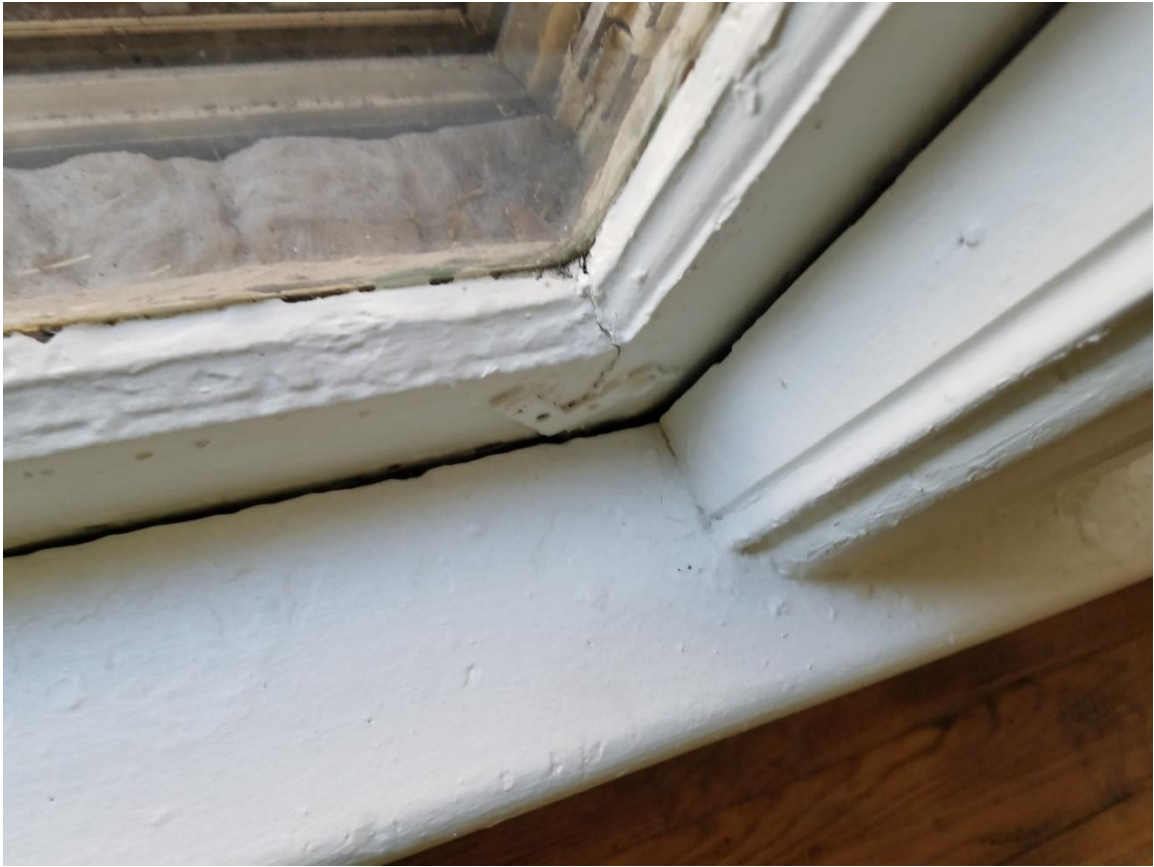
*Figure 3 - lower level sill. – Photos from September.*

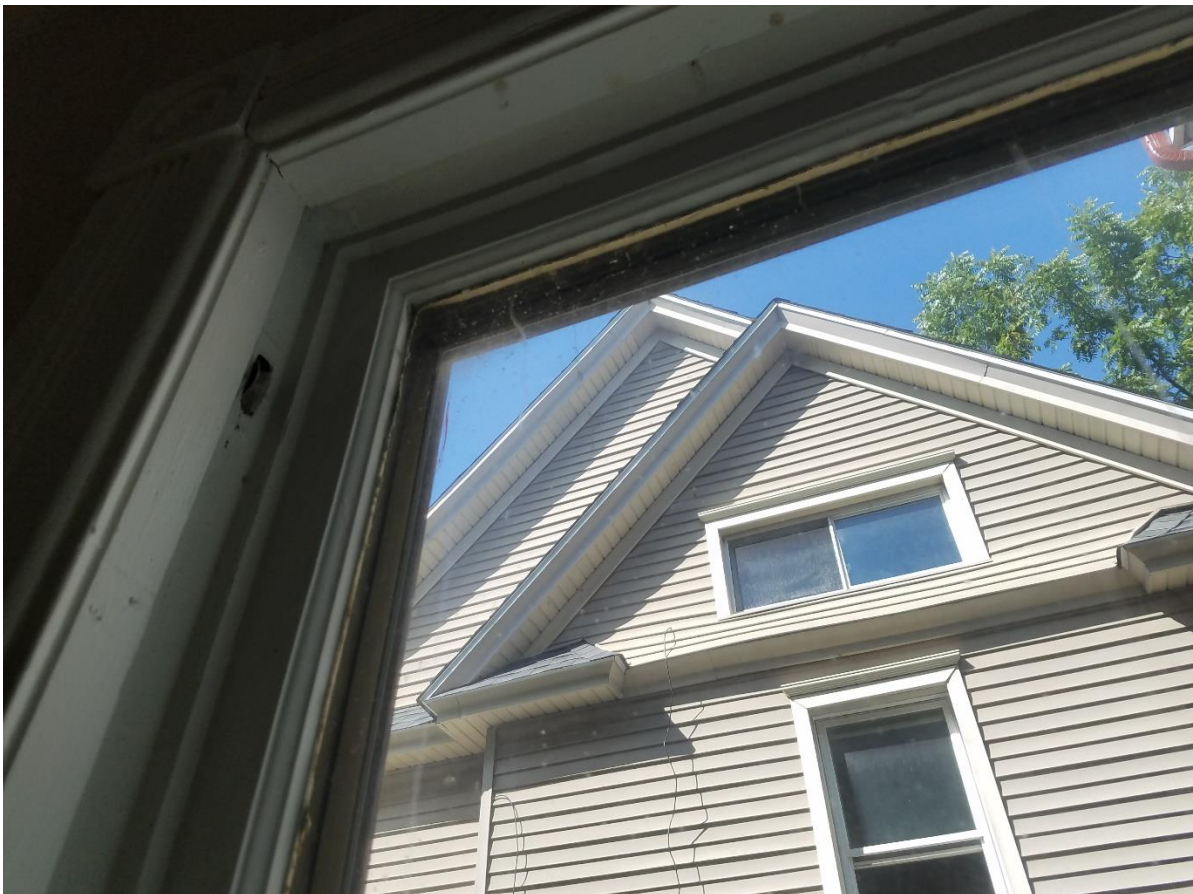
*Figure 4 - Missing weights / ropes. – Photos from September.*

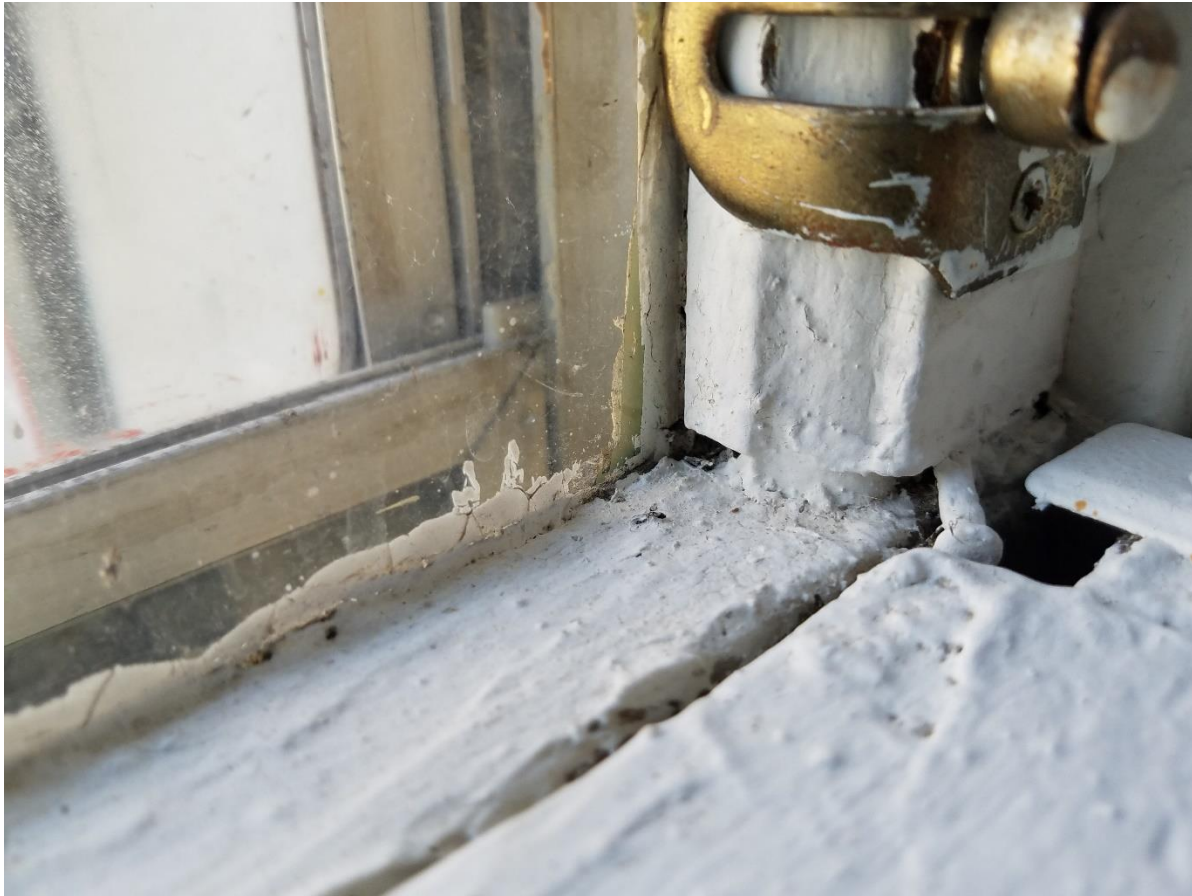
Figure 5 - Lower level window sash, nailed shut. – Photos from September.
