# STAFF REPORT

## CONCERNING APPLICATION FOR A CERTIFICATE OF APPROPRIATENESS

**Application Number:** 2019-0404

**Property Location:** 821 Ashland Avenue

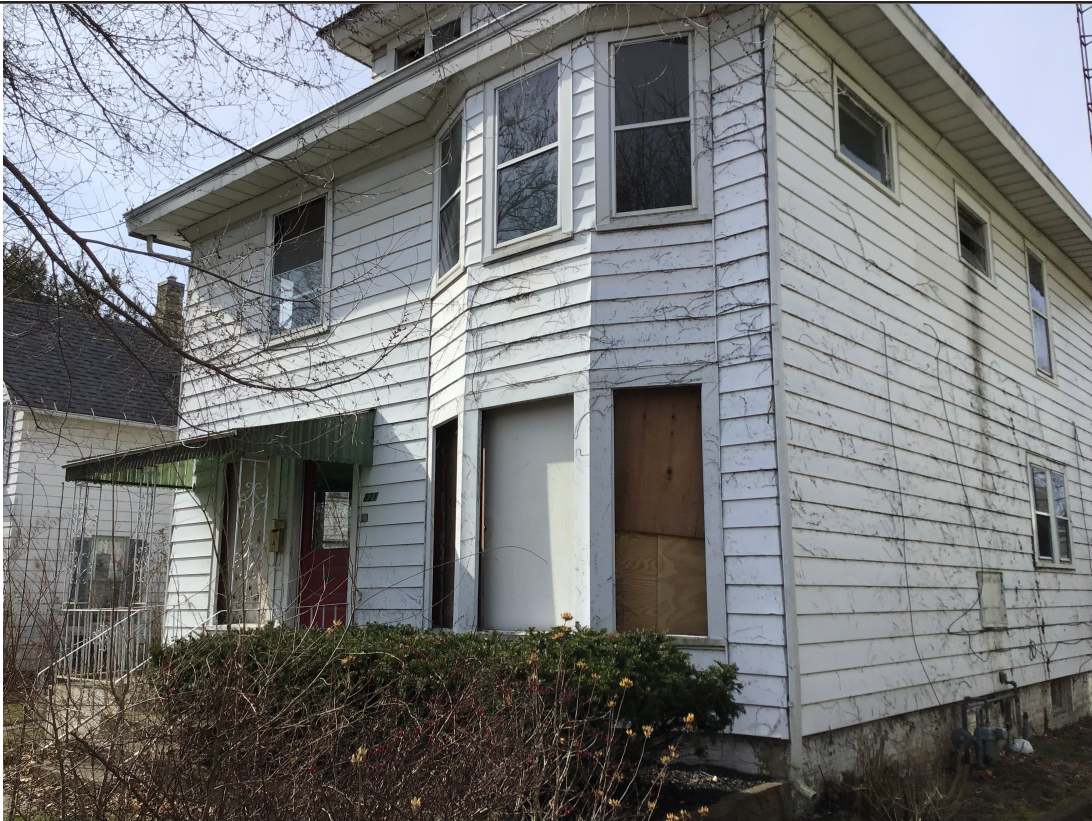
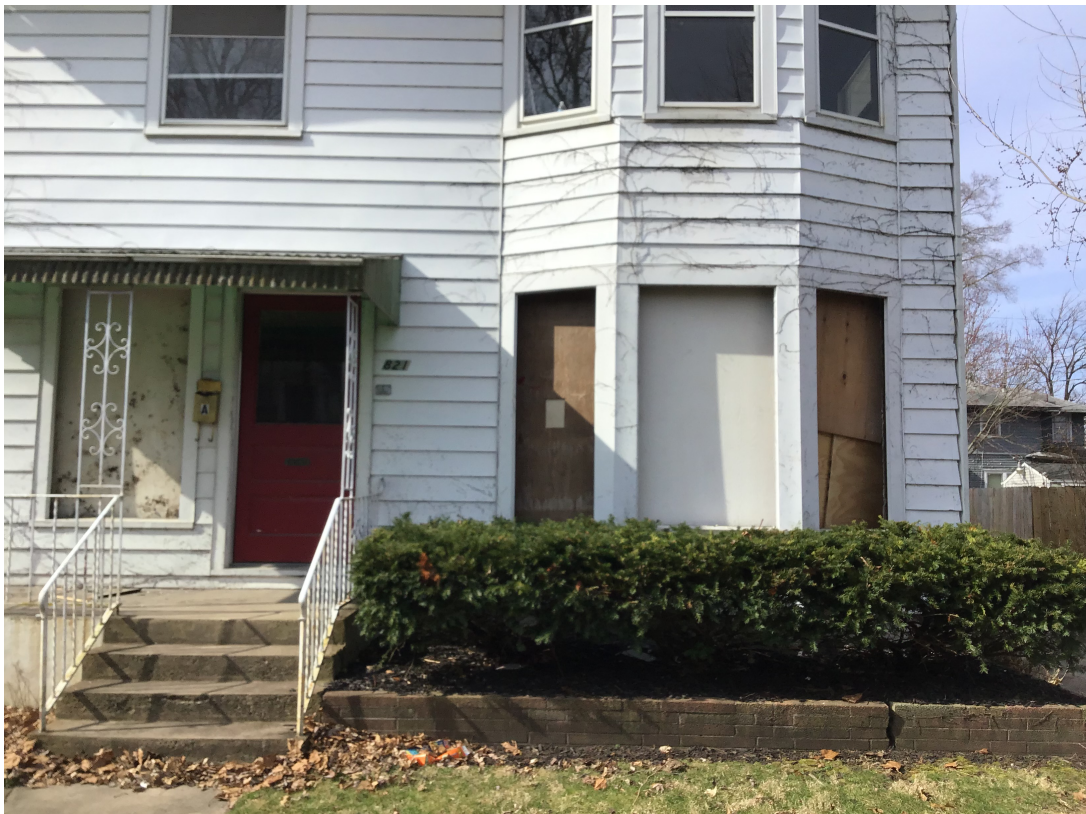
PICTURES OF ITEMS THAT NEED ATTENTION - Front of structure re ce n o s s e - 4/4/2019

HP Inspector Szaday noticed that modifications had occurred on site April 2<sup>nd</sup>. The Building Department issued a ‘Red Tag’ for the property on the same date, as no building permits had been received for work inside or out on the property.

Were this a proactive application for the replacement of existing windows, staff would require evidence that the existing windows were deteriorated beyond repair. The unique and character defining design of the original windows comprised one of the few remaining features of the original structure. The “diamond pattern muntins” and “stained glass in [the] diamond pattern” (as described in the 1987 survey) are irreplaceable.

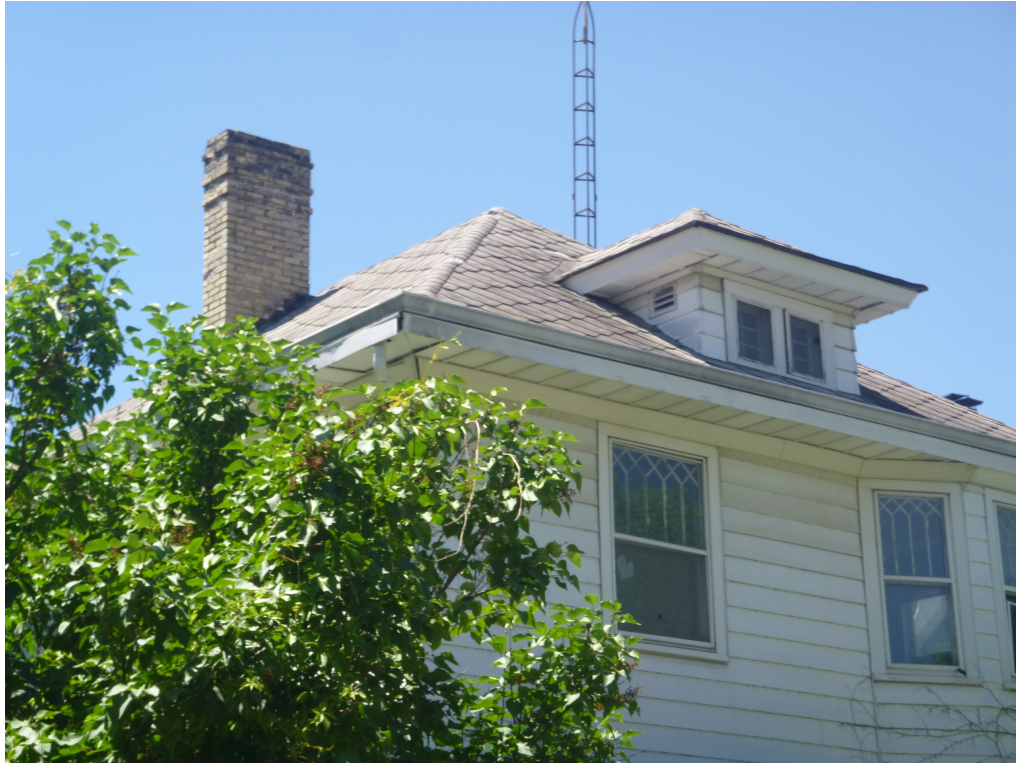
ITEMS NEEDING ATTENTION: Historic window style, front of house, dated 6/4/2018.

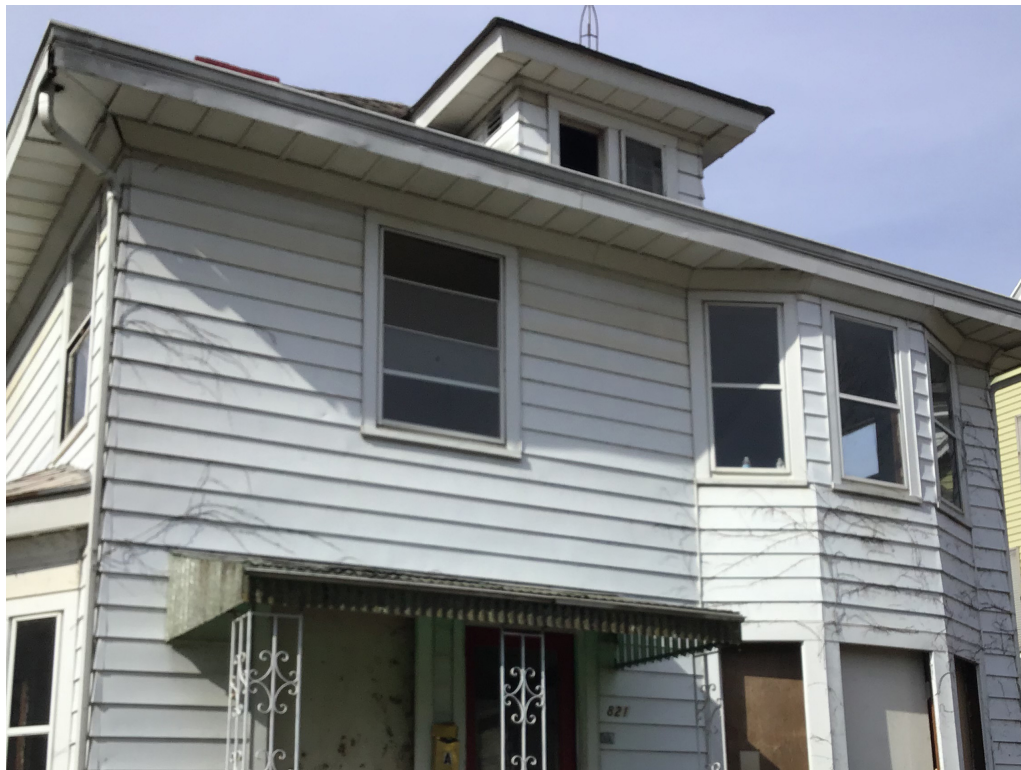
ITEMS NEEDING ATTENTION: Same perspective, 4/4/2019.

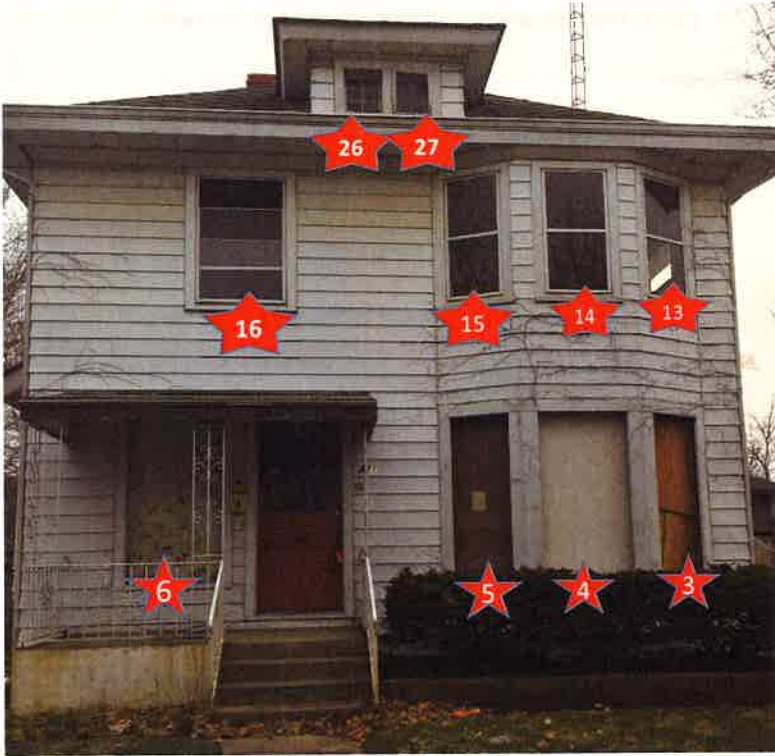
### Front

Front 1 <sup>st</sup> floor	Front 2 <sup>nd</sup> floor	Front Attic
3. 28" x 74"	13. 28" x 62"	26. 19.5" x 23"
4. 42" x 74"	14. 32" x 62"	27. 19.5" x 23"
5. 28" x 74"	15. 28" x 62"	
6. 42" x 74"	16. 42" x 62"

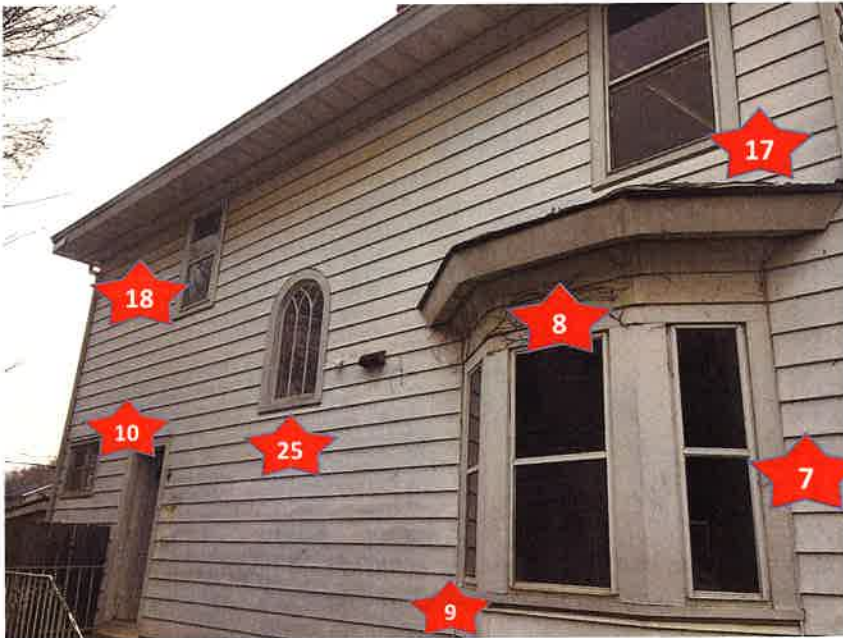
### South

South 1 <sup>st</sup> floor	South 2 <sup>nd</sup> floor
7. 18' x 62"	17. 33 x 62"
8. 30" x 62"	18. 29 x 54"
9. 18" x 62"	25. Leaving
10. 38.5" x 27" (sliders)

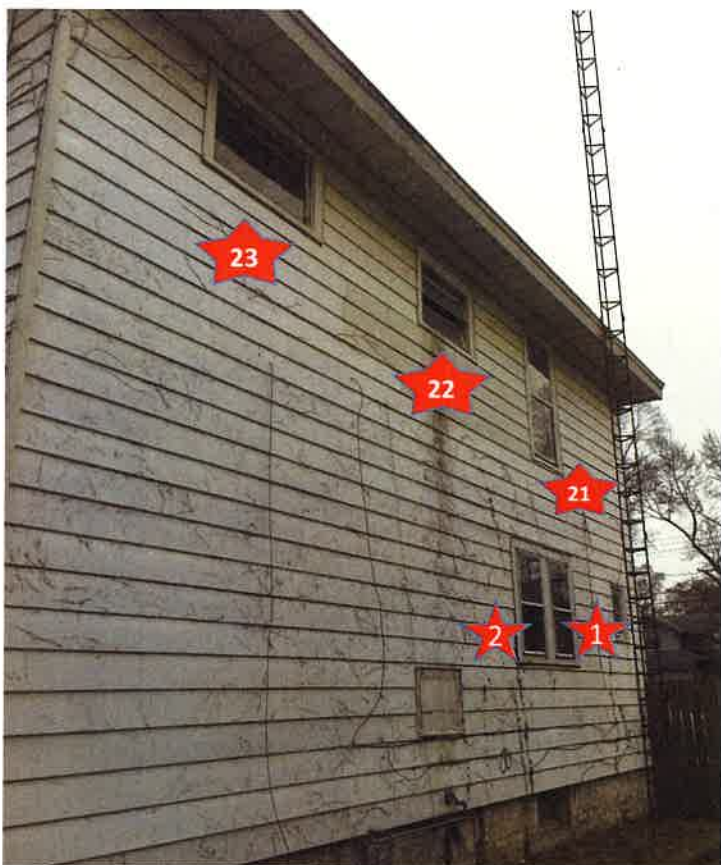
North 1 <sup>st</sup> floor	North 2 <sup>nd</sup> floor
1. 28" x 46"	21. 32" x 66"
2. 28" x 46"	22. 41" x 28"
	23. Leaving

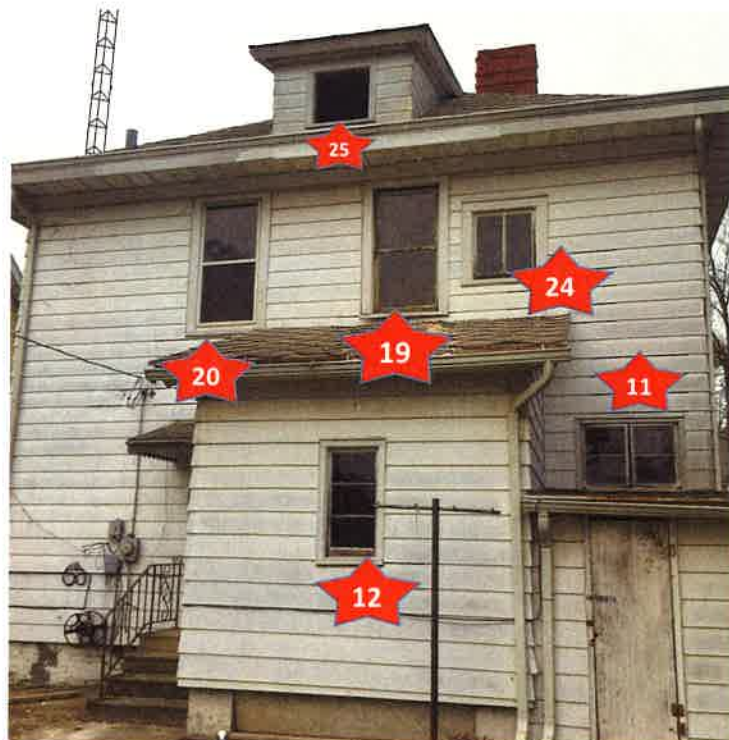
Back 1 <sup>st</sup> floor	Back 2 <sup>nd</sup> floor	Back Attic
11. 38.5 x 27" (sliders)	19. 32" x 62"	25. 29" x 29"
12. 18.5" x 37.5"	20. 32" x 66"	
	24. Leaving
