**STAFF REPORT**  
CONCERNING APPLICATION FOR A  
**CERTIFICATE OF APPROPRIATENESS**

**Application Number:** 2019-0603A

**Property Location:** 1133 East Wayne Street

**APPLICATION ITEMS:** *“Replacement of the asbestos tile roof and galvanized gutters with the Classic Products Oxford metal shingle and new galvanized gutters”*

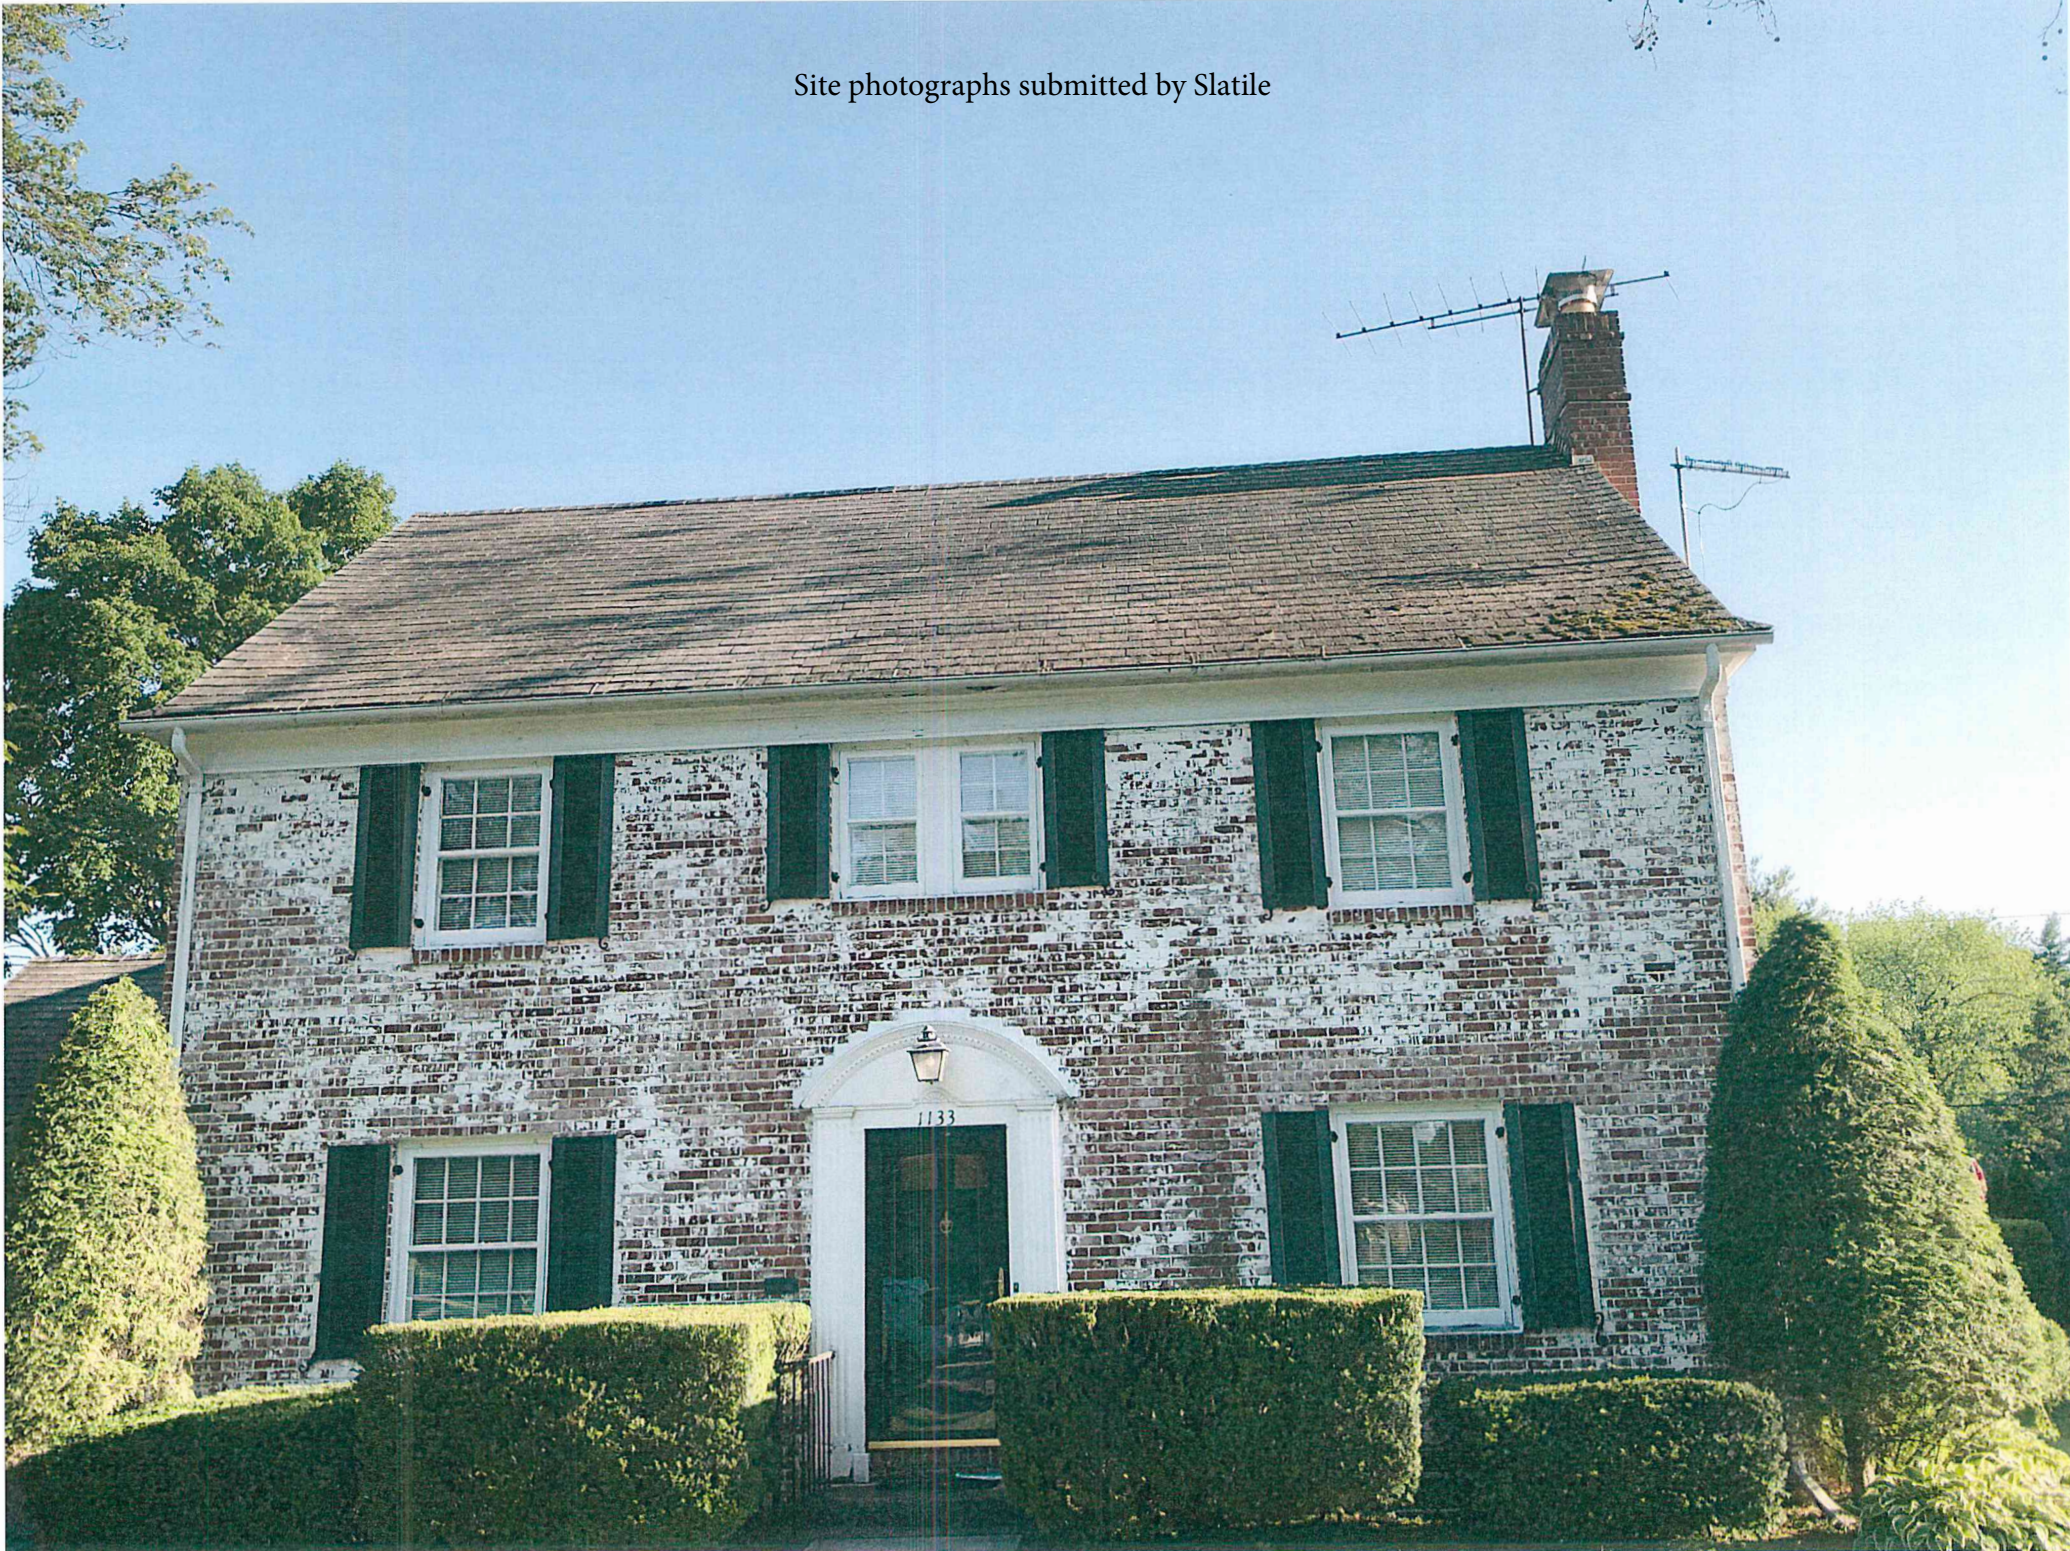
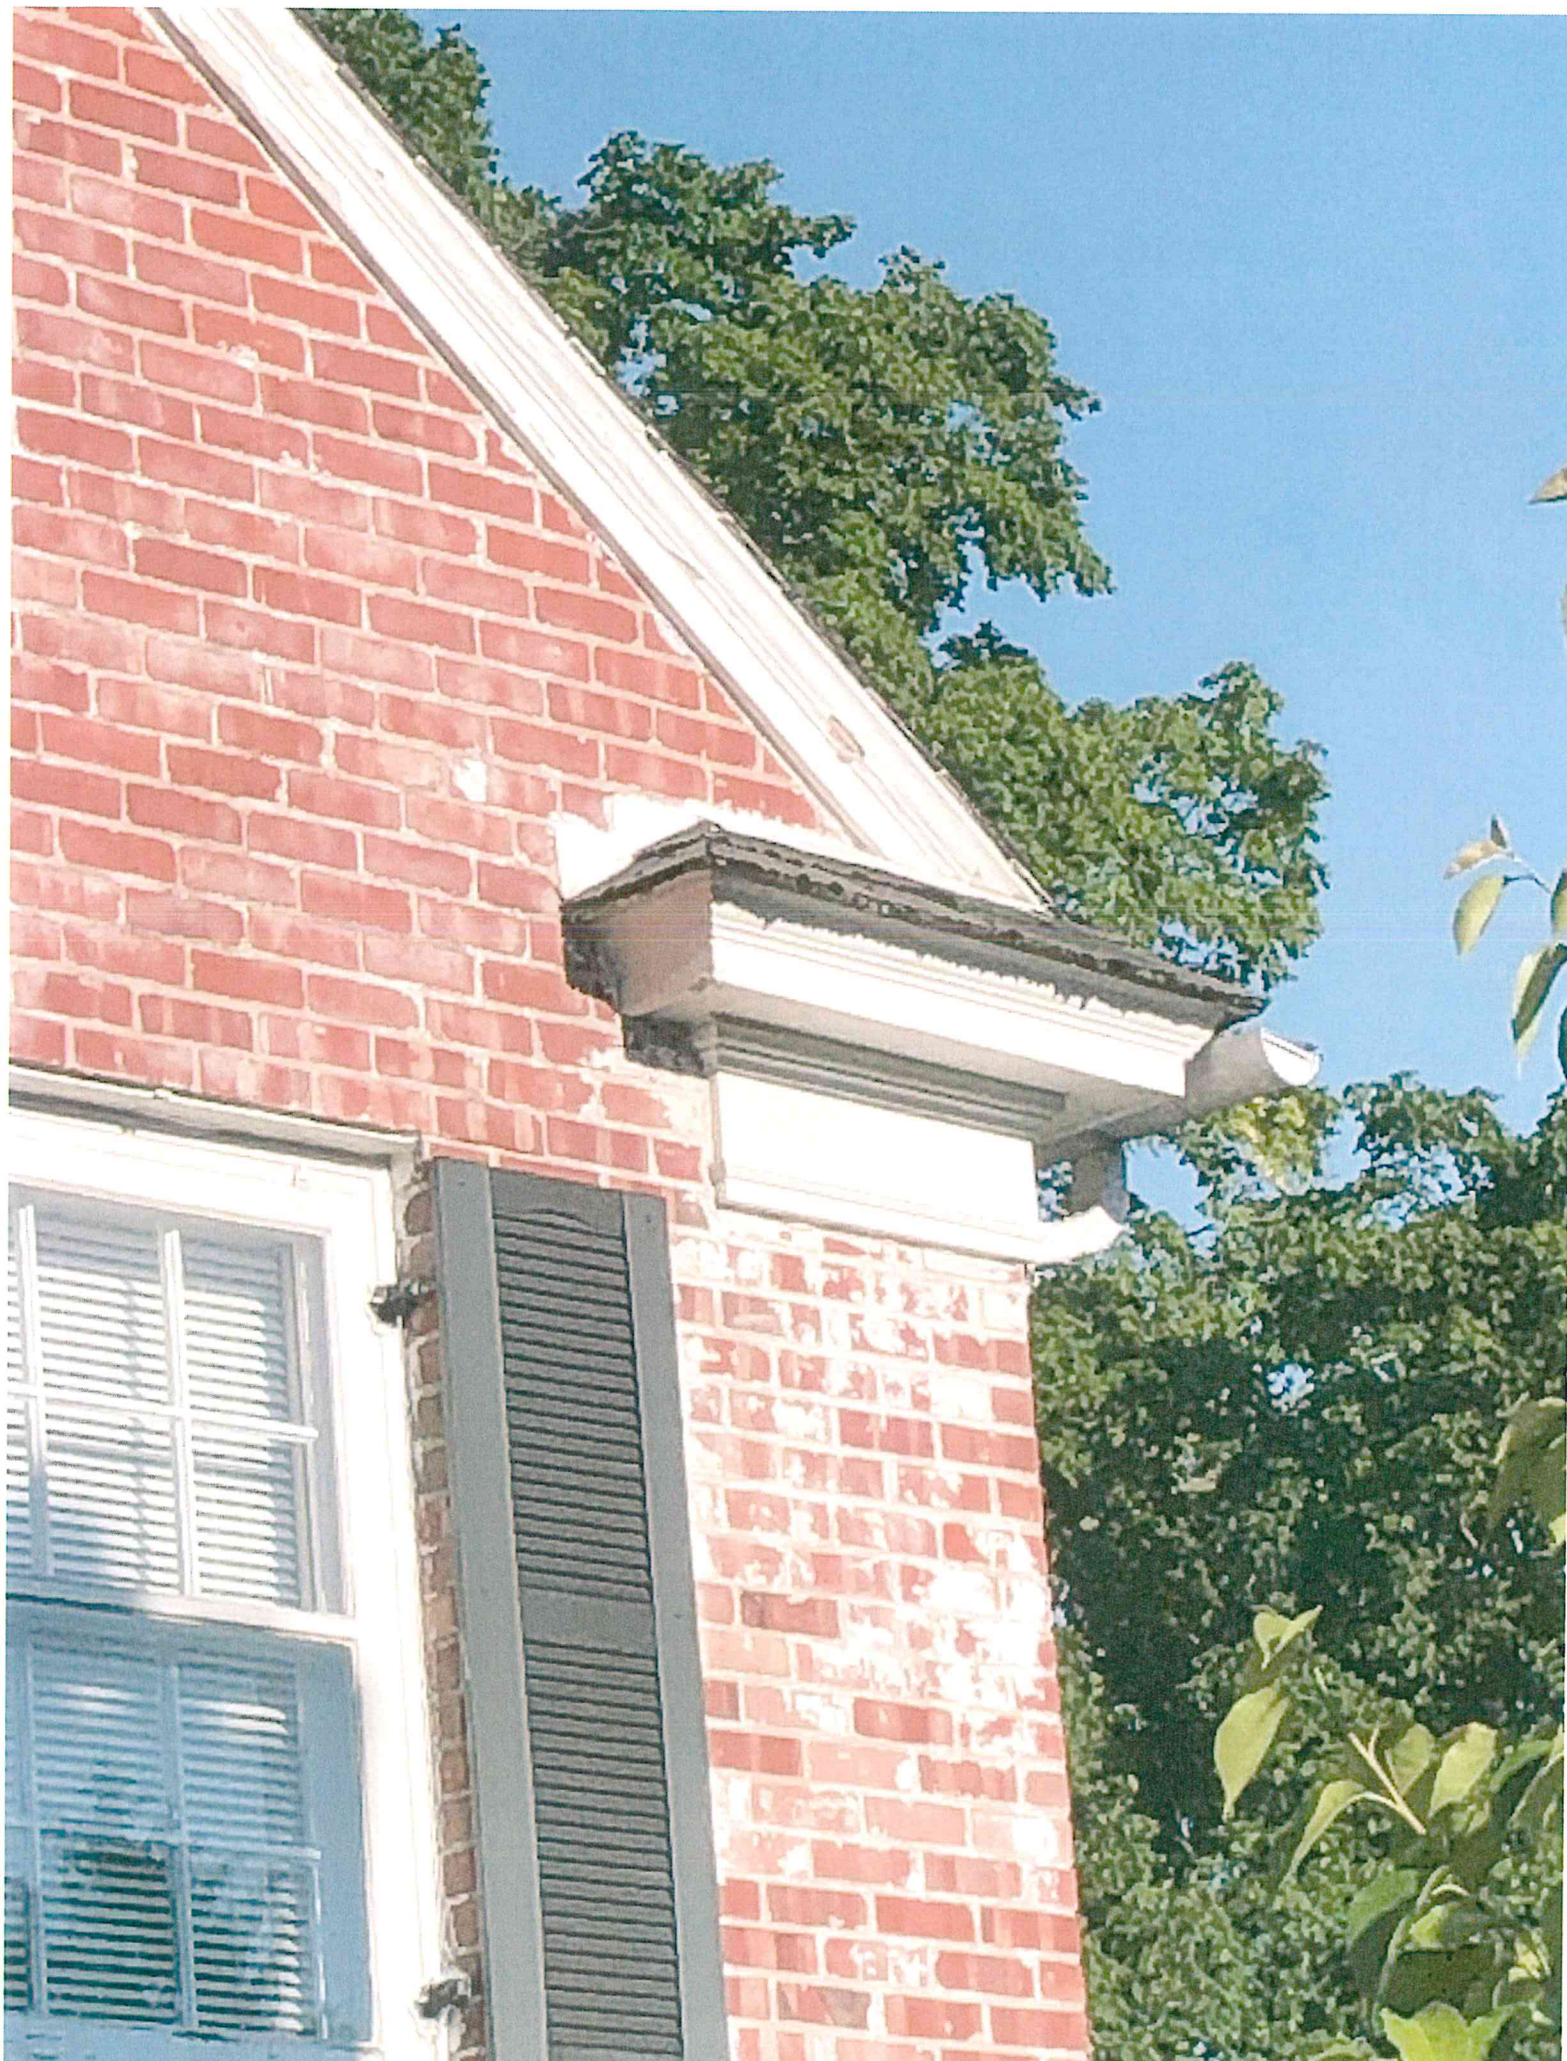
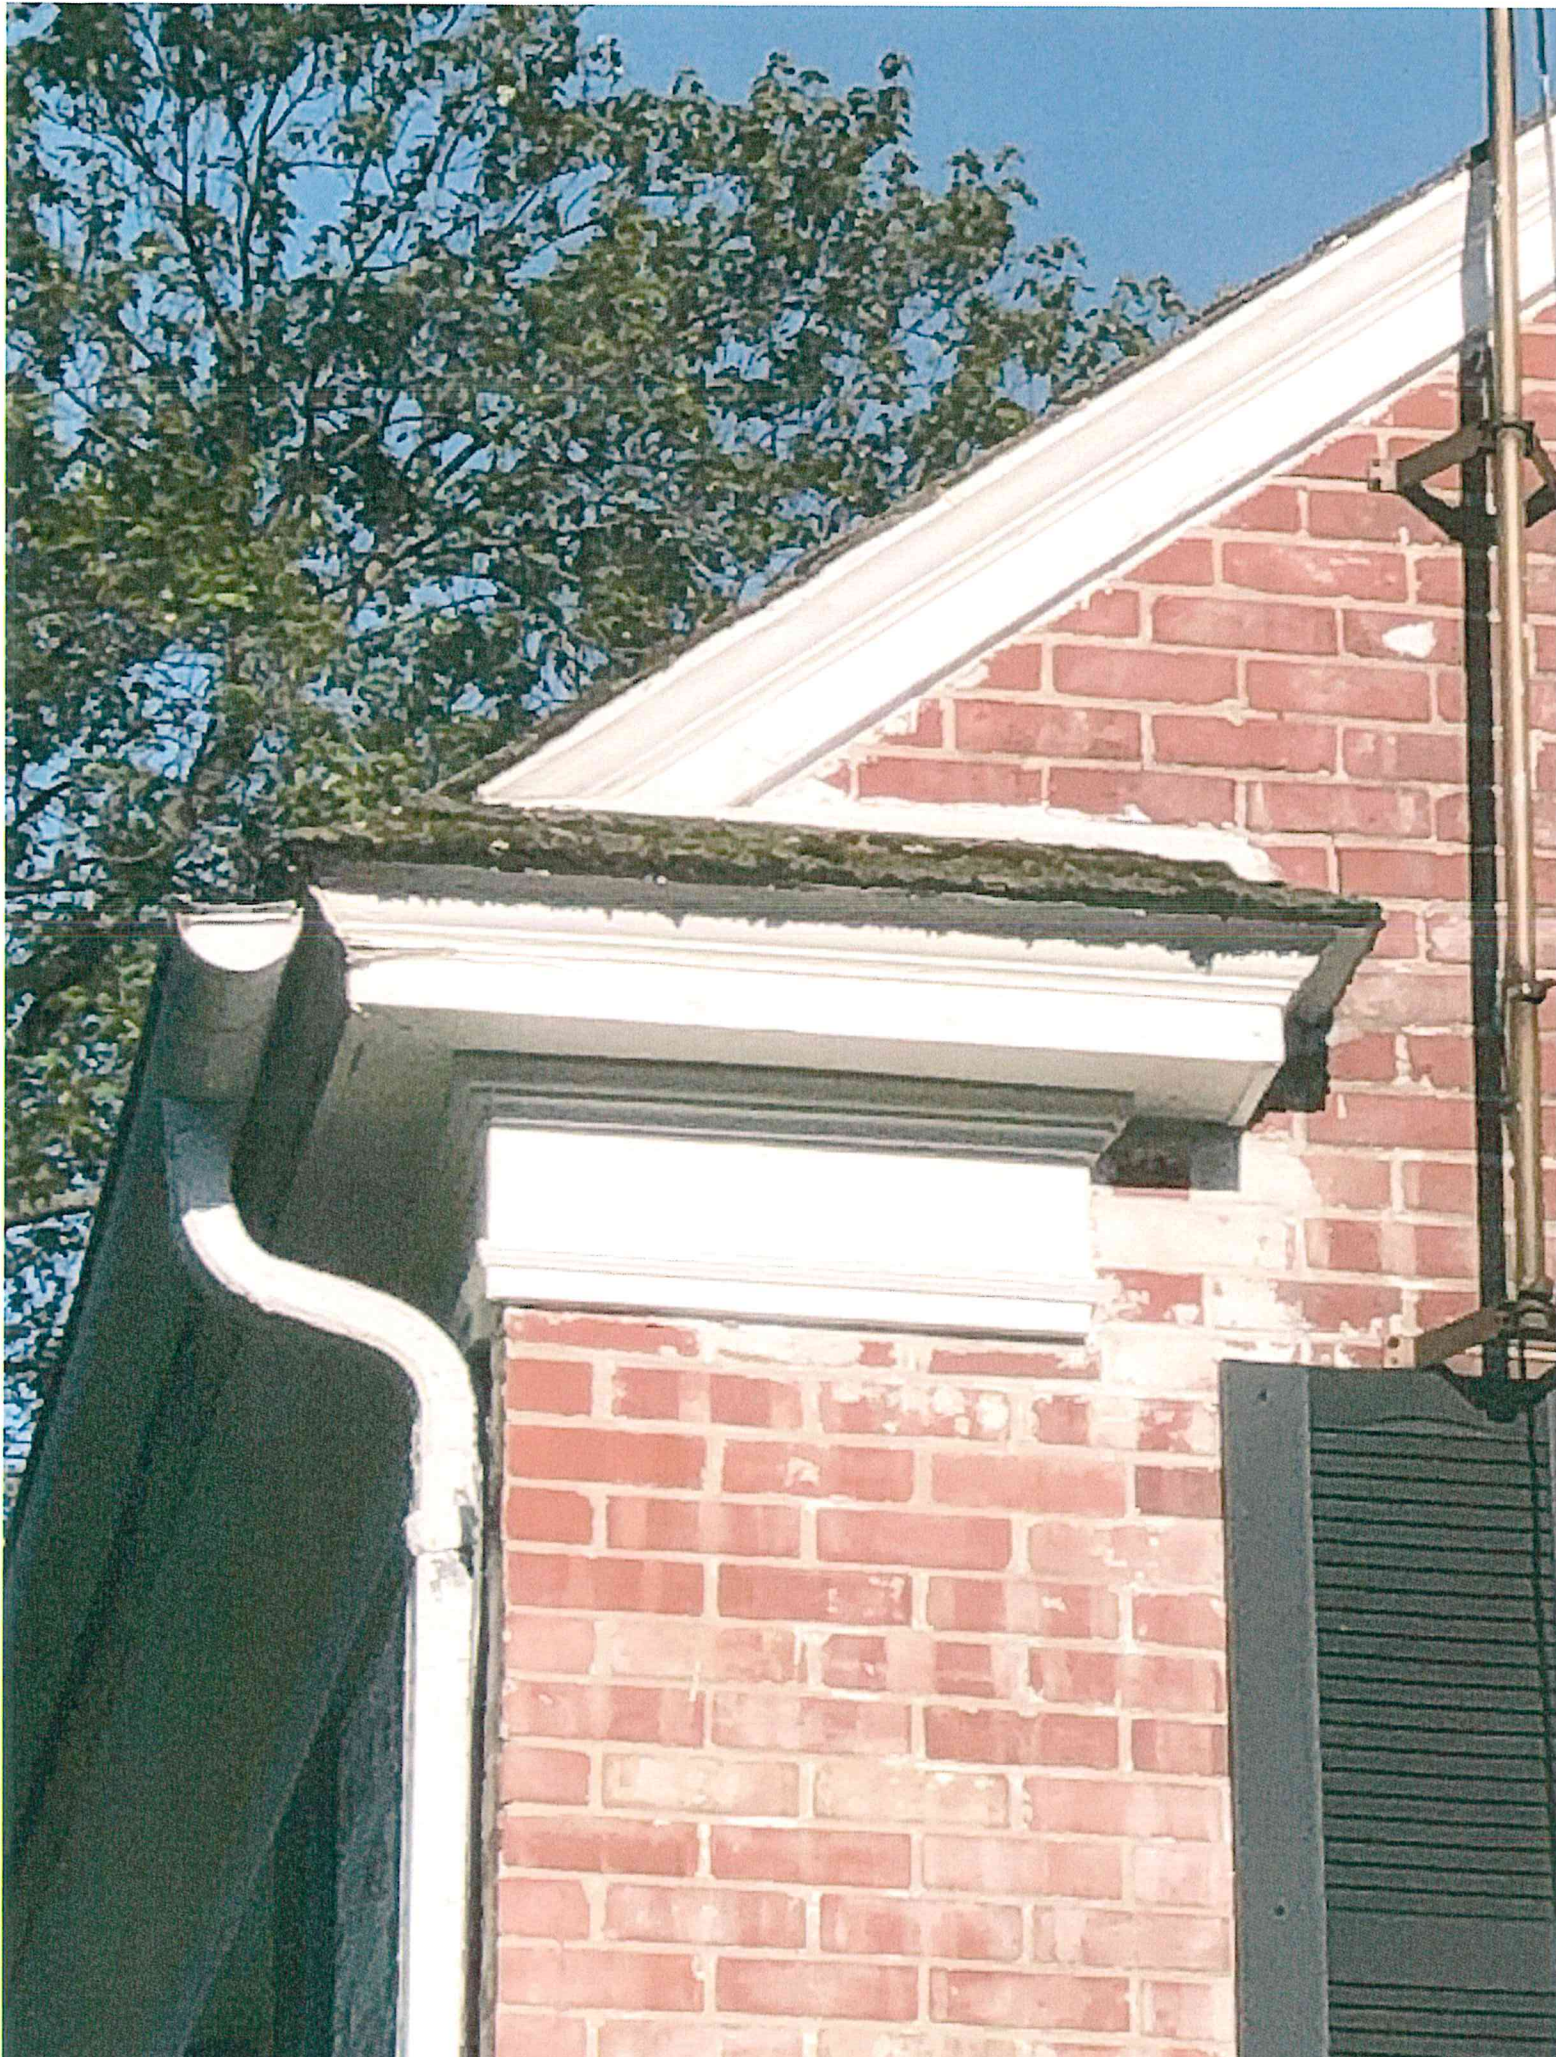
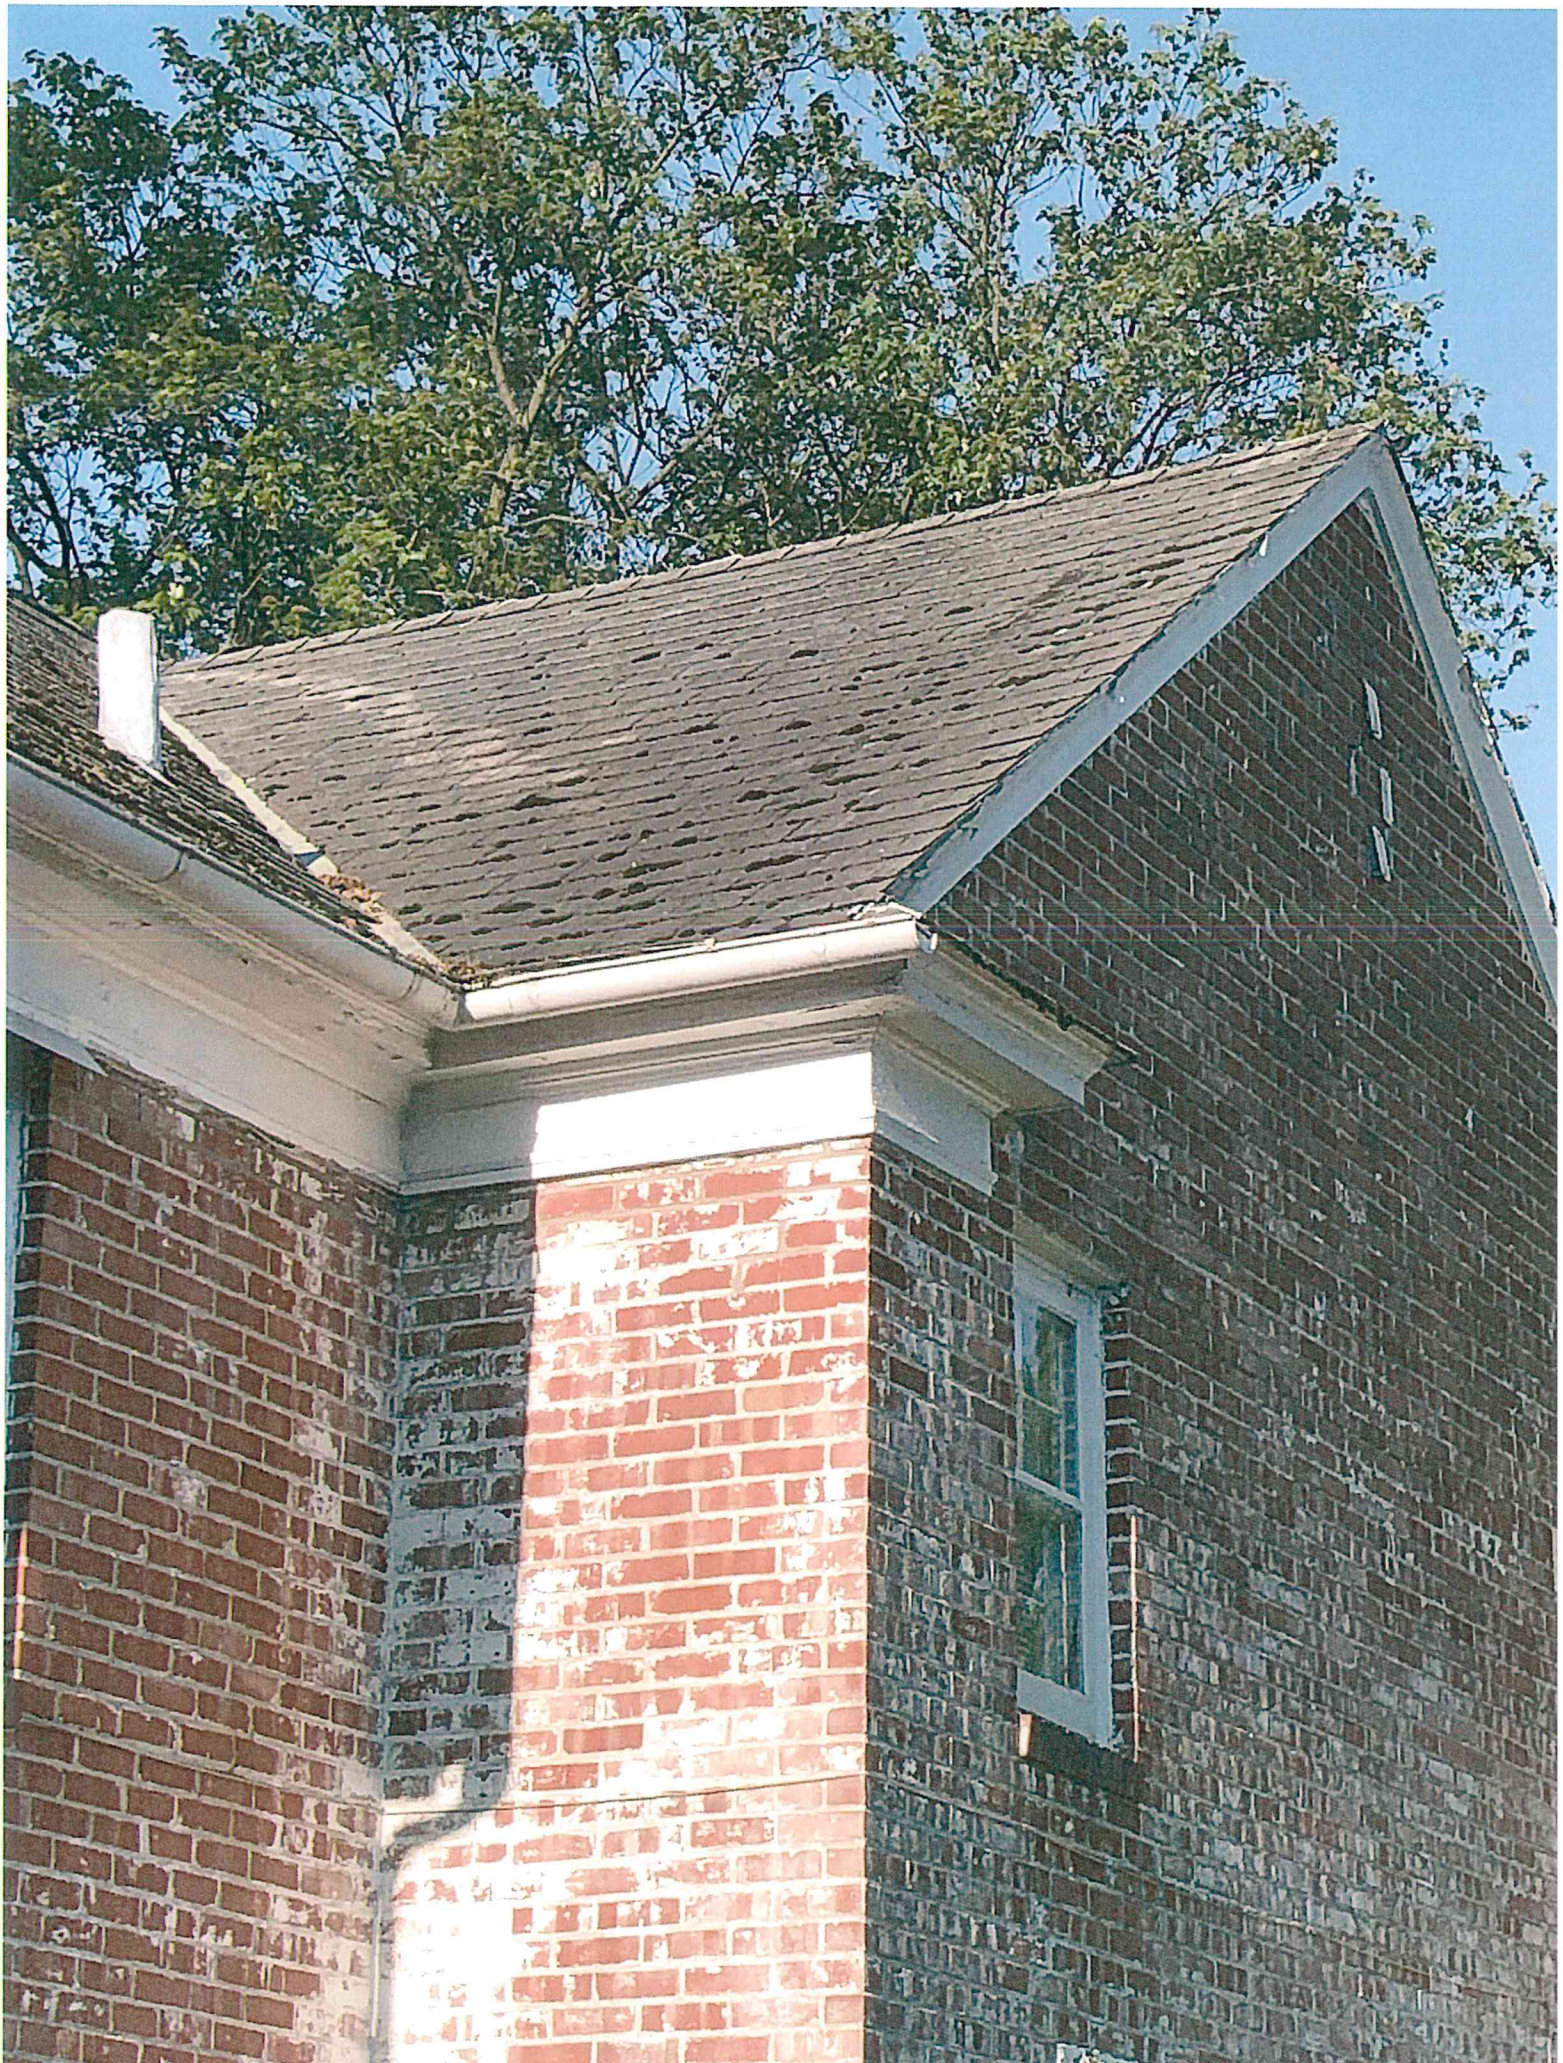
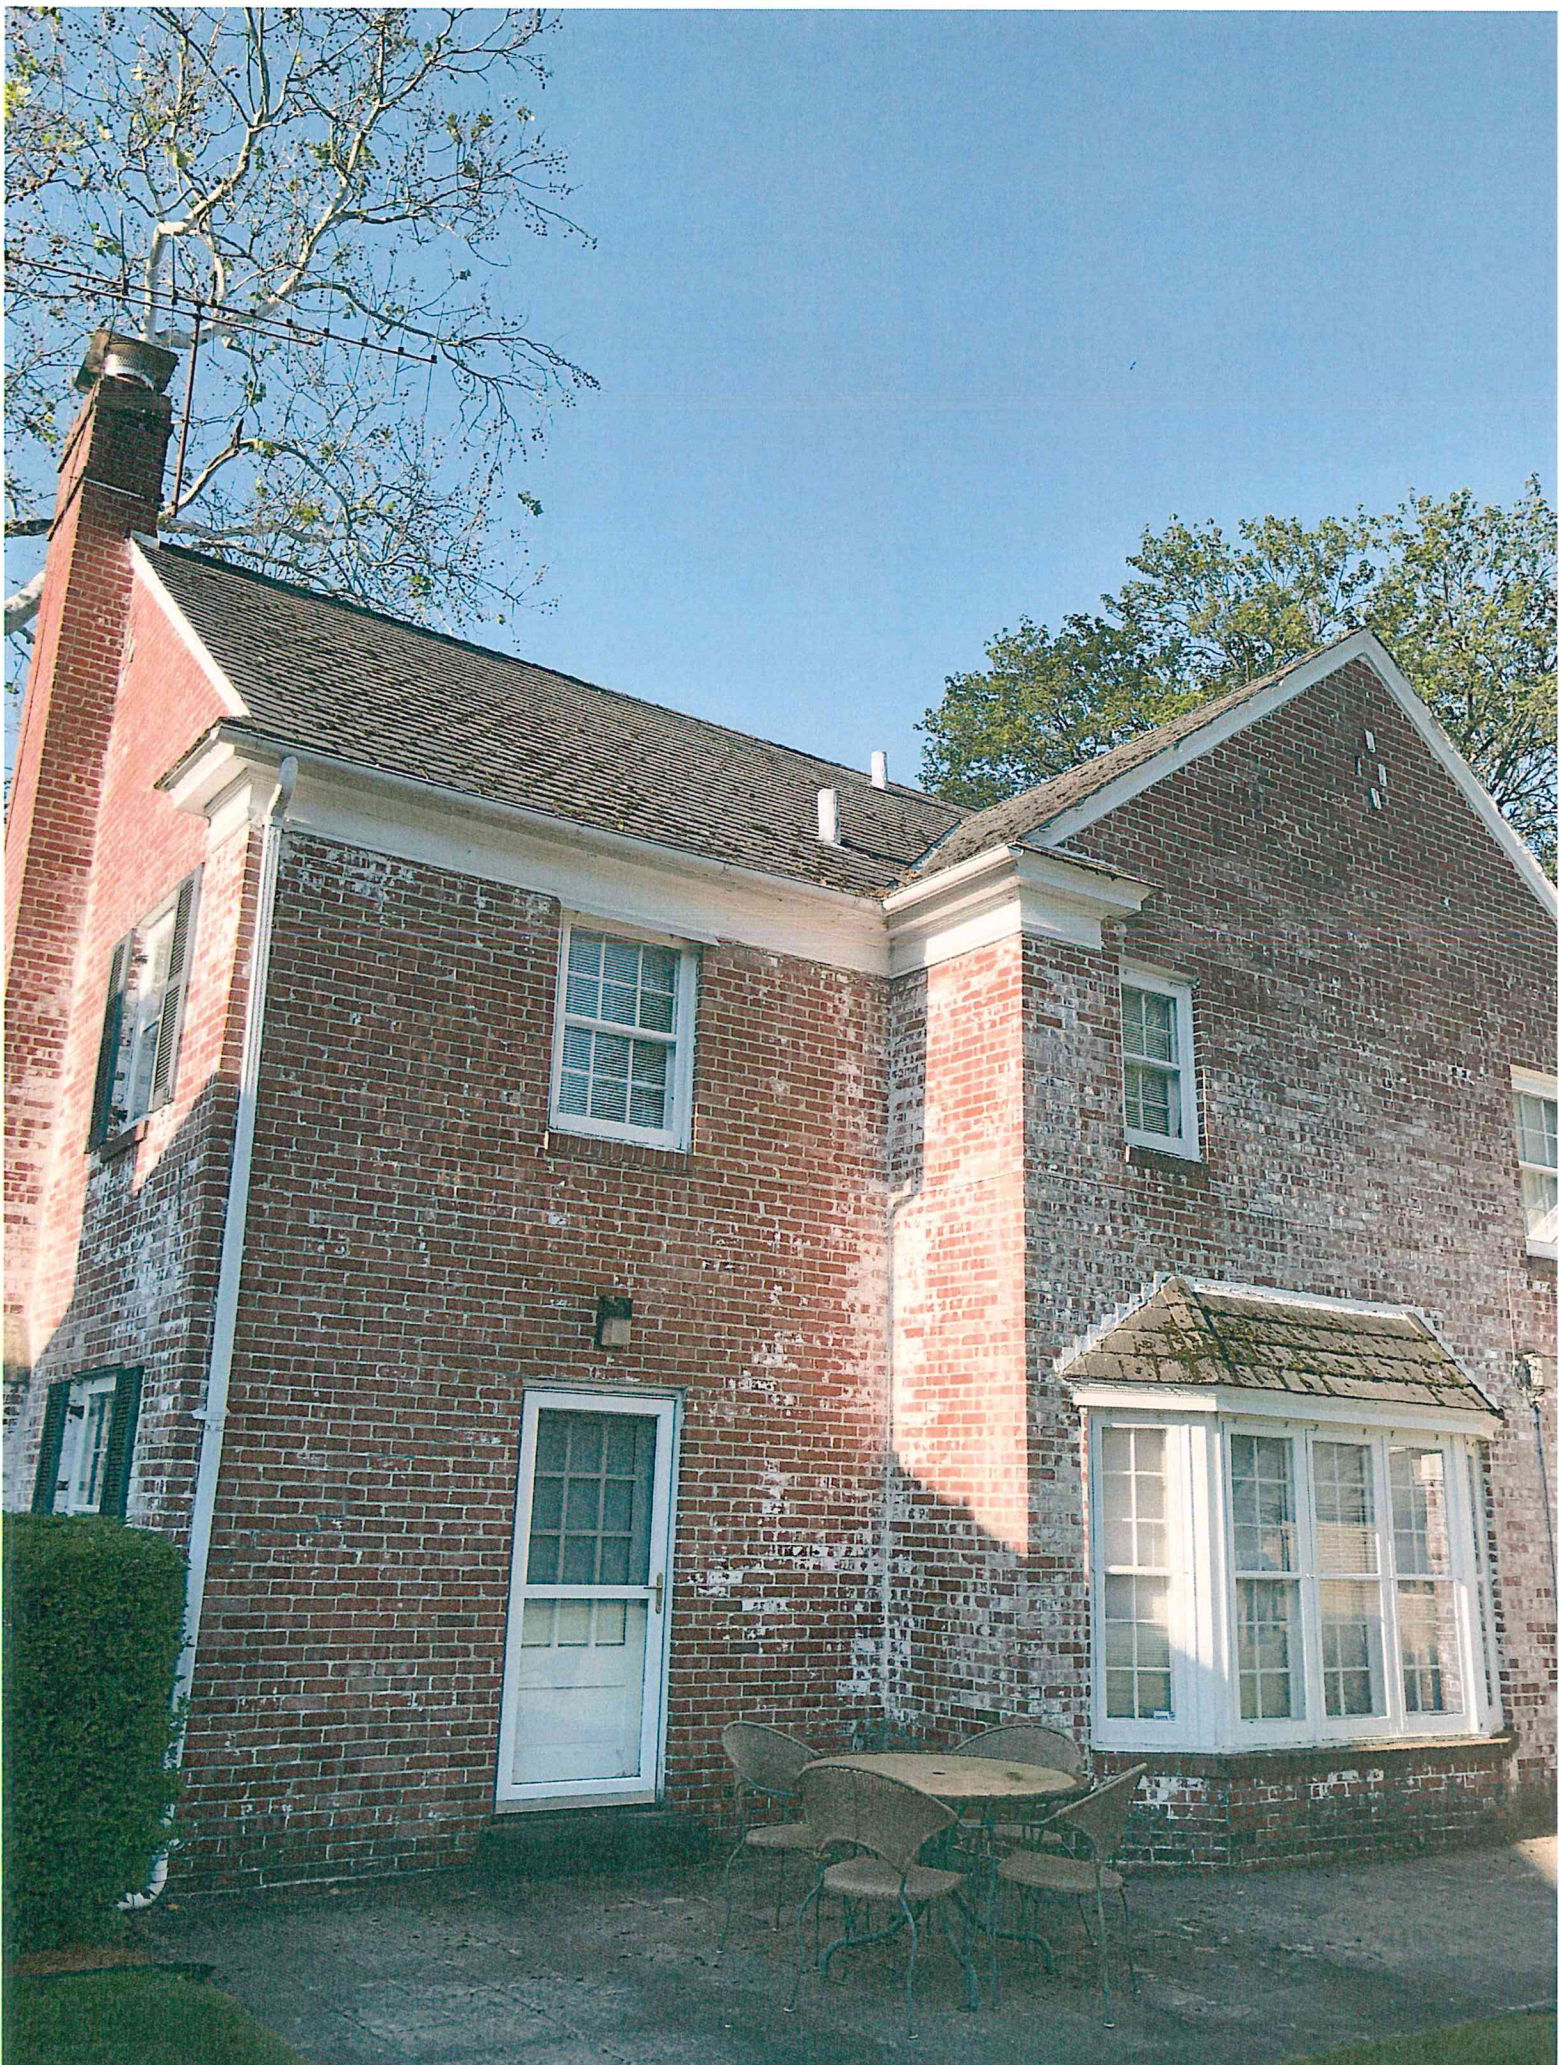
Site photographs submitted by Slatile

There are missing or broken tiles in several locations. The owners and contractors have been using up a stockpile of matching tiles, but now that supply has been depleted. Patches of moss are everywhere on all sides of the roof. This would suggest that the existing underlayment under the asbestos tiles has failed so far as to allow moisture to pool. Not to mention the extra weight. The moss will need to be removed and the areas washed to prevent regrowth.

The current roof is an asbestos tile system. According to the owner, this is the original roof from when the house was built in 1938. Our company has been doing various repairs for the last 5+ years for missing or broken tile, miscellaneous flashings and such. At this time it is becoming more difficult to obtain replacement tile for these repairs. After inspection of the roof I found that there are currently 1-2 broken or missing tile but because of the pitch of the roof I am unable to see all of the north elevations. Mr. Nowicki informed me that he had found additional tile pieces in his yard so I am assuming there are more on that north side.

We were contacted about the possibility of replacing the asbestos system with a new roofing system. After discussion with Jim we discussed the possibility of installing a metal shingle style roof system in lieu of the standard architectural shingles that have become common in this area. The reasoning behind this is to offer a system that would not mean a total tear off of the asbestos. With a tear off of asbestos there are special precautions that need to be taken before and during the process. Although this type of asbestos is non-friable we would still have to notify all neighboring houses, take special care in the demolition to not break the tile if possible and to notify the refuse company we use so they could provide a lined dumpster and individual bags to contain the tile. All of this makes the labor and material costs go up and with the metal we can offer a system that will out preform the standard asphalt shingles and give an aesthetic look that fits the neighborhood at a cost not much more than installation of the shingles. We would basically encapsulate the asbestos by installing a synthetic underlayment over them. All existing flashings will be removed and replaced with new.
