# STAFF REPORT

## CONCERNING APPLICATION FOR A CERTIFICATE OF APPROPRIATENESS

**Application Number:** 2019-0923A

**Property Location:** 708 Forest Avenue

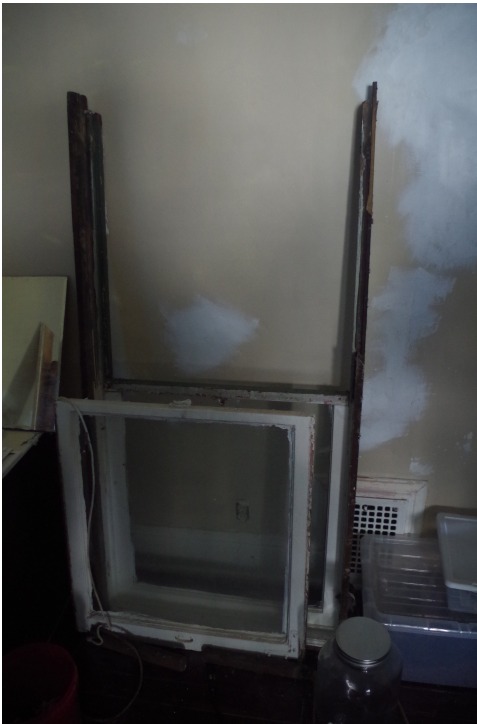
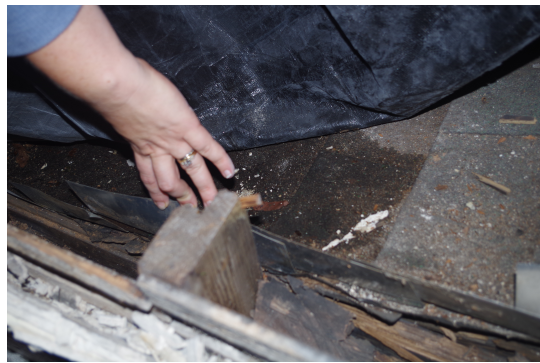
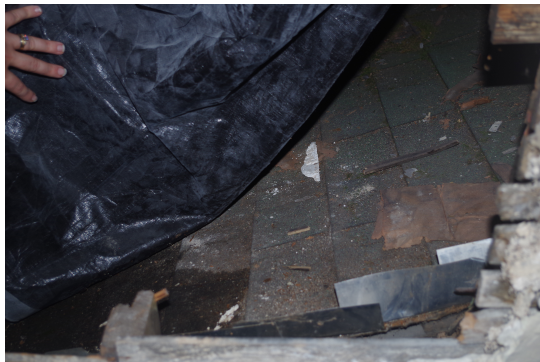
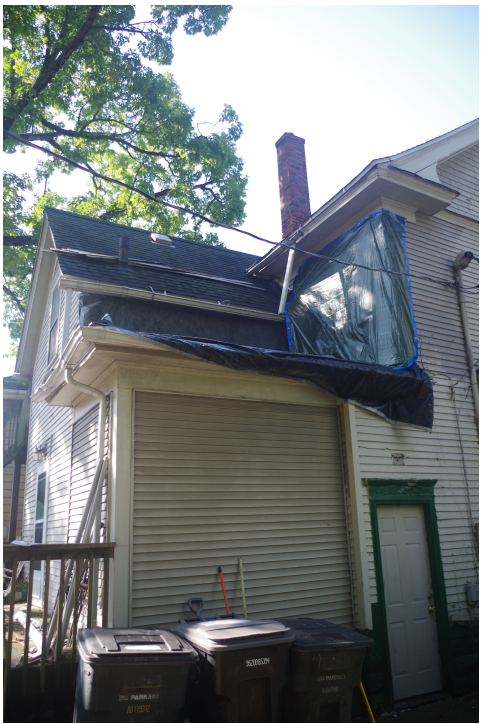
1. Resizing of second story rear window (at northeast corner). The current window receives constant moisture contact from the adjacent roof, leading to accelerated deterioration. Applicant seeks to decrease the overall size of the window enclosure to ‘raise up’ the window sill above the adjacent exterior roof line.

- a. Window Configuration
    - i. The existing sashes have been retained and appear in decent / restorable condition. These could be cut down in size to accommodate the new window size. The frame of the window has been removed and appears to have deteriorated and would need to be reconstructed. This new framing would require skilled carpentry work. Staff would prefer to see original material (that is in good condition) be re-used in the future window enclosure.

Window Project Detail - Original sashes at left. Temporary window covering at right.

**STAFF RECOMMENDATION:** Staff recommends approval of the project as submitted. Staff would like the original sashes to be resized and reconfigured in the new smaller window opening.

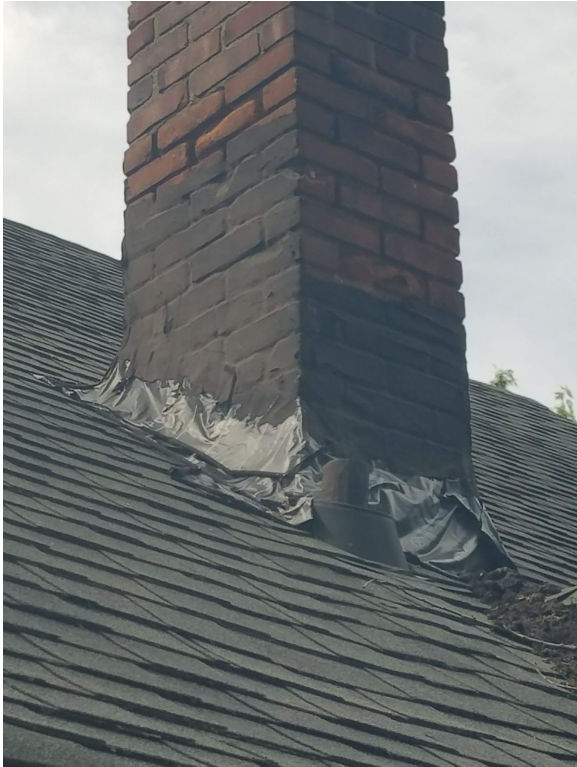
1. Install new flashing and counter flashing to replace incorrectly installed chimney flashing.  
(See attached Dennison Exterior Solutions Repair Order)

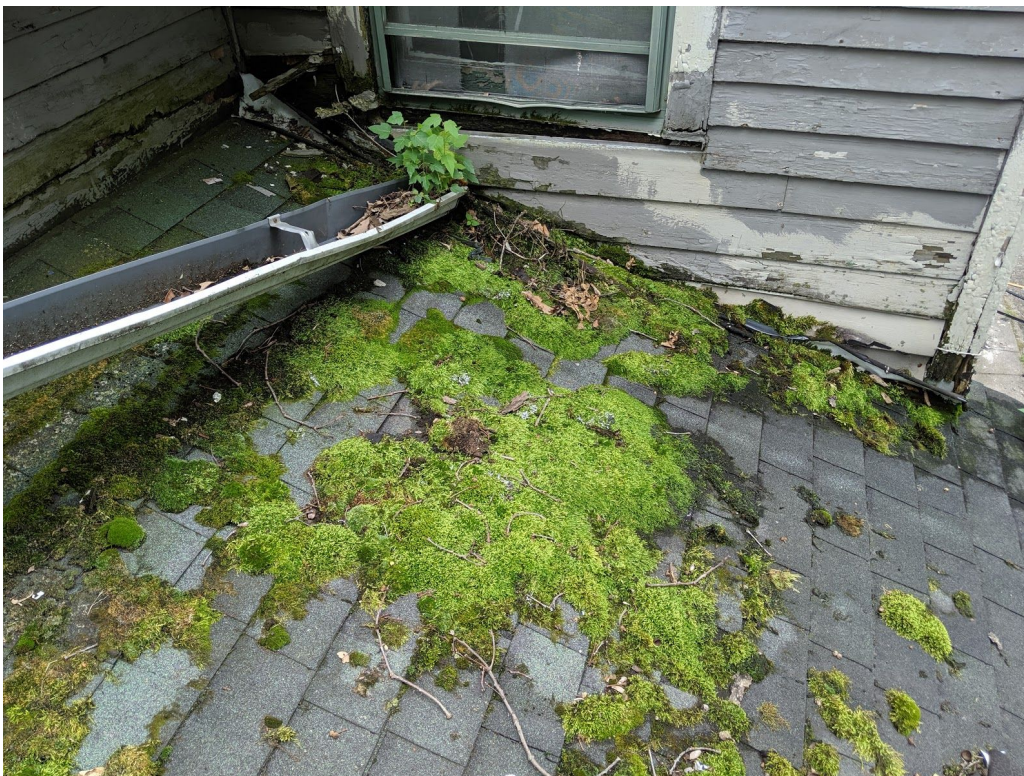
2. 8x14 section of roof -water damaged and rotting away from the wall of the house in the Northeast corner. Replacing the sub-roof, ice & water shield, asphalt shingles and wall flashing with like materials.

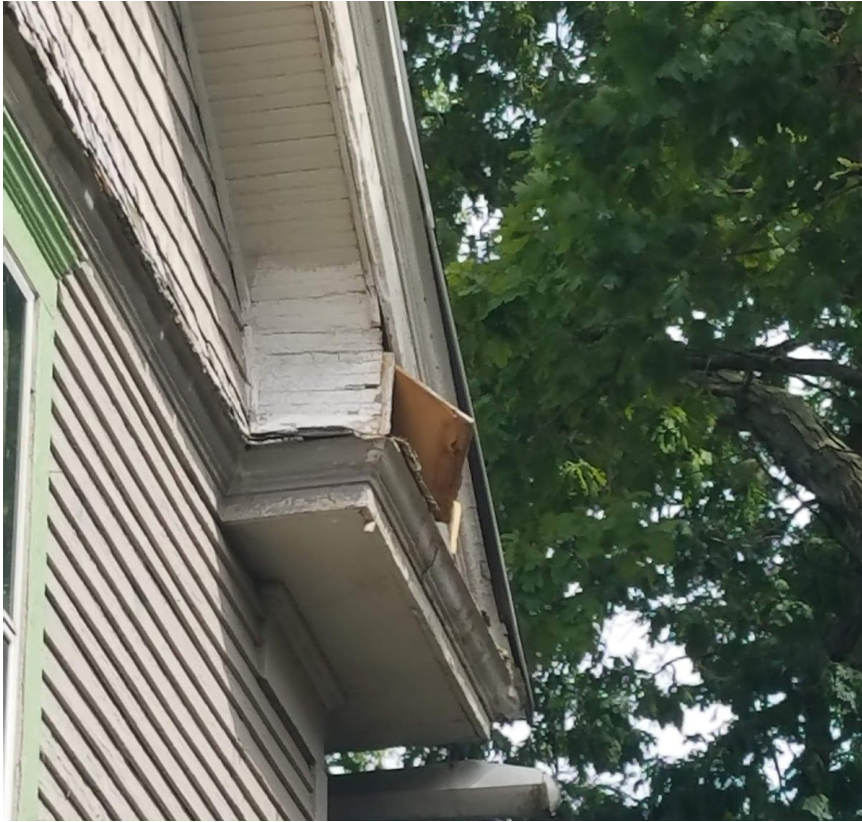
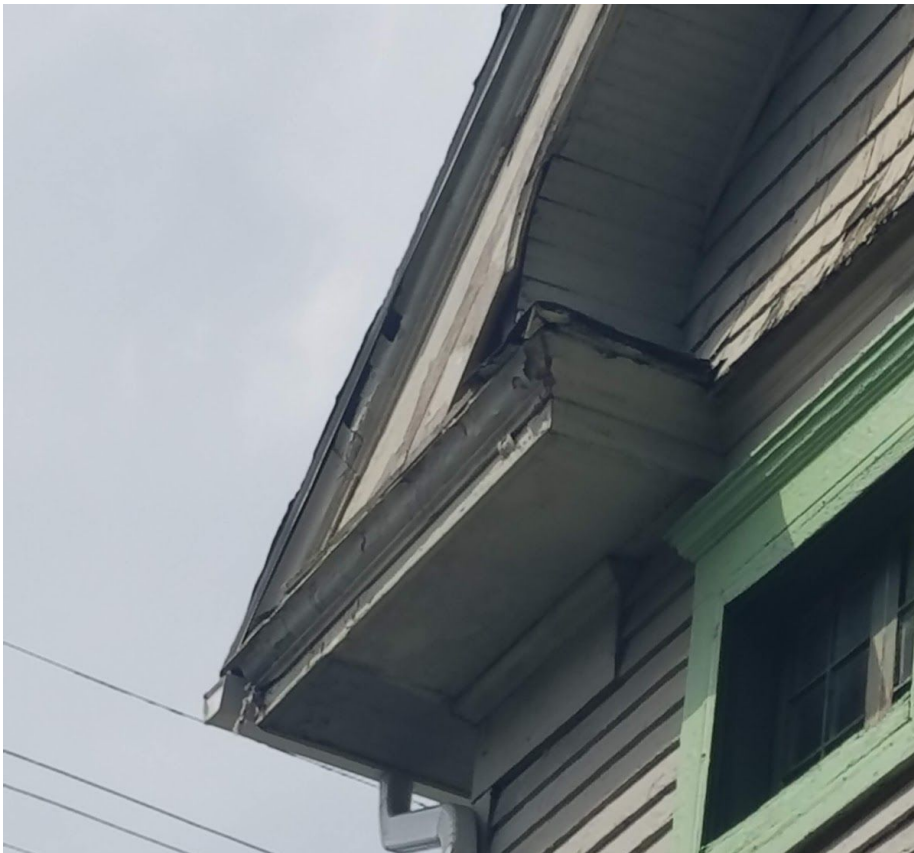
3. Replace 3 areas of soffit which are missing with new wood soffit. Matching wood and paint to match.

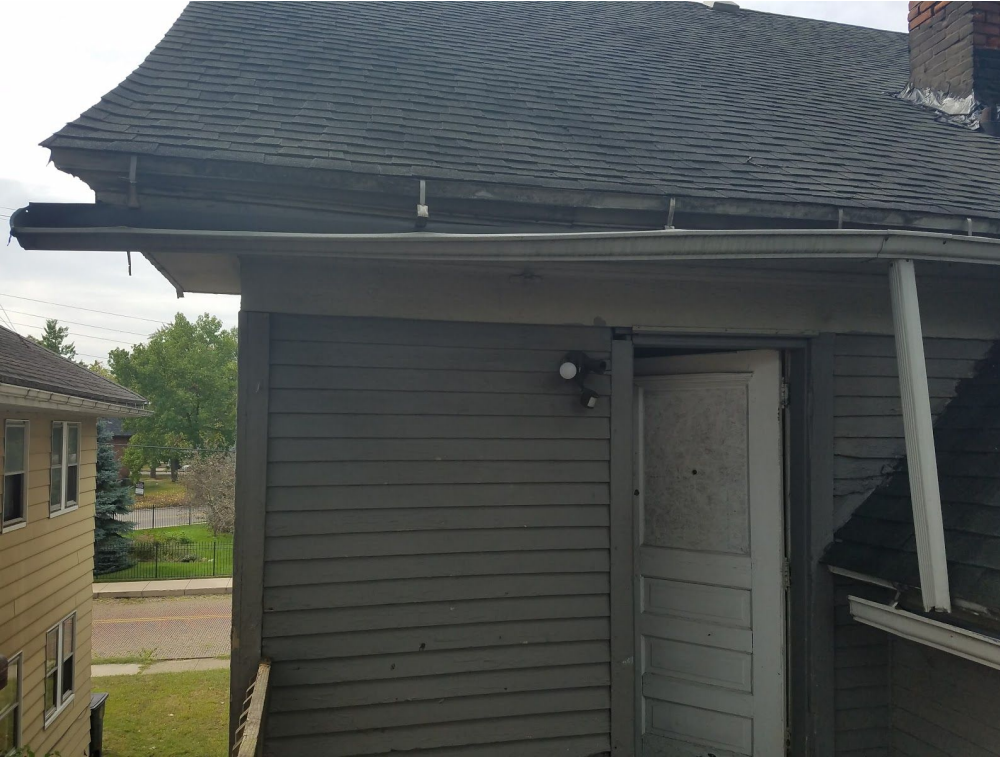
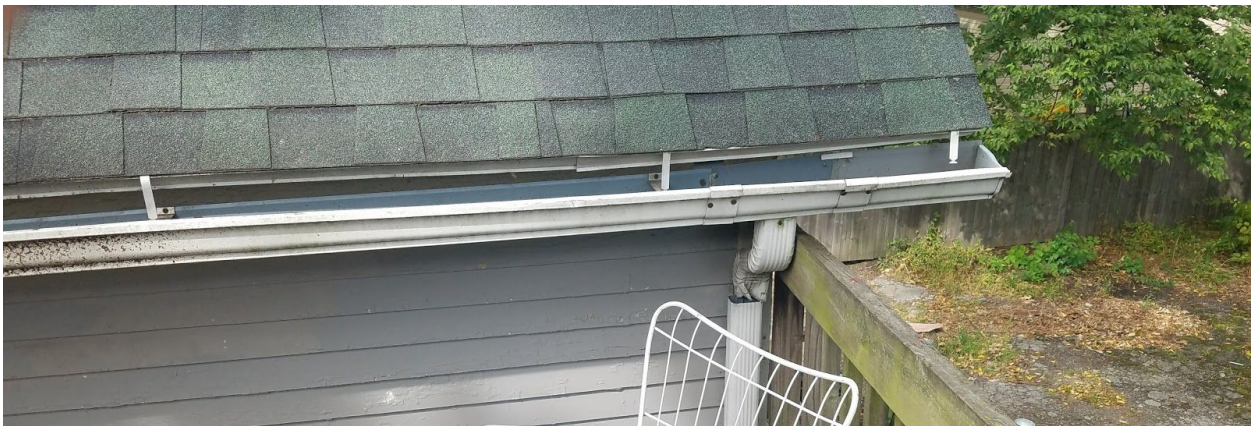
4. Remove existing white gutters and replace with like gutters.  
(See attached Dennison Exterior Solutions Repair Order)

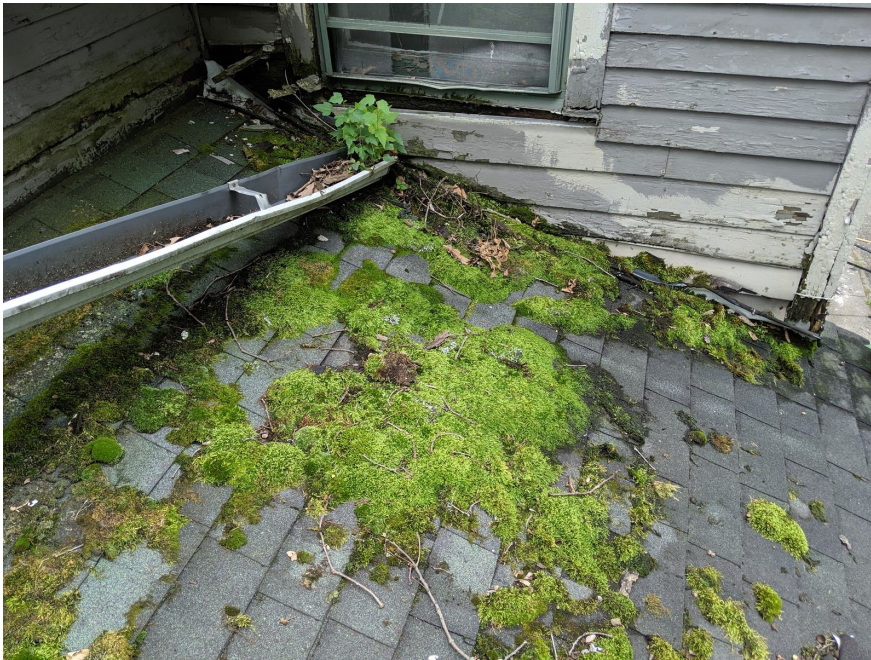
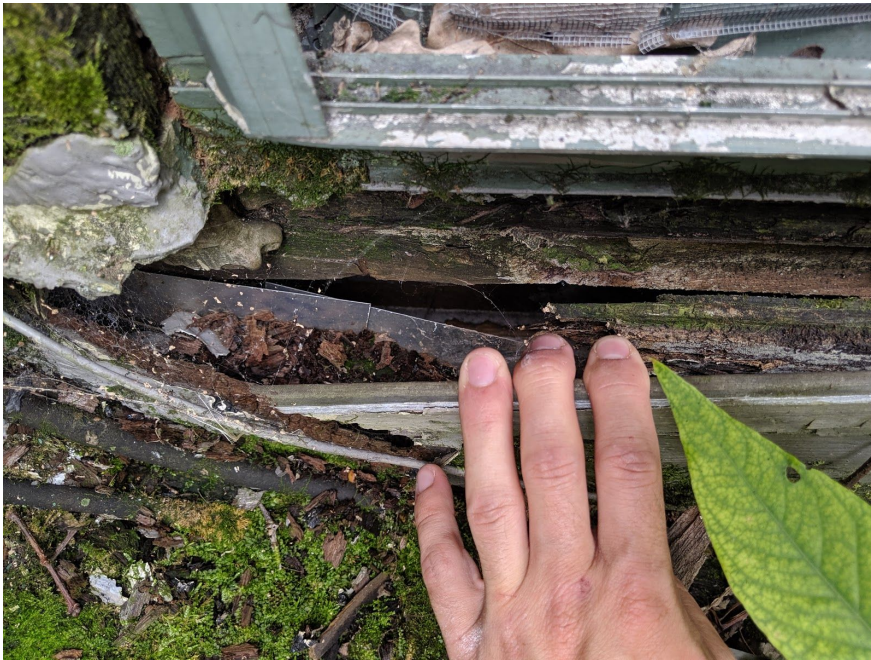
5. Remove and replace wood siding, window and framing in the Northeast corner with like siding and framing, but a smaller window (24x54?). The roof of the addition overlaps the window & trim. Our carpenters believe that the window trim is in danger of rotting again do to this quirk in the construction of the past addition. A smaller window will fix the problem by moving the trim out of the way of the eaves & gutters. Without this change our carpenters believe the window will need to be replaced or repaired frequently.

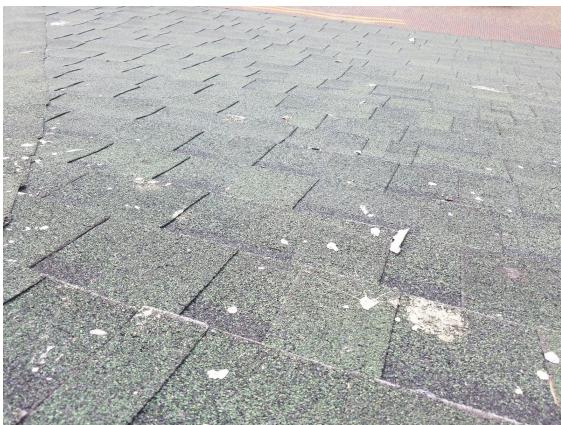
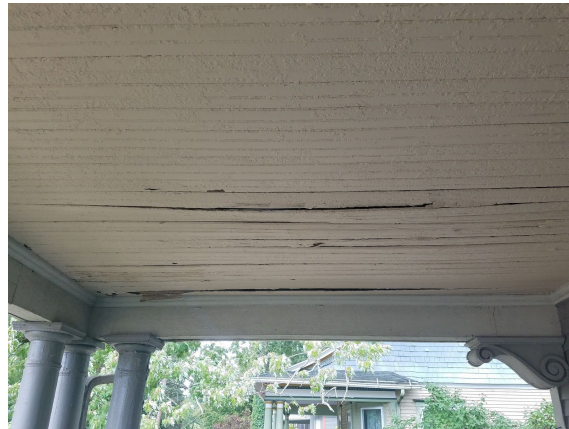
7. Repair leaking porch roof, replacing asphalt shingles for asphalt shingles. Upon visual inspection, the roof appears sound. However, the amount of damage to the porch ceiling and flooring due to water dripping during rain indicates repair is necessary.

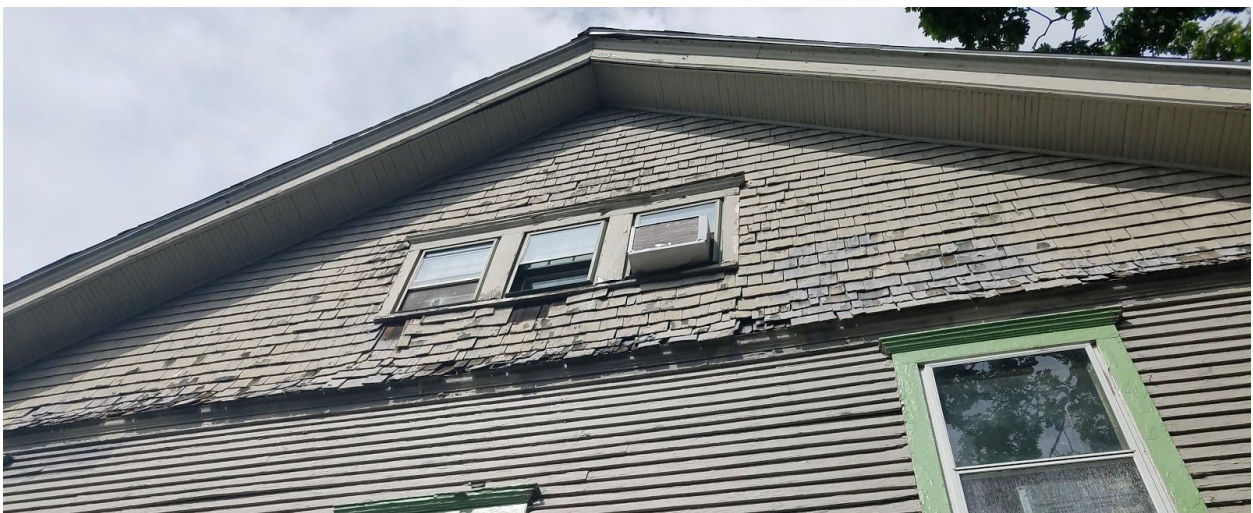
8. Replace missing cedar shingles with like cedar shingles.

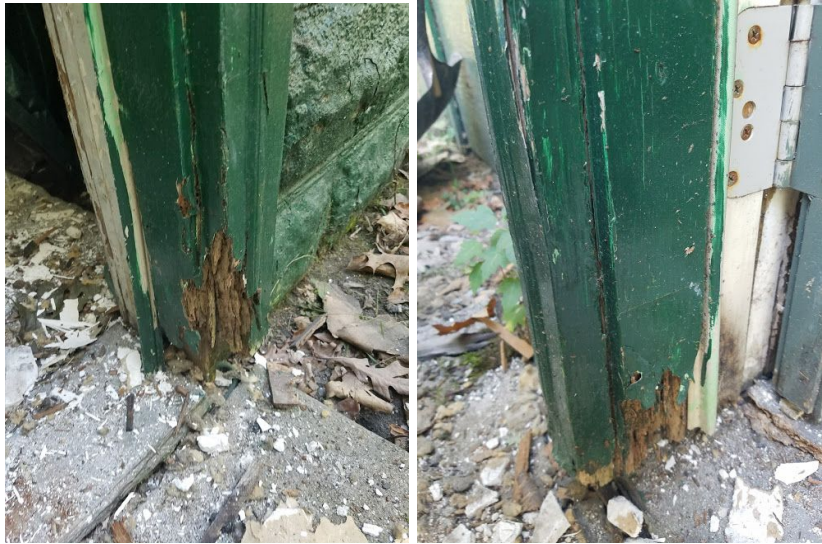
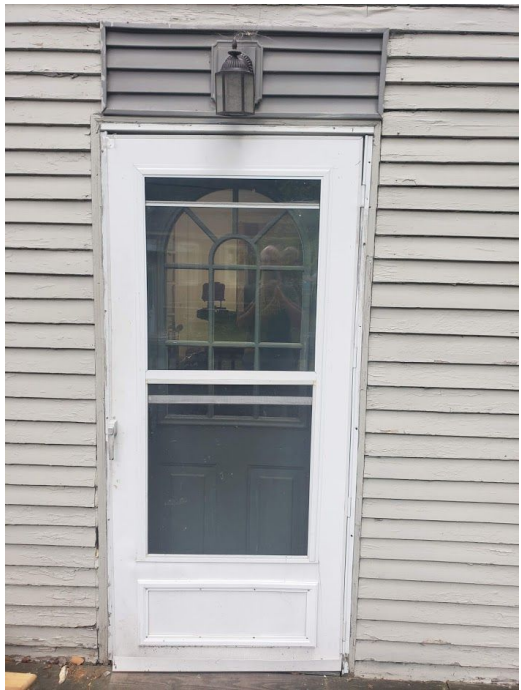
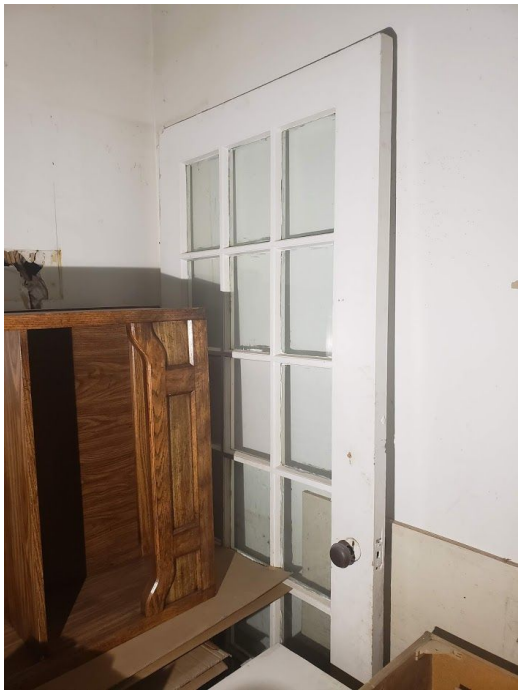
9. Install new side door and back door with doors that fit the aesthetic of the house. Including adding trim to doors that were never trimmed.. Replacing rotten framing where needed.

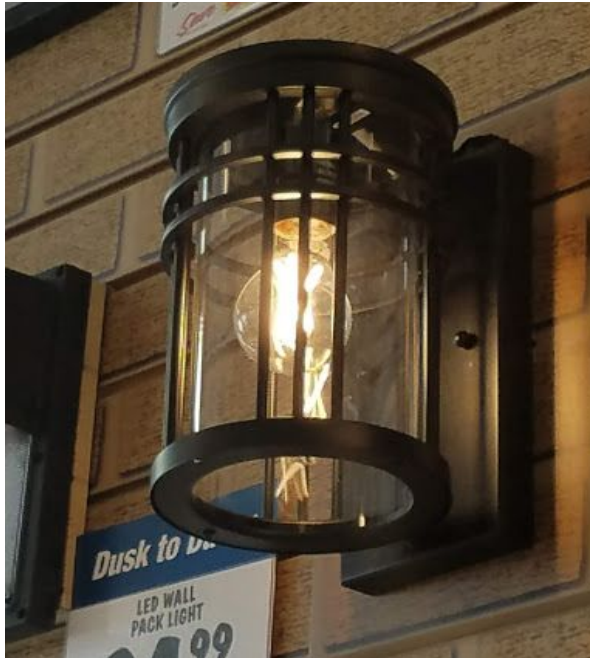
10. Replace 4 exterior lights with working, matching lights.
