# CERTIFICATE OF APPROPRIATENESS RETROACTIVE ADMINISTRATIVE APPROVAL

1168 LINCOLNWAY  
South Bend , IN, 46618  
Lincolnway East  
Application No. 2019-1104

RE: 1168 Lincoln Way East

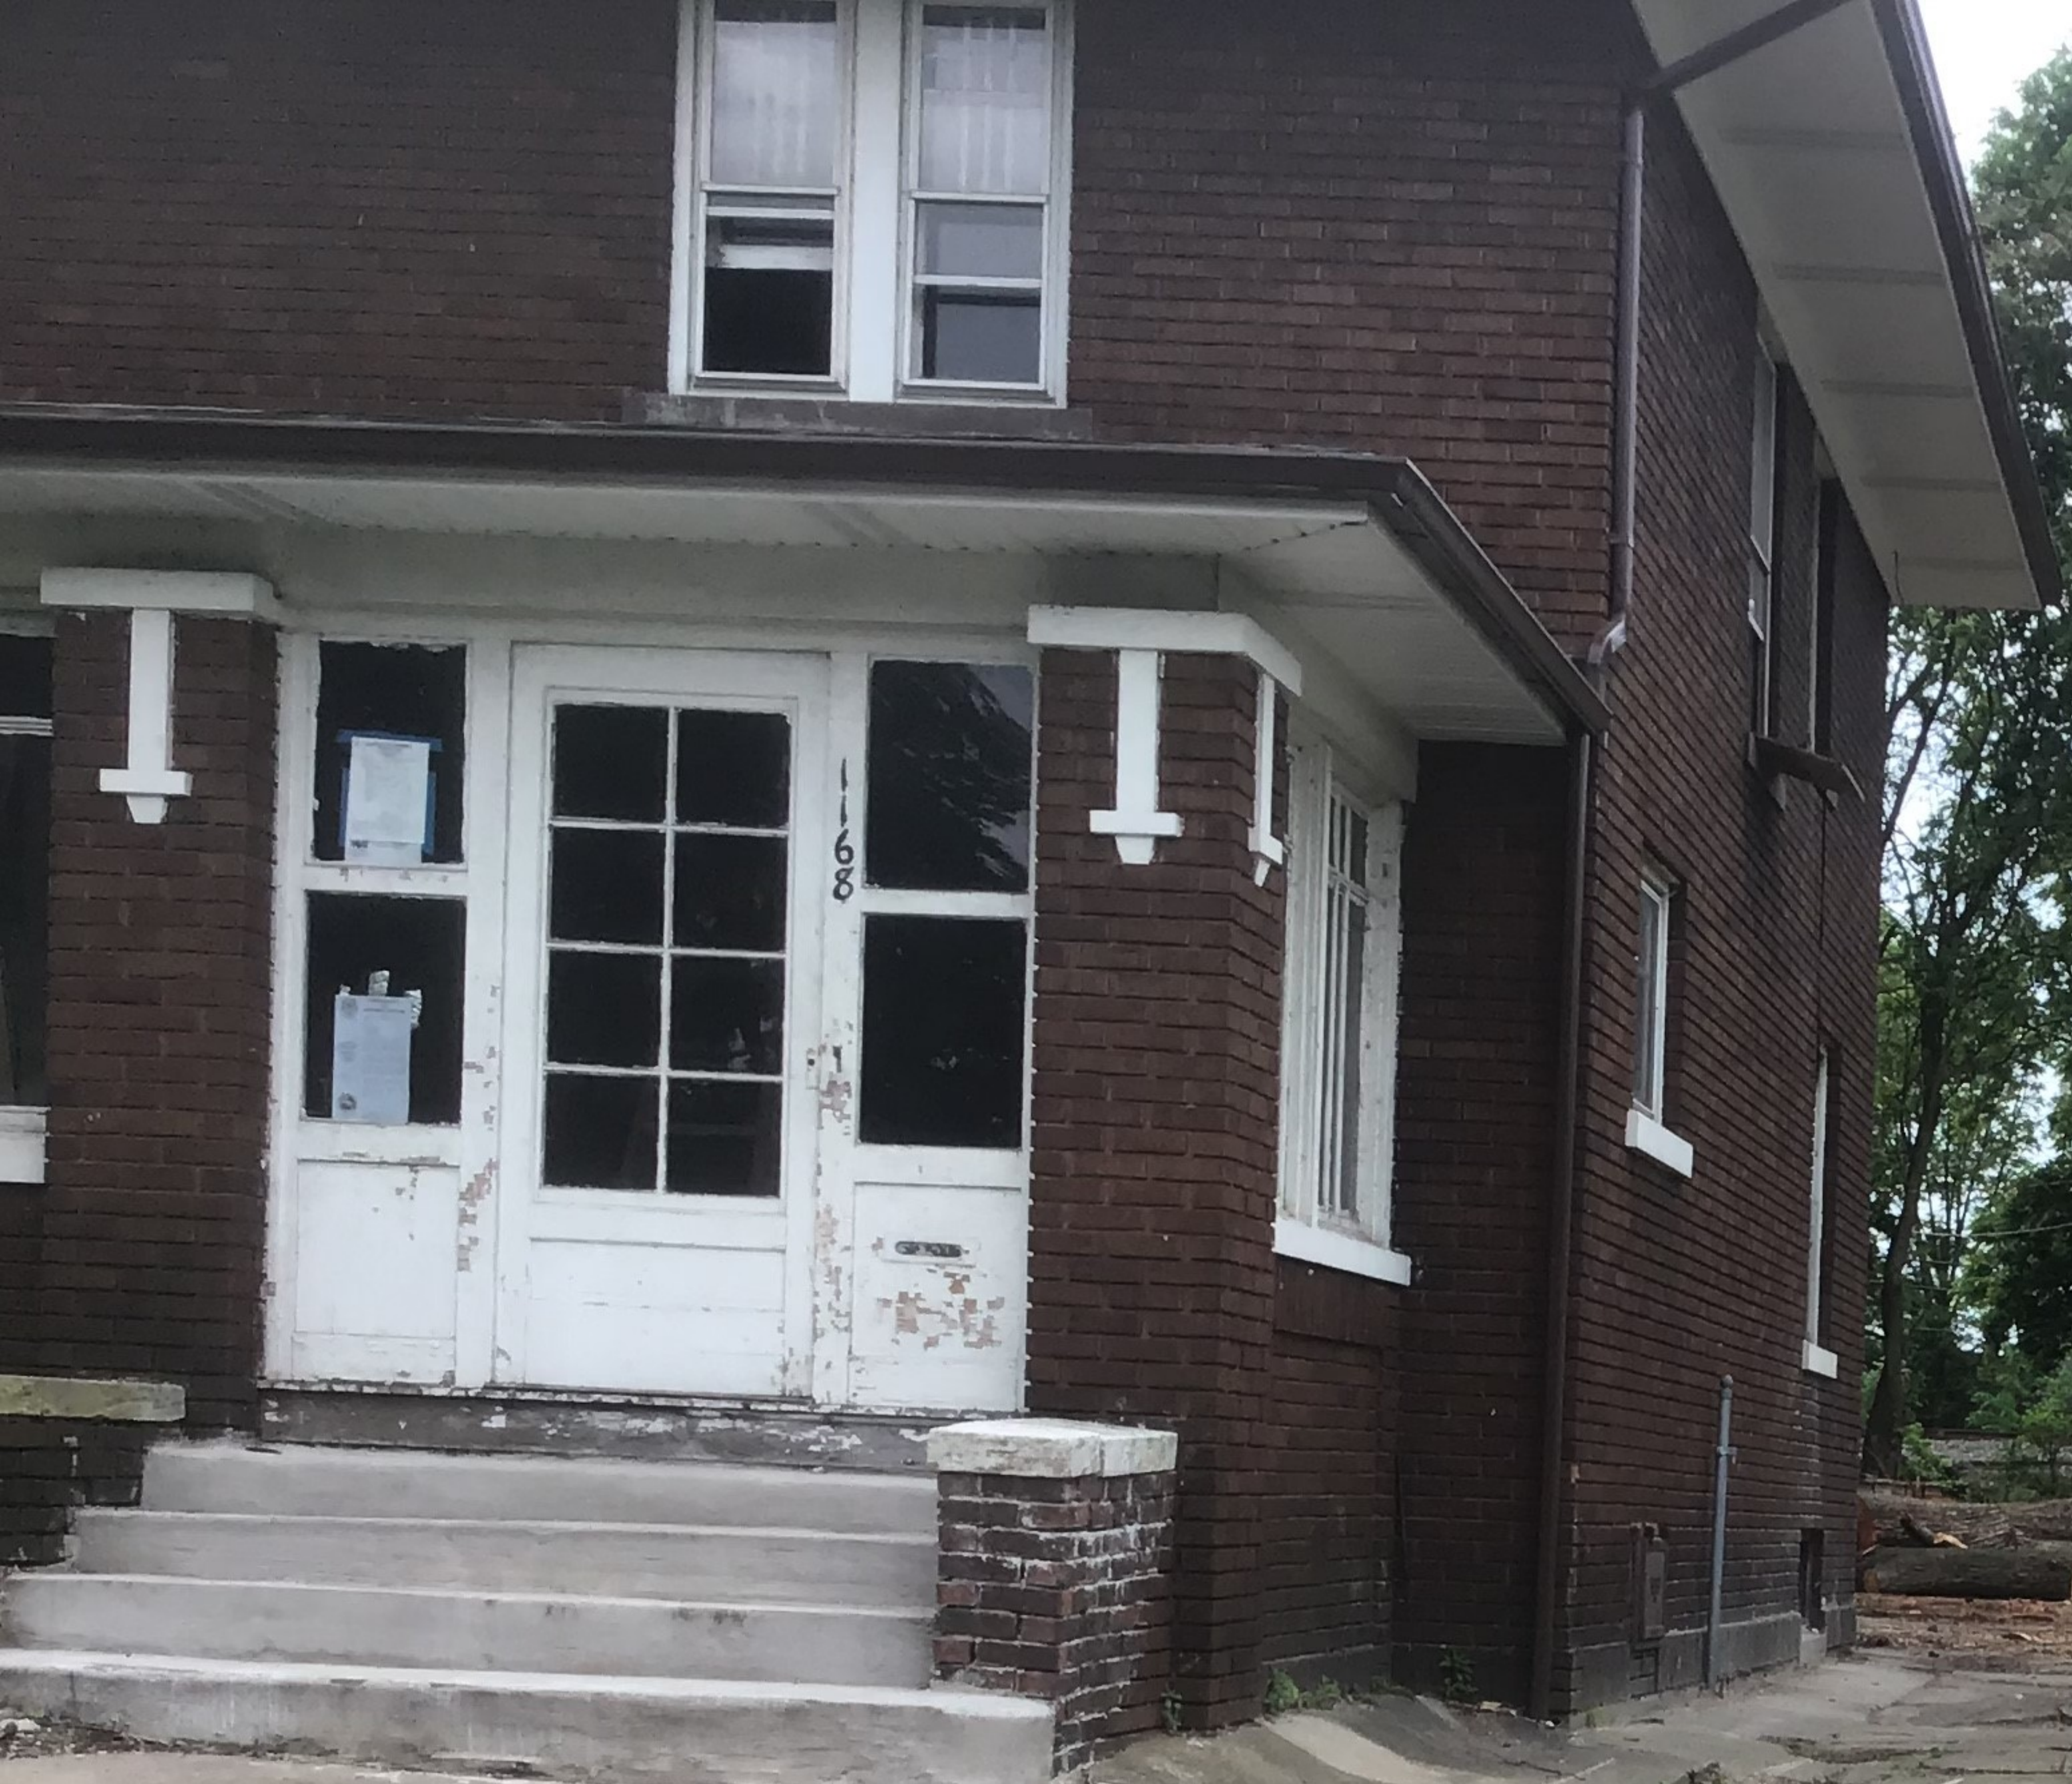
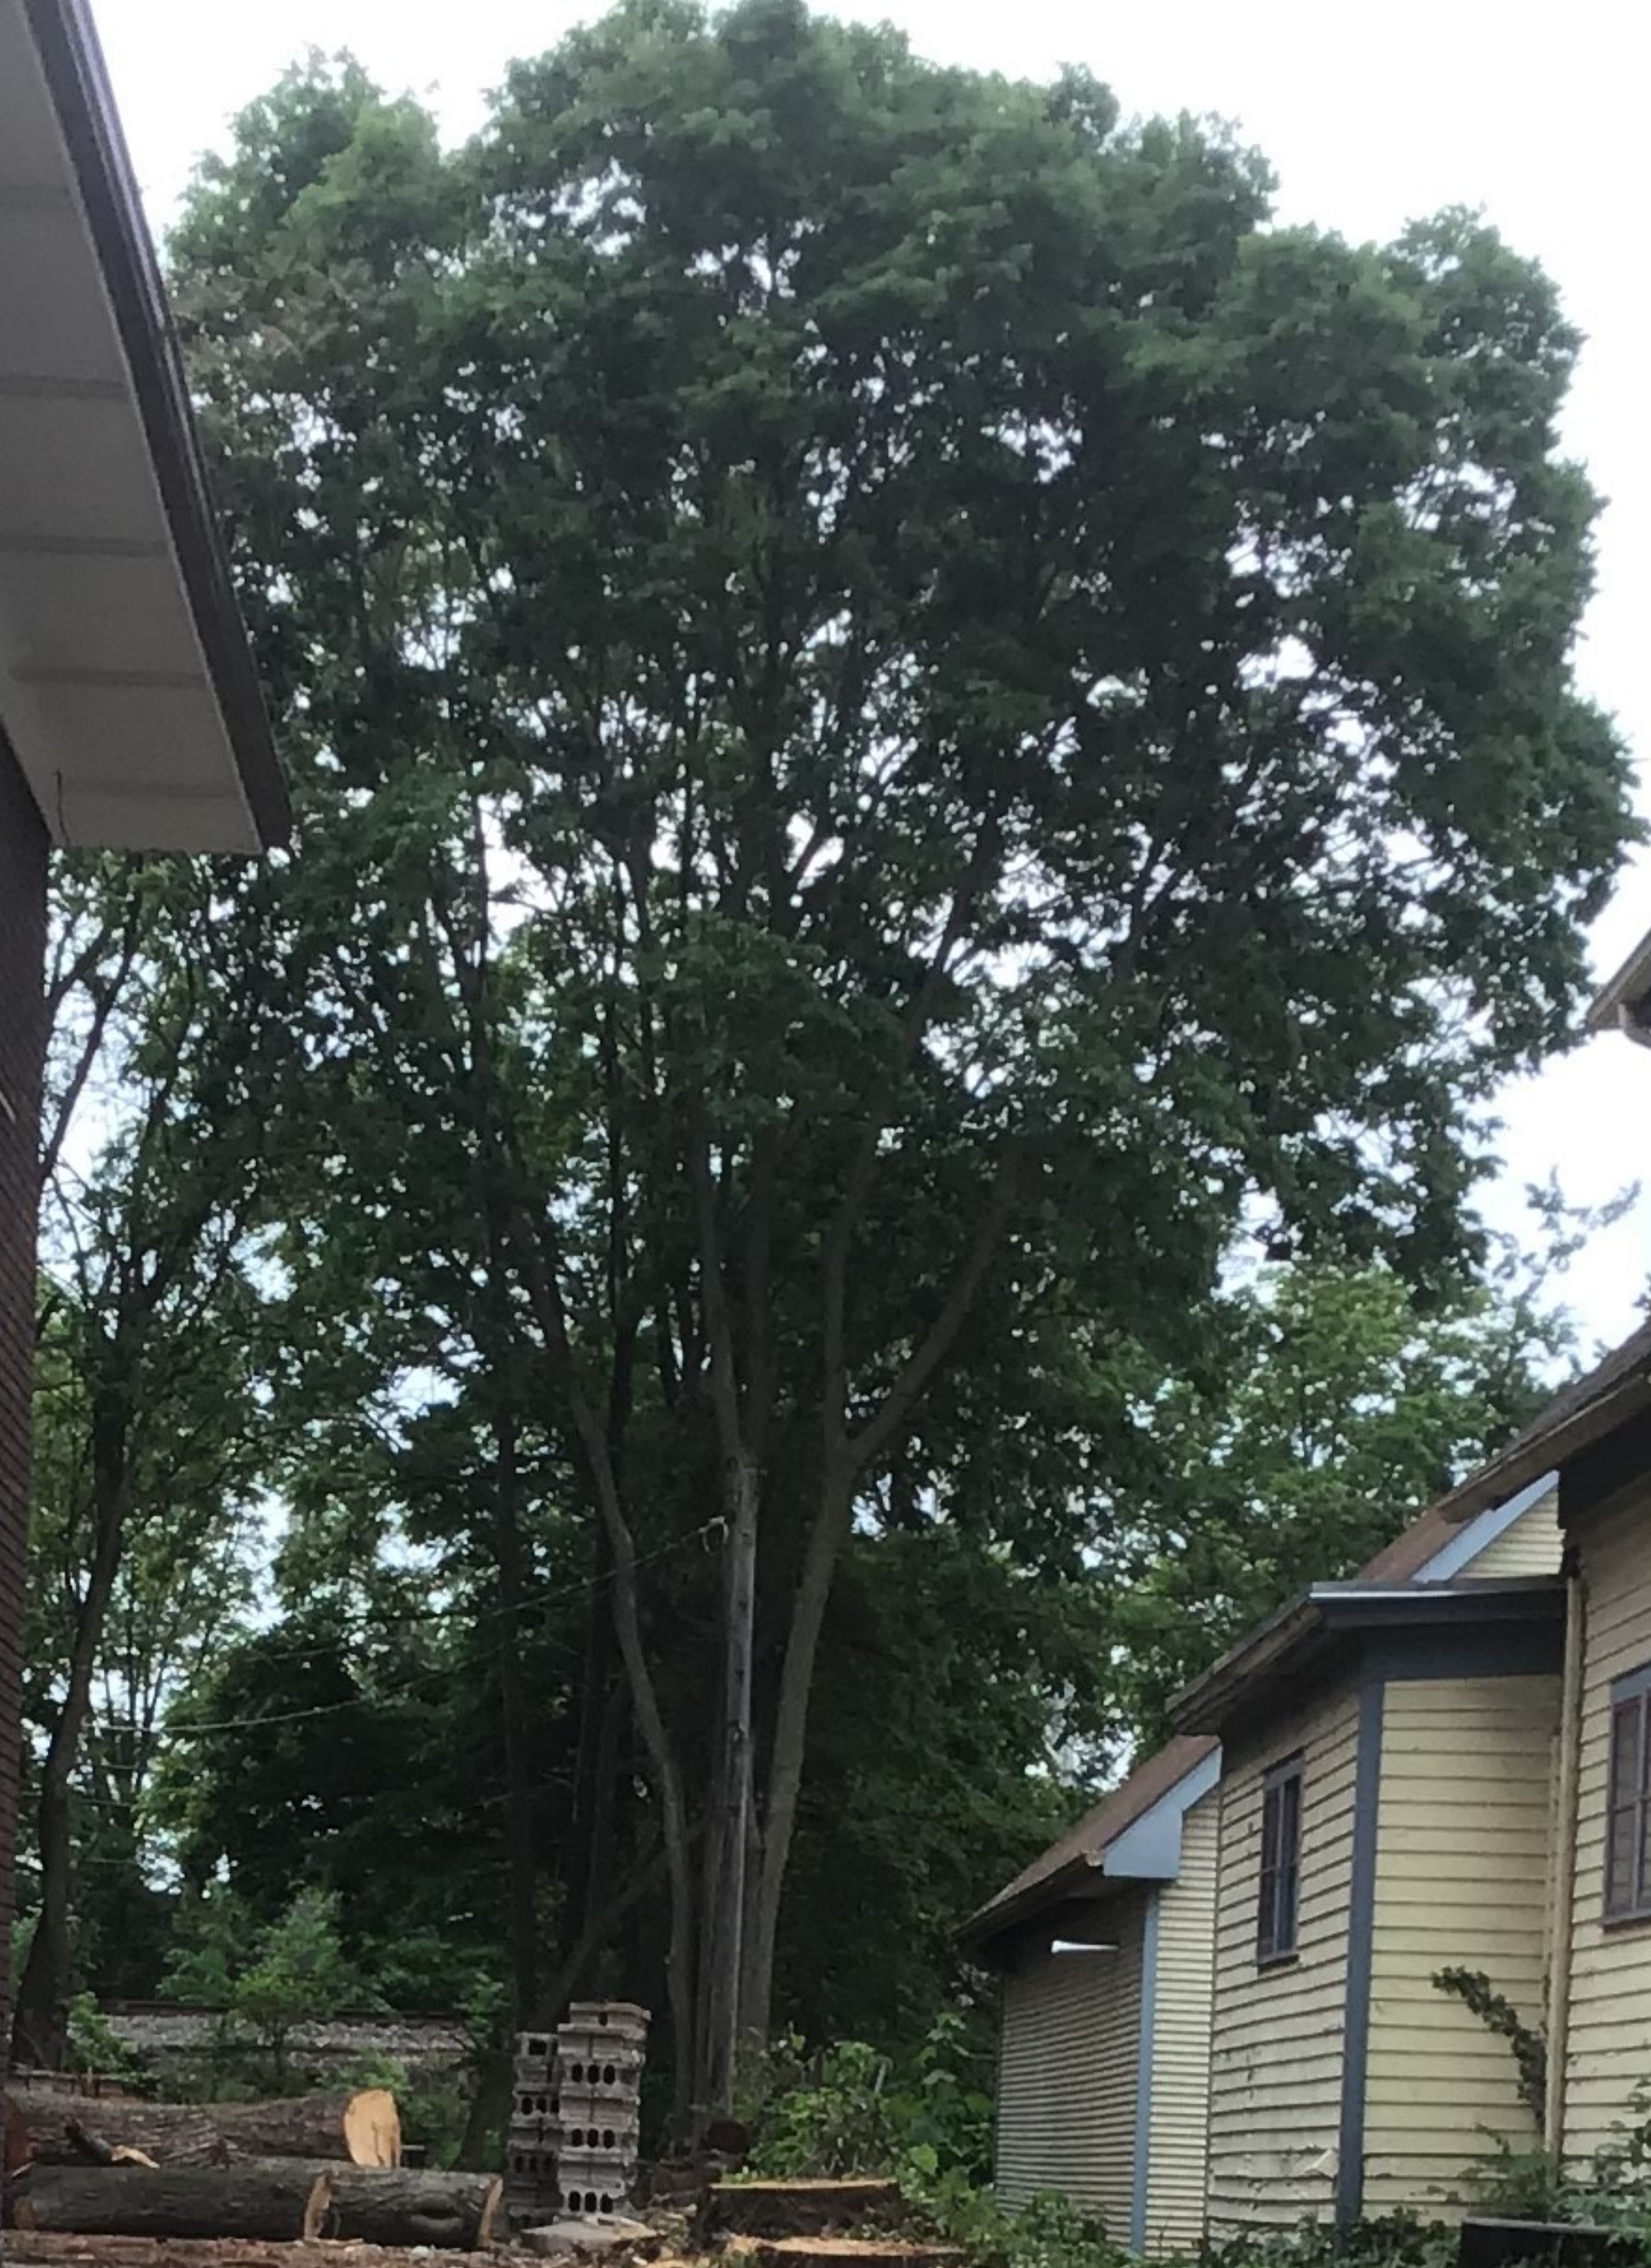
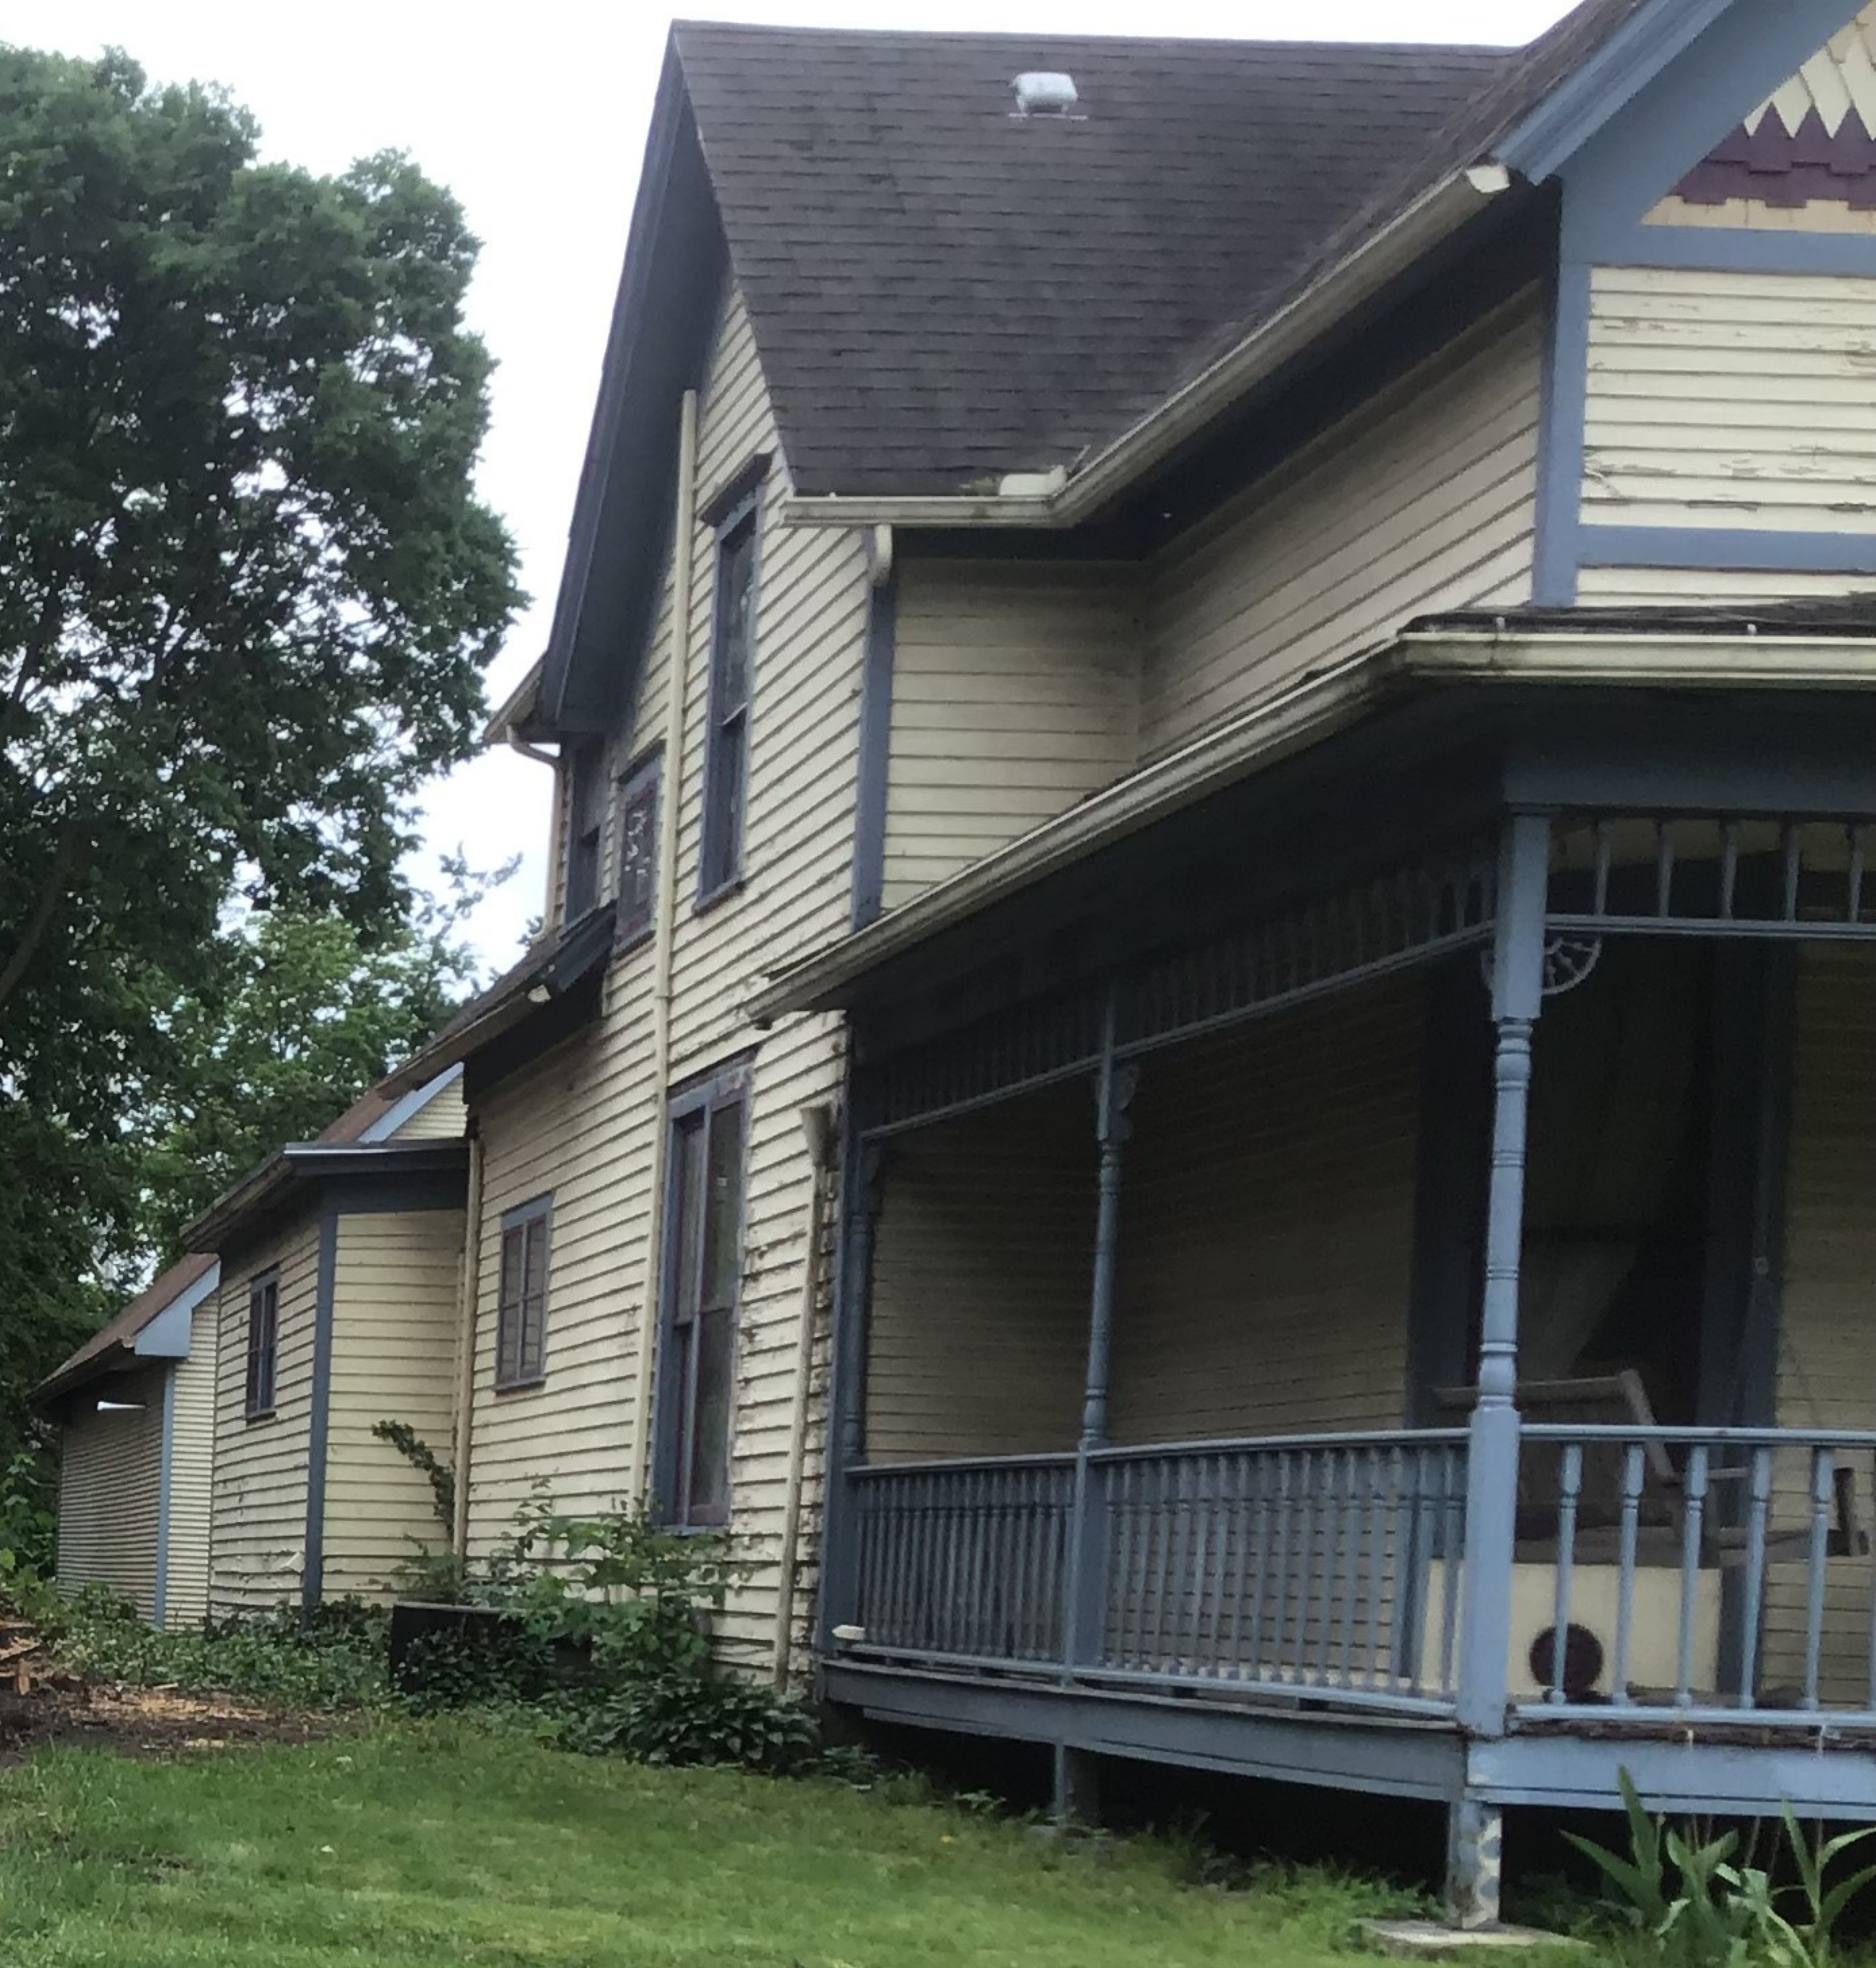
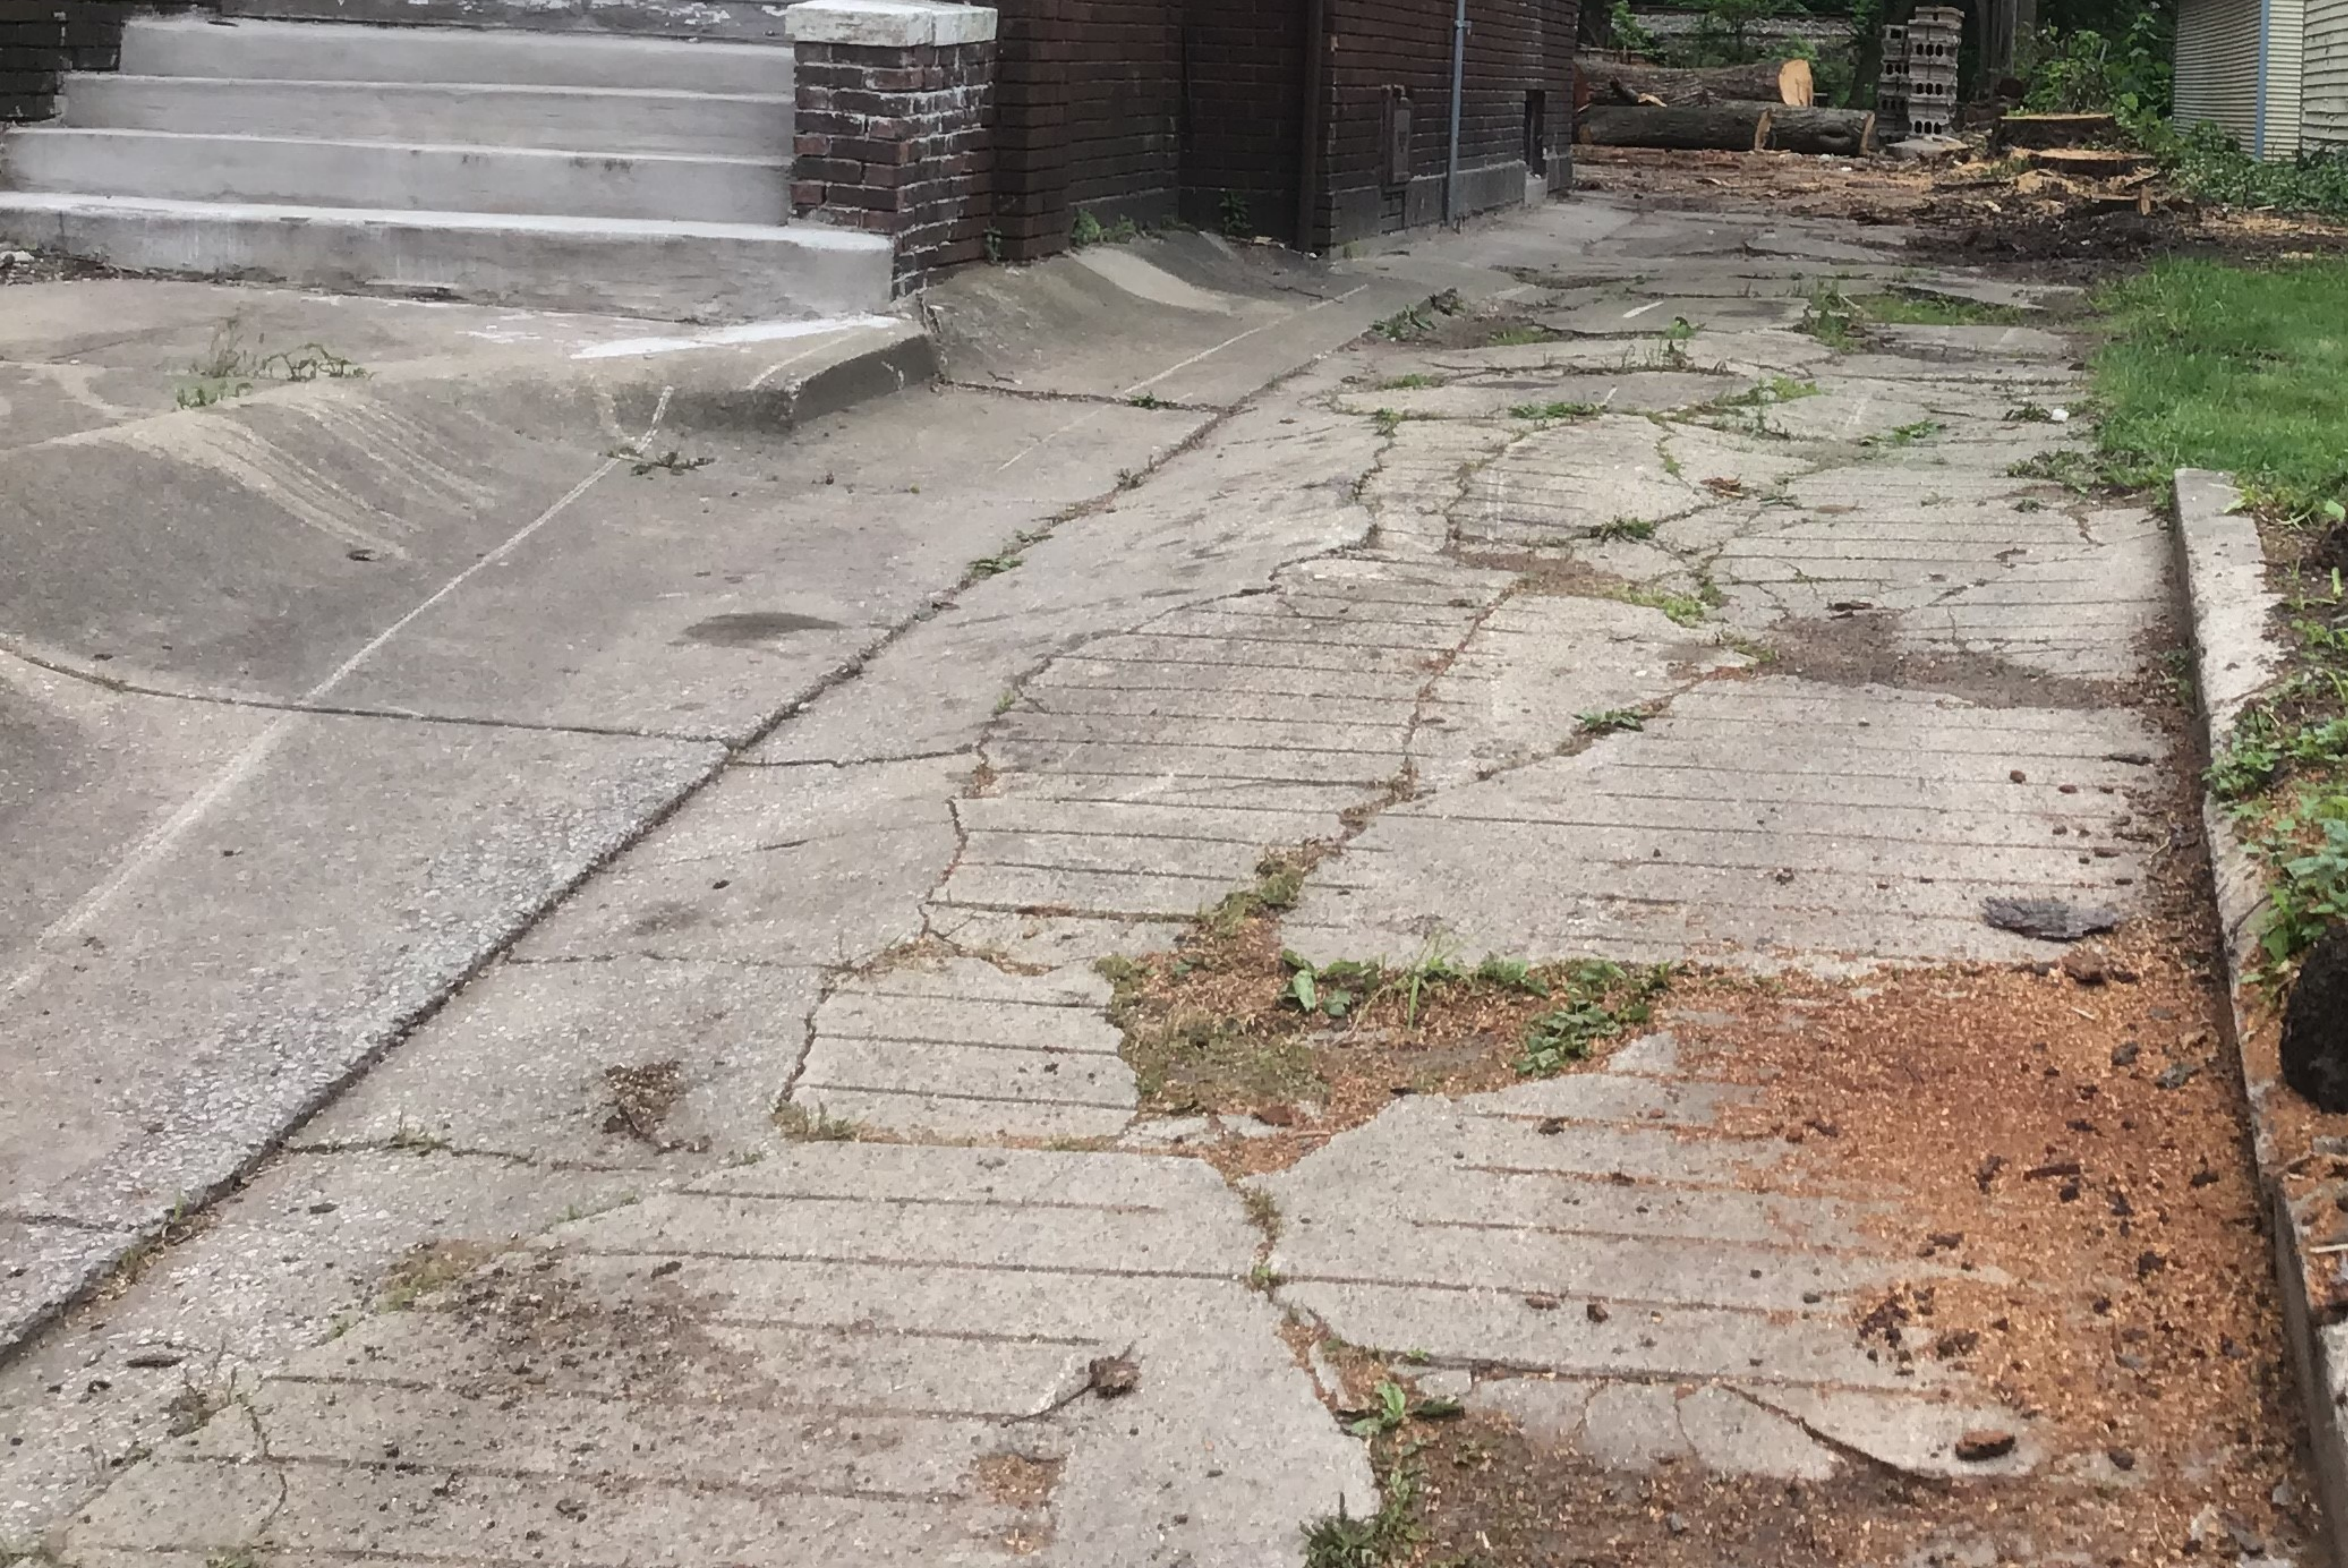
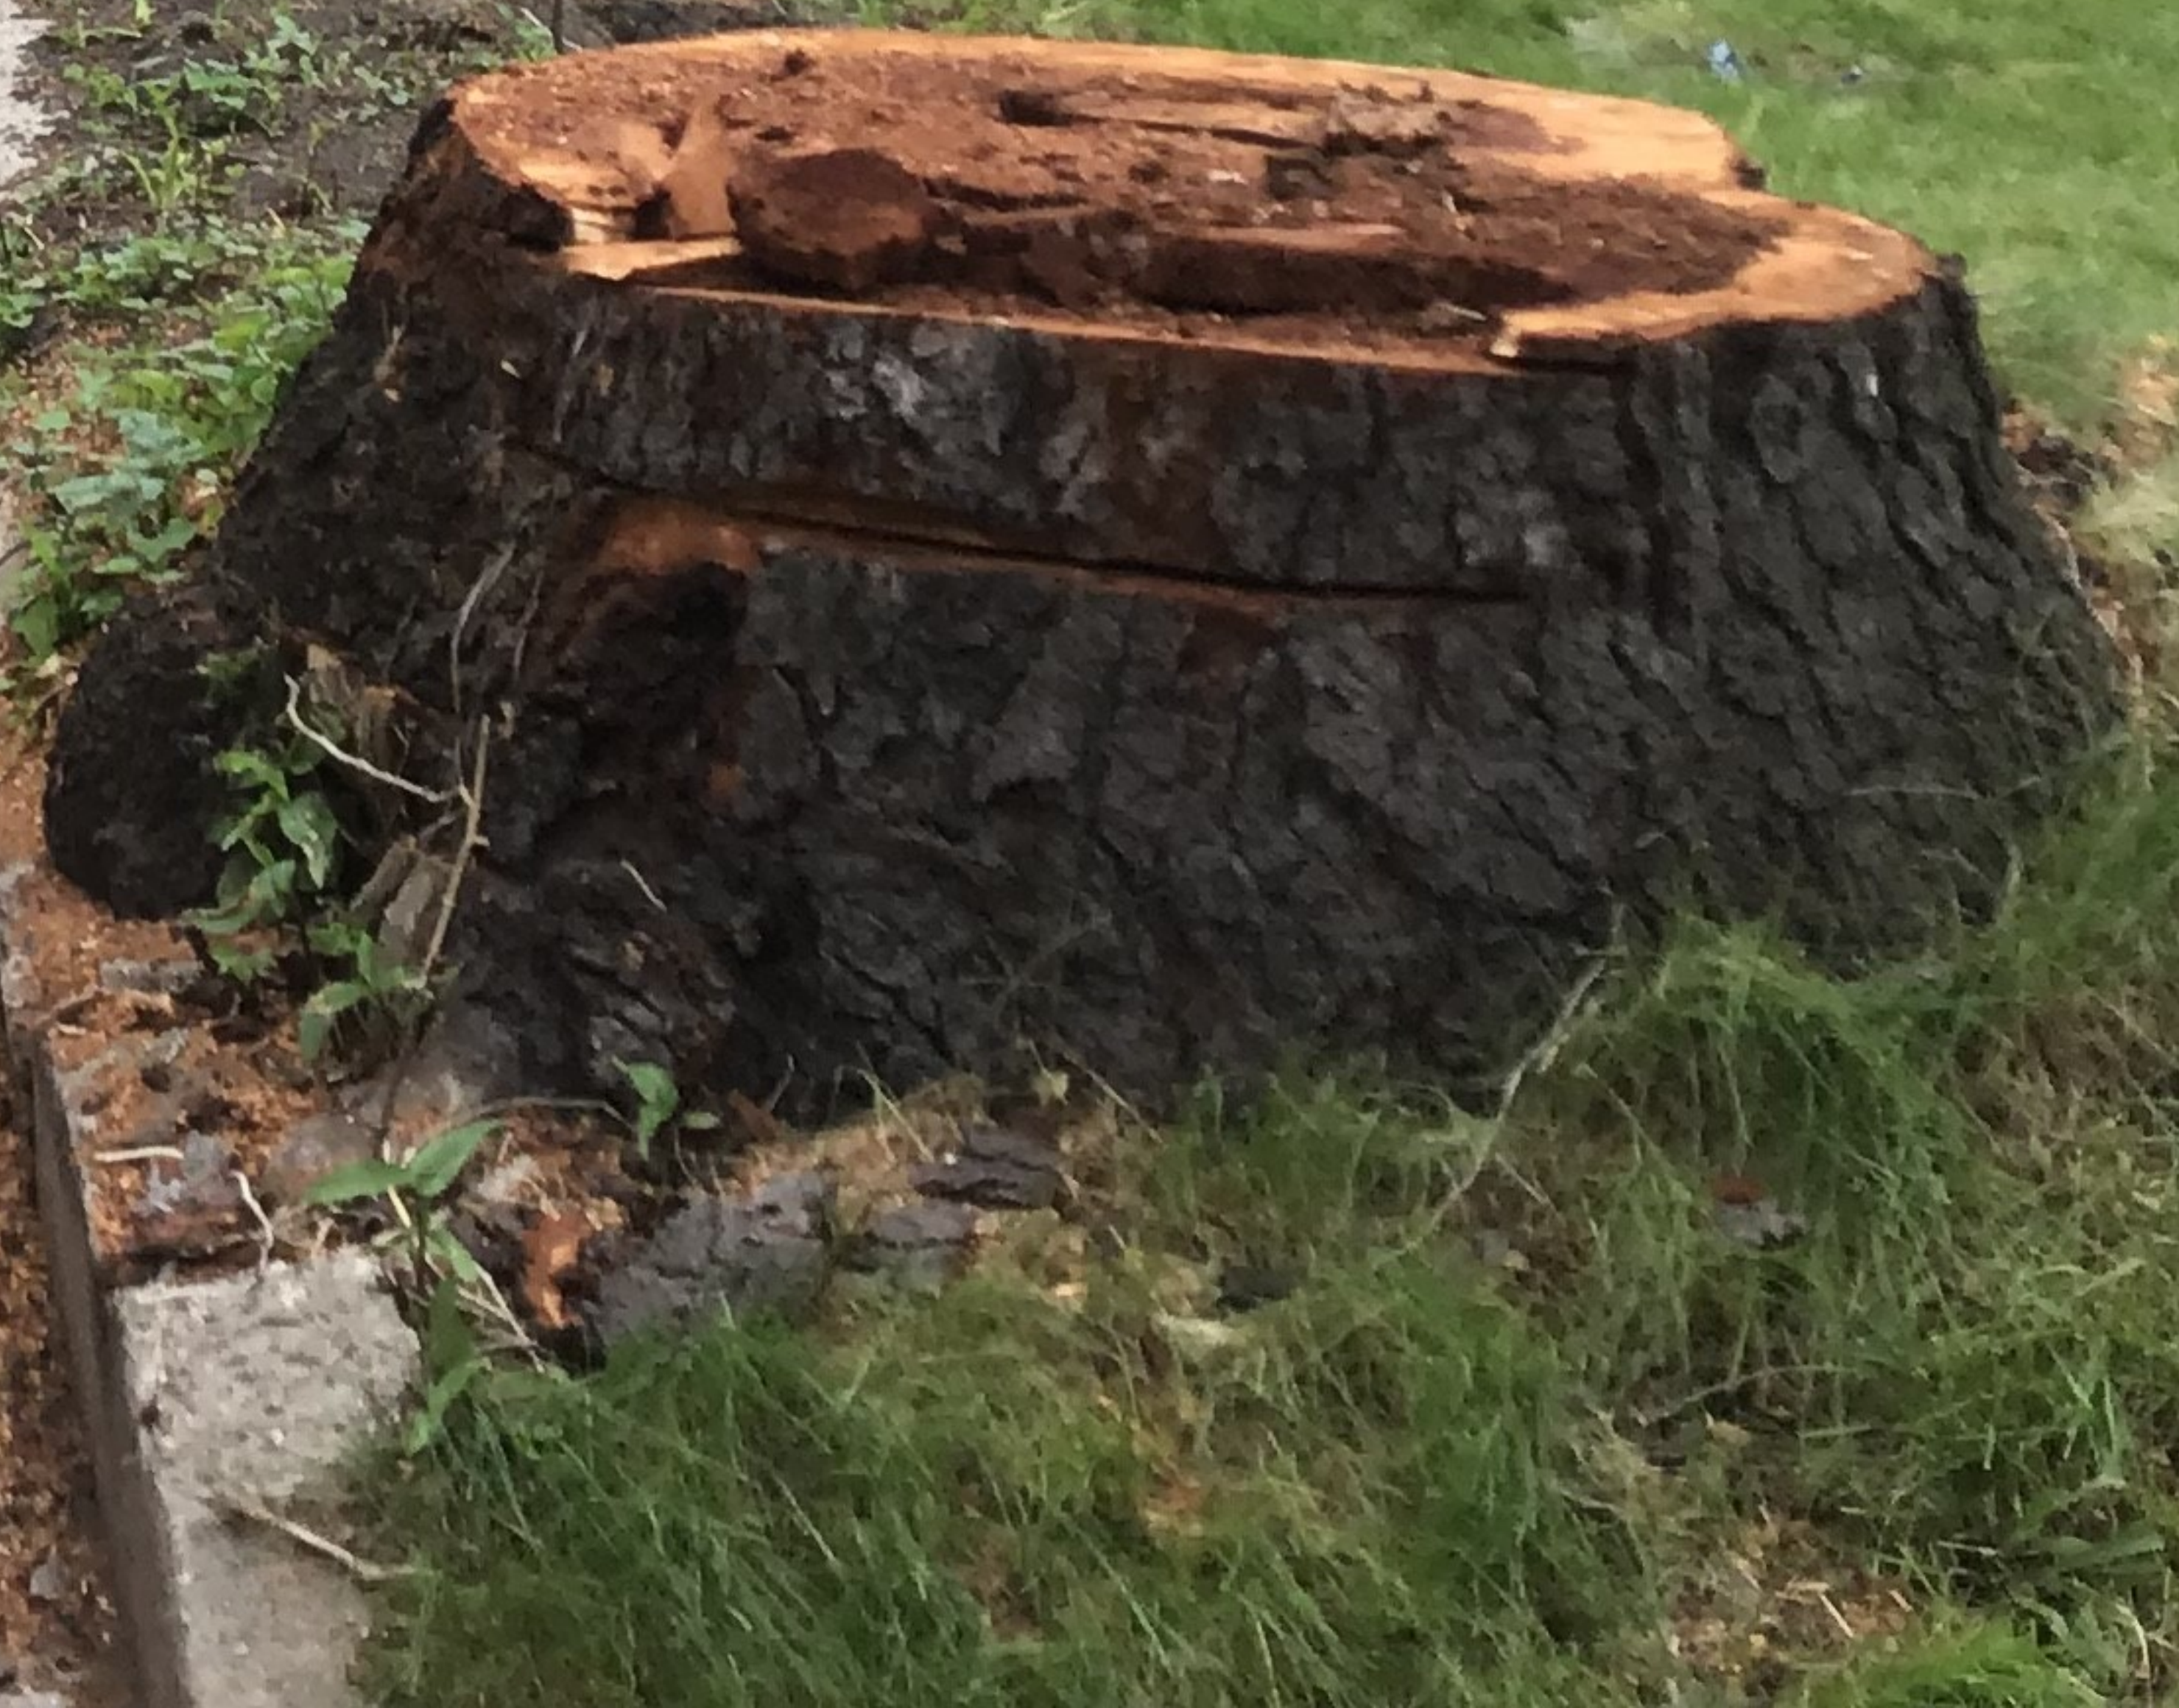
The trees are located on the western property line. Three are located at the rear of the house the fourth is located just off the municipal sidewalk and driveway intersection. The rear trees have gone unkept for a long time and have large branches that stretch over both the structure and the neighbor's house as well. Several large branches are dead and hollowed out. The root system of the trees have uprooted the driveway concrete and have made it difficult to use. The one tree closest to the street has a large dead branch and is overhanging the municipal sidewalk and street. The owner informed me that his insurance company would not insure the house until the trees were removed. He had contacted a different insurance company with the same end result. He has contacted two tree companies for their opinion of the trees and estimates, although he is more interested in their removal than pruning.

The windows are original wood windows with a unique design that is character defining. Most of the windows have triple track aluminum storm windows. Many of the storms have broken or missing sashes. The original windows themselves have several broken glass panes, (I counted 14), but are in good structural condition.

The interior trim and walls boards have all been removed exposing the window weight chases. The lower sashes have had brass track strips added for security and weatherization. I showed the owner how to remove and sash and verbally instructed him on the repairs needed to be done. Many of the broken glass visible from the street are the broken aluminum storms. He is aware that he may be able to get replacement aluminum storms where need through an Administrative approval. He is going to attempt to make window repairs himself prior to moving forward with his application to replace the original windows.
