STAFF REPORT

CONCERNING APPLICATION FOR A CERTIFICATE OF APPROPRIATENESS

Date: December 6, 2023
Application Number: 2023-1208i8i6
Property Location: 635 South Main Street
Architectural Style/Date/Architect or Builder: Renaissance Revival / 1910
Property Owner: Studebaker Center, LLC
Landmark or District Designation Local Landmark, #8267-92
Rating: *Significant/Notable*

STUDEBAKER ADMINISTRATION BUILDING EXTERIOR ENVELOP REHABILITATION SCOPE OF WORK PROPOSED:

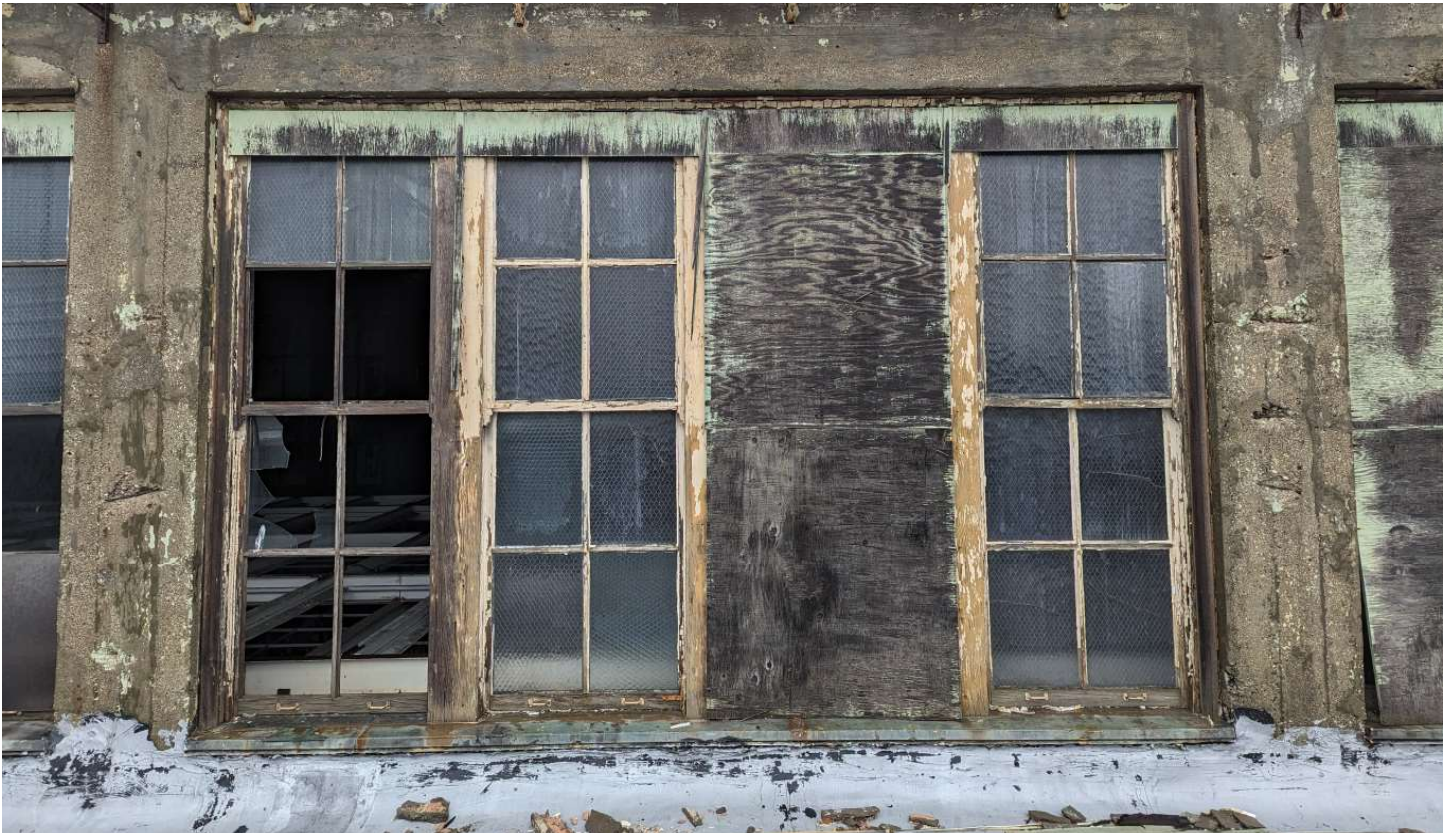
Photo 19 - Typical Bank of Clerestory Double Hung Windows

The clerestory windows are set back from the perimeter upper parapet and as such are not visible at grade. These window units are in very poor condition, and mostly boarded up. The windows are large double-hung units (4 over 4 lights). The proposed new all aluminum windows would be non-operable fixed windows but will match the 4 over 4 light pattern. Since these units would be visible from the interior double height atrium space, this geometry is important to replicate (muntin/sash/frame/glass geometry). These windows are visible two levels above

the Third Floor atrium floor as viewed from the inside. The proposed windows are based on a Quaker Window Specification H650 (or approved equal). Color would be a dark or medium bronze finish as proposed, exact color to be determined and coordinated with the exterior Sash and frame color of the restored windows on the East, South and West facades.

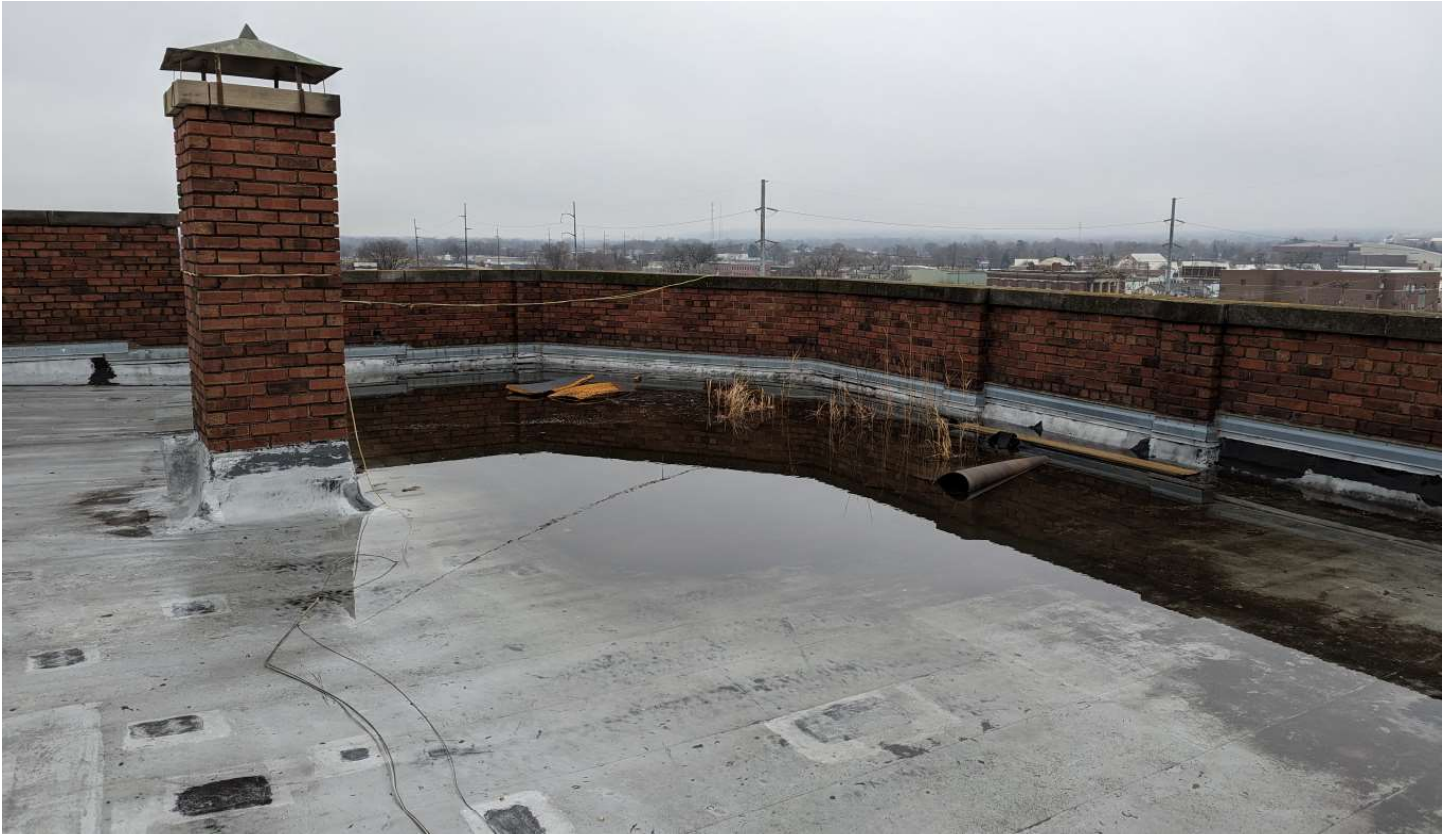
Photo 22 - Significant Ponding above Executive Offices

- d. *Drains:* The roof slopes to the four corners (NE/SE/SW/NW), where internal roof drains exist. Overflow drains will be added so there will be two drains per corner for a total of eight total roof drains. Only one drain in each corner is functioning, with the remainder clogged or damaged. The drains and strainers will be cleared and repaired to allow for full functionality of all eight drains.

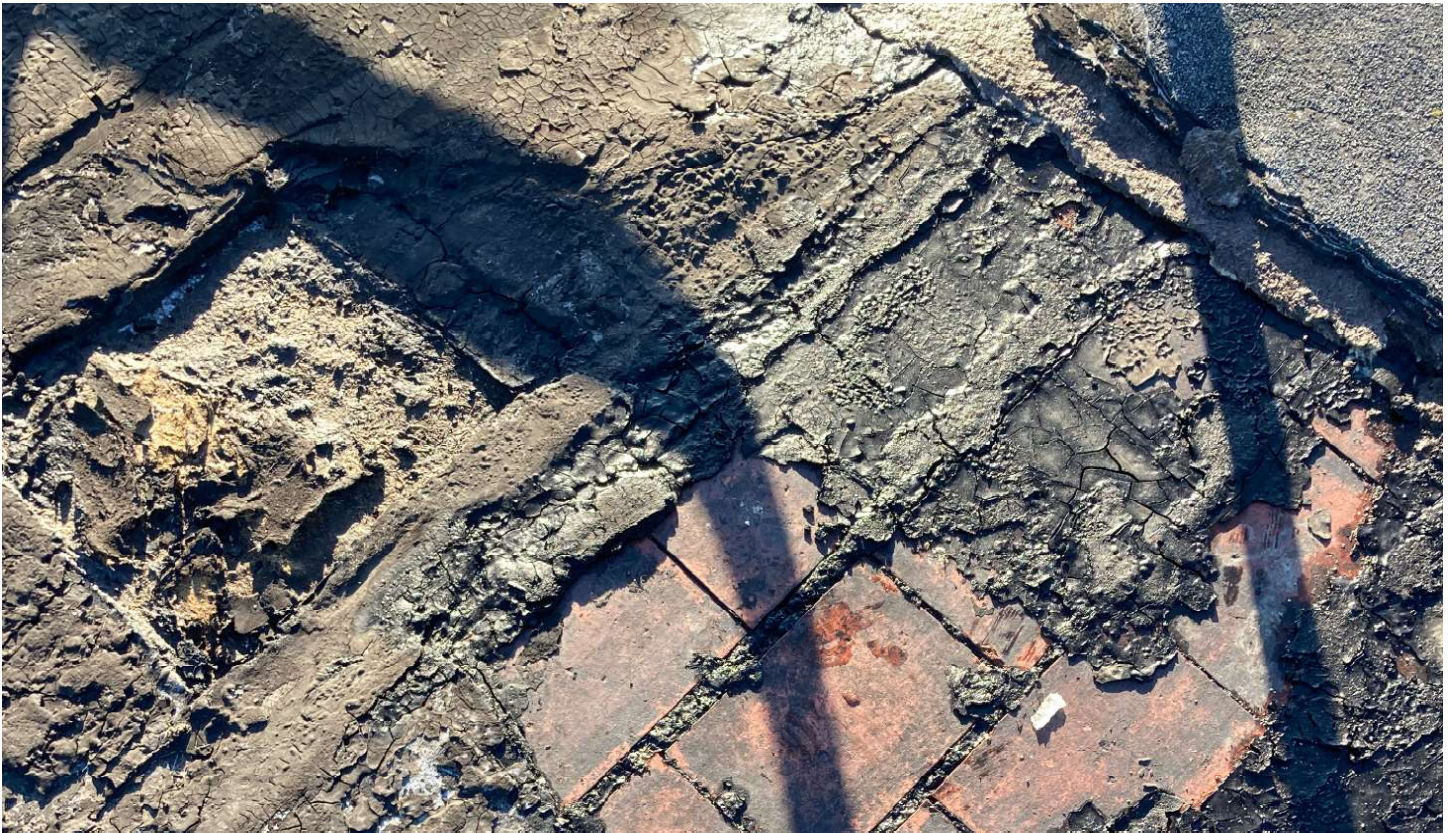
Photo 23 - Roof condition at top of Monitor Roof (bricks above concrete wall below)

- a. *Replacement of Roofing*: The existing roof consists of 2 layers of BUR (smooth BUR over granular) on the original poured in place concrete deck. The roof is deteriorated and leaking in certain areas and will be replaced with a new 60 mil

TPO 20 year warranted membrane or comparable. New perimeter flashing will be added as required for a complete and warranted new roofing system.
