STAFF REPORT

CONCERNING APPLICATION FOR A CERTIFICATE OF APPROPRIATENESS

Application Number: 2018-0725

Property Location: 627 Portage Avenue

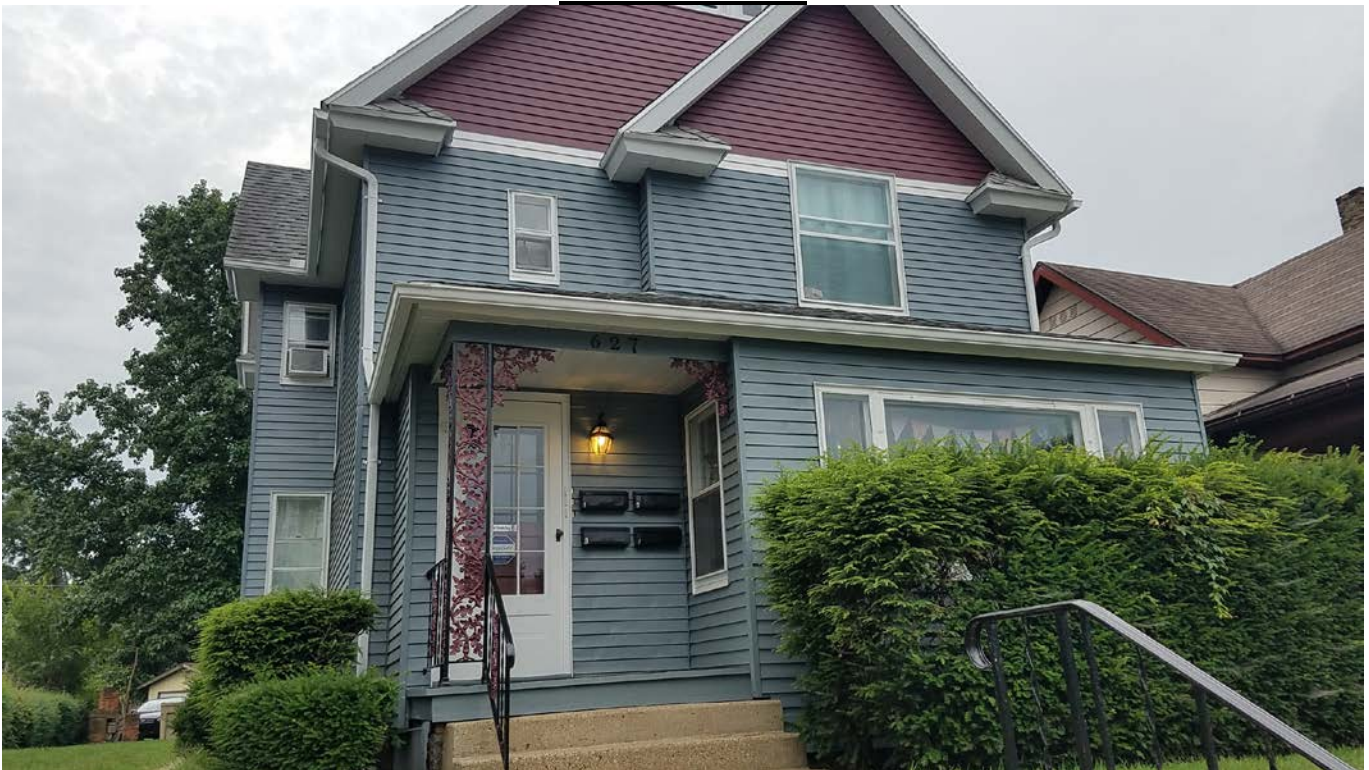
Figure 1 – 627 Portage from the street, looking west. The fence is to the right, on the other side of the hedge.

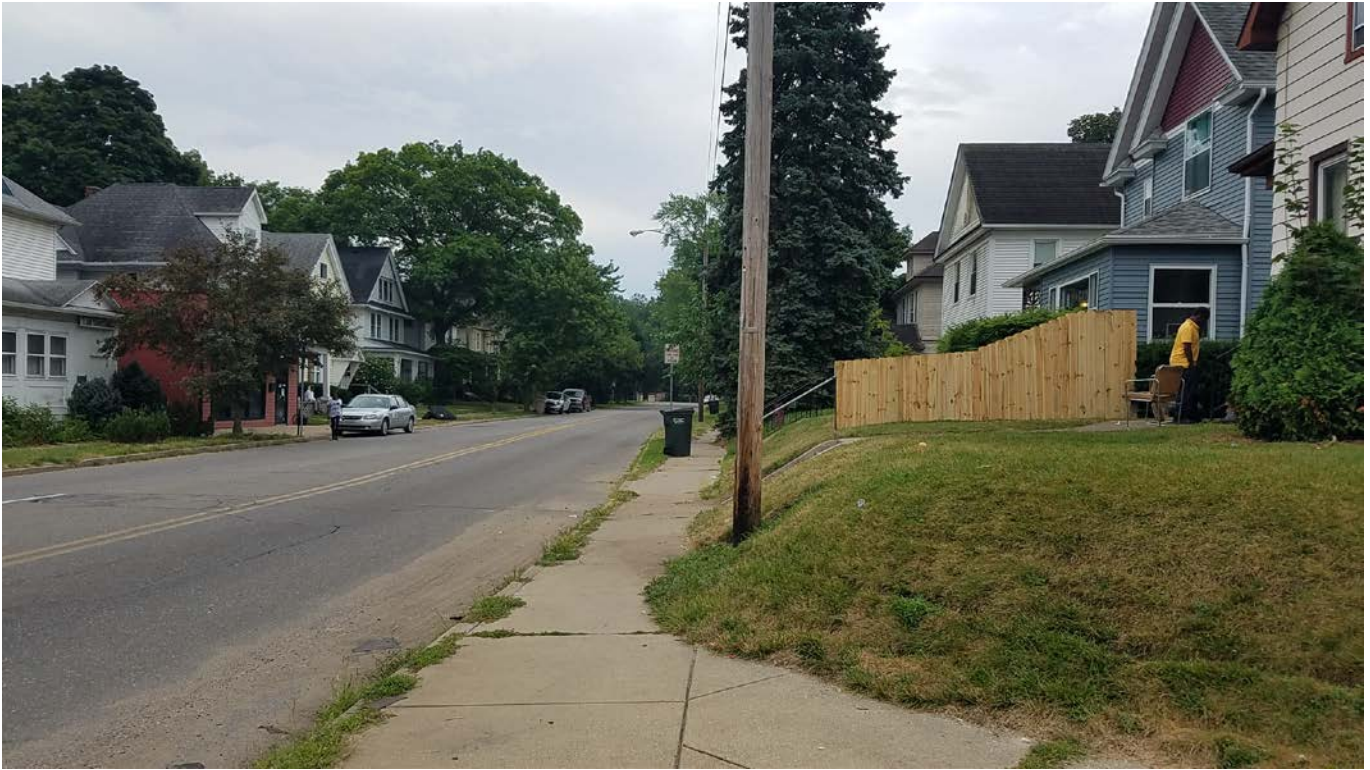
Figure 2 – The subject fence, looking southeast along Portage Avenue.

Staff would recommend that the fence – certainly the portion closer to the street from the set-back line – be removed and replaced with an ‘open’ format (for example, metal or wood picket fence).

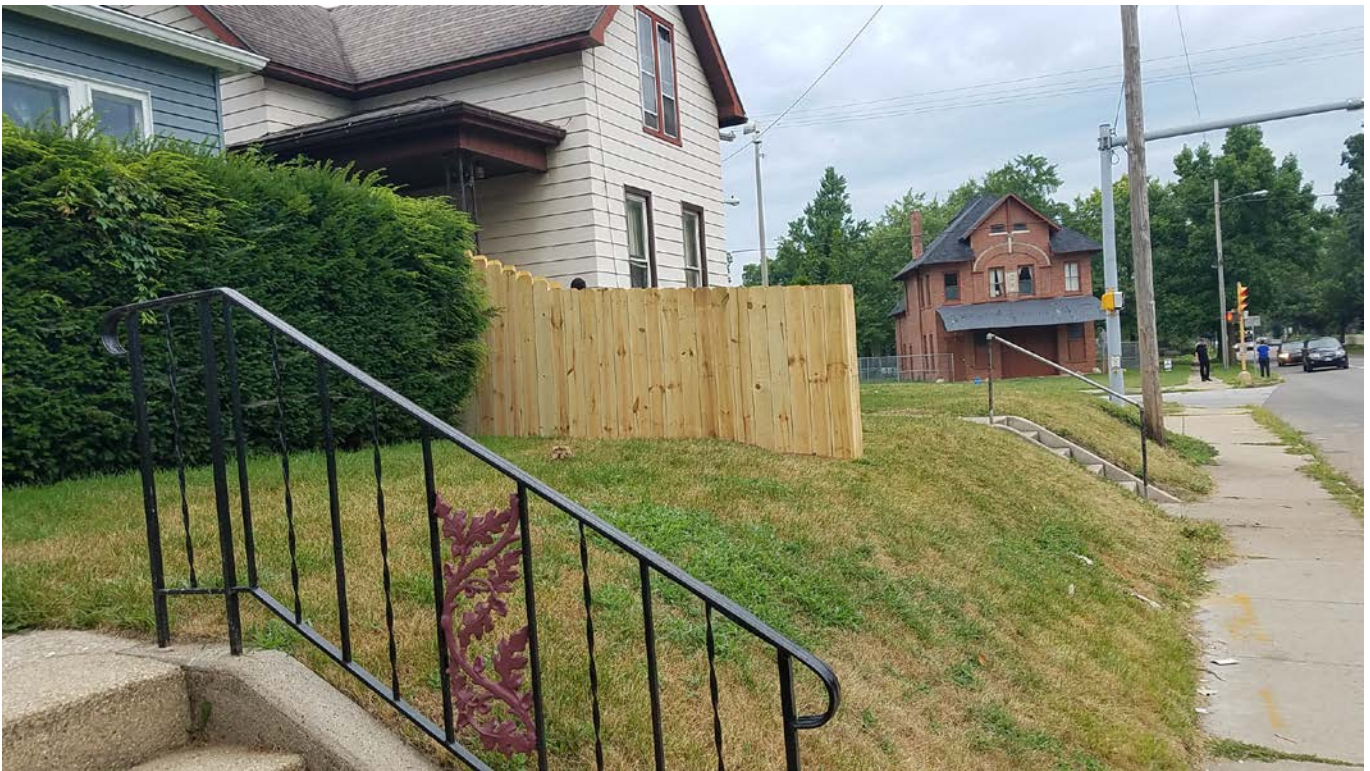
Figure 3 – The fence, looking to the northwest along Portage Avenue. Firehouse #6 is visible in the distance.

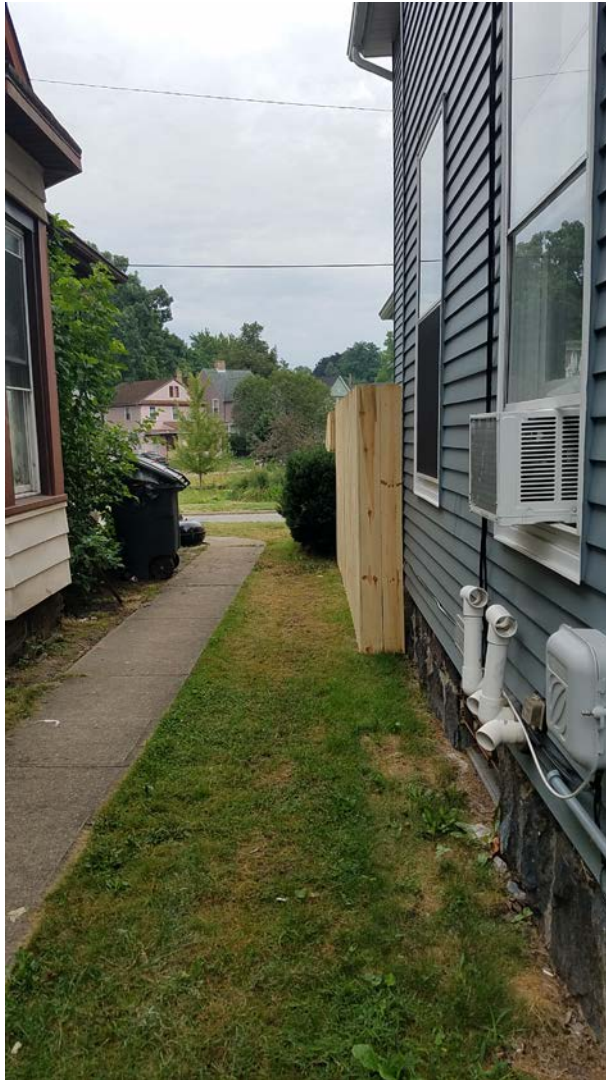
First, the Chapin Park Standards and Guidelines are explicit that “*fencing visible from the street in front of the structure shall be open (meaning spaces between the pickets) and consistent with the historic character of a structure enclosed*” (emphasis added). While this particular application is for a stretch of fence along the border or edge of the property, the project fence *is* visible from the street. Further, the Standards and Guidelines state that “*the erection of high walls or barriers, which would alter the relationship of the houses, shall be prohibited*” (emphasis added).

Figure 4 - The fence, looking towards the street, showing depth and proximity to the main structure.

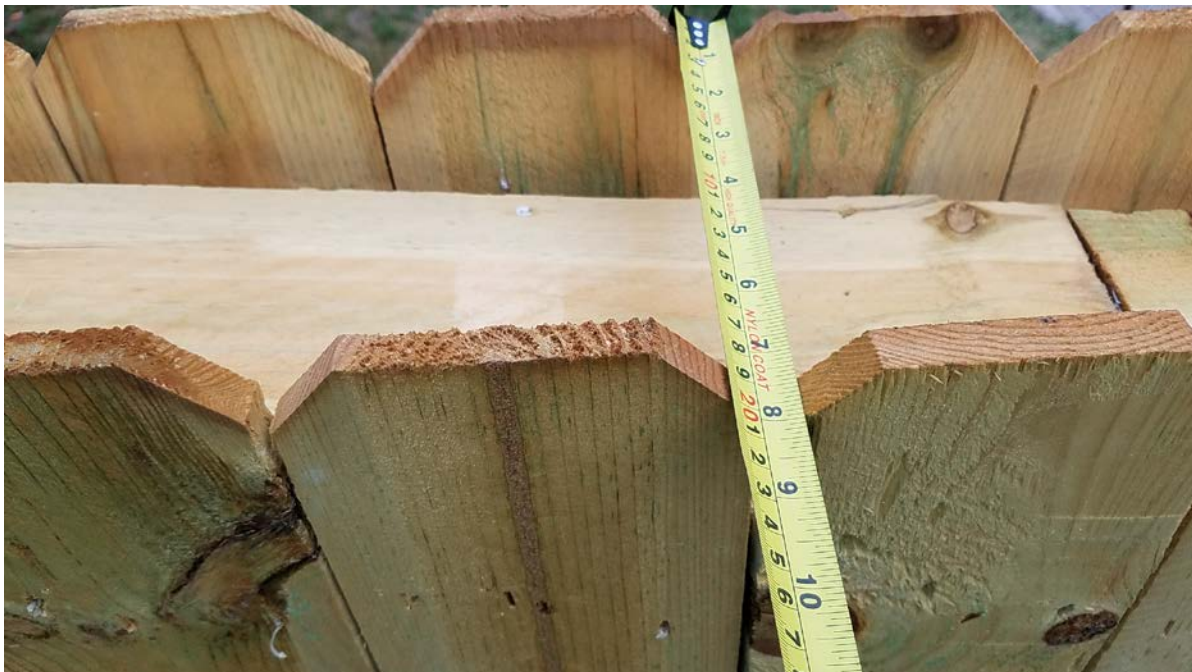
Figure 5 -- Showing the construction and width (8") of the fence.

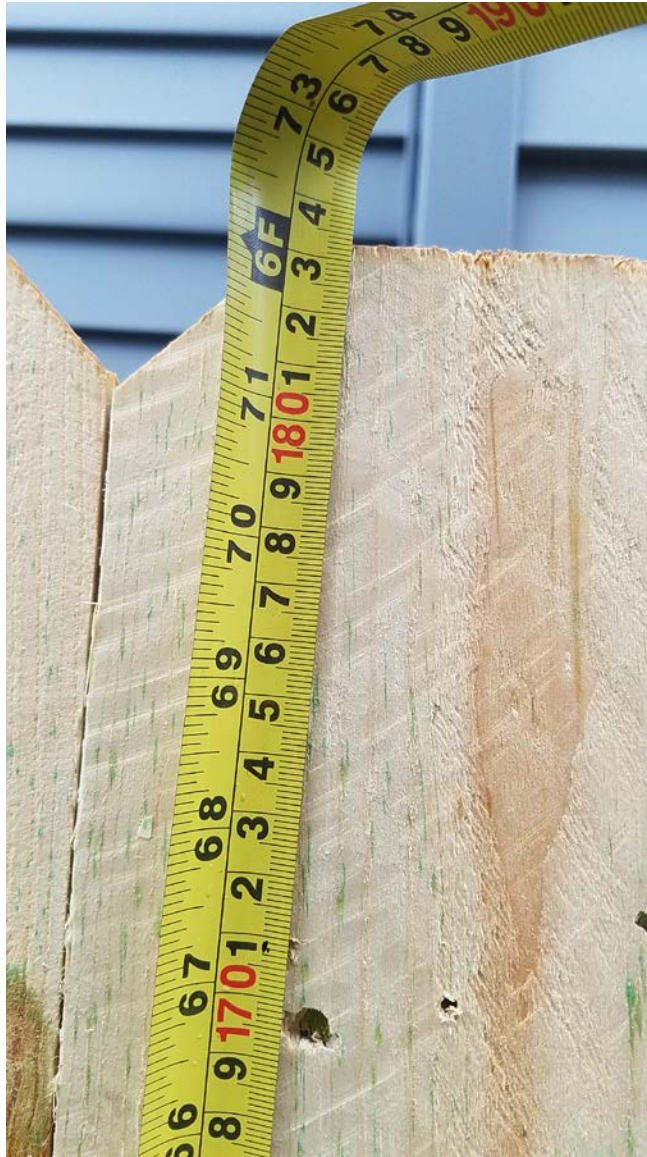
Figure 6 - Showing the height (6') of the fence.

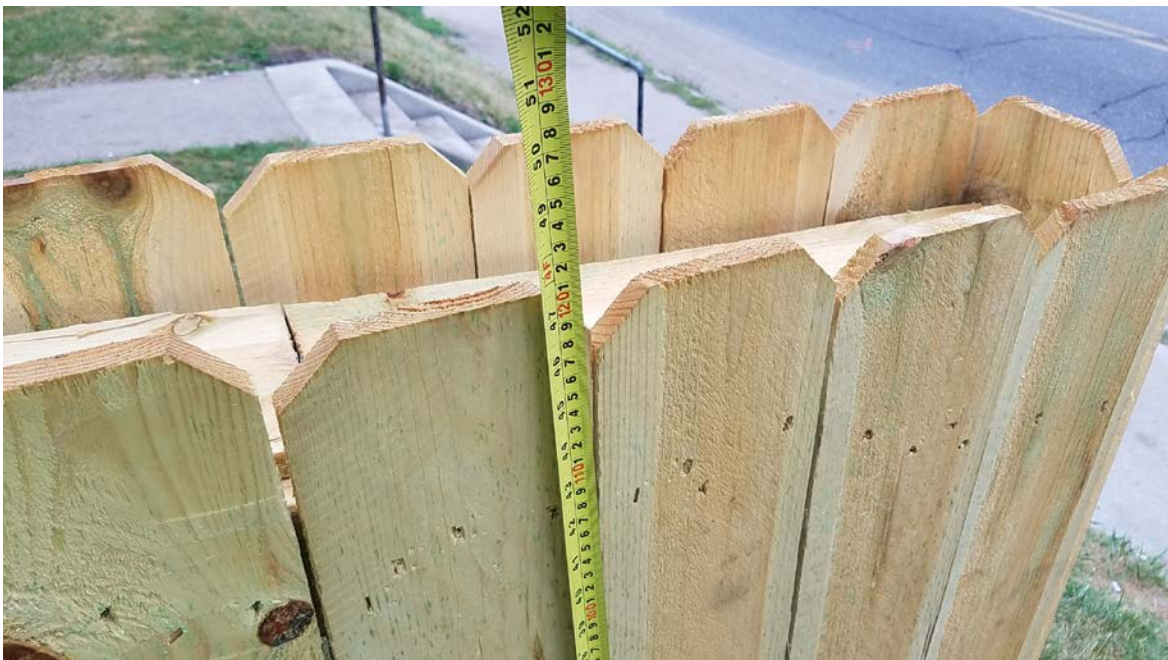
Figure 7 -- Showing the height of the shorter (4') fence portion.

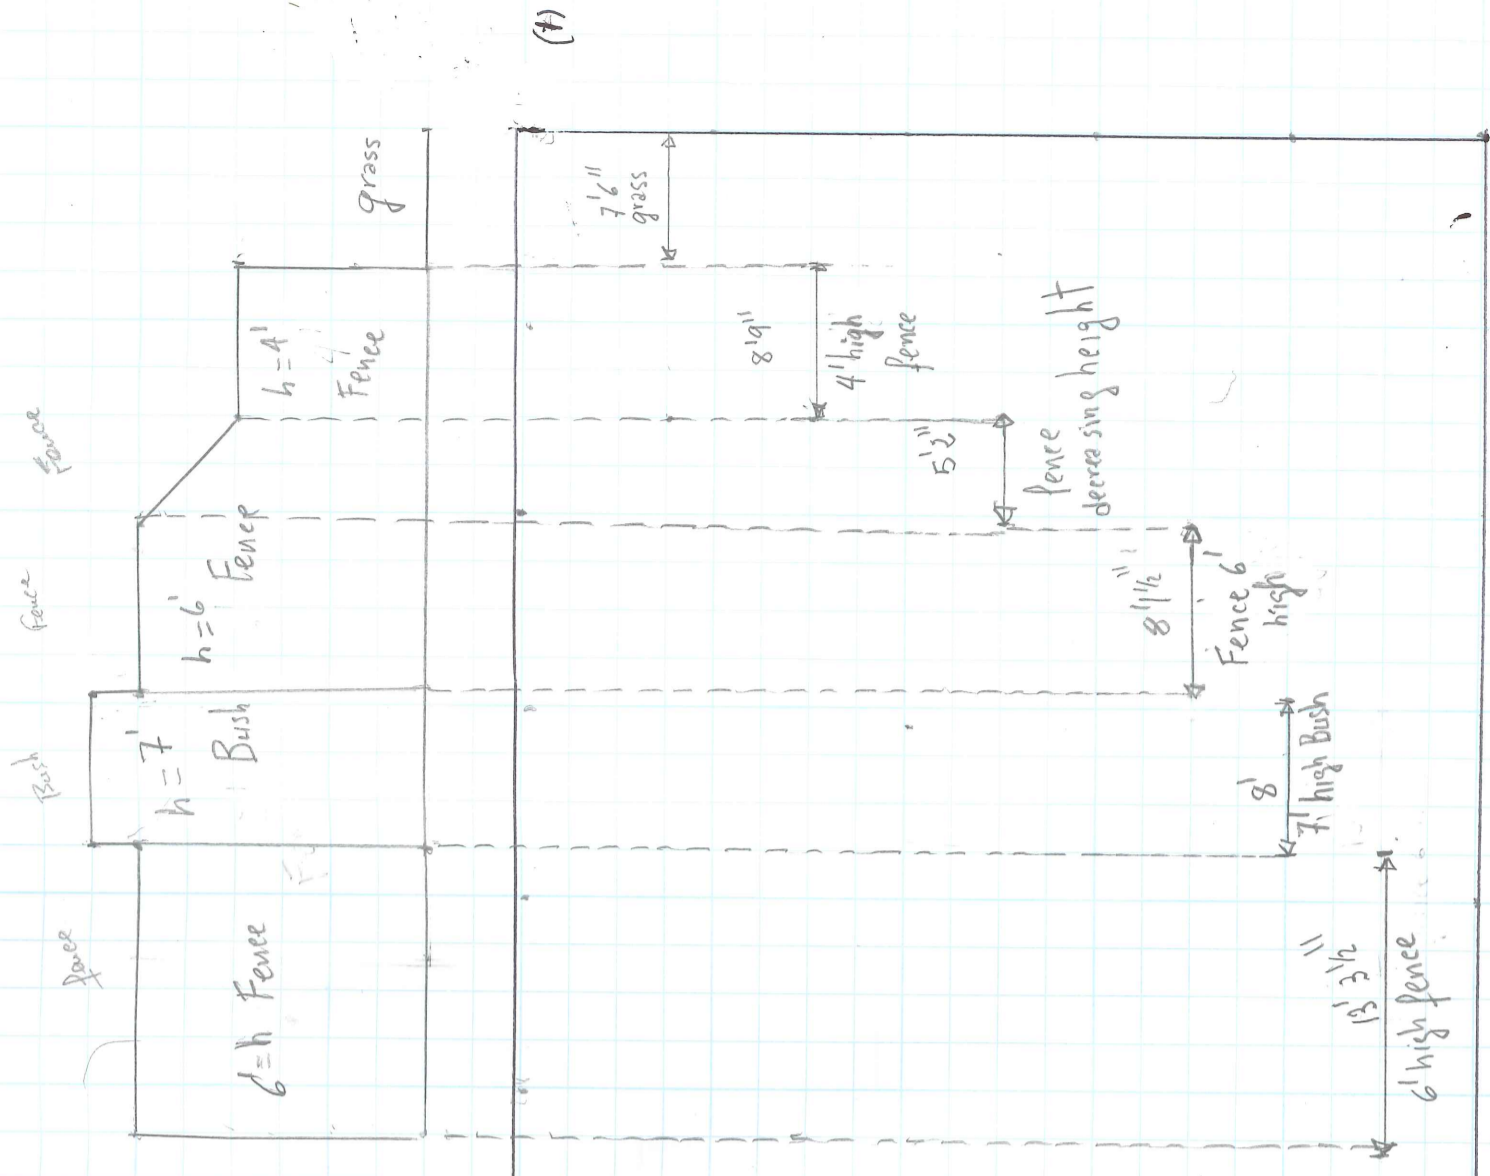
(1) Fence is 4" inside property line
