# STAFF REPORT

## CONCERNING APPLICATION FOR A CERTIFICATE OF APPROPRIATENESS

**Application Number:** 2018-0906

**Property Location:** 601 N Lafayette Boulevard

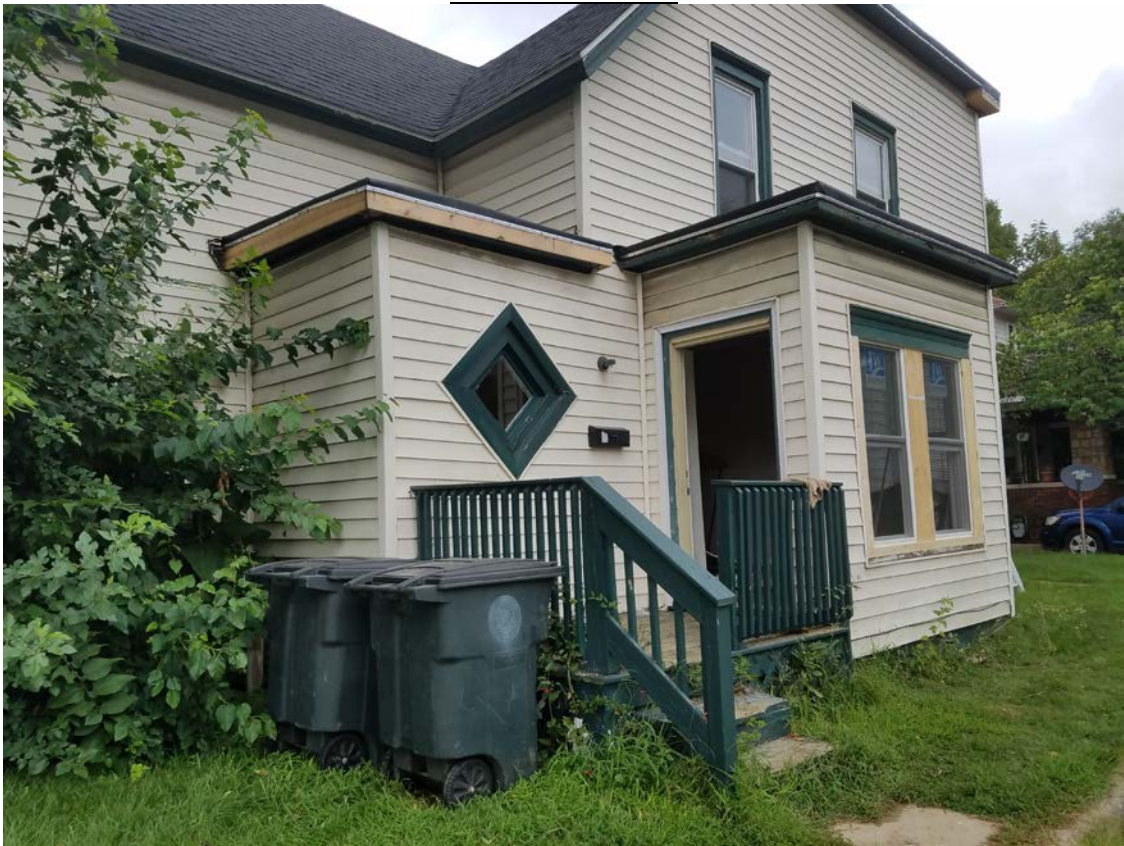
*Figure 2 – 601 Lafayette Boulevard from the sidewalk, looking north west. Window replacement on entry addition is visible at right.*

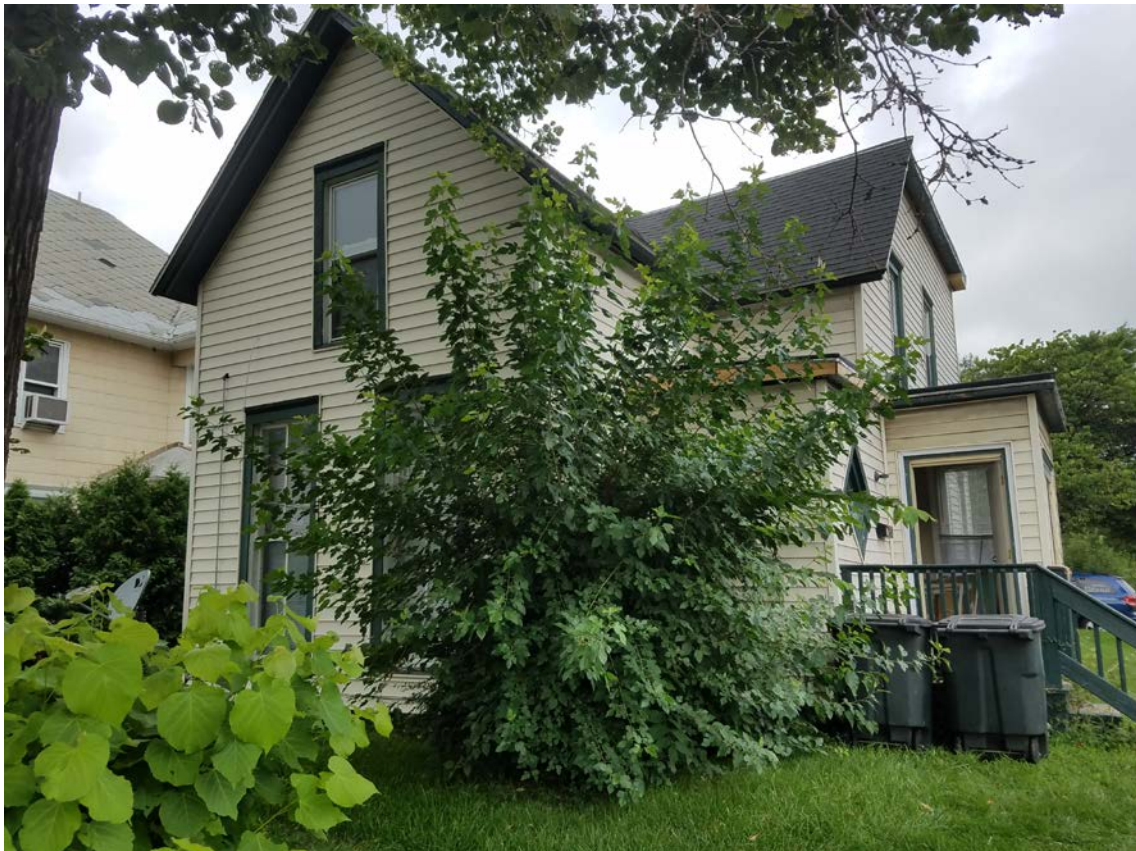
*Figure 3 – 601 Lafayette Boulevard, from the sidewalk corner, looking north, northwest. Original windows are obscured by the bush.*

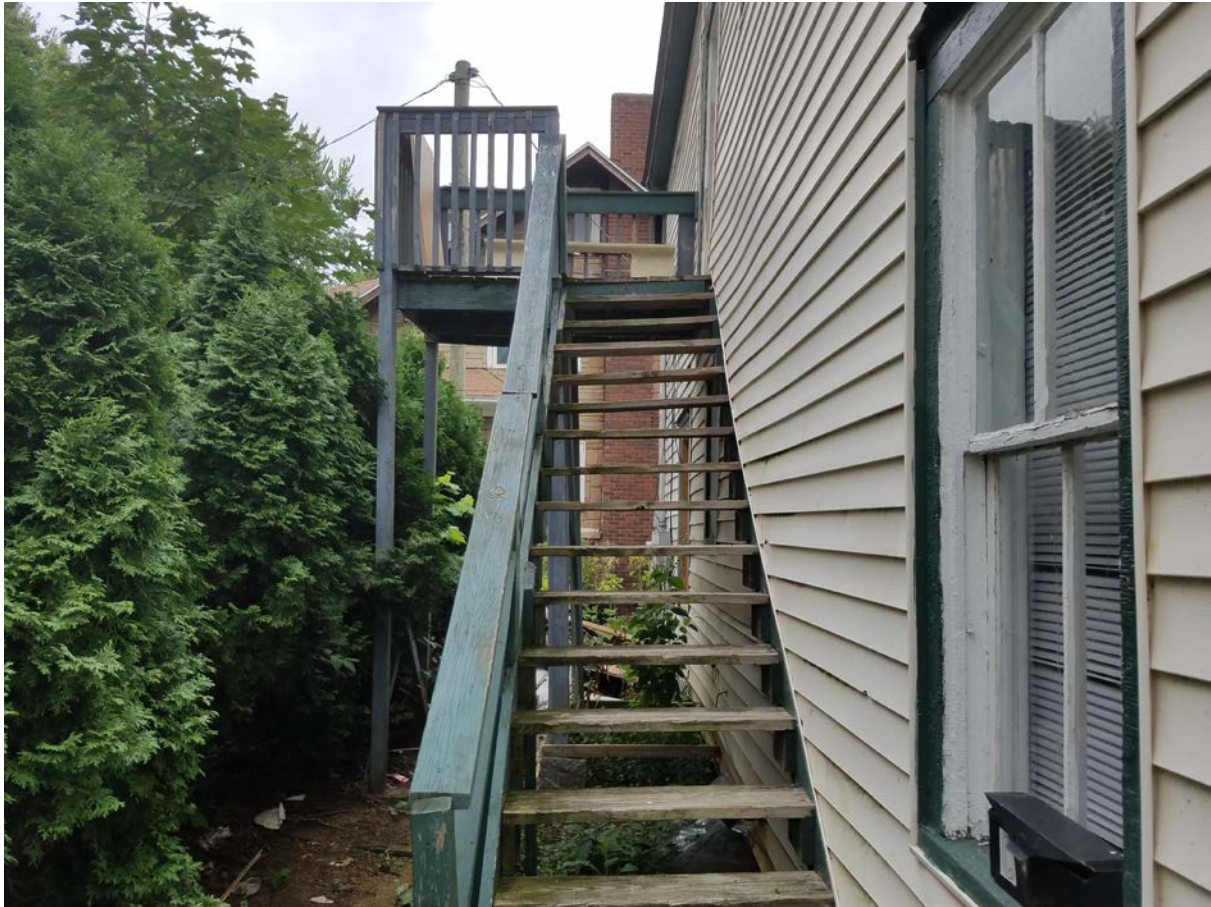
*Figure 6 - Subject property, looking north. Original window at edge of frame.*

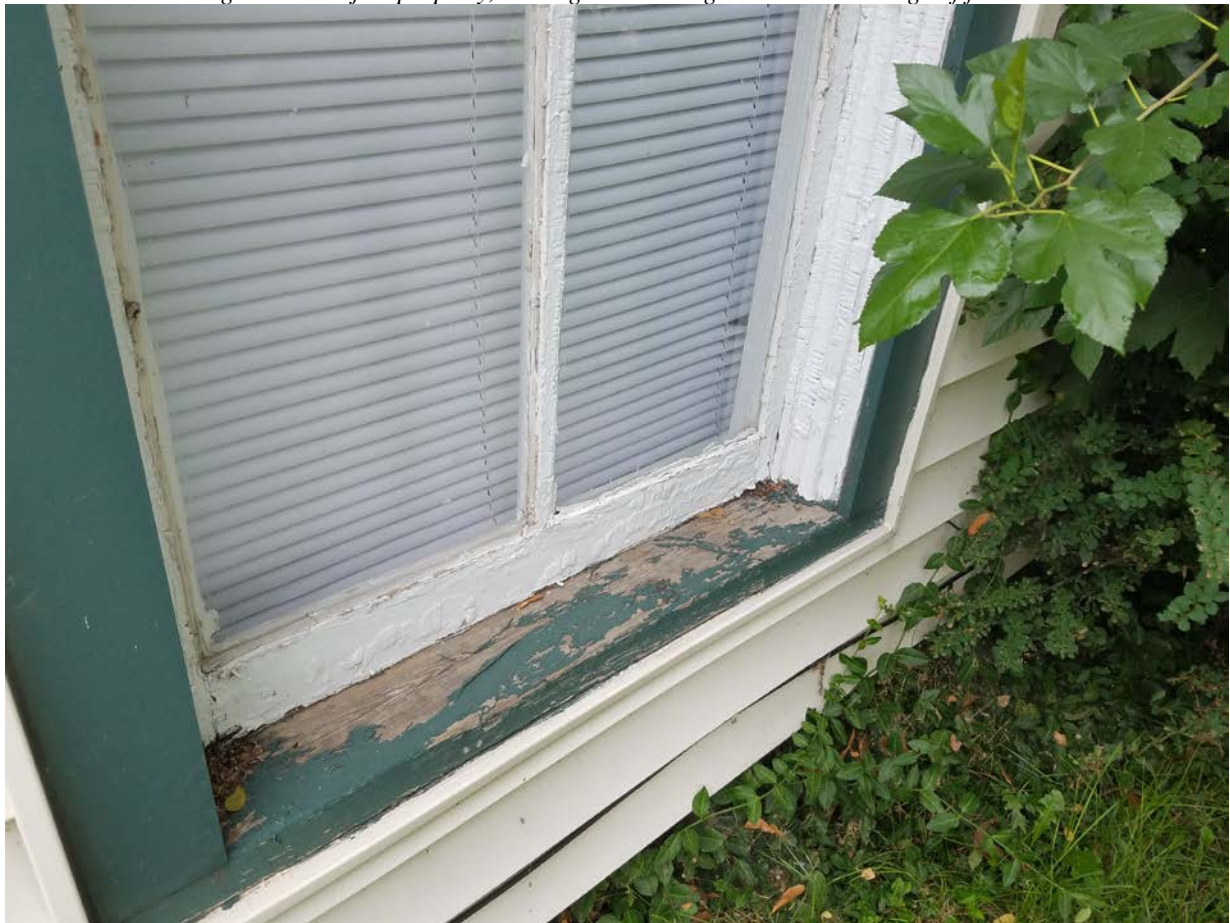
Two large double hung wood windows on the south face of the structure have multiple repairs including metal angle brackets and screws. The original storms are missing and have allowed the deep window framework to collect the elements and rot out the bottom sash and sill. Water stains are present on the inside wall material as a result of the water infiltration. These two windows will need the jambs rebuilt and the lower sashes remade or replaced. I believe these are beyond repair. The two upper sashes are structurally intact but have started to separate. There is ample caulk applied to these sashes which has caused greater separation and damage. Still repairable but will require considerable attention.

*Figure 7 - Original window/sill on the south face of the subject property.*

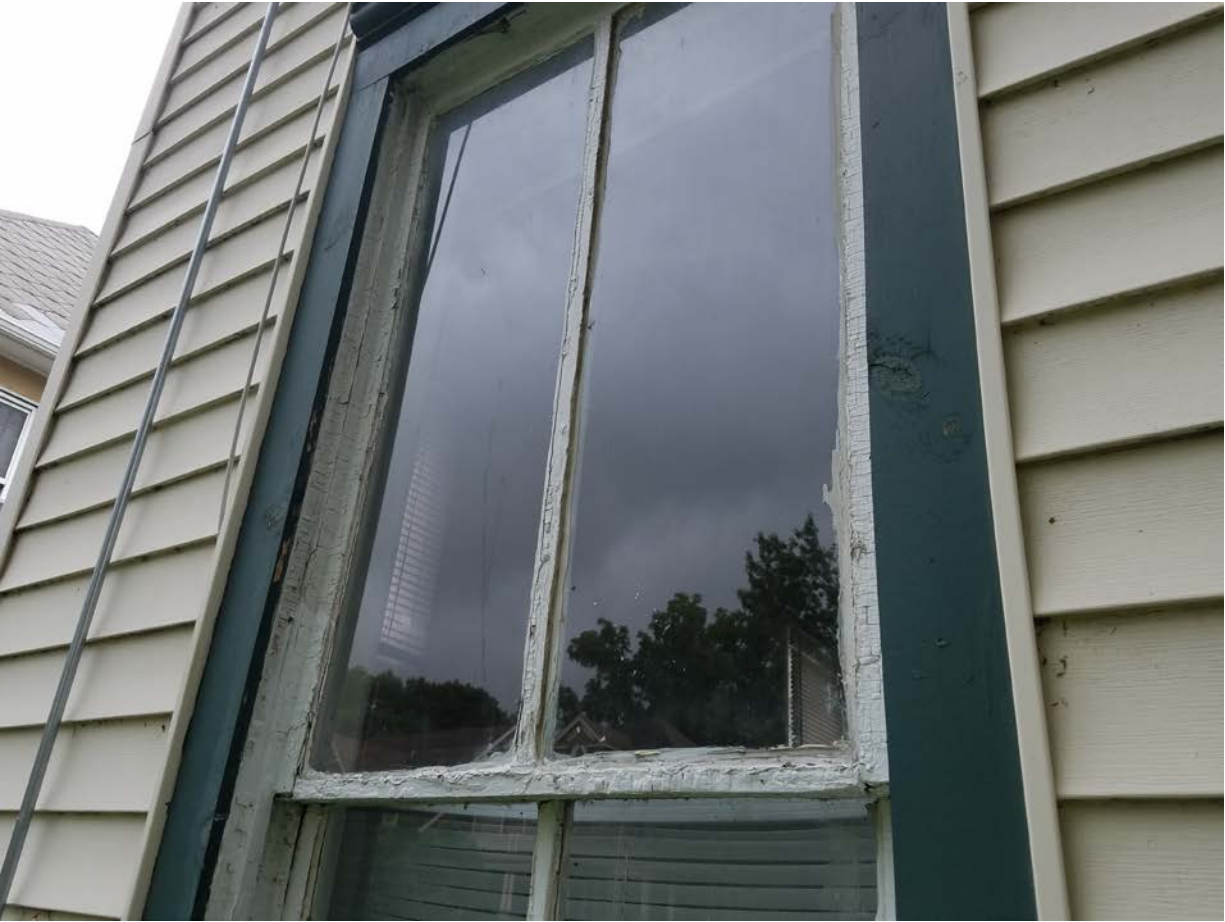
*Figure 8 - Original window, south side of the subject property.*
