STAFF REPORT

CERTIFICATE OF APPROPRIATENESS

Application Number: 2018-1001C **Property Location:** 50106 Bittersweet Trail

Corn Crib Project

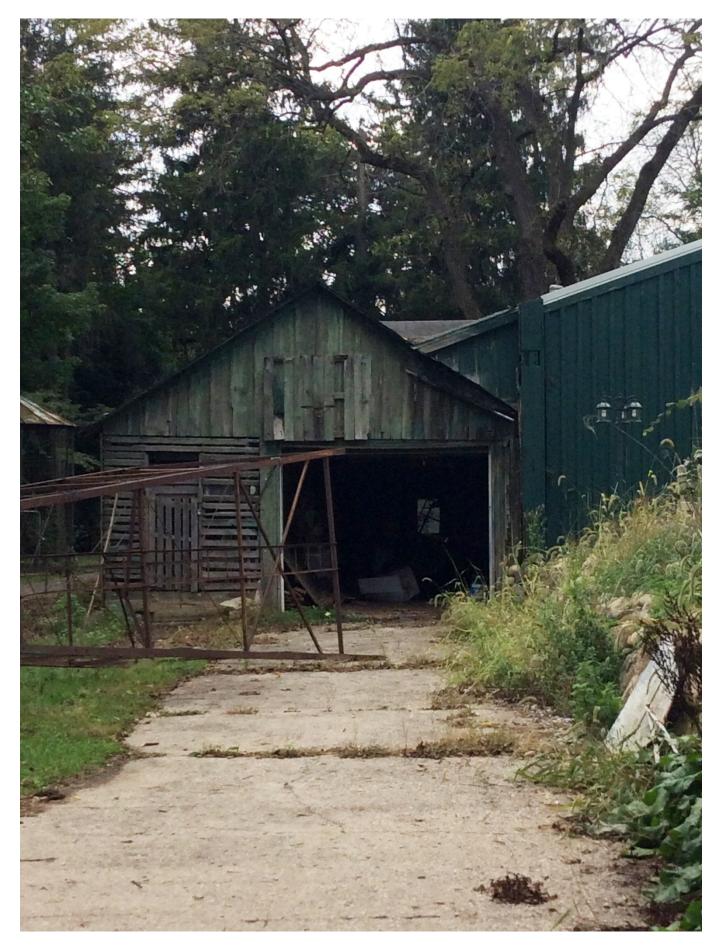
Figure 5 - Corn crib, east facade. Note roof eave.

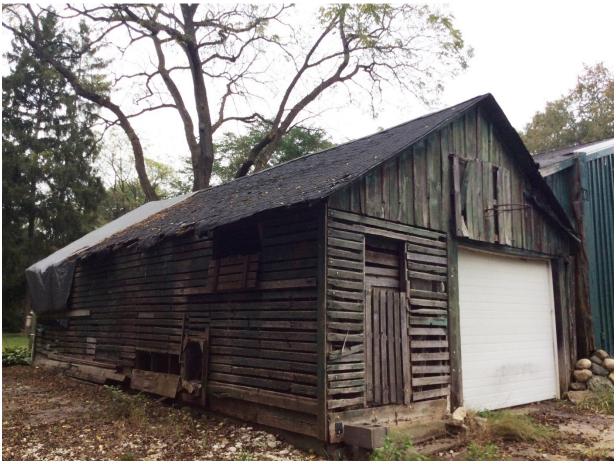
- -Alternating open siding exterior wall originally designed to allow air to pass through crop allowing crop to dry. Later this section was adapted to a chicken coop. This stage added chicken wire, feeding doors, ramps, and roosts. I feel that is reasonable to believe that presence of the chicken wire is the only reason this outside wall has not completely collapsed. Reference *Figure 7*.

Figure 7 - Southeast corner of the corn crib.

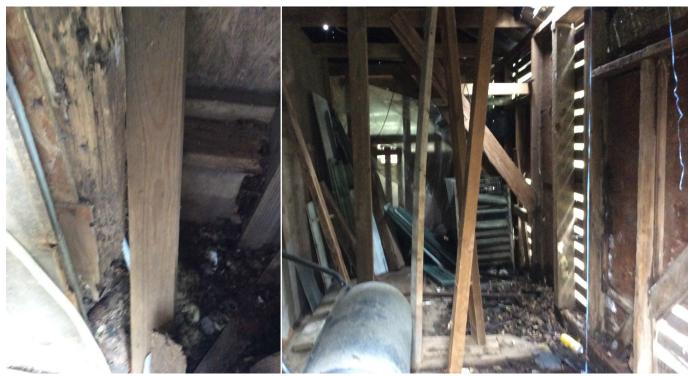
- -The roof trusses are failing as vertical supports have been recently added to hold up the roof structure. Reference *Figure 9*.
- -The plywood over joist floor has failed. I stepped right through to the dirt floor underneath when I walked through this section. Reference *Figure 8*.

- -This section was enclosed with a front door, windows, and rear overhead garage door.
- -A concrete floor was added later as well as a curb along the bottom of both east-west walls.
- -The roof on the northern part has holes with bad deck and rotten trusses. Reference Figure 11.
- -This small section of roof is receiving the brunt of all the elements that run off the southern roof of the large shop area. A pitch/storage area was added to perhaps divert this load, but it has weakened the roof and the wall supports.
- -There is a wall for the middle section that is inches away from the wall that is the southern wall of the large shop section. Termites and water have damaged the wall to the point where additional supports had to be added to help hold up the roof in this section. Reference *Figure 8, left frame*.

Figure 8 - Interior condition. Note termite damage in the image at left.

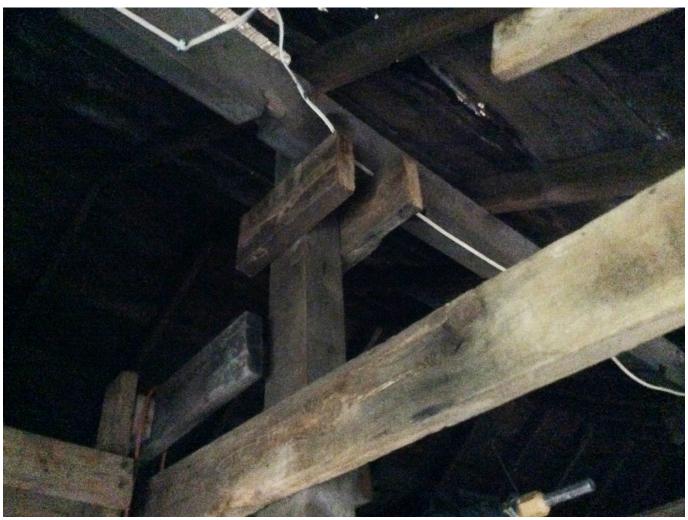
Figure 9 - Roof beams.

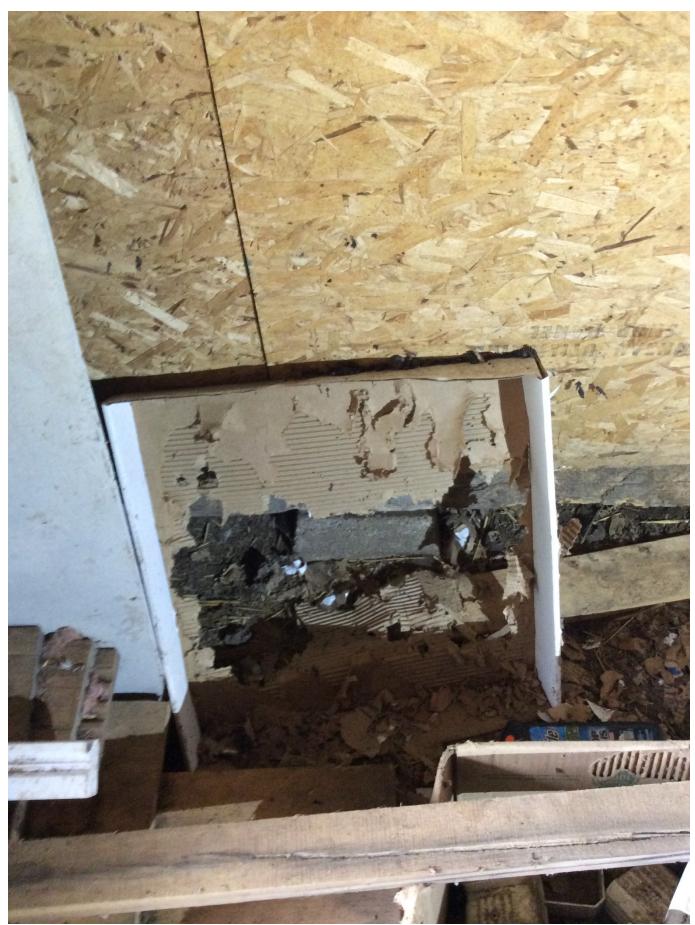
- -The wall in between this and the next section is an addition wall that is framed and on a combination of brick and toward the rear a cement curb. There is dry rot and termite damage along the entire bottom of this wall. Reference *Figure 10*.

Figure 10 - Foundation rot at shared wall with newer barn structure.

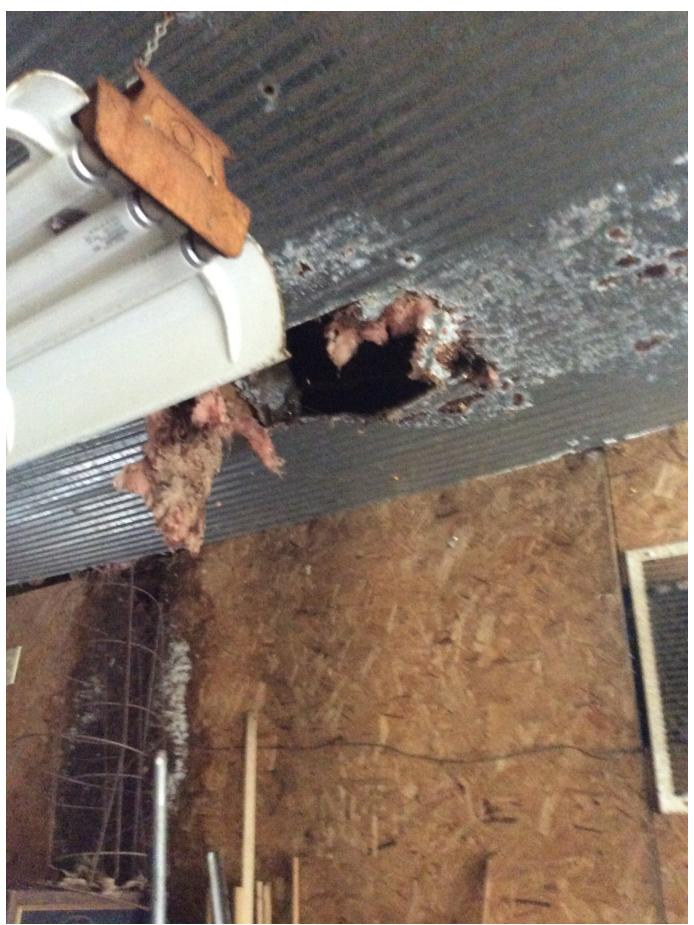
Figure 11 - Evidence of sustained water damage in corn crib garage bay.

This building will continue to deteriorate if it is not separated from the rest of the structure. It is not structurally strong enough to hold its own weight let alone strong enough to support the weight of the elements from the shop roof. The roofs and walls need to be rebuilt separately with truss supports, floors, and proper gutters. The structure is not safe and will not likely survive a serious winter as it sits.
