STAFF REPORT
CONCERNING APPLICATION FOR A
CERTIFICATE OF APPROPRIATENESS

Application Number: 2018-0427 continued

Property Location: 736 Portage Avenue

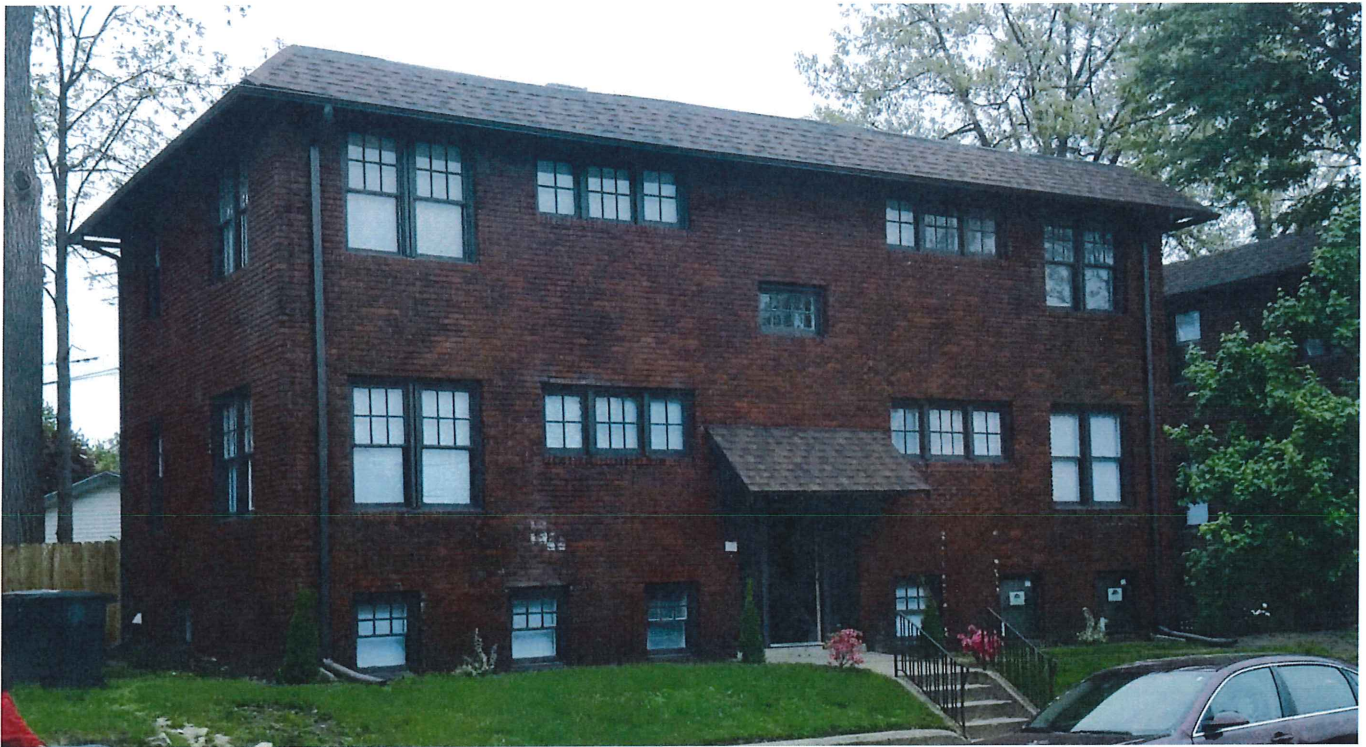
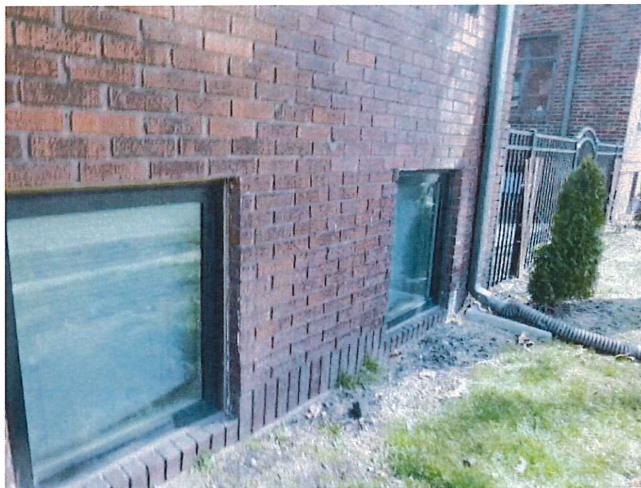
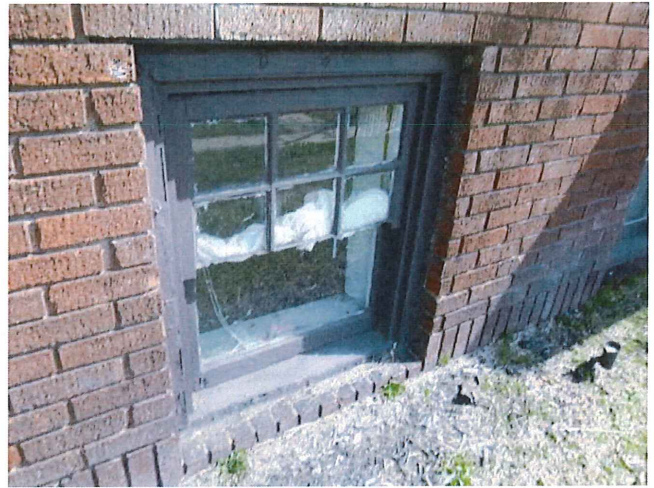
ALTERATIONS: Two original wood 6/1 windows were replaced with black aluminum full light casement without COA.

March 21, 2018 I met with the property manager of 736 Portage, Valerie of VPM at the location. We discussed window replacement for the basement windows at 736. Some windows at both buildings at the lower level have already been replaced from the wood double hung to aluminum casements. Four windows are wood double hung are not functioning and are damaged beyond repair. One sash is missing the meeting rail and another is completely missing the mortise and tenon joint. The casement windows also allow a legal egress.
Steve Szaday, Preservation Inspector

Continued from May HPC meeting. Replace four (4) original wood 6/1 windows AND two (2) black aluminum full light casements installed without COA with new Semco casement aluminum clad exterior/wood interior 6/1 simulated divided light with wider simulated meeting rail (see Semco sheet). The replacement windows will not reduce the overall size of the opening but will resemble the original window pattern while providing the necessary egress. The existing windows have been deemed deteriorated beyond repair by Preservation Inspector and window repair contractor.

STAFF RECOMMENDATION: Staff recommends approval.

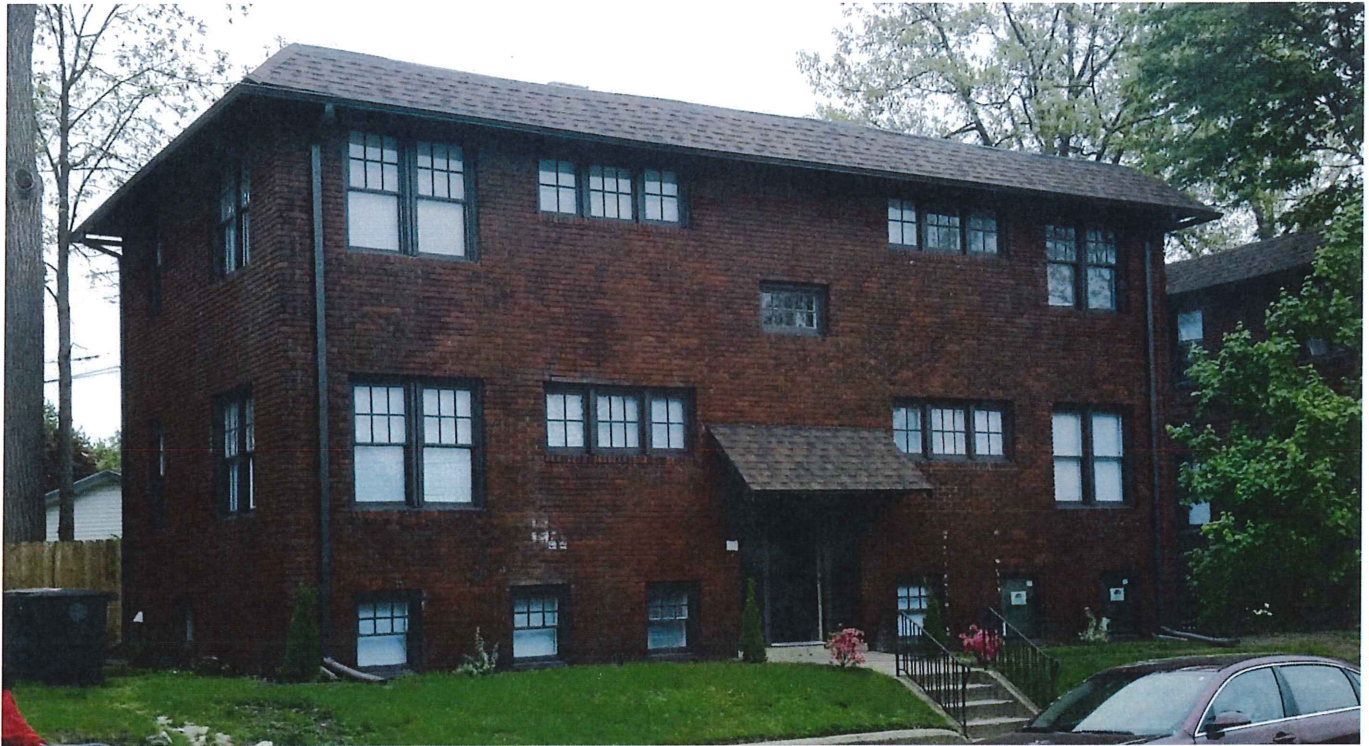
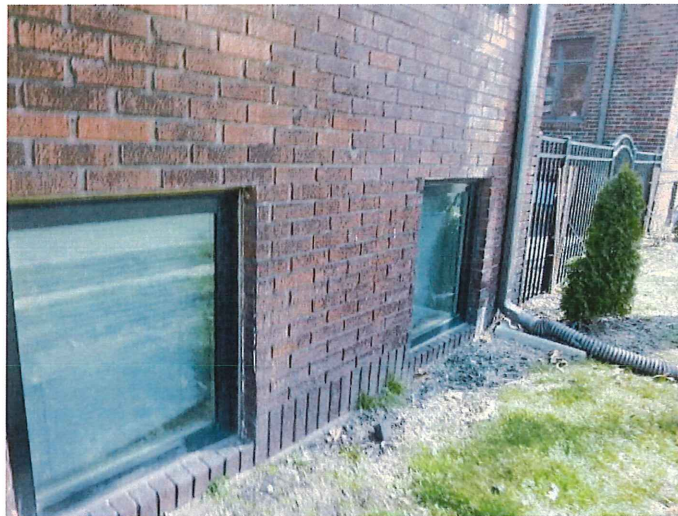
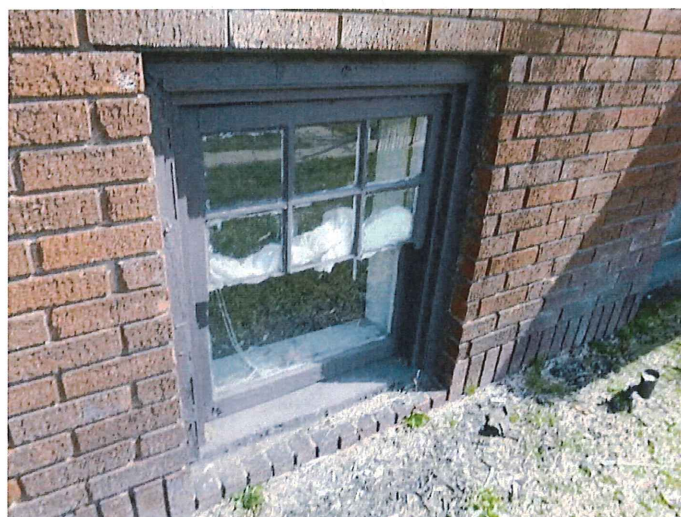
ALTERATIONS: Two original wood 6/1 windows were replaced with black aluminum full light casement without COA.

March 21, 2018 I met with the property manager of 736 Portage, Valerie of VPM at the location. We discussed window replacement for the basement windows at 736. Some windows at both buildings at the lower level have already been replaced from the wood double hung to aluminum casements. Four windows are wood double hung are not functioning and are damaged beyond repair. One sash is missing the meeting rail and another is completely missing the mortise and tenon joint. The casement windows also allow a legal egress.
Steve Szaday, Preservation Inspector

DESCRIPTION OF PROPOSED PROJECT: Replace four original wood 6/1 windows in front on basement level with new black aluminum full light casement windows, by Vinyl Craft, to match two windows replaced previously (without COA). The replacement windows will not reduce the overall size of the opening but will change the light pattern from 6/1 to full light. The existing windows have been deemed deteriorated beyond repair by Preservation Inspector and window repair contractor.

STAFF RECOMMENDATION: Staff recommends approval.

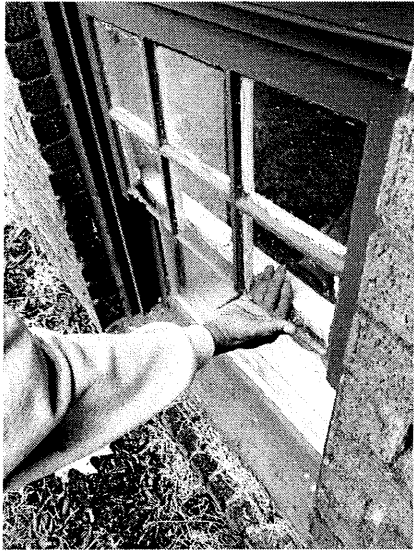
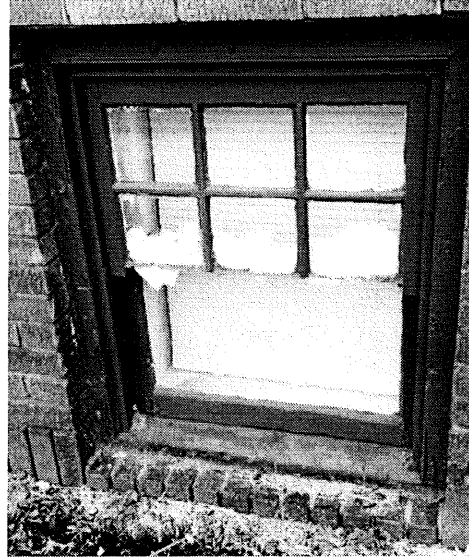
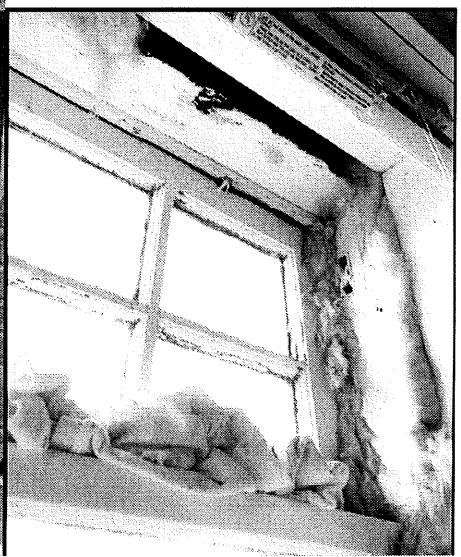
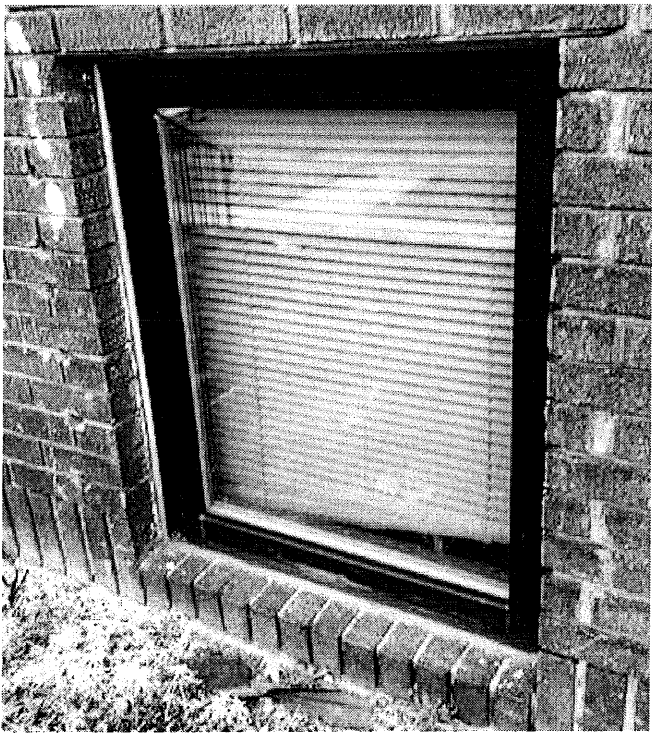
There are 4 windows on the basement level of the building that face the front of the building that are in very bad condition. All 4 windows face the front and are the original double hung wood windows. Two of these windows have frames that are cracked/broken and/or completely missing.

The old rotted windows are a safety hazard since they aren't secure, they are a health hazard because mice and other pests can easily come in to the building and that apartment. Randy from Indiana Glass has already looked at the older windows and due to the severity of the condition of them he recommended having them replaced to match the 2 newer windows.

We just took over the management of this building as of March 1, 2018 and so that is why are just now addressing the building. We want to replace the 4 original windows with the exact same windows that were already replaced. The 2 most south basement windows on the building have already been replaced with aluminum casement windows. We simply want to match these windows. The measurements of the windows are 30 inches wide and 39 ¾ inches tall. The windows would be black to match the ones that have already been installed.
