# STAFF REPORT

## CONCERNING APPLICATION FOR A CERTIFICATE OF APPROPRIATENESS

**Application Number:** 2018-0605

**Property Location:** 608 Park Avenue

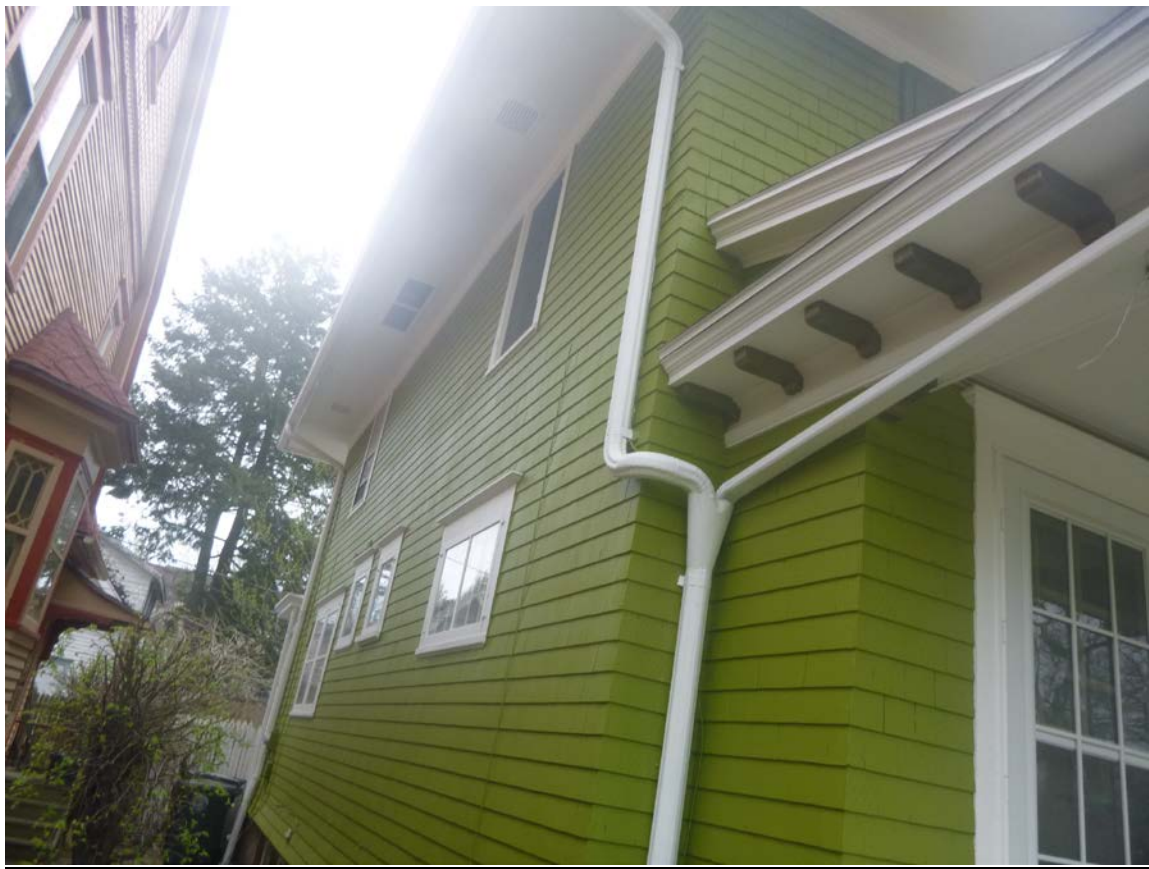
The north side has a twelve-light original fixed window, two nine light original casement windows, and two original nine over one double hung windows with textured glass at the far end.

*Figure 2 - 608 Park, north face. Window #1, #2, #3, and #4 are visible.*

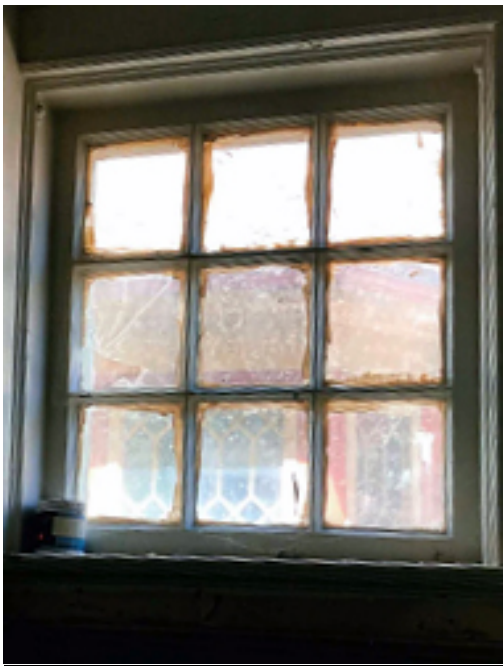
*Figure 3 - window #2*

Glass is broken and grids are damaged.

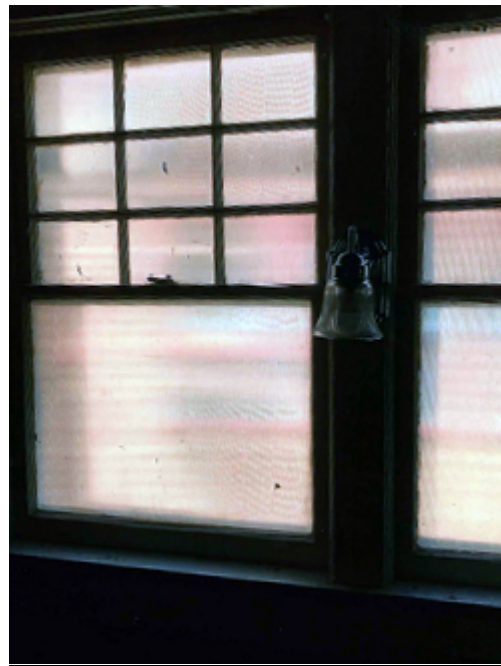
*Figure 4 - window #3, parts of window #4*

Window has frosted tape over all the glass.

Caulked and painted shut and the weights are cut.

Windows do not open at all.

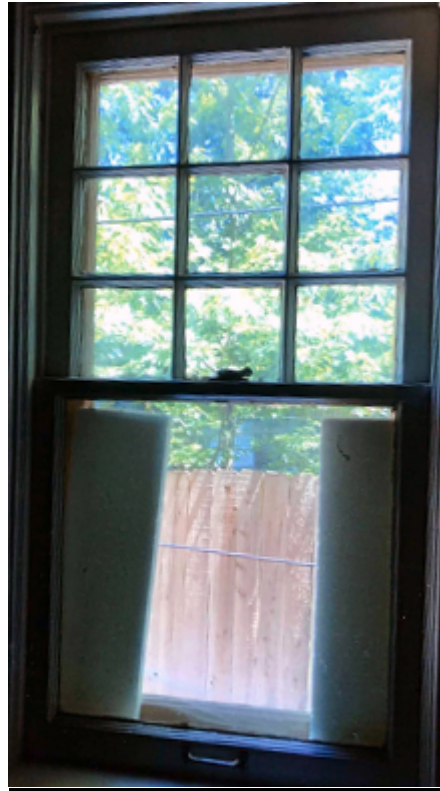
*Figure 5 - Window #5*

Window is Caulked and Painted and weights are cut.

Wood of window is starting to rot

Window do not open at all

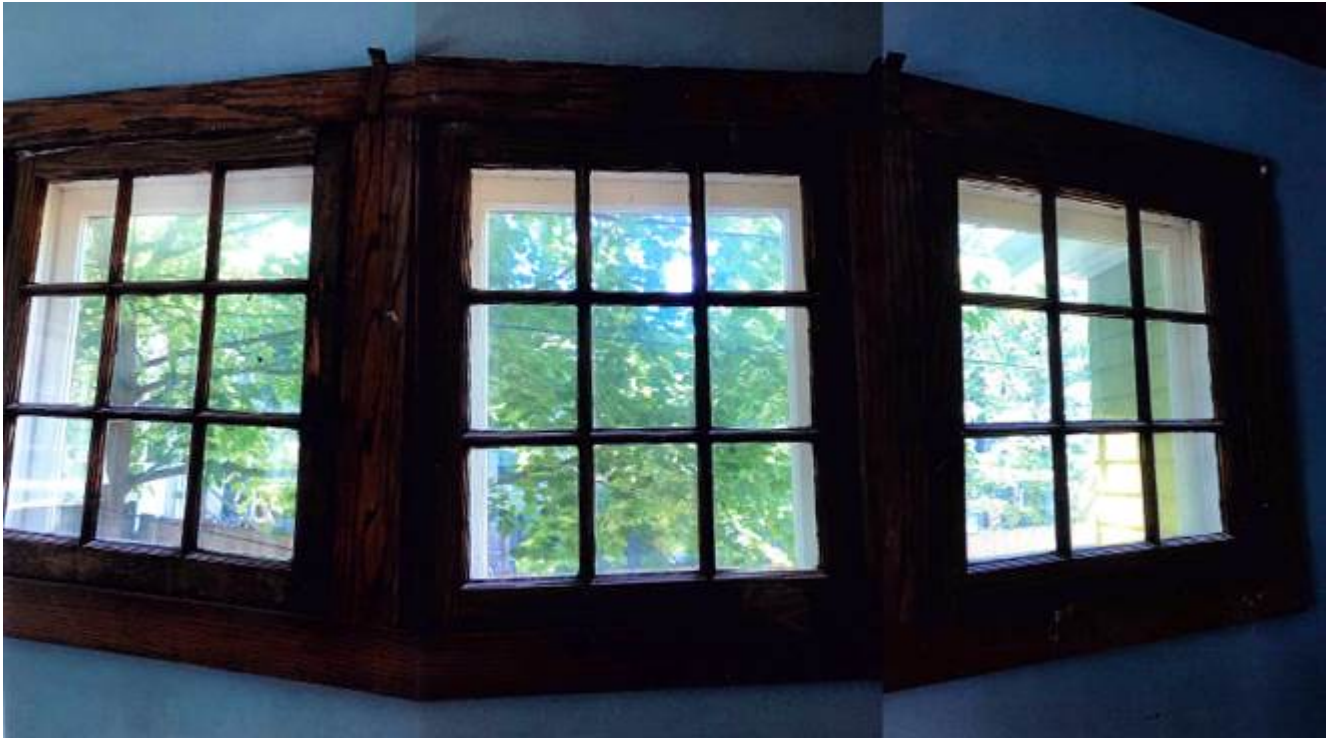
The rear (east) face has a three bay, nine light casement window unit. These are wood, but I do not believe to be original, as they have a veneer of wood finish that is peeling off.

*Figure 6 – Windows #6, #7, #8*

Rotting wood on all these windows

Swollen wood causing windows to not open

Hinges are rusted out

Found PVC Tape all over the window that is heavily glued

The replacement of the non-original windows on the South and East side is received favorably by Staff, and is therefore recommended for approval.

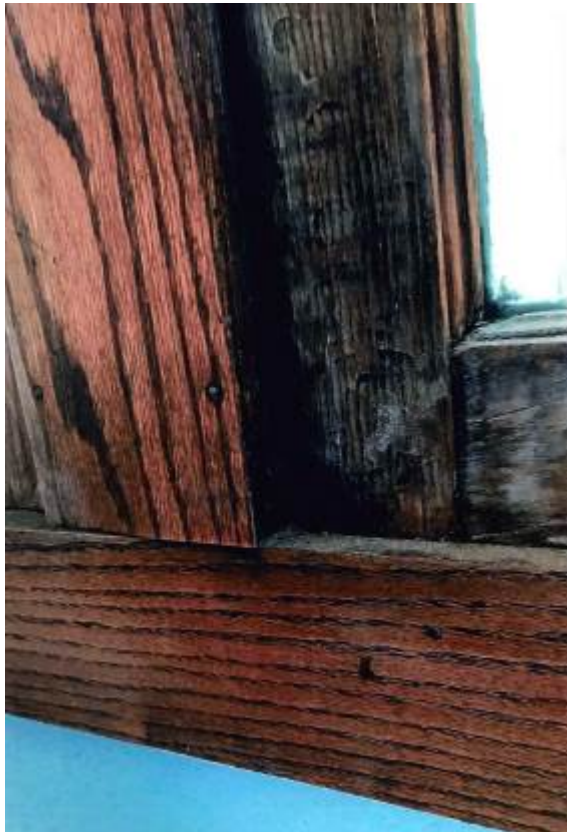
*Figure 7 – veneer*

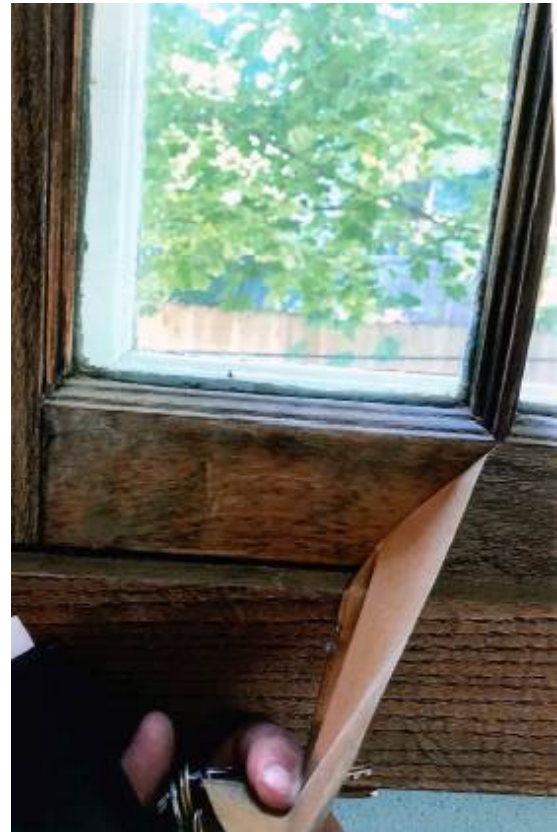
*Figure 8 – Peeling veneer*

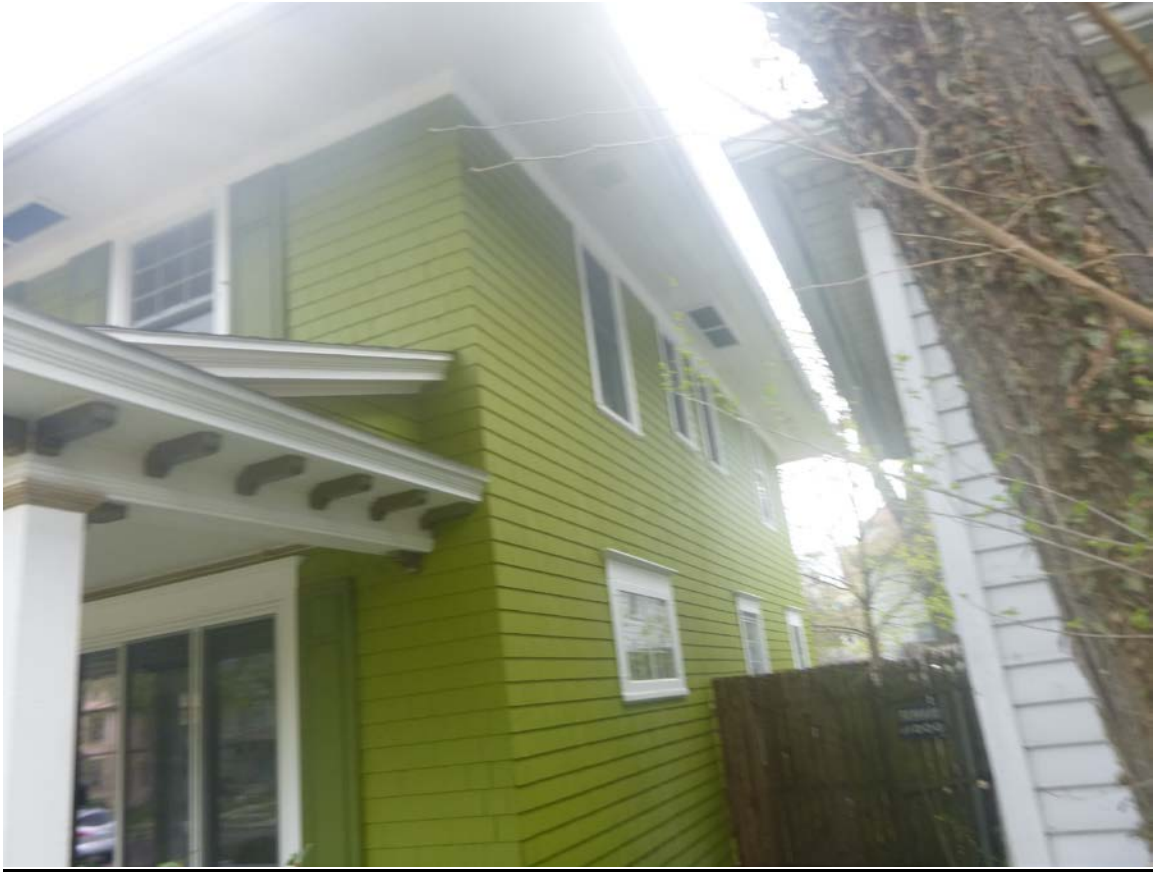
The double hung windows on the south side (right side when looking at front of house) are non-original replacement windows with false grids.

*Figure 3 - 608 Park, south face. Windows #9 and #10 are visible.*

Windows have been replaced with vinyl windows
