STAFF REPORT

CONCERNING APPLICATION FOR A CERTIFICATE OF APPROPRIATENESS

Application Number: 2018-0703A

Property Location: 801 Park Avenue

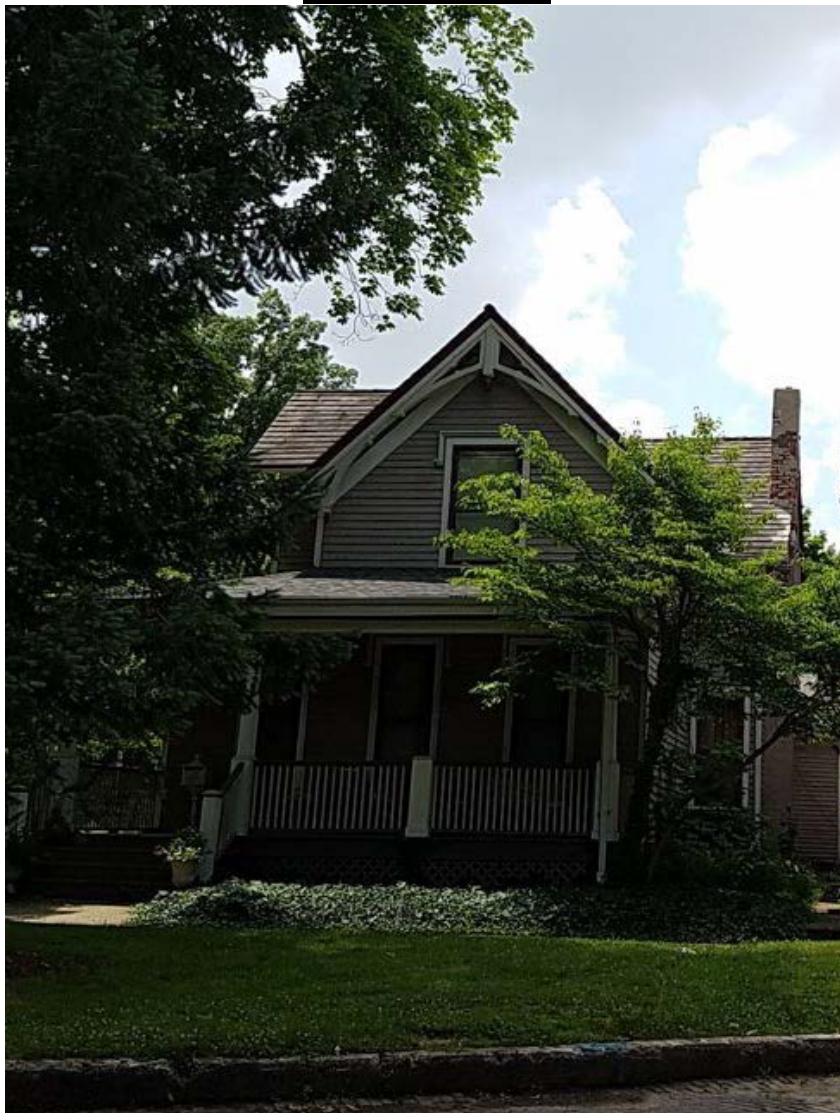
Figure 1 -- 801 Park from the street, looking west. The subject chimney is visible along at right.

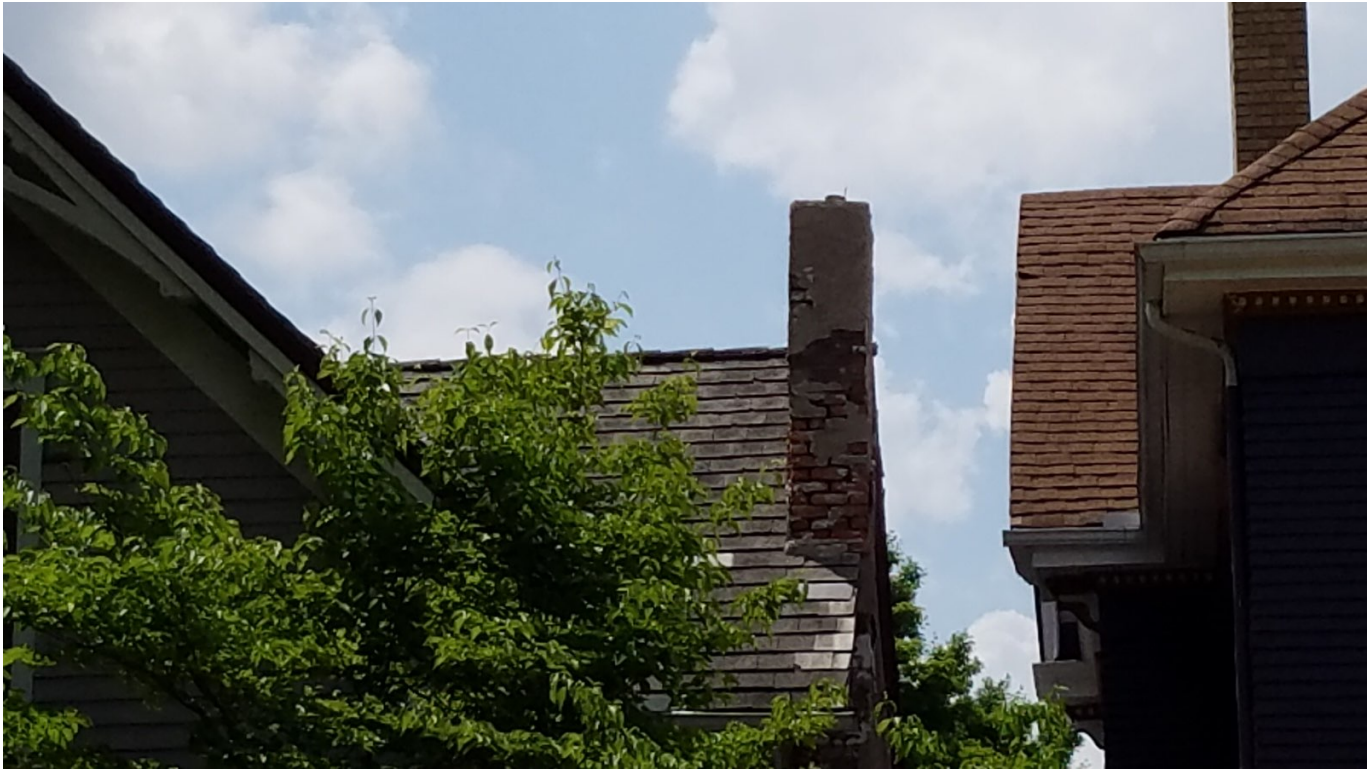
1. The removal of a degraded external chimney at the north-east corner of the structure. The chimney is visible from the street when looking at the front (Park Avenue) side of the home. Stucco and paint that had encapsulated the chimney has fallen off and exposed the brick beneath. The chimney is non-functional, and was not venting water heater exhaust properly, leading to a build-up of gases in the basement. The water heater is now vented out of the house from a different location.
 - a. The chimney will be removed in its entirety (to the foundation).
 - b. The wood siding, molding, and other external details will be replicated, in-kind to 'cover' the exposed area where the chimney once stood.

Figure 2 -- Close-up of the chimney at the northeast corner of the structure.

Staff recommends denial of the project, as the Standards & Guidelines of the Chapin Park Local and National Historic District are explicit that “*all architectural features, which give the roof its essential character, shall be retained, including [...] chimneys [...].*” In lieu of deconstruction and demolition of this feature, staff would recommend that it be rehabilitated.

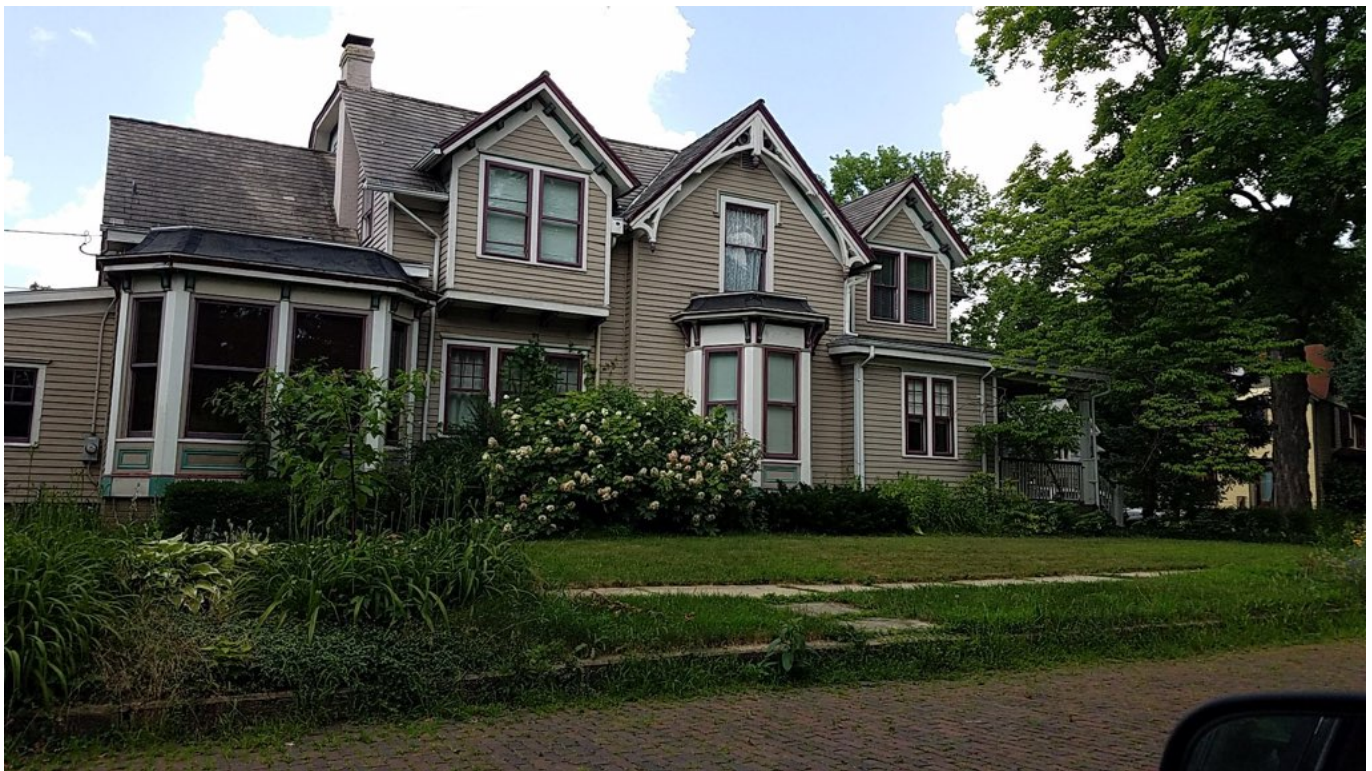
Figure 3 -- 801 Park, looking north from Manitou Place. Main chimney visible at left, while the subject chimney is obscured by the roof line.
