STAFF REPORT

CONCERNING APPLICATION FOR A CERTIFICATE OF APPROPRIATENESS

Application Number: 2018-0911A

Property Location: 510 S Carroll

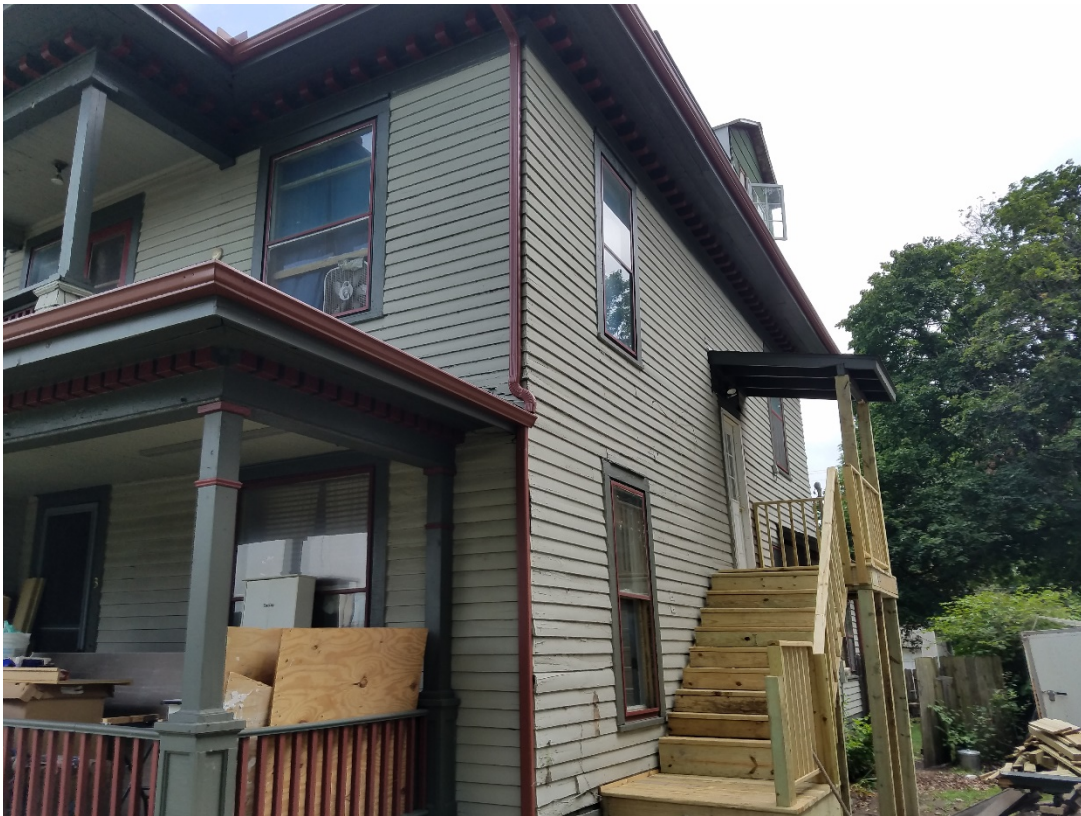
Figure 3 - Close-up of the stairs.

Exterior Side Staircase: the new staircase is sturdy and composed of wood as the previous staircase was. I requested that the contractor confer with the building department to make sure the baluster spacing meet code requirements. The remaining block and concrete landing and steps are failing. The steps have sunken to the south and there is a washout spot on the southeast base of the structure has left a deep void underneath. The removal of the knee wall has left the underground staircase to the cellar exposed and should be addressed.

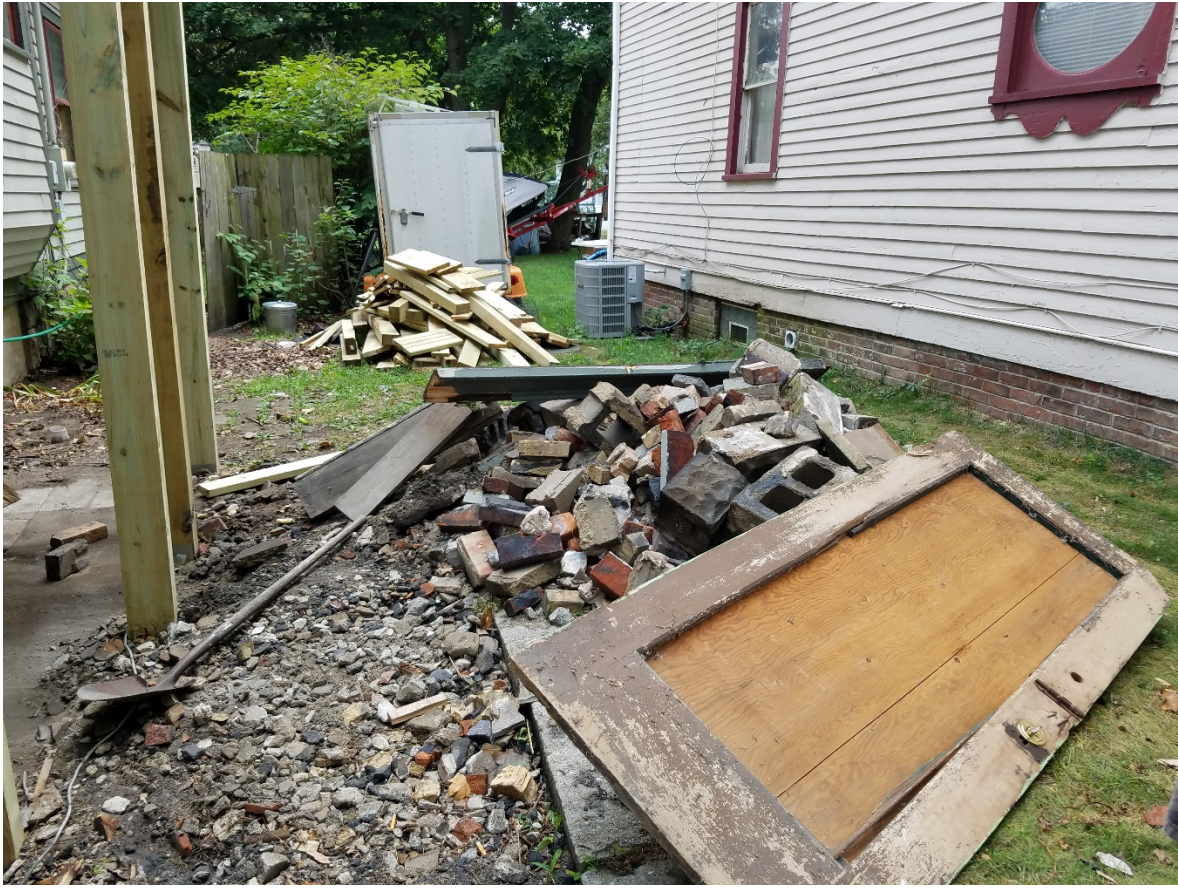
Figure 6 - Deconstructed stone and brick wall.

I saw a new wooden staircase on the south side of the house where the previous wooden one was. I noticed the sculpted block knee wall that was at the bottom of the previous staircase was removed. I also saw new wooden fence panels both in place and stacked on the ground.

Regarding the low stone and brick wall: of the prior projects, COA #2003-0308 explicitly stated that “*the existing stone and brick structure along the south side of the house, enclosing cellar stairs and partly supporting the existing stair to the second floor, is to be retained and repaired.*” Inspector Szaday confirmed that the structure was being ‘washed out.’ The structure has been removed, and its likelihood of reconstruction is low. Staff makes no recommendation.

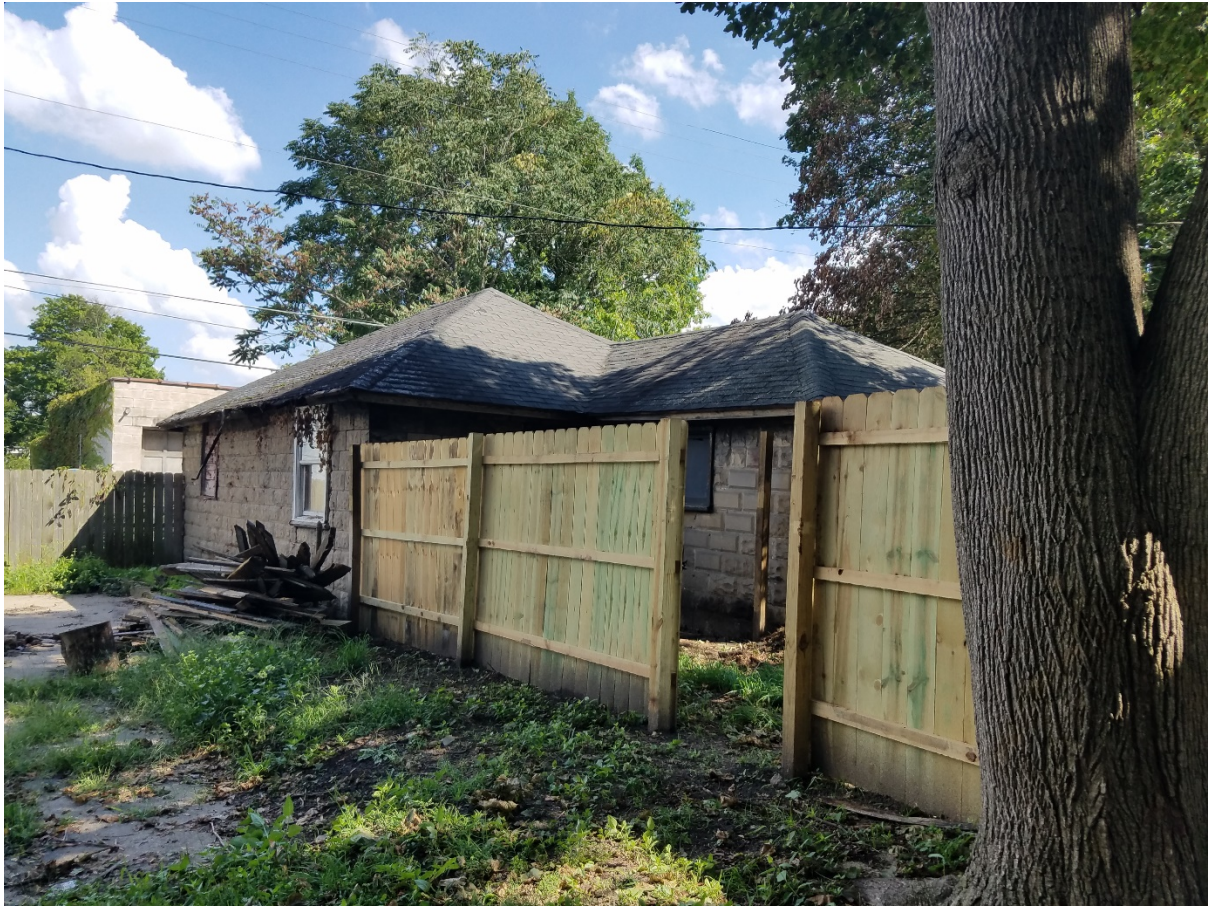
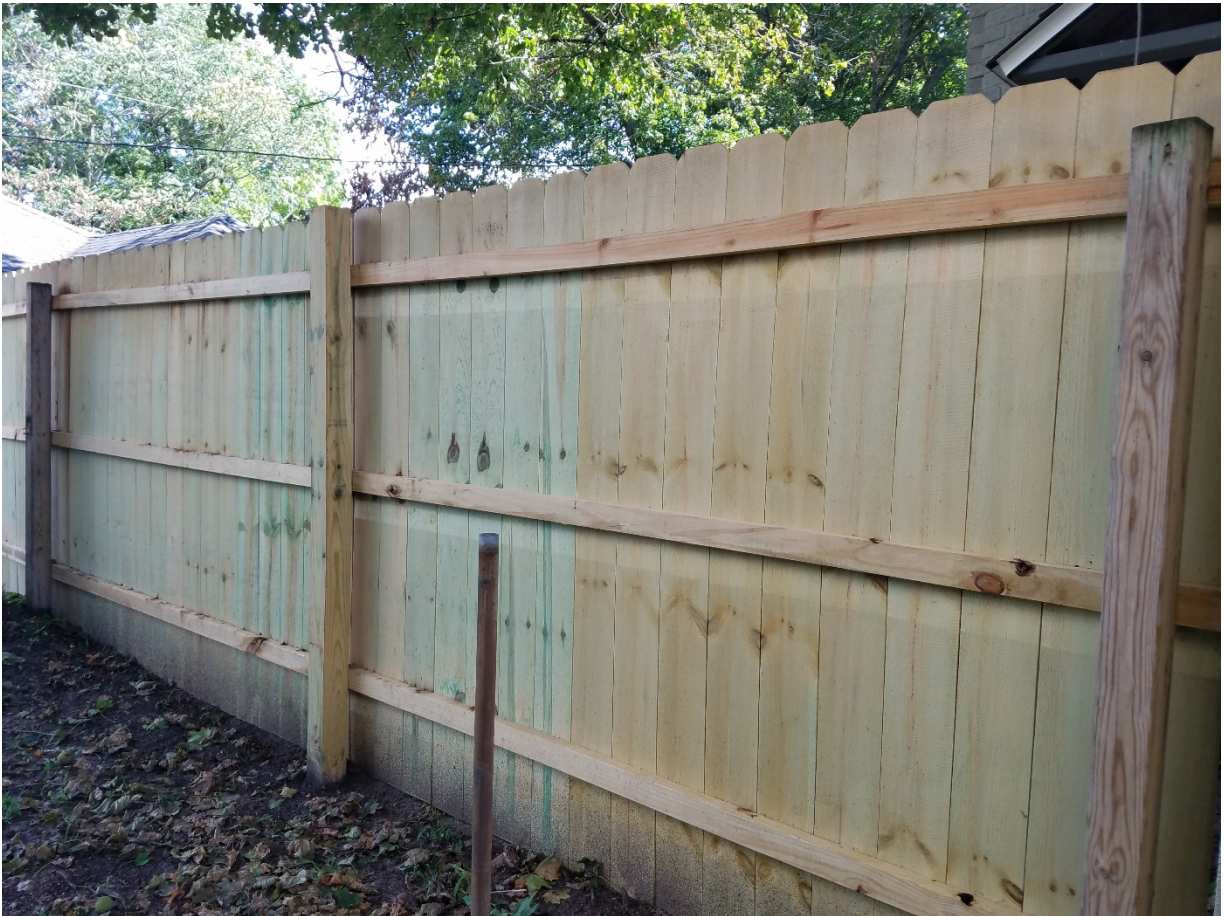
Figure 8 - Replacement fence.

Fence: Most of the posts were original with some new ones replacing old. The panels are similar to those that were there according to the 2013 digital file photos. The footprint does not appear to have been altered based upon those 2013 photographs.

Regarding the retroactive reconstruction of the fence using the existing fence posts, staff recommends approval.

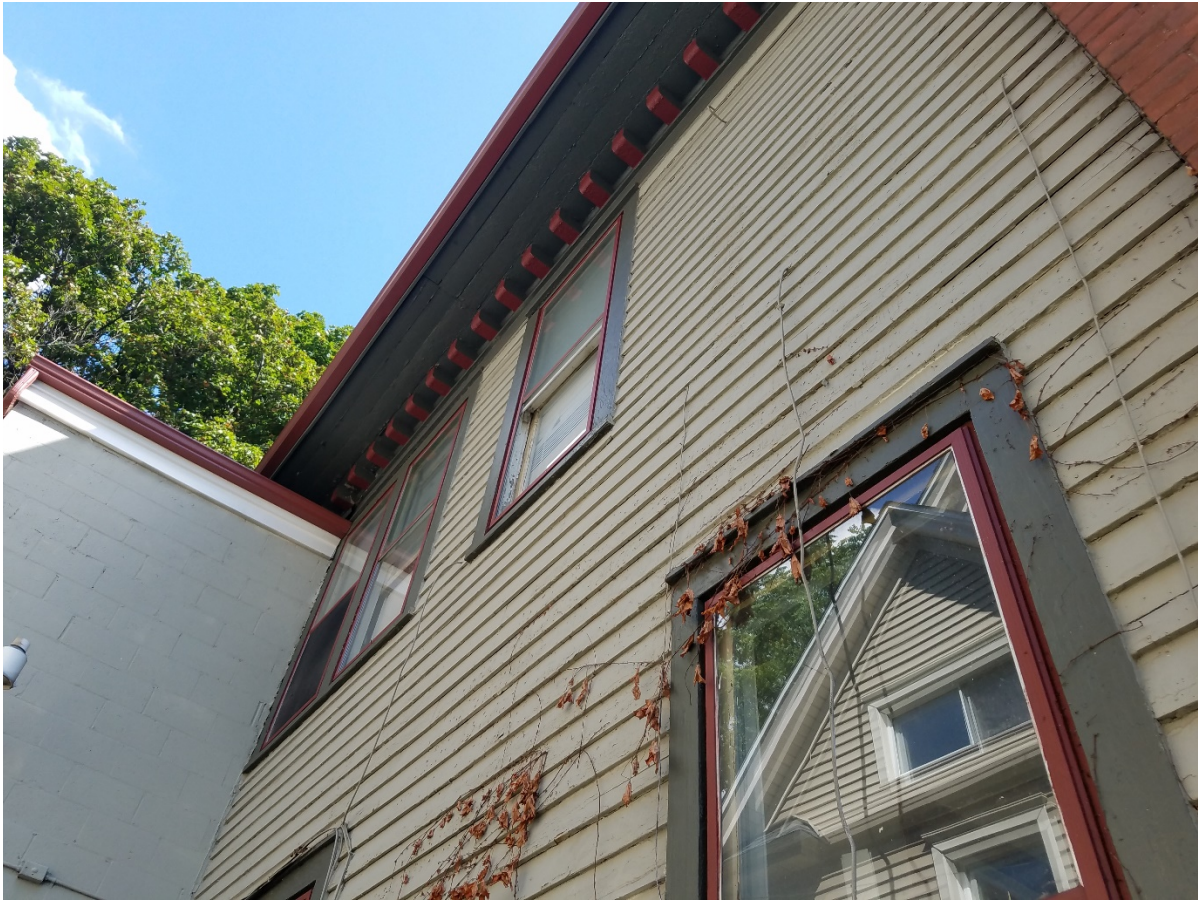
Figure 10 - North face, upper three windows to be replaced.

Windows: The owner has proposed the replacement of 7 original wood double-hung windows. I was unable to inspect the windows in the second floor as the apartment is occupied and the renter was not home. The four on the first level all have lower sashes that are broken and each have metal angle brackets holding the sashes together. These sashes are missing ropes and are not rotted, but rather are structurally damaged beyond repair. The metal storm windows are missing screens but have kept the original sashes and sills safely out of the elements. The upper sashes are painted and nailed in place.

Regarding the removal and replacement of the windows with Jeld-Wen vinyl windows, staff recommends approval based upon Inspector Szaday’s opinion of the existing window condition.

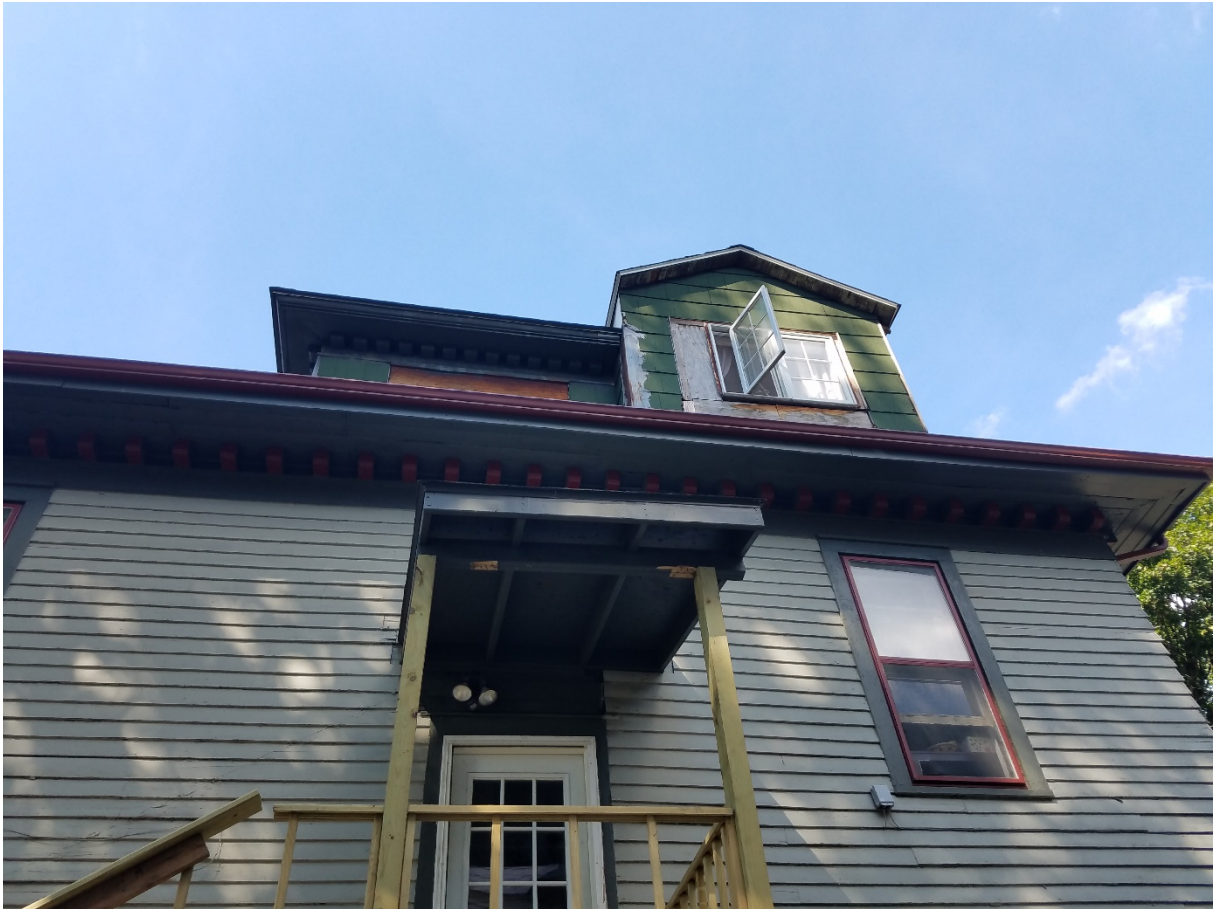
Siding: The siding on the dormers have both mastic/asphalt siding and asphalt shingles. The 2013 file photographs show a better view of what was in place then. There are places where siding has been replaced with plywood and left unfinished. The remainder of the house is covered with wood clap board with a 4" reveal.

Figure 16 - South gable with window (replaced by previous owner without COA), mastic/asphalt siding.

Regarding the replacement of the exterior mastic siding with vinyl siding on the rear upper story of the structure, staff recommends approval.

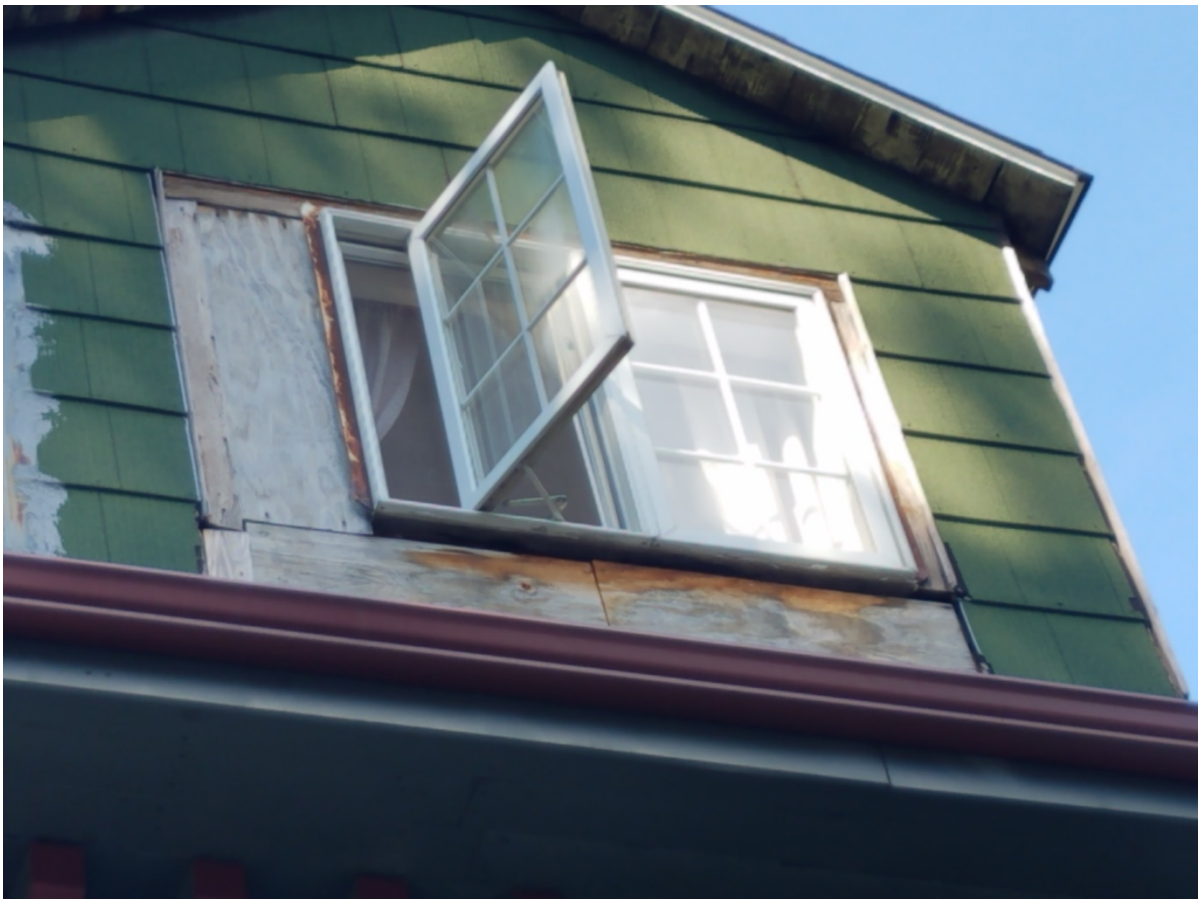
Figure 17 - Close-up of ill-fitting window and mastic siding.

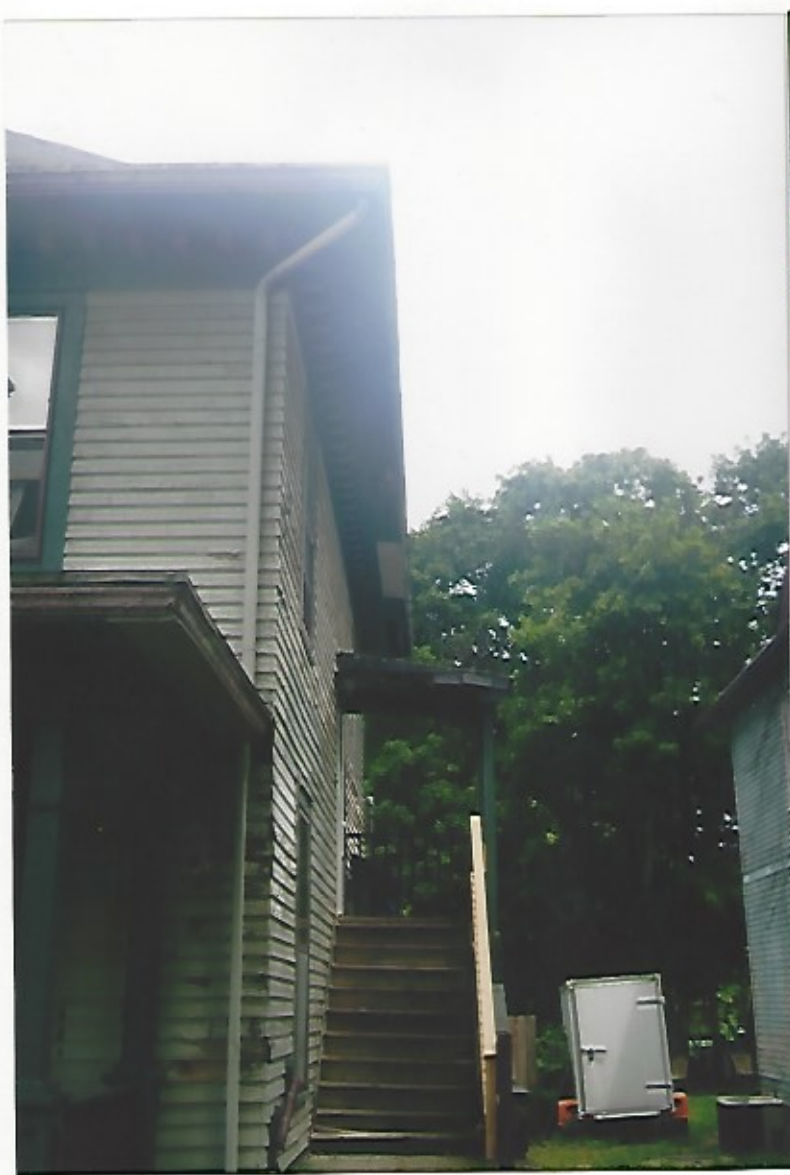
ORIGINAL STEPS

1. Outdoor Side Stair replacement. These stairs were failing and needed to be replaced. They were never installed properly and were attached to a stone and brick wall which was about to fail. We replaced the steps without approval, therefore we have pictures of the actual replacement step. I have included pictures of the new steps and the old steps from the street.

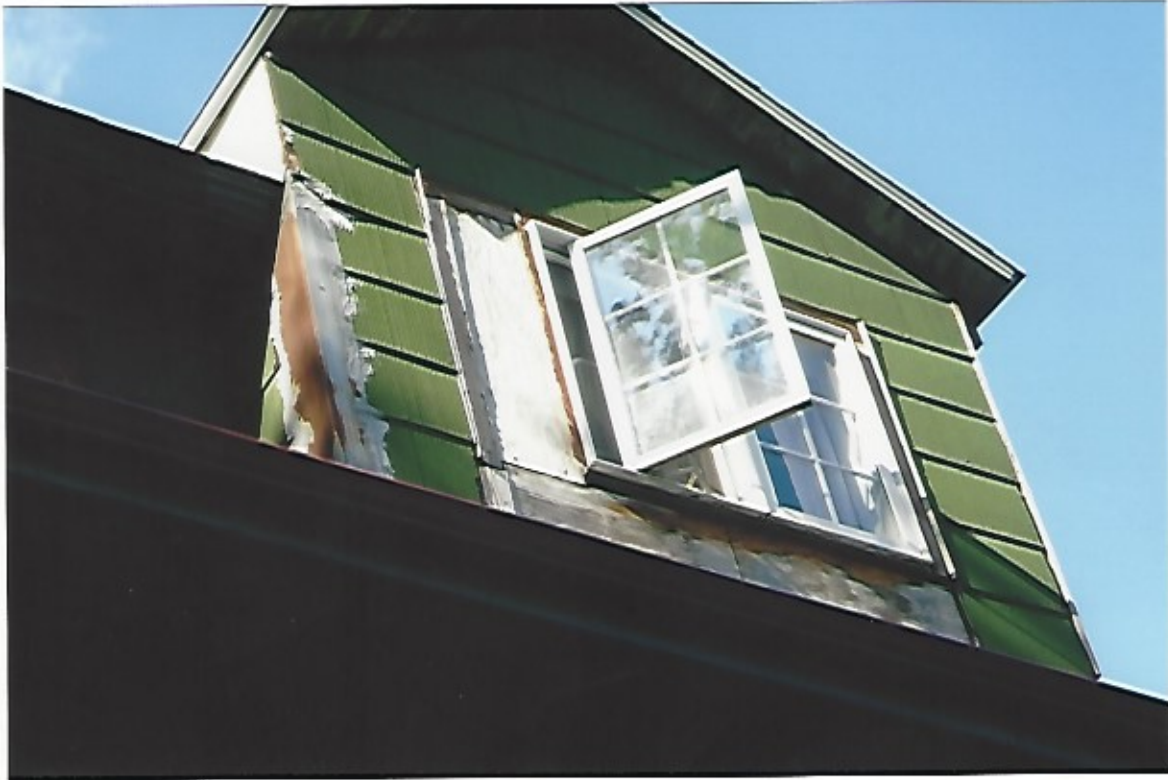
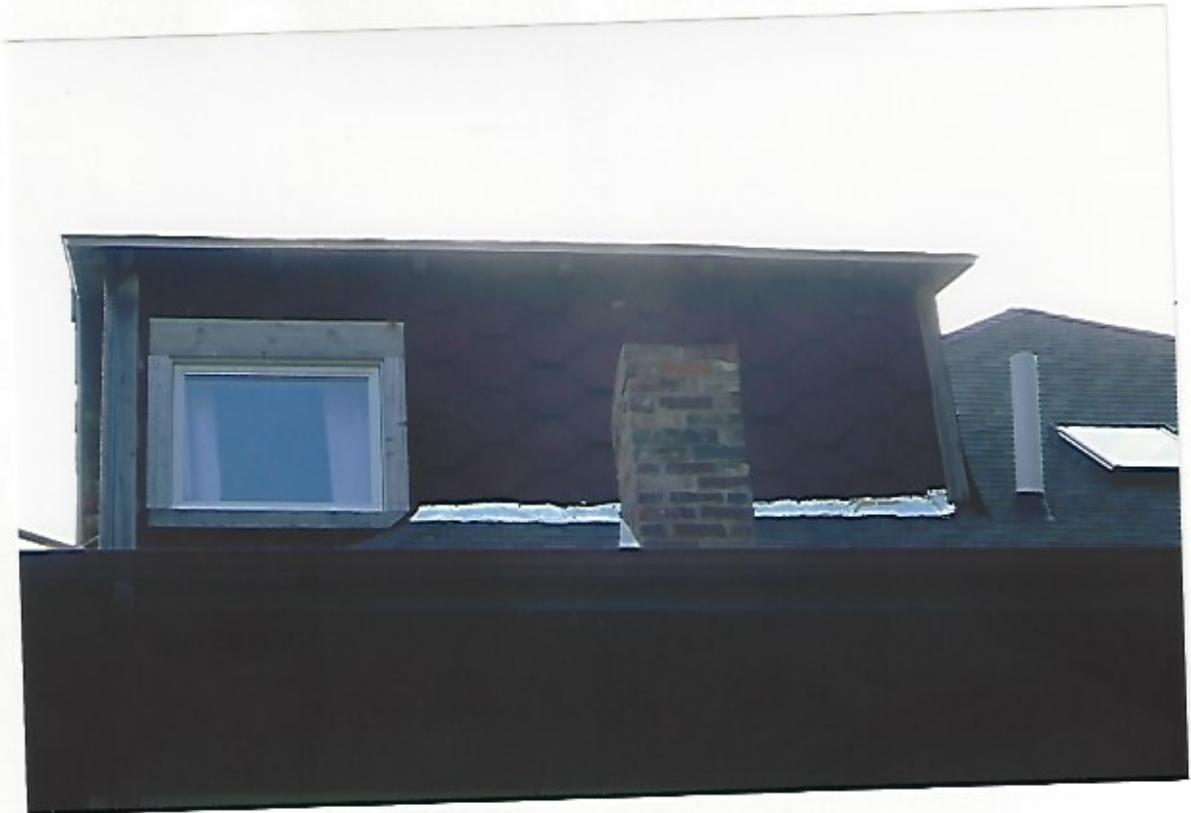
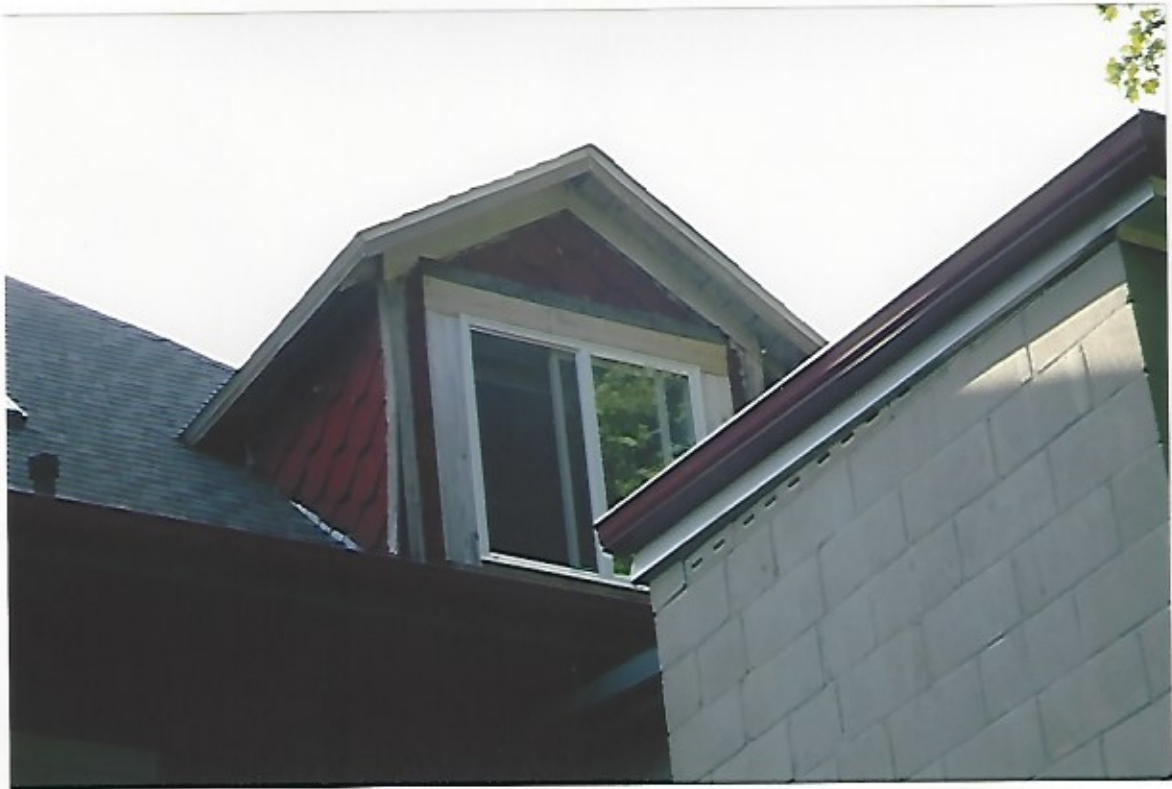
SIDING

4. The siding on the second floor in the back is in poor shape some is green and other is red all do not match the house. We would plan to put in vinyl siding to come close to matching the house color. See pictures.
