STAFF REPORT

CONCERNING APPLICATION FOR A CERTIFICATE OF APPROPRIATENESS

Application Number: 2018-1001A

Property Location: 760 Portage

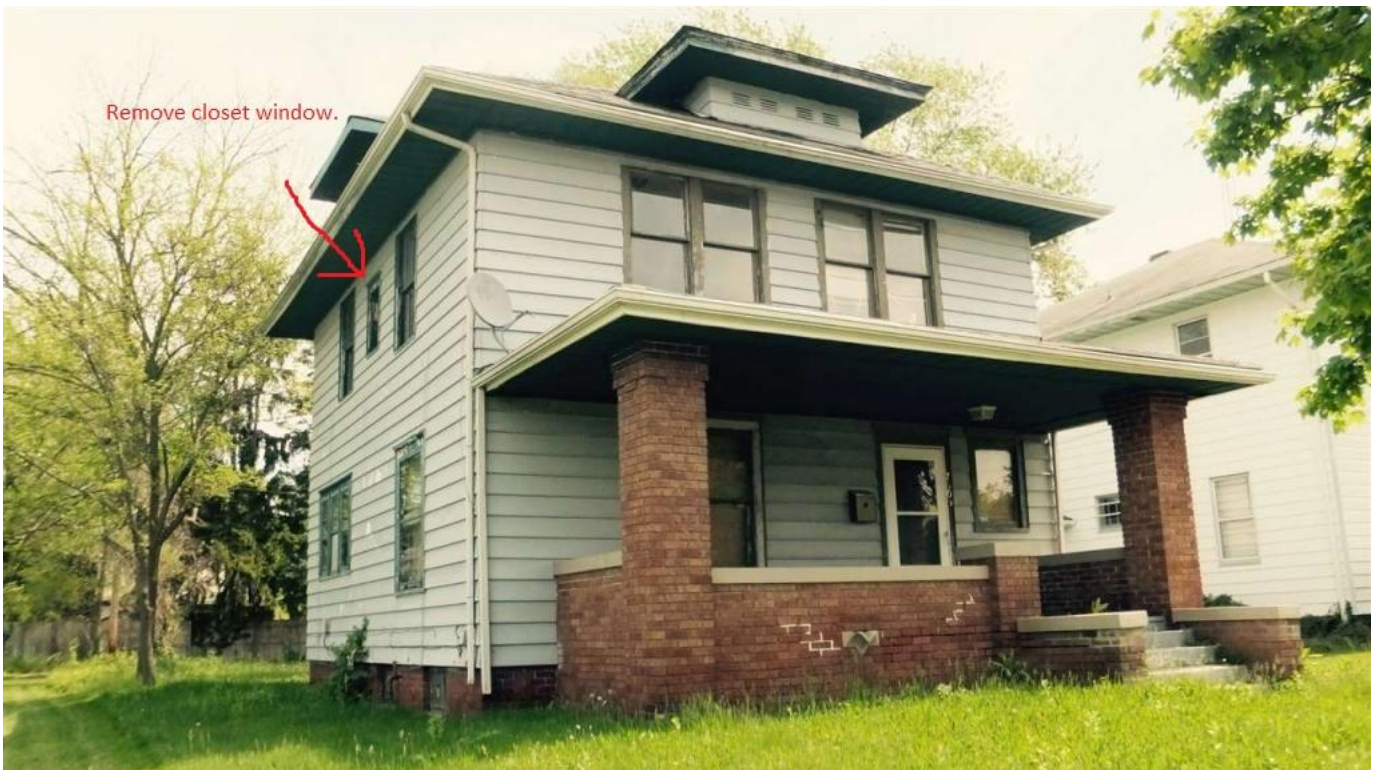
Figure 1 – 760 Portage, from sidewalk, looking north east. Window proposed for removal is visible at left.

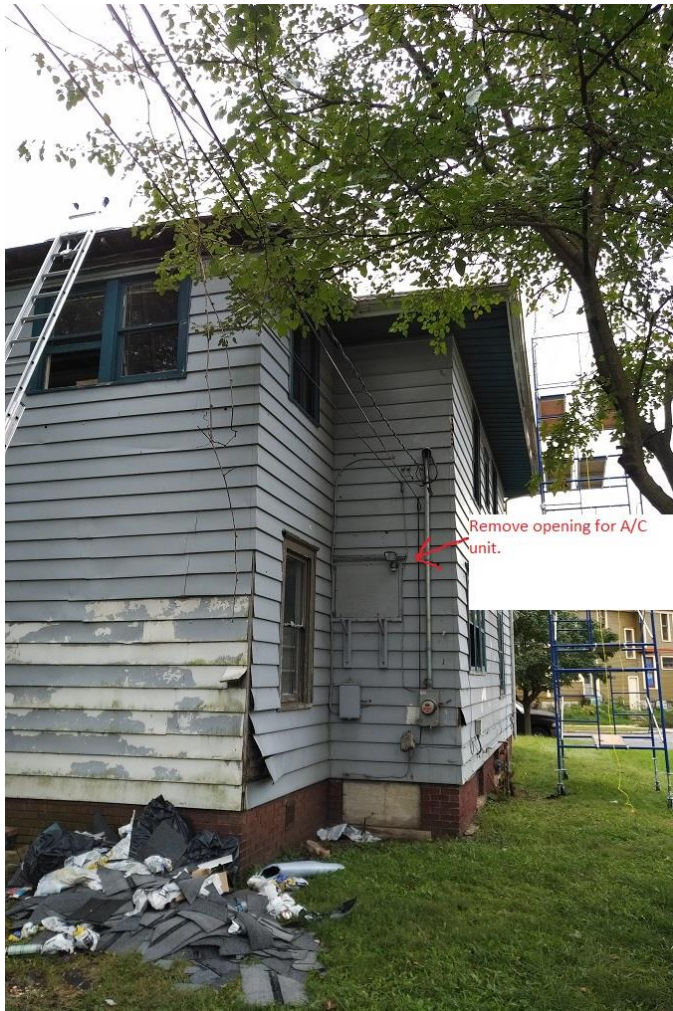
***Figure 2 – 760 Portage, looking south west.
Window proposed for removal is visible at center.***

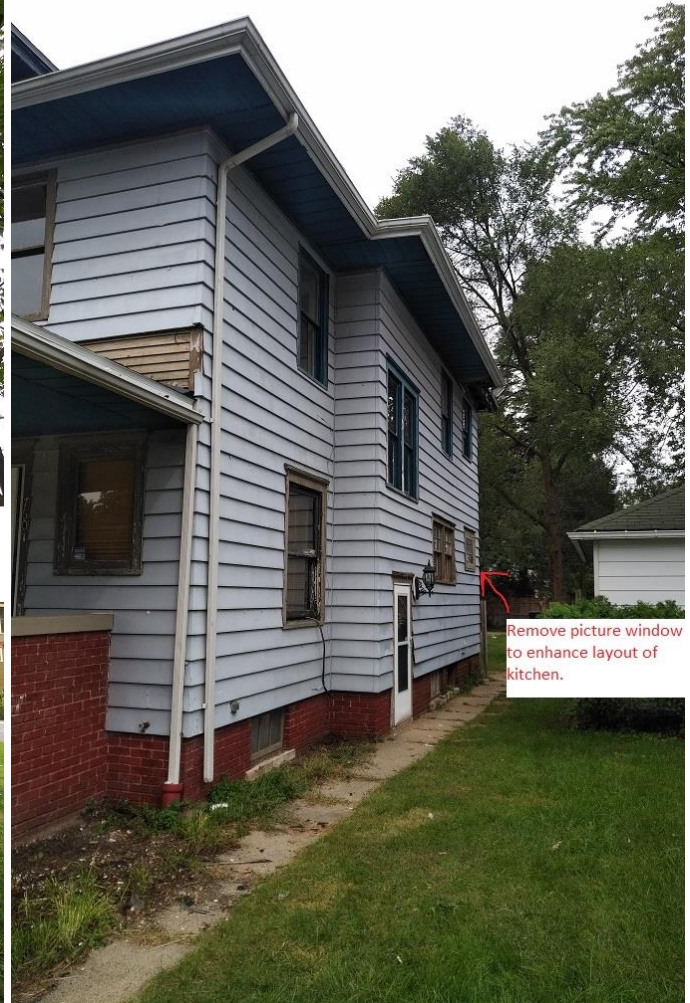
***Figure 3 – 760 Portage, looking north.
Window proposed for removal is visible at left.***

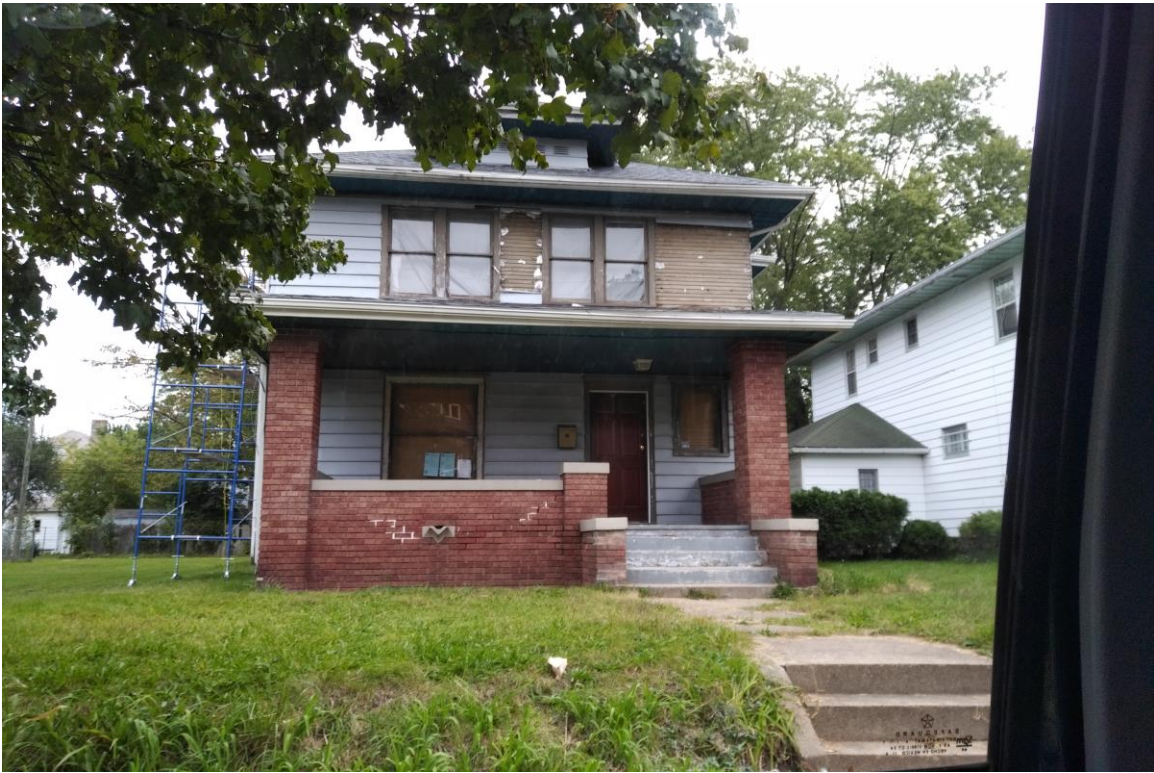
I also was able to view the structure on Monday, October 1, 2018 to view areas of the house where the owners had removed sections of the aluminum siding in order to determine the condition of the original clap board siding underneath. First thing I noticed was the amount of holes that were made to inject insulation. There are hundreds on each side without rhyme or reason and most without plugs. They are not lined up to floor levels as this technique is usually done. There is an infestation of yellow jackets in these holes. They have bedded in the cavities behind the siding via these holes especially in the northeast corner of the structure.

The siding outside of the holes has a different reveal on the lower half versus the upper half. Many of the corner boards should be replaced. The siding would need the paint scraped and repaired where needed, and there are several courses that I could see that would need replacement. I was told by the owner that the paint was lead based, but I did not test it myself to verify that statement. I do not have a percentage of siding that needs to be replaced, the owner will continue to remove more aluminum siding as that will have to happen no matter what the future plan. I would like to revisit the site after more aluminum is removed to get a more accurate reading of the state of the original siding.

Figure 4 – 760 Portage, front. Aluminum siding removal.

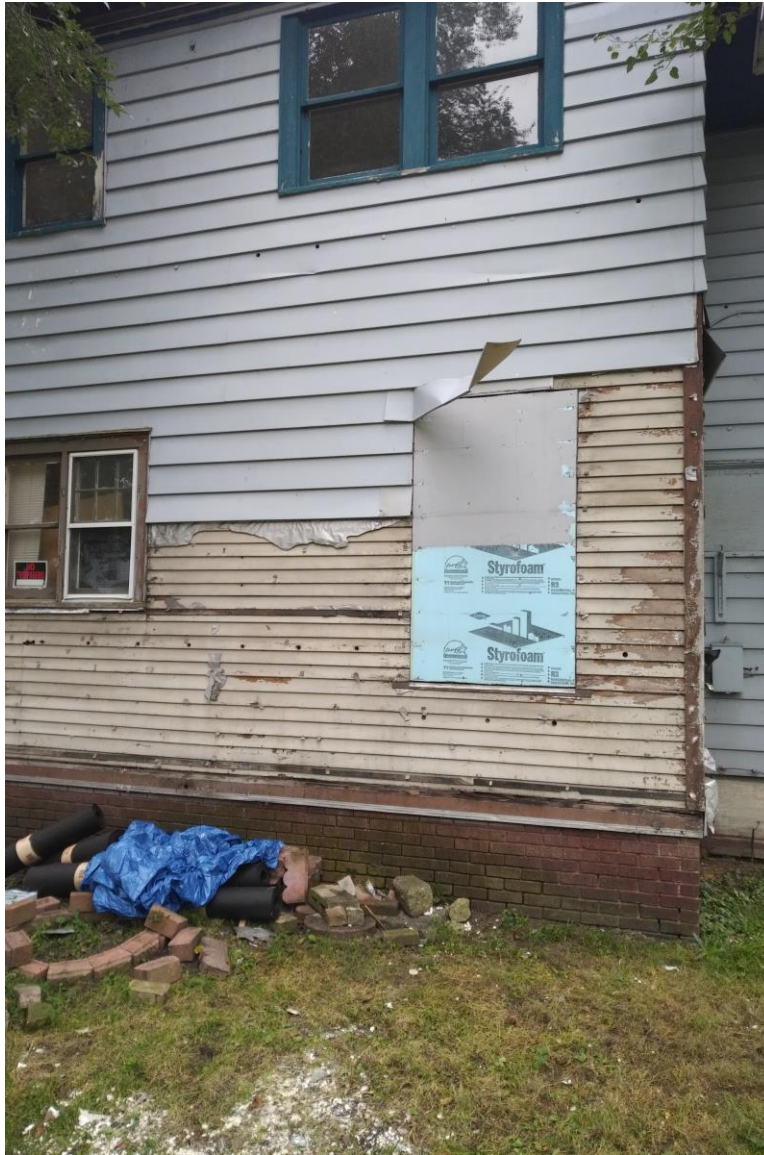
Figure 6 – 760 Portage, side. Aluminum siding removal.

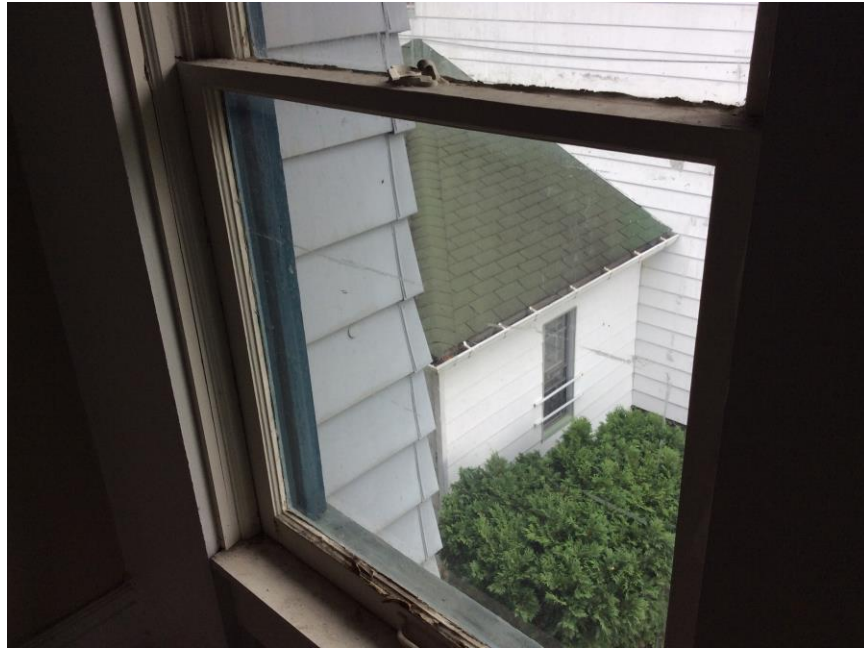
Figure 7 – 760 Portage. Existing window.

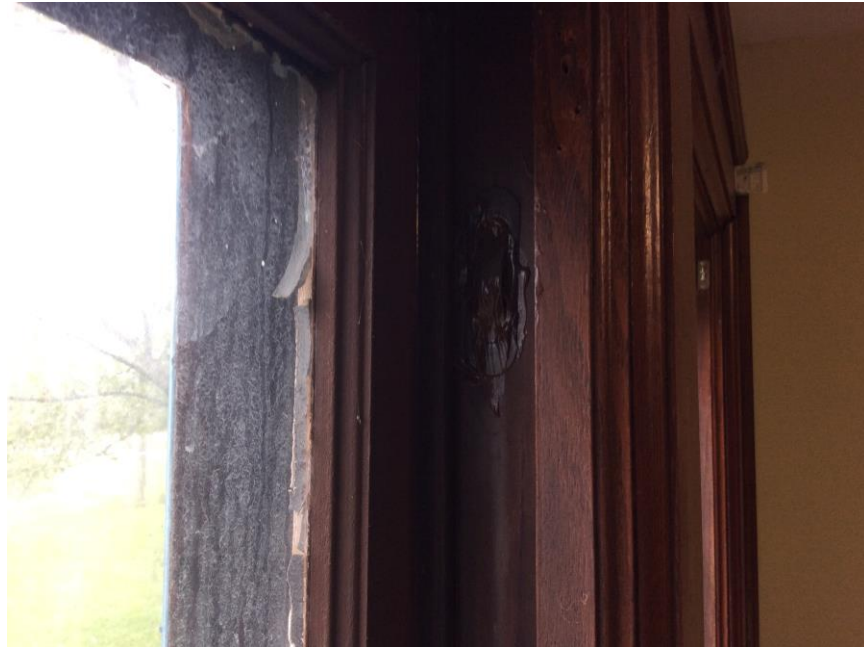
Figure 8 – 760 Portage. Existing window.

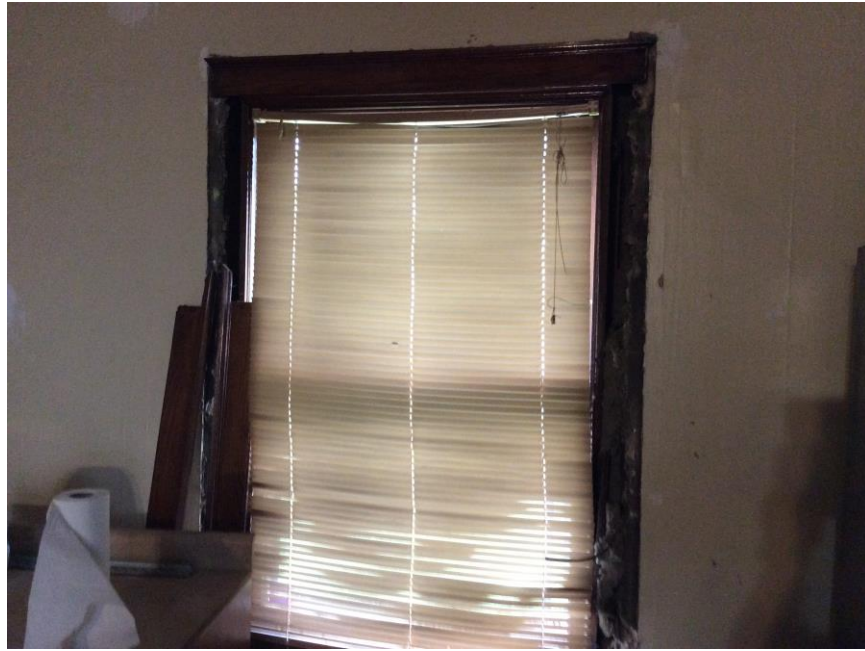
Figure 9 – 760 Portage. Existing window.

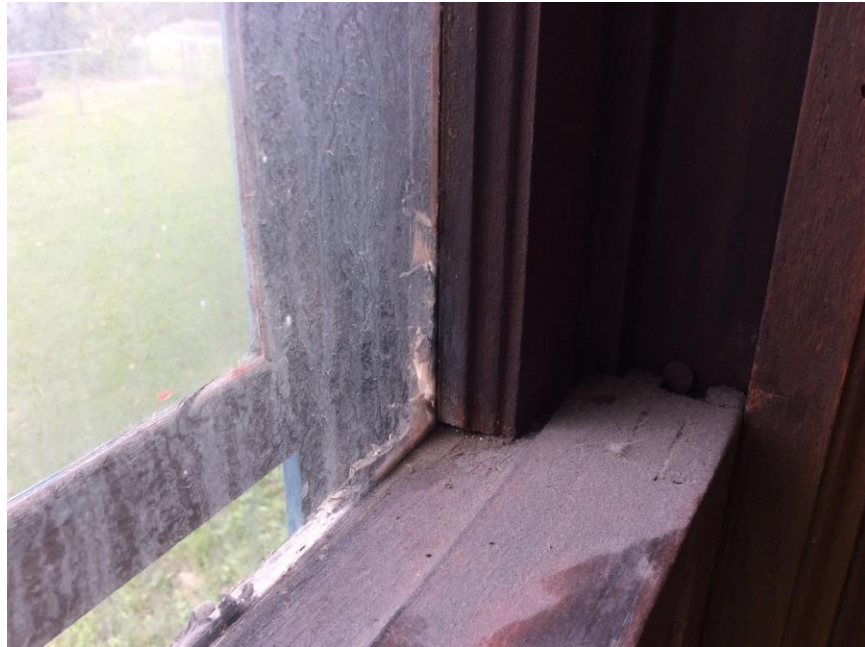
Figure 10 – 760 Portage. Existing window.
