# STAFF REPORT

## CONCERNING APPLICATION FOR A CERTIFICATE OF APPROPRIATENESS

**Application Number:** 2018-1113A

**Property Location:** 702 N St Joseph

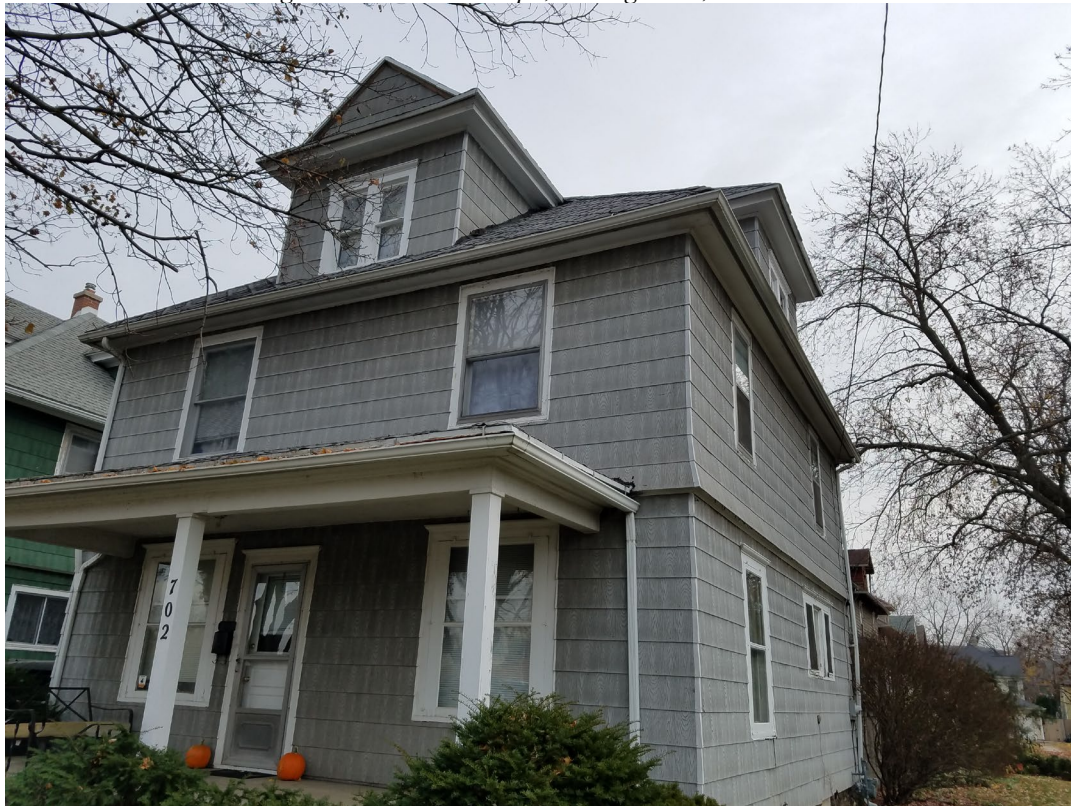
On November 12, 2018 I met with the owner of the property located at 702 N St. Joseph. She has applied to replace the windows located on the south-facing third floor dormer. I was unable to go inside the structure as the tenant works from home and did not want to be disturbed. I photographed the windows from the outside and was able to determine that the one of the four sashes would need to be replaced or be rebuilt. The meeting rail of the top sash is broken free. The other window has the sashes reversed meaning upper forced down and lower sash forced up. The sashes do not look to be in place.

*Figure 3 - 702 N St Joseph, taken on November 11th.*

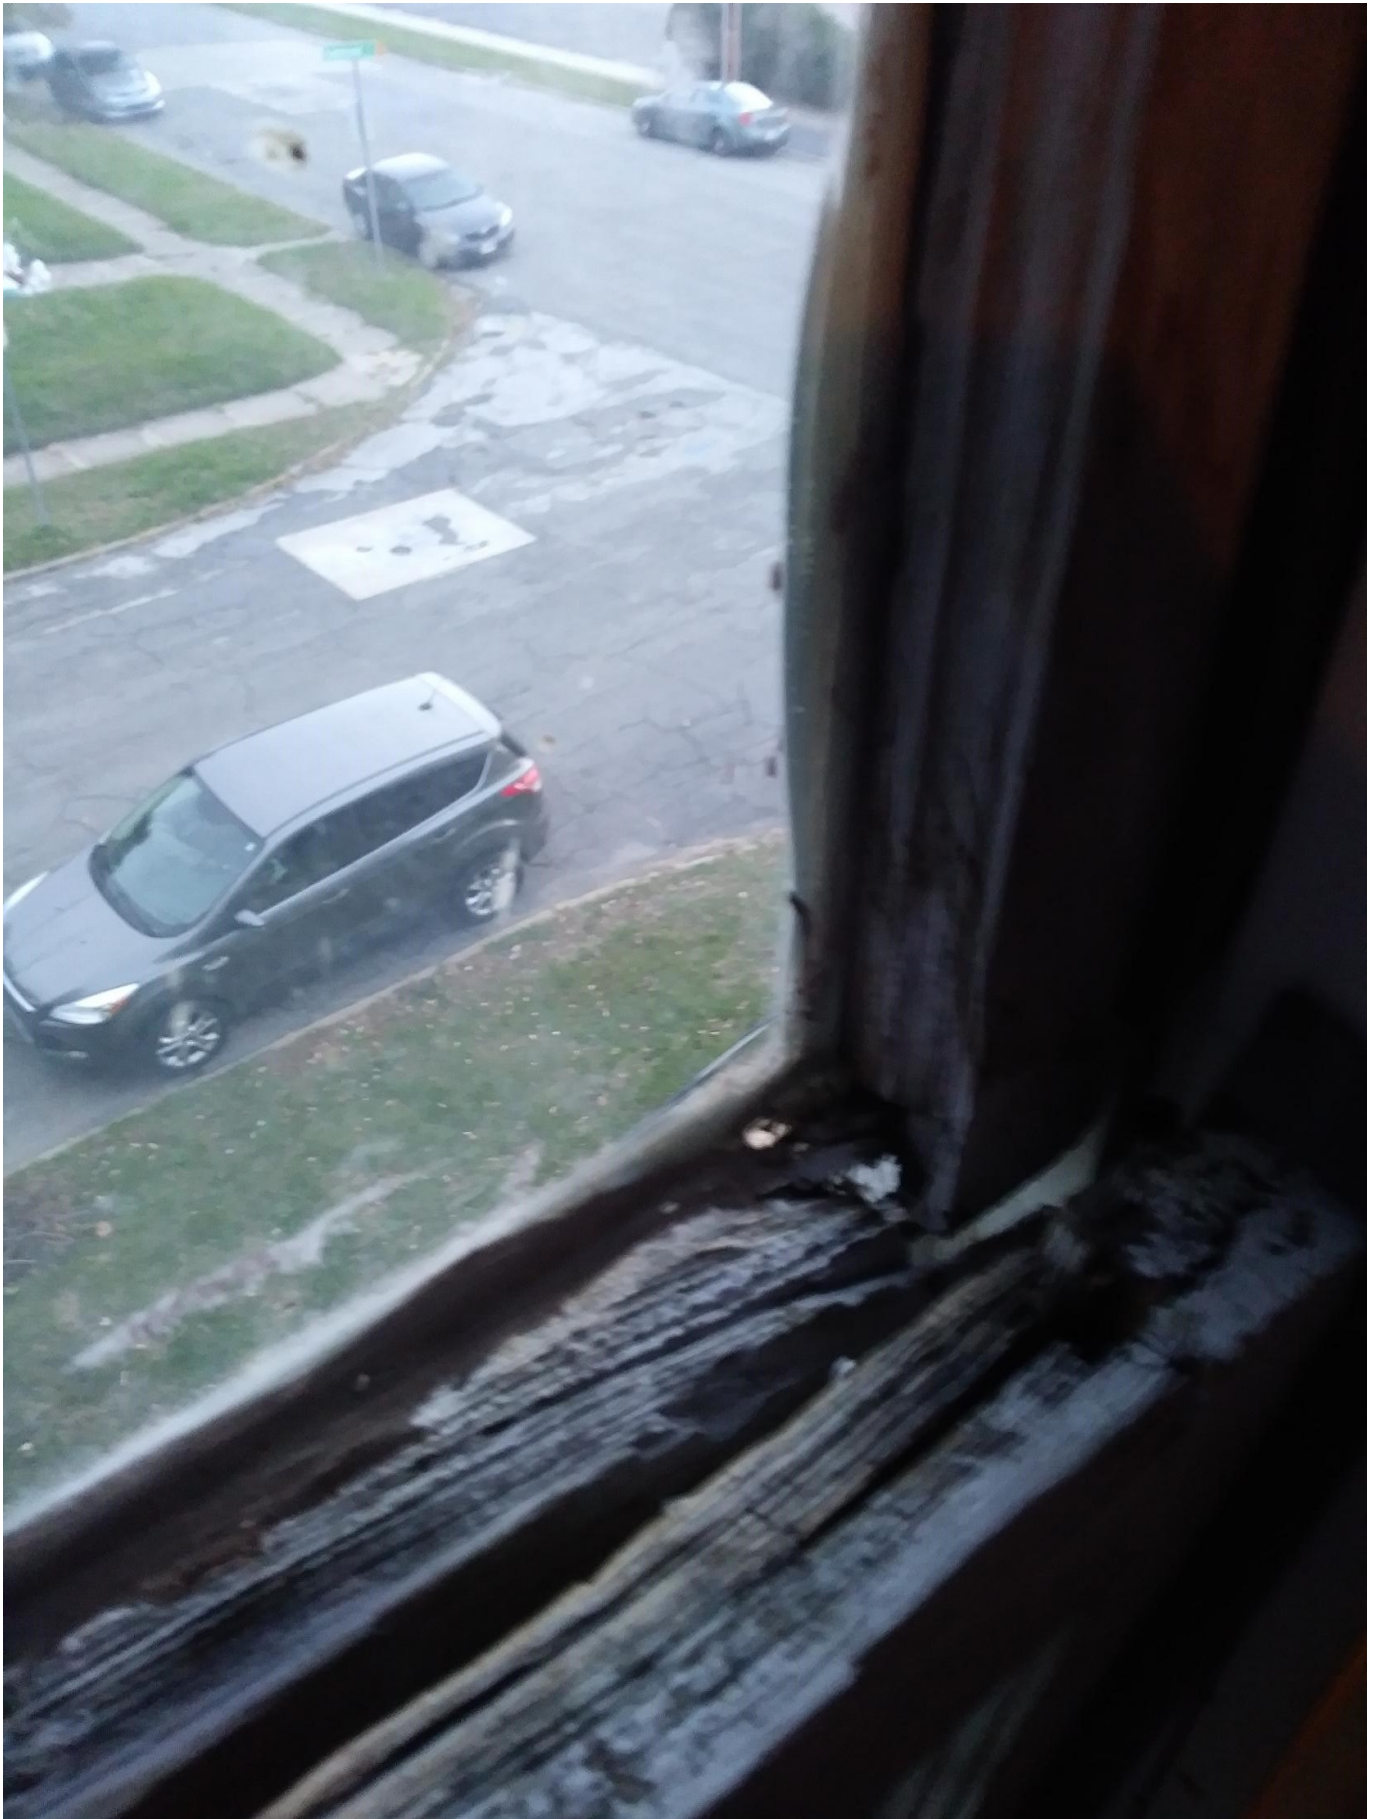
1. Removal of two (2) existing double-hung windows from the south attic dormer.
  - a. Windows are approximately 28" high by 10" wide,
  - b. Windows are extensively deteriorated, per photographs supplied by the applicant.
2. Replace with one (1) SEMCO brand aluminum-clad (wood core) window, approximately 28" x 28".
  - a. SEMCO (allegedly) does not manufacture windows of the size of the original windows.
  - b. The replacement window will fill the entire cavity of the previous windows.

**STAFF RECOMMENDATION:** Staff concedes that one of the sashes is extensively deteriorated. Replacement of the windows with an aluminum-clad window model is supported, although staff would prefer to see the original “two-window” format be replicated.

*Figure 4 - Applicant supplied image of the deteriorated sash.*

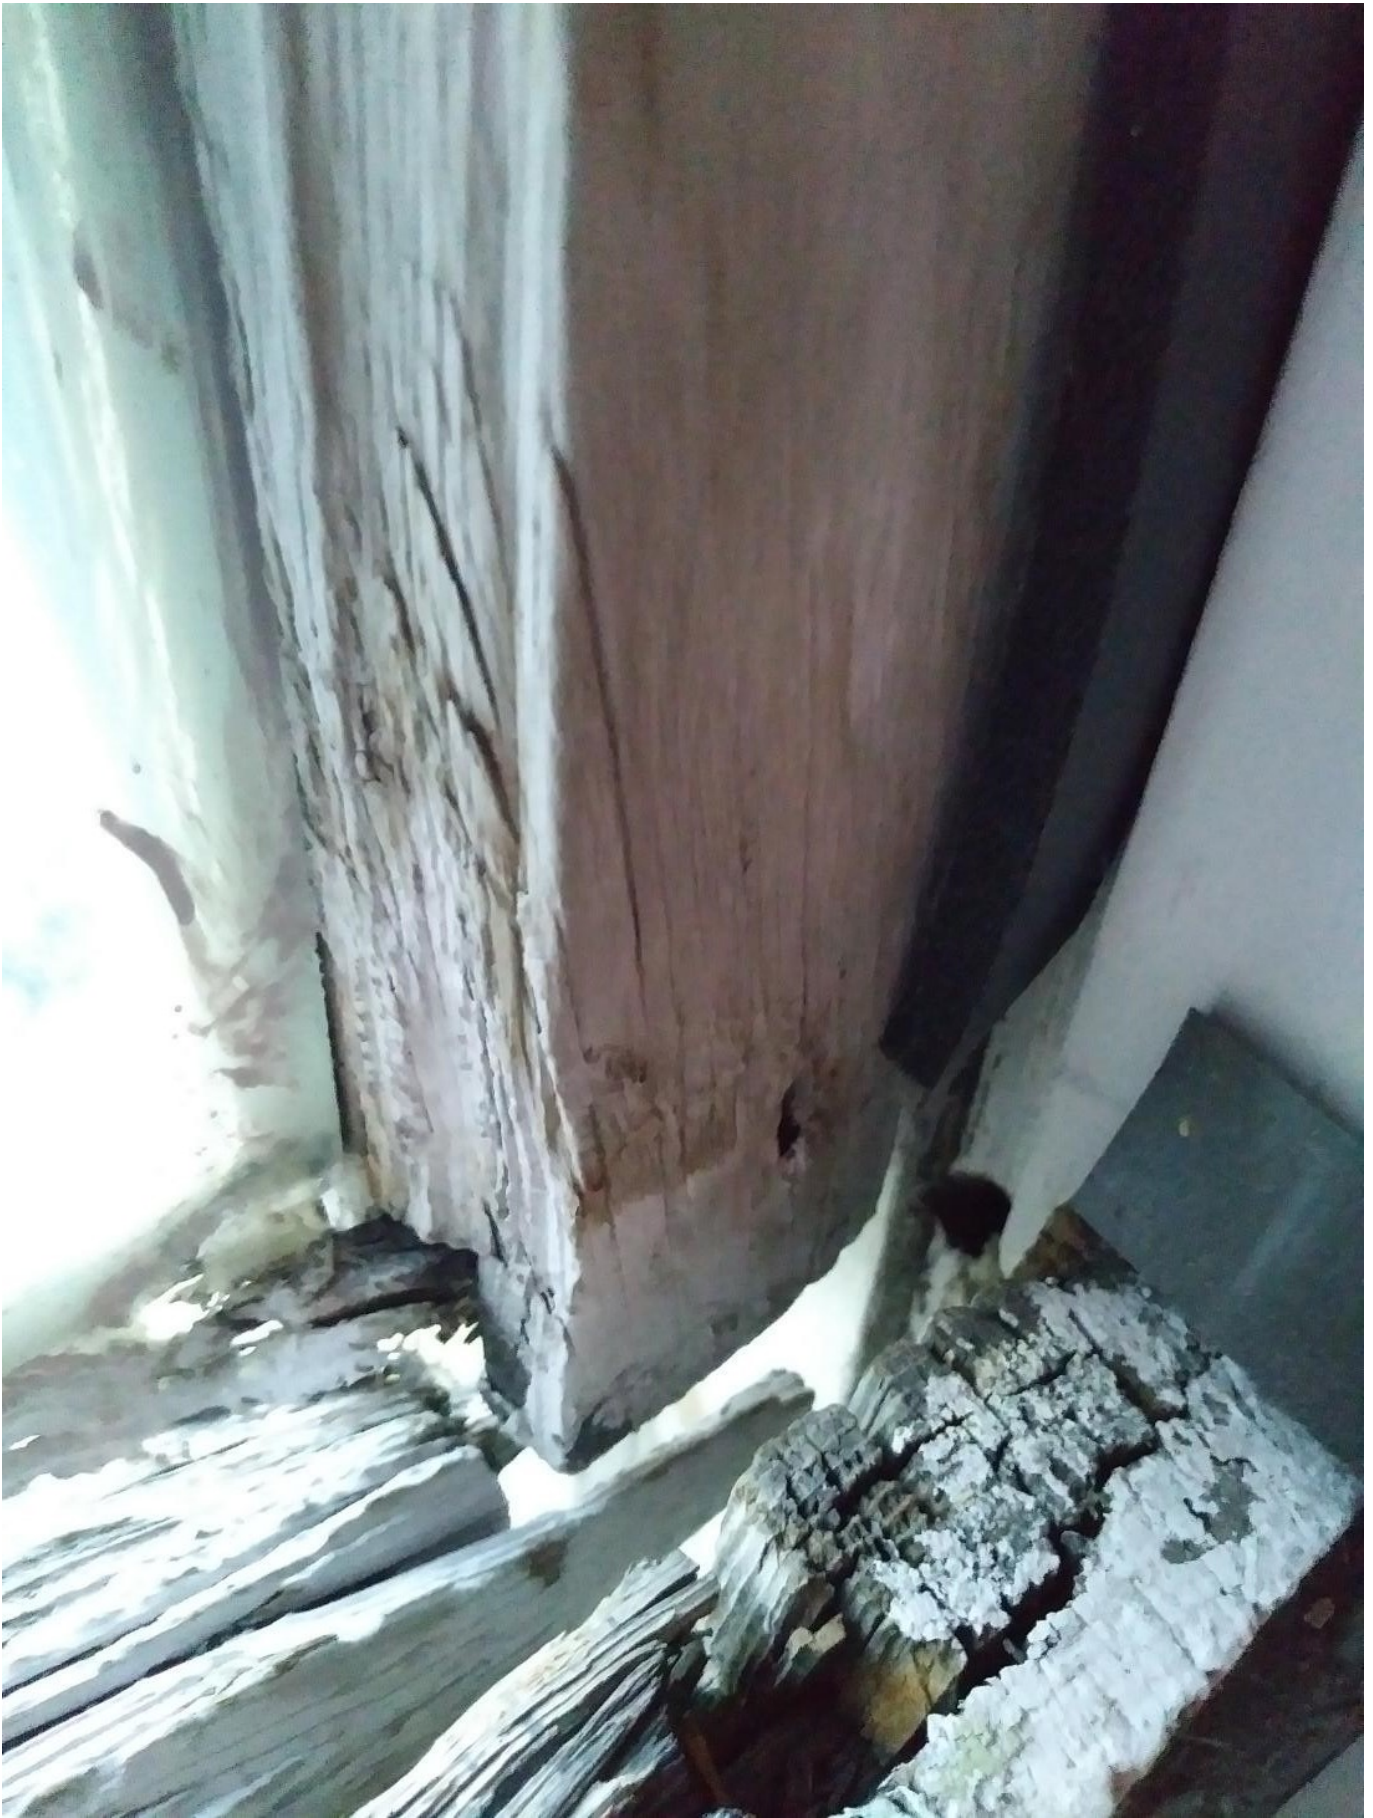
*Figure 5 - Applicant supplied image of the deteriorated sash.*

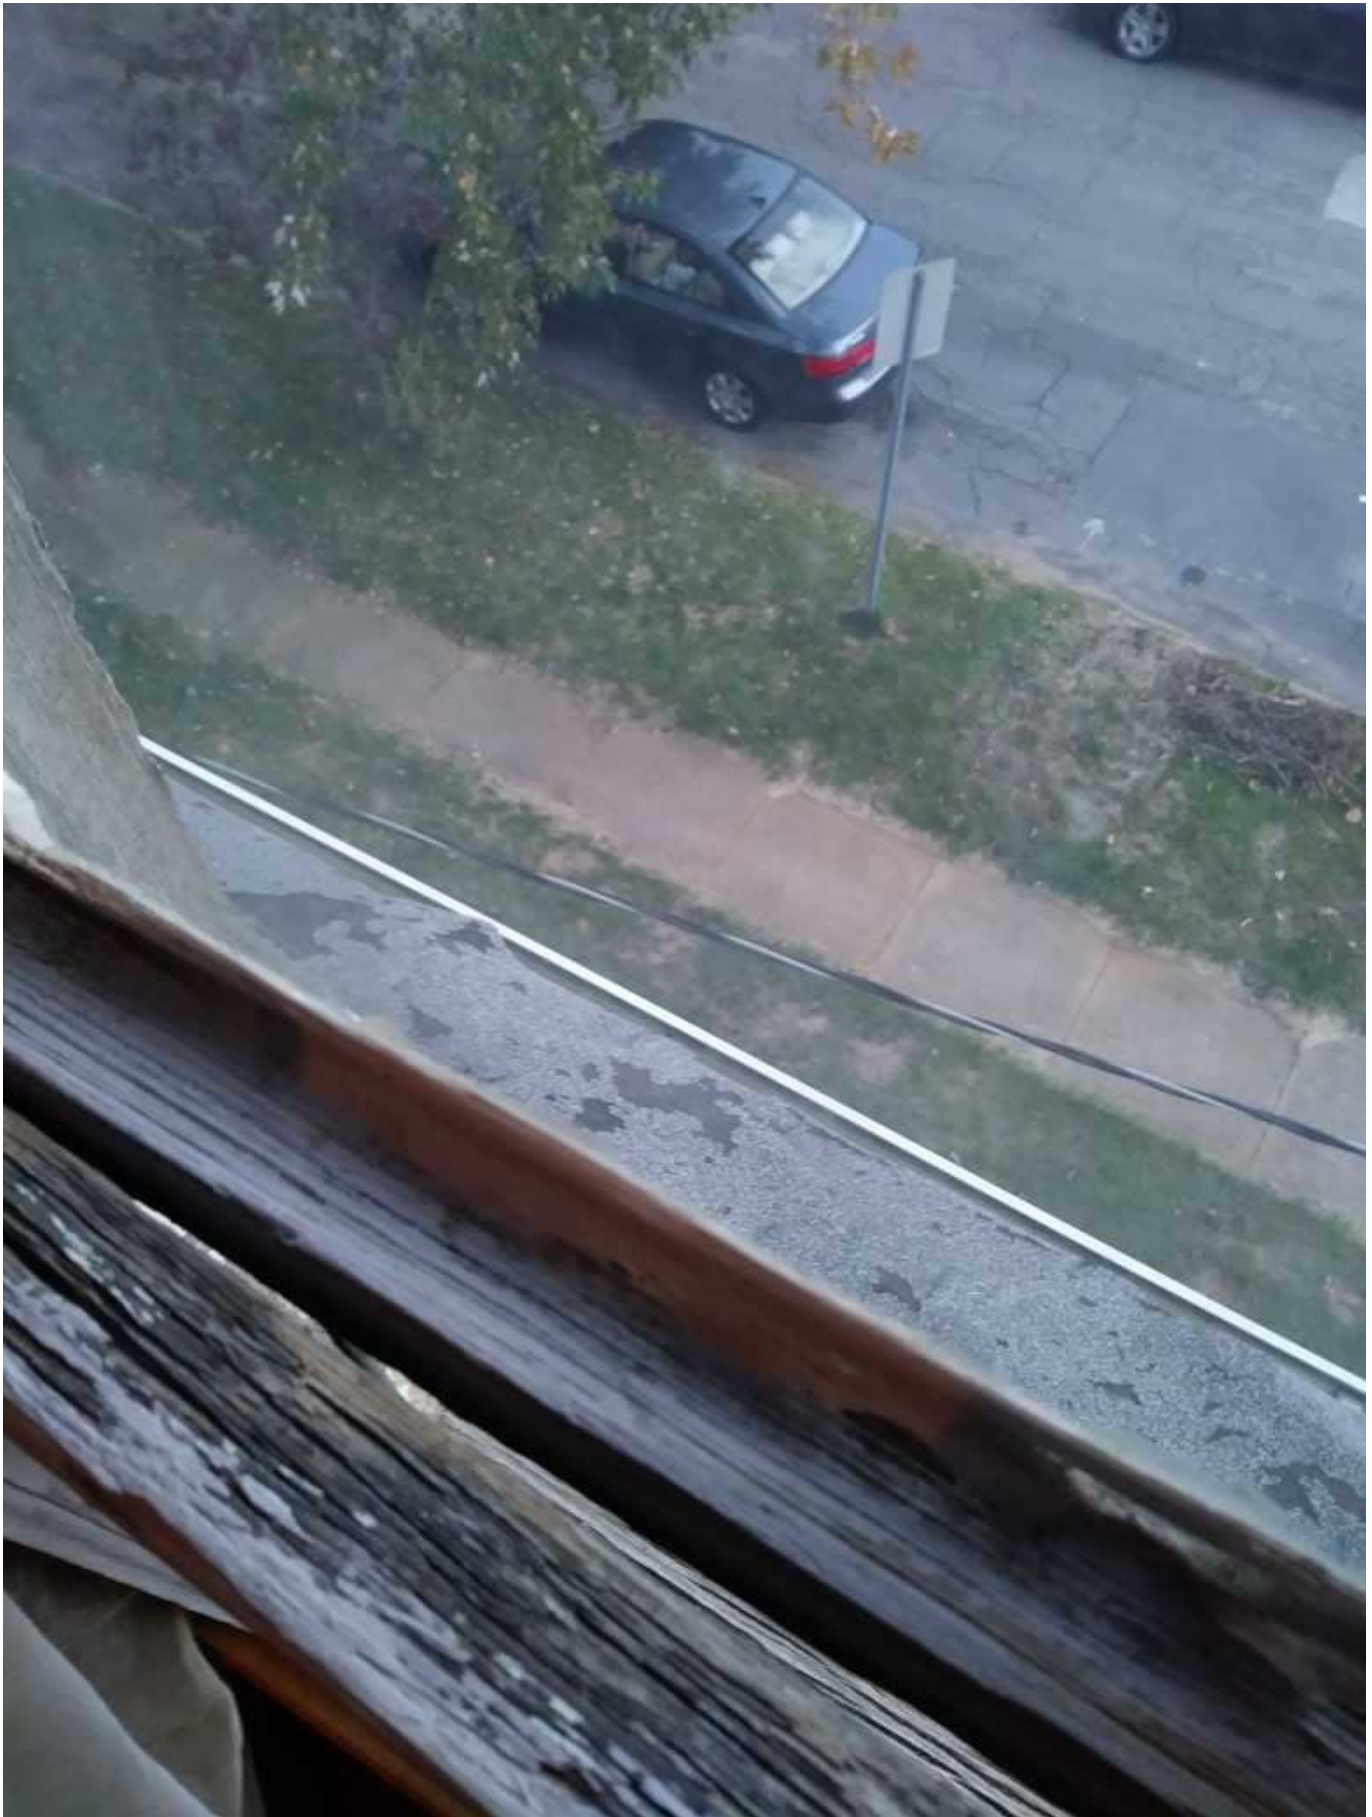
*Figure 6 - Applicant supplied image of the deteriorated sash.*
