STAFF REPORT

CONCERNING APPLICATION FOR A CERTIFICATE OF APPROPRIATENESS

Application Number: 2018-1001A EXTENTION

Property Location: 760 Portage

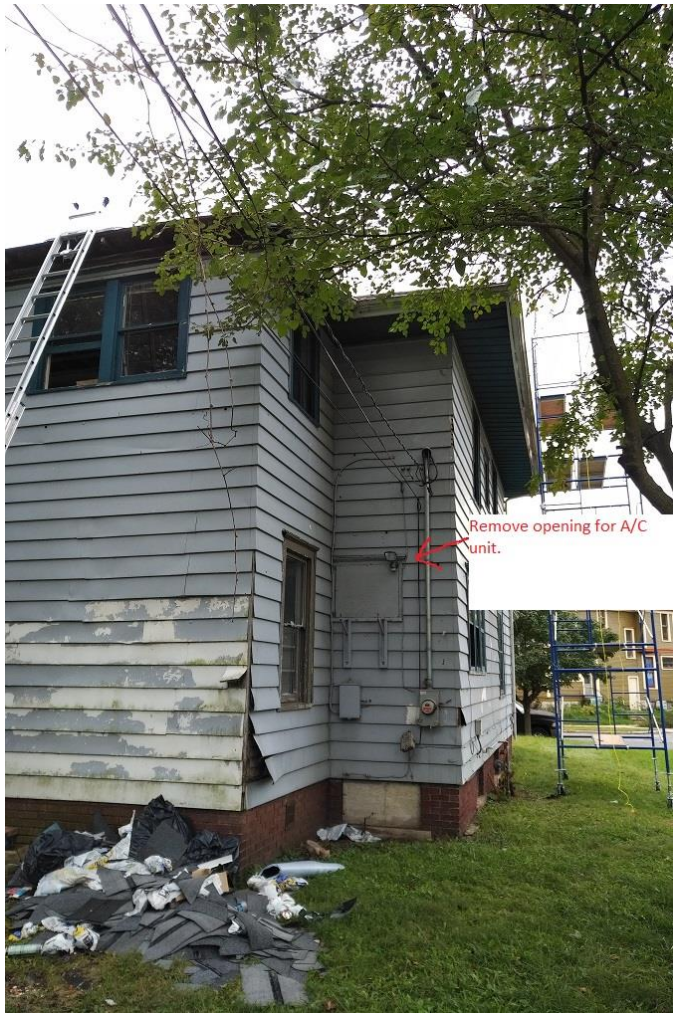
***Figure 2 – 760 Portage, looking south west.
Window proposed for removal is visible at center.***

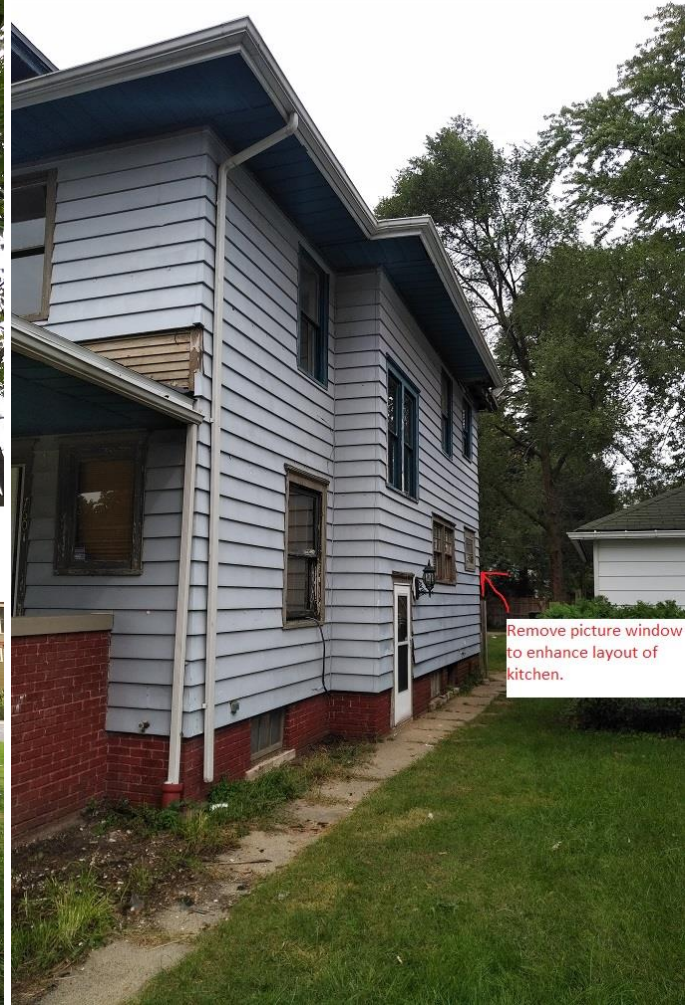
***Figure 3 – 760 Portage, looking north.
Window proposed for removal is visible at left.***
