**PHASE I ENVIRONMENTAL
SITE ASSESSMENT**

**Lafayette Building
115 South Lafayette Boulevard
South Bend, Indiana 46601**

January 18, 2018

Heartland Project Number 5200-17-11

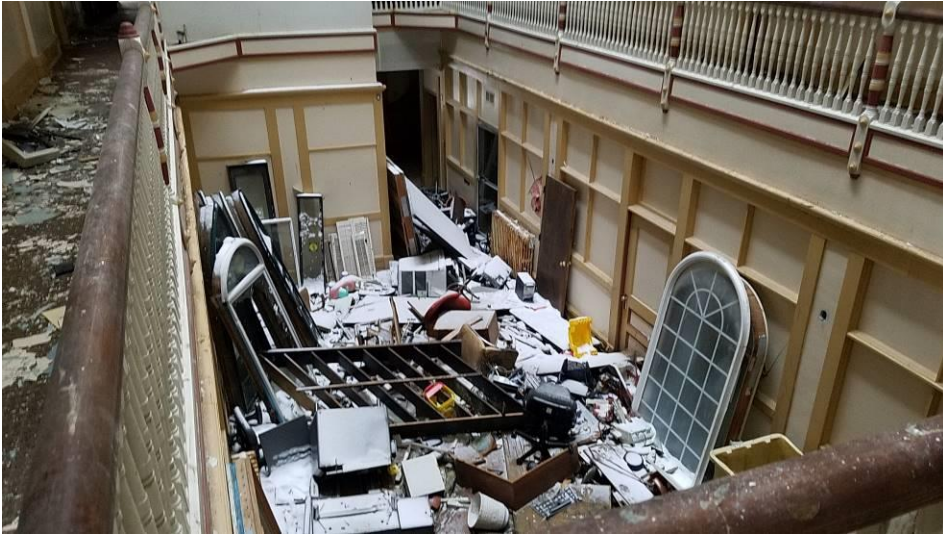
PHOTO: 2

CLIENT NAME: City of South Bend & South Bend Brownfields Coalition
DATE: December 14, 2017
LOCATION: Lafayette Building, 115 South Lafayette Boulevard in South Bend, Indiana
SUBJECT: View entryway of site building, looking down from second floor walkway
PHOTOGRAPHER: Nivas R. Vijay (Heartland)
PHOTO: 3

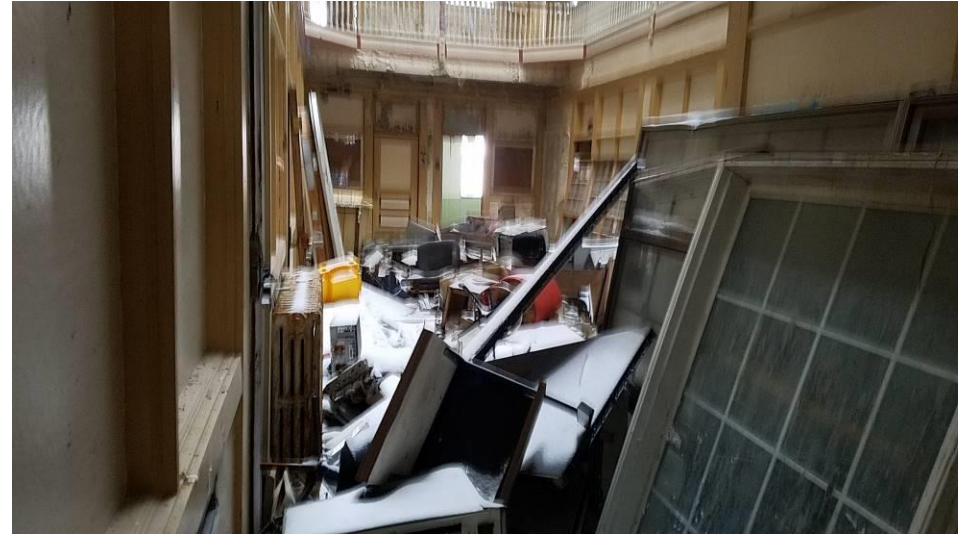
CLIENT NAME: City of South Bend & South Bend Brownfields Coalition
DATE: December 14, 2017
LOCATION: Lafayette Building, 115 South Lafayette Boulevard in South Bend, Indiana
SUBJECT: Close up view of strewn refuse and debris and entry way area of site building
PHOTOGRAPHER: Nivas R. Vijay (Heartland)
PHOTO: 4

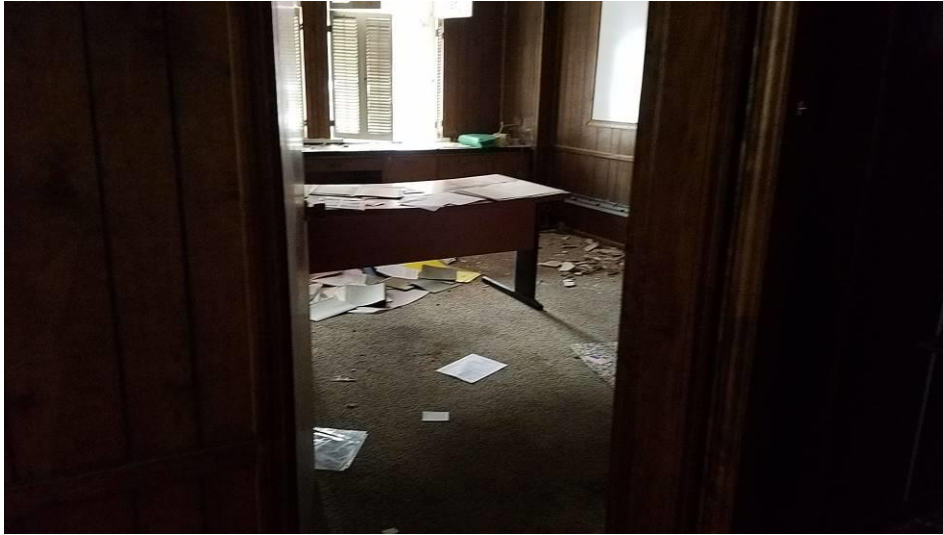
CLIENT NAME: City of South Bend & South Bend Brownfields Coalition
DATE: December 14, 2017
LOCATION: Lafayette Building, 115 South Lafayette Boulevard in South Bend, Indiana
SUBJECT: General view of vacant former office space in site building
PHOTOGRAPHER: Nivas R. Vijay (Heartland)
PHOTO: 5

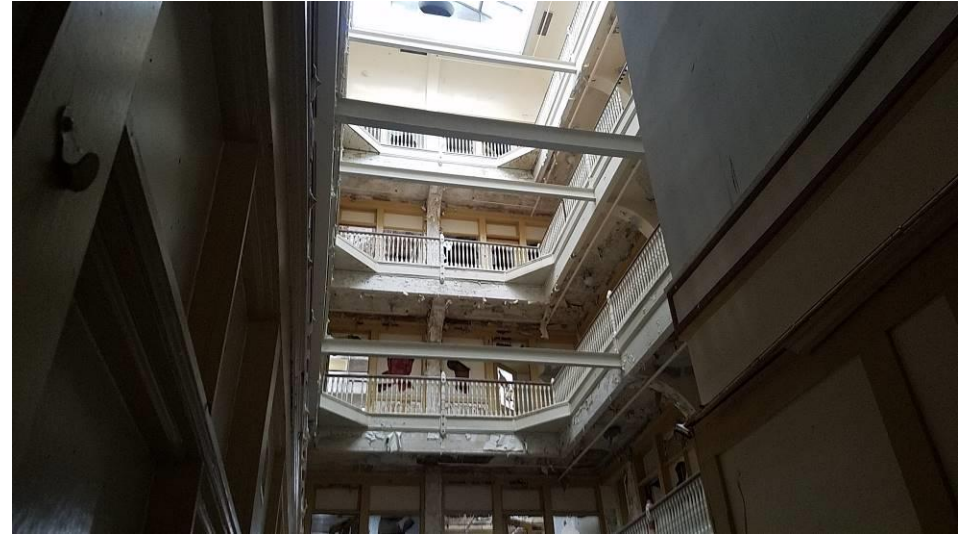
CLIENT NAME: City of South Bend & South Bend Brownfields Coalition
DATE: December 14, 2017
LOCATION: Lafayette Building, 115 South Lafayette Boulevard in South Bend, Indiana
SUBJECT: View looking up at floors of site building from entry way
PHOTOGRAPHER: Nivas R. Vijay (Heartland)
PHOTO: 6

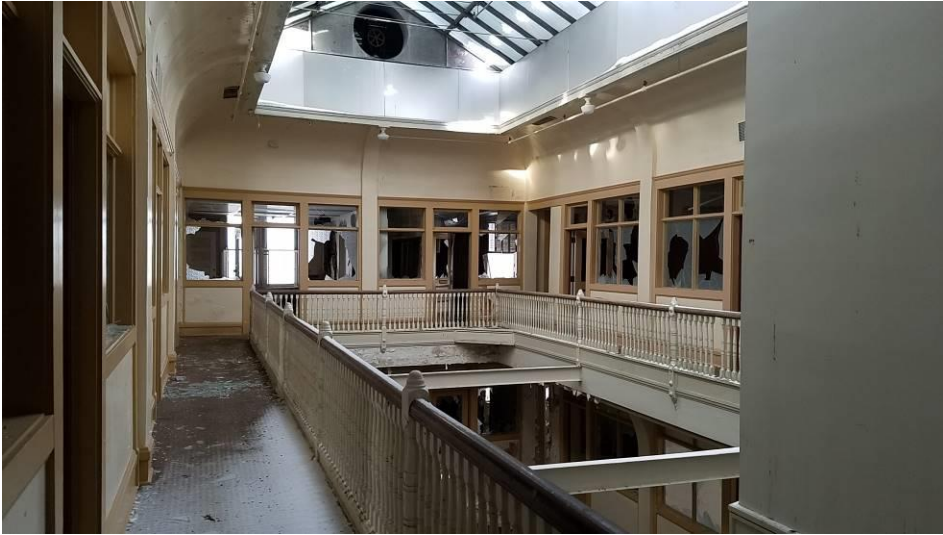
CLIENT NAME: City of South Bend & South Bend Brownfields Coalition
DATE: December 14, 2017
LOCATION: Lafayette Building, 115 South Lafayette Boulevard in South Bend, Indiana
SUBJECT: View of second floor offices and walkway area
PHOTOGRAPHER: Nivas R. Vijay (Heartland)
PHOTO: 7

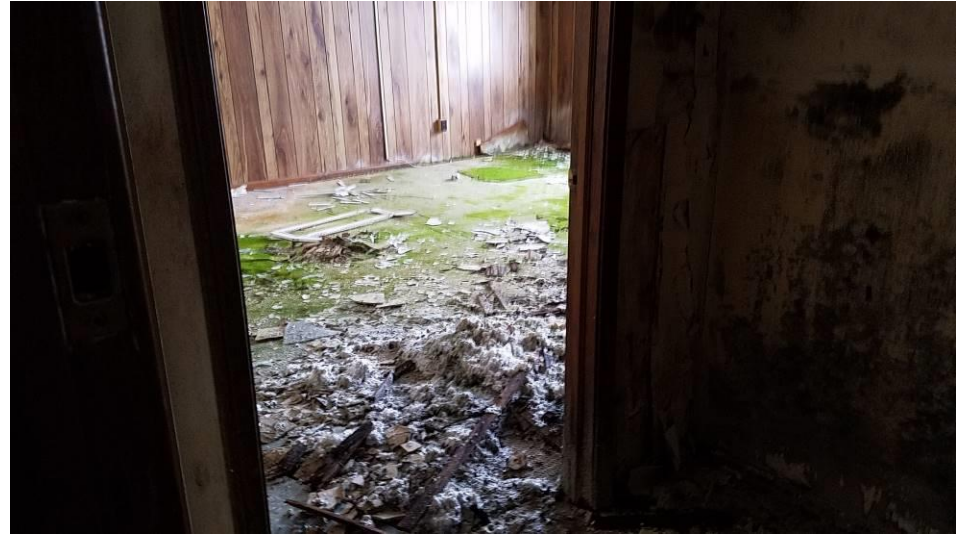
CLIENT NAME: City of South Bend & South Bend Brownfields Coalition
DATE: December 14, 2017
LOCATION: Lafayette Building, 115 South Lafayette Boulevard in South Bend, Indiana
SUBJECT: View of water damaged office area on third floor of site building
PHOTOGRAPHER: Nivas R. Vijay (Heartland)
PHOTO: 8

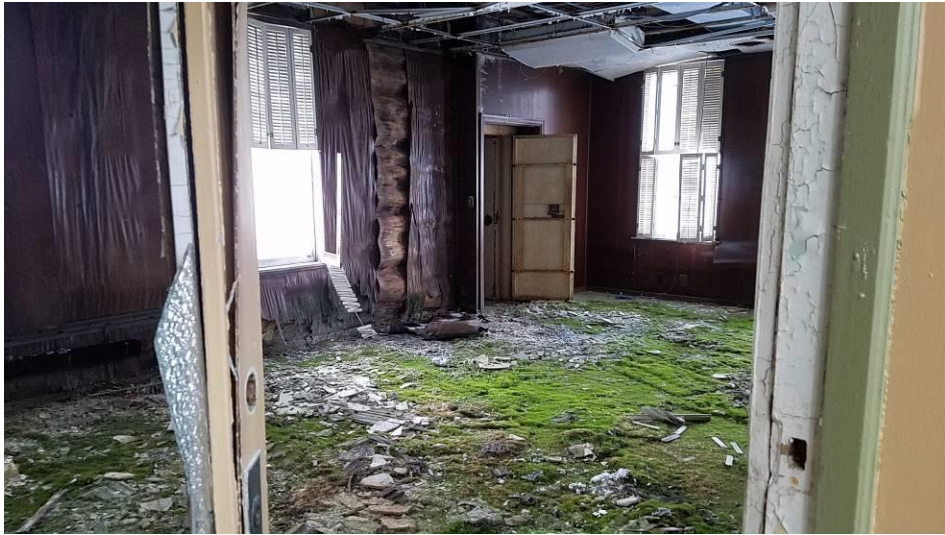
CLIENT NAME: City of South Bend & South Bend Brownfields Coalition
DATE: December 14, 2017
LOCATION: Lafayette Building, 115 South Lafayette Boulevard in South Bend, Indiana
SUBJECT: View of water damaged office area on third floor of site building
PHOTOGRAPHER: Nivas R. Vijay (Heartland)
PHOTO: 9

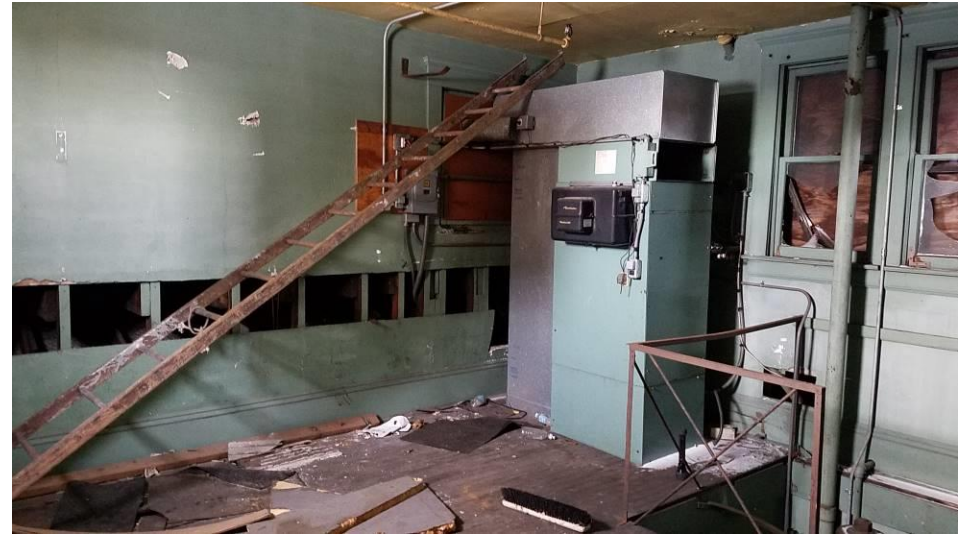
CLIENT NAME: City of South Bend & South Bend Brownfields Coalition
DATE: December 14, 2017
LOCATION: Lafayette Building, 115 South Lafayette Boulevard in South Bend, Indiana
SUBJECT: View of roof access area maintenance/HVAC equipment on top story of site building
PHOTOGRAPHER: Nivas R. Vijay (Heartland)
PHOTO: 10

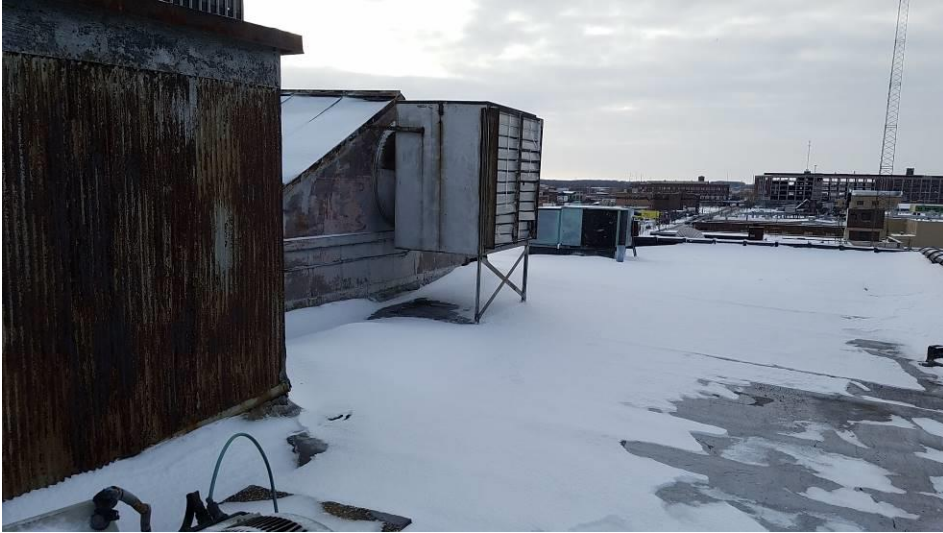
CLIENT NAME: City of South Bend & South Bend Brownfields Coalition
DATE: December 14, 2017
LOCATION: Lafayette Building, 115 South Lafayette Boulevard in South Bend, Indiana
SUBJECT: View of rooftop of site building
PHOTOGRAPHER: Nivas R. Vijay (Heartland)
PHOTO: 11

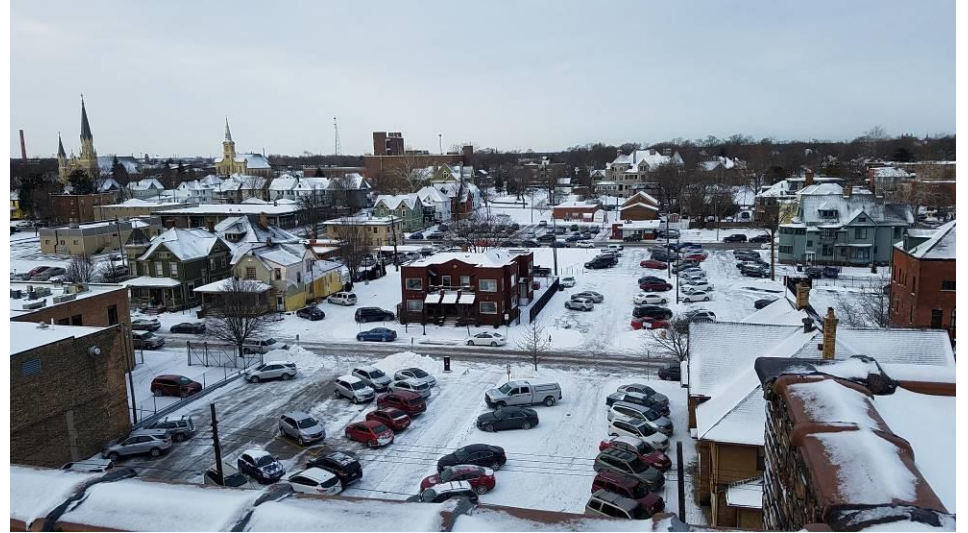
CLIENT NAME: City of South Bend & South Bend Brownfields Coalition
DATE: December 14, 2017
LOCATION: Lafayette Building, 115 South Lafayette Boulevard in South Bend, Indiana
SUBJECT: View of surrounding downtown area of South Bend, Indiana, looking west from site building rooftop
PHOTOGRAPHER: Nivas R. Vijay (Heartland)
PHOTO: 12

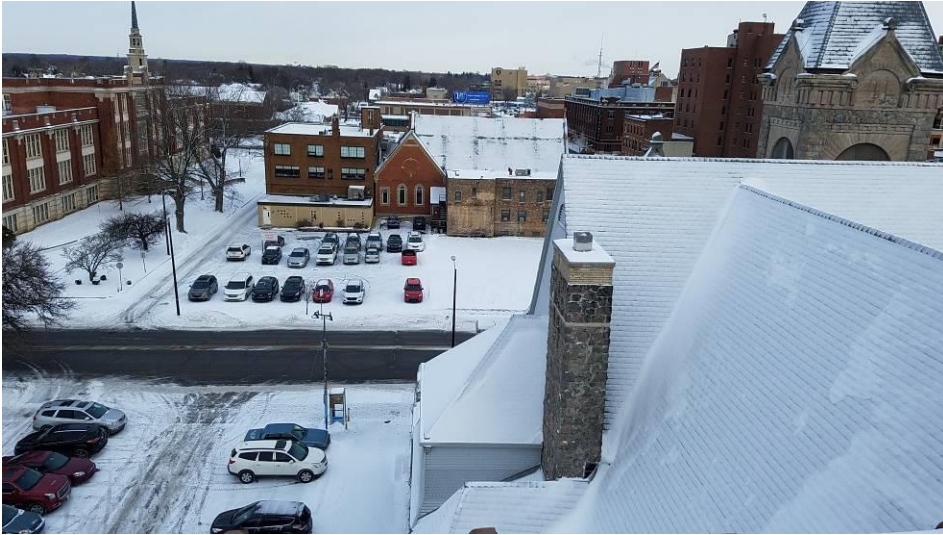
CLIENT NAME: City of South Bend & South Bend Brownfields Coalition
DATE: December 14, 2017
LOCATION: Lafayette Building, 115 South Lafayette Boulevard in South Bend, Indiana
SUBJECT: View of surrounding downtown area of South Bend, Indiana, looking north from site building rooftop
PHOTOGRAPHER: Nivas R. Vijay (Heartland)
PHOTO: 13

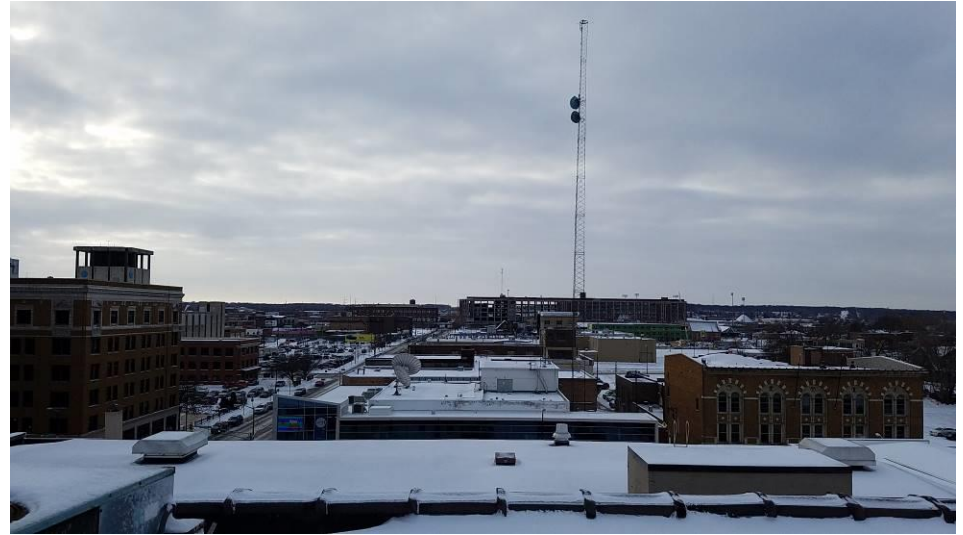
CLIENT NAME: City of South Bend & South Bend Brownfields Coalition
DATE: December 14, 2017
LOCATION: Lafayette Building, 115 South Lafayette Boulevard in South Bend, Indiana
SUBJECT: View of surrounding downtown area of South Bend, Indiana, looking east from site building rooftop
PHOTOGRAPHER: Nivas R. Vijay (Heartland)
PHOTO: 14

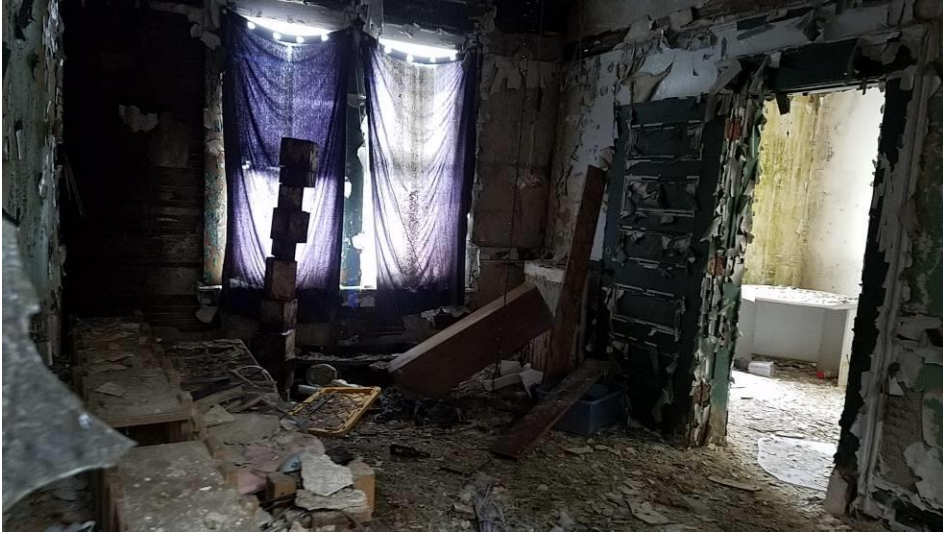
CLIENT NAME: City of South Bend & South Bend Brownfields Coalition
DATE: December 14, 2017
LOCATION: Lafayette Building, 115 South Lafayette Boulevard in South Bend, Indiana
SUBJECT: View of fire and water damaged office on fourth floor of site building
PHOTOGRAPHER: Nivas R. Vijay (Heartland)
PHOTO: 15

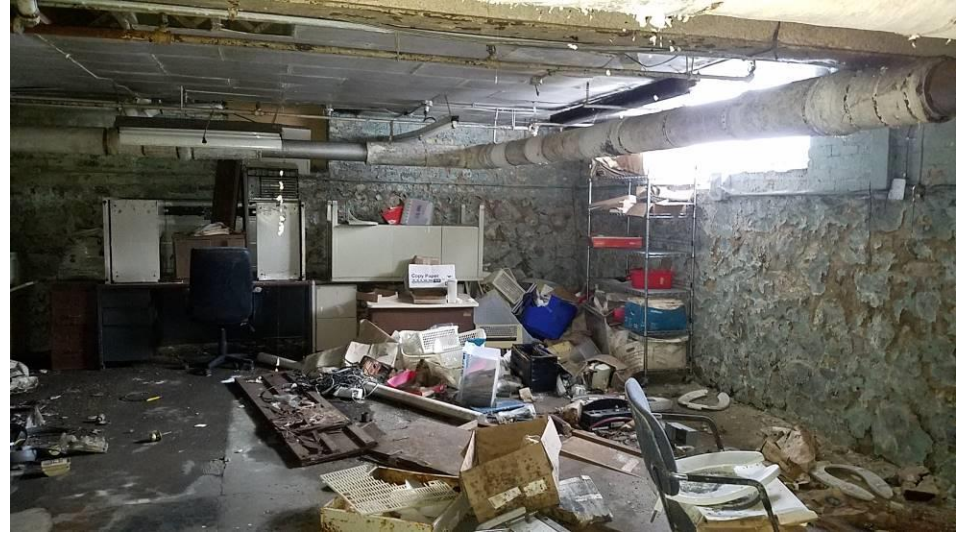
CLIENT NAME: City of South Bend & South Bend Brownfields Coalition
DATE: December 14, 2017
LOCATION: Lafayette Building, 115 South Lafayette Boulevard in South Bend, Indiana
SUBJECT: View of storage room in basement of site building. Note asbestos containing pipe wrapping on ceiling pipe chase
PHOTOGRAPHER: Nivas R. Vijay (Heartland)
PHOTO: 16

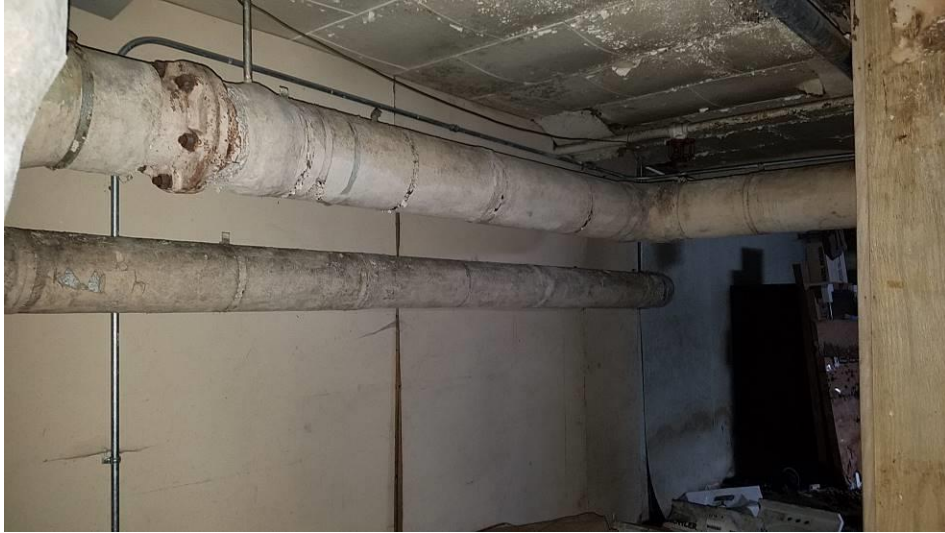
CLIENT NAME: City of South Bend & South Bend Brownfields Coalition
DATE: December 14, 2017
LOCATION: Lafayette Building, 115 South Lafayette Boulevard in South Bend, Indiana
SUBJECT: Close up view of asbestos containing pipe wrapping in basement of site building
PHOTOGRAPHER: Nivas R. Vijay (Heartland)
PHOTO: 17

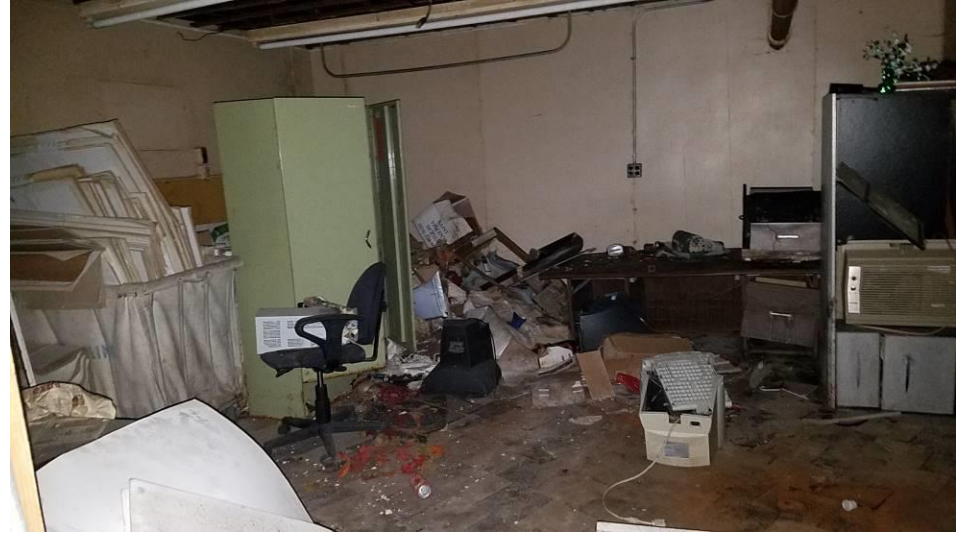
CLIENT NAME: City of South Bend & South Bend Brownfields Coalition
DATE: December 14, 2017
LOCATION: Lafayette Building, 115 South Lafayette Boulevard in South Bend, Indiana
SUBJECT: View of storage room in basement of site building
PHOTOGRAPHER: Nivas R. Vijay (Heartland)
PHOTO: 18

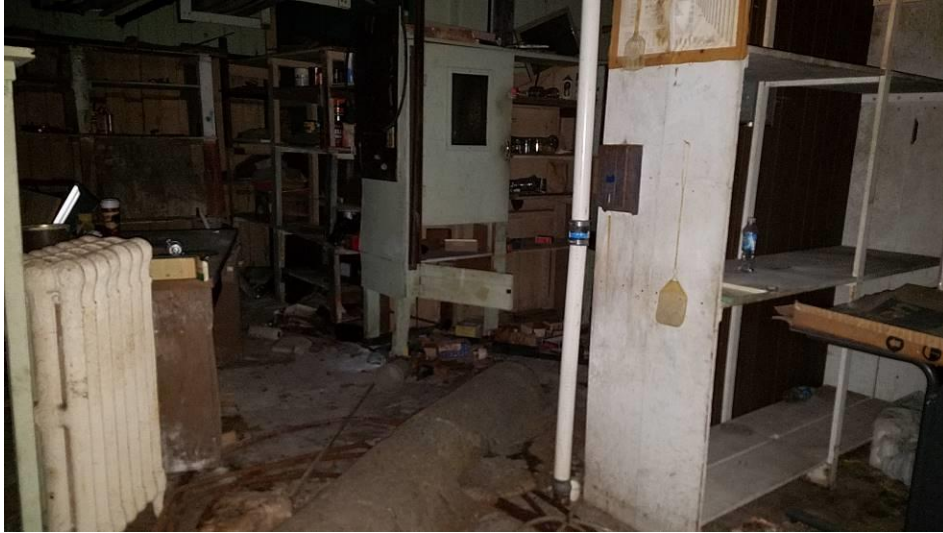
CLIENT NAME: City of South Bend & South Bend Brownfields Coalition
DATE: December 14, 2017
LOCATION: Lafayette Building, 115 South Lafayette Boulevard in South Bend, Indiana
SUBJECT: View of storage room and maintenance area in basement of site building
PHOTOGRAPHER: Nivas R. Vijay (Heartland)
PHOTO: 19

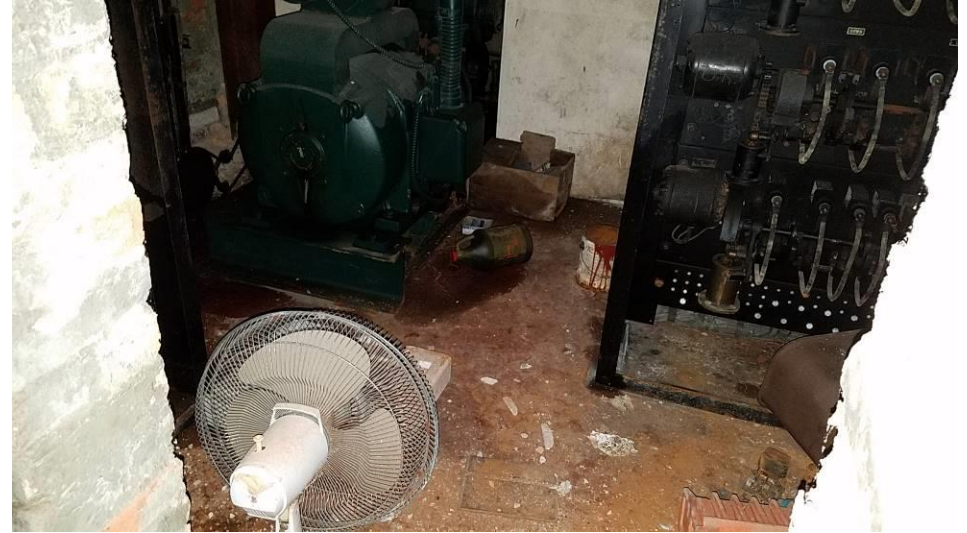
CLIENT NAME: City of South Bend & South Bend Brownfields Coalition
DATE: December 14, 2017
LOCATION: Lafayette Building, 115 South Lafayette Boulevard in South Bend, Indiana
SUBJECT: View of motor room with stained concrete in basement of site building
PHOTOGRAPHER: Nivas R. Vijay (Heartland)
PHOTO: 20

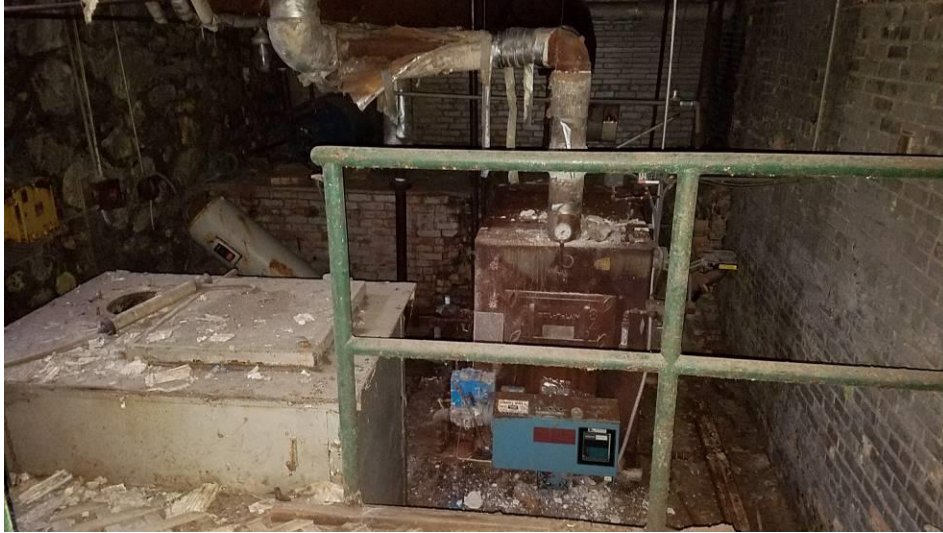
CLIENT NAME: City of South Bend & South Bend Brownfields Coalition
DATE: December 14, 2017
LOCATION: Lafayette Building, 115 South Lafayette Boulevard in South Bend, Indiana
SUBJECT: View of boiler room in basement of site building
PHOTOGRAPHER: Nivas R. Vijay (Heartland)
PHOTO: 21

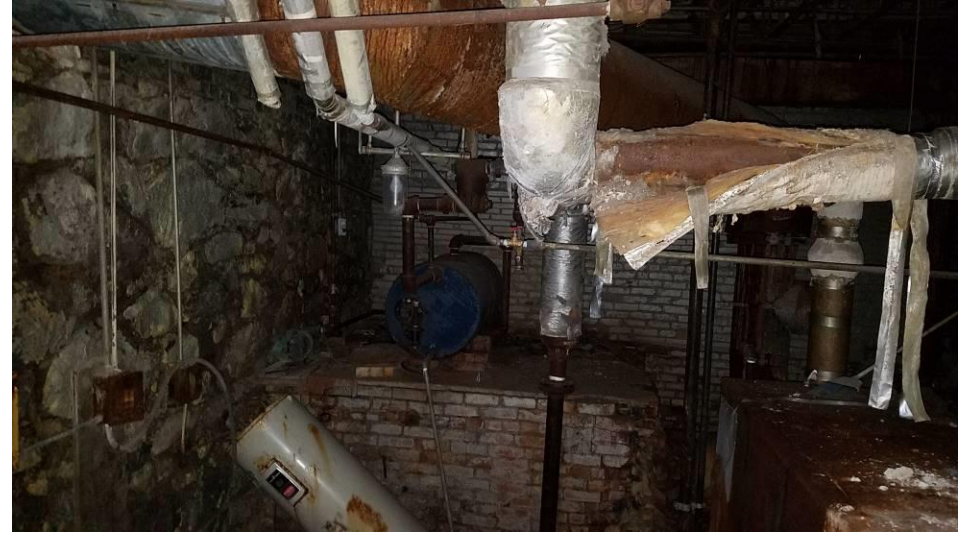
CLIENT NAME: City of South Bend & South Bend Brownfields Coalition
DATE: December 14, 2017
LOCATION: Lafayette Building, 115 South Lafayette Boulevard in South Bend, Indiana
SUBJECT: View of boiler room and abandoned tanks associated with boilers in basement of site building
PHOTOGRAPHER: Nivas R. Vijay (Heartland)
PHOTO: 22

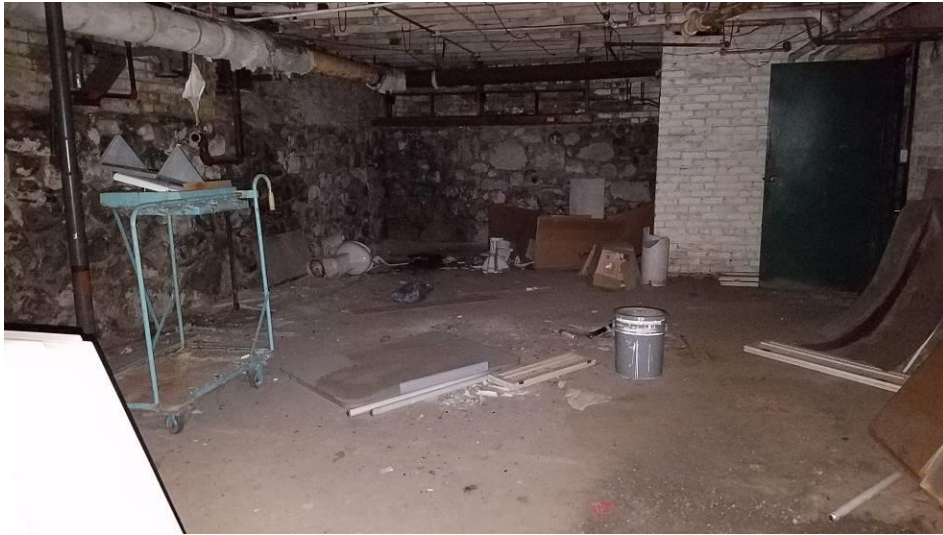
CLIENT NAME: City of South Bend & South Bend Brownfields Coalition
DATE: December 14, 2017
LOCATION: Lafayette Building, 115 South Lafayette Boulevard in South Bend, Indiana
SUBJECT: View of basement room. Note asbestos containing pipe wrapping on pipe chase on ceiling of room
PHOTOGRAPHER: Nivas R. Vijay (Heartland)
PHOTO: 23

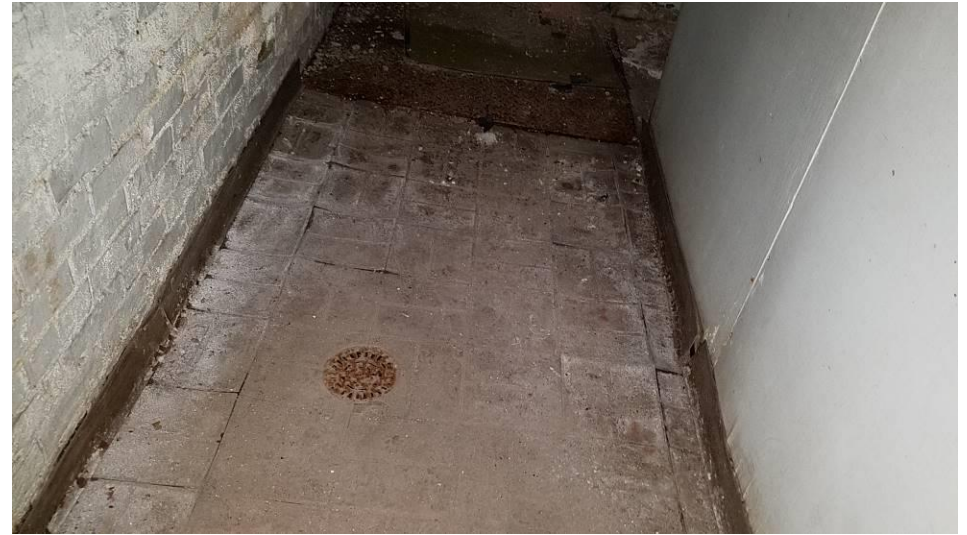
CLIENT NAME: City of South Bend & South Bend Brownfields Coalition
DATE: December 14, 2017
LOCATION: Lafayette Building, 115 South Lafayette Boulevard in South Bend, Indiana
SUBJECT: View of floor drain in basement of site building
PHOTOGRAPHER: Nivas R. Vijay (Heartland)
PHOTO: 24

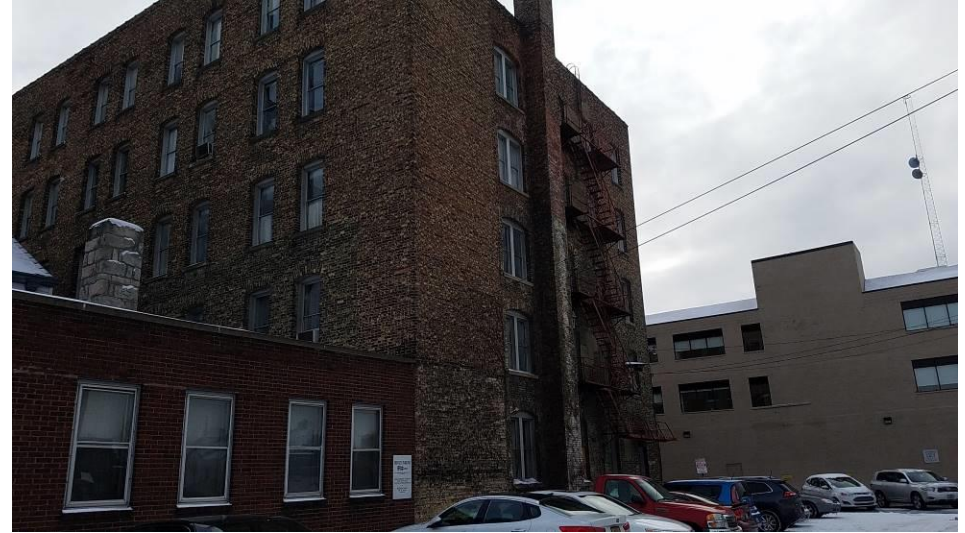
CLIENT NAME: City of South Bend & South Bend Brownfields Coalition
DATE: December 14, 2017
LOCATION: Lafayette Building, 115 South Lafayette Boulevard in South Bend, Indiana
SUBJECT: View of back of site building, looking west from alleyway
PHOTOGRAPHER: Nivas R. Vijay (Heartland)
PHOTO: 26

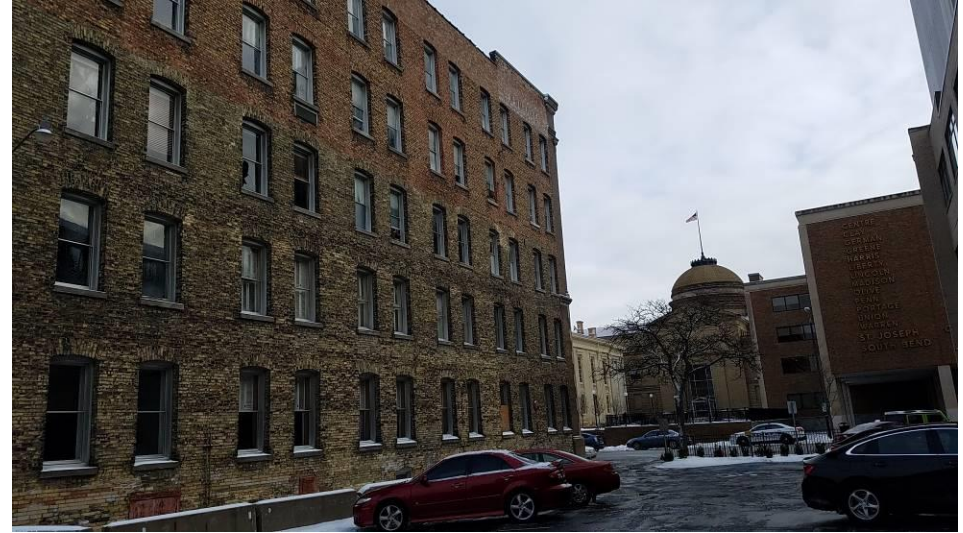
CLIENT NAME: City of South Bend & South Bend Brownfields Coalition
DATE: December 14, 2017
LOCATION: Lafayette Building, 115 South Lafayette Boulevard in South Bend, Indiana
SUBJECT: View of southern parking lot and neighboring office property, looking east
PHOTOGRAPHER: Nivas R. Vijay (Heartland)
PHOTO: 28

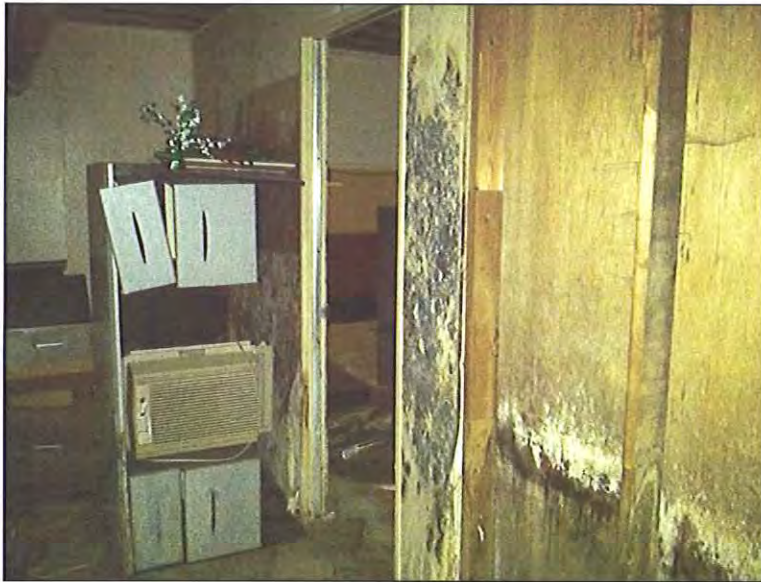
Basement - Center location - Visible mold growth on drywall and wooden building materials

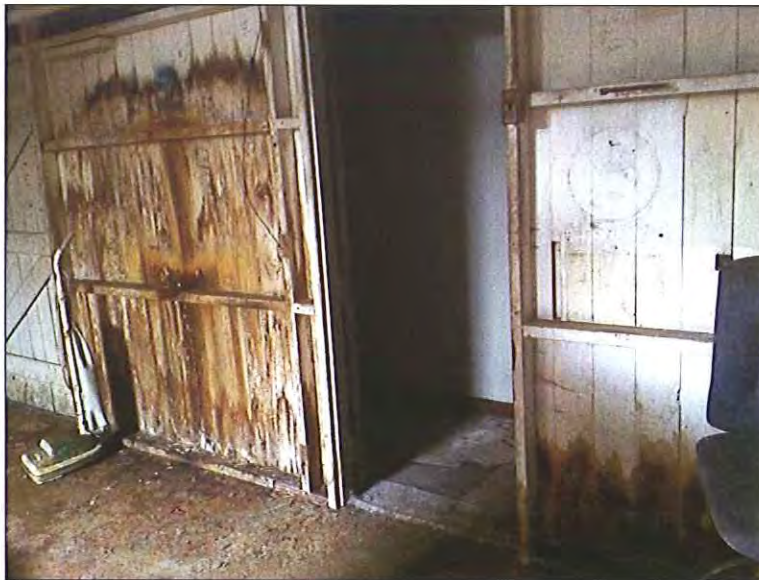
Basement - South location - Moisture related staining and mold growth on wooden wall paneling

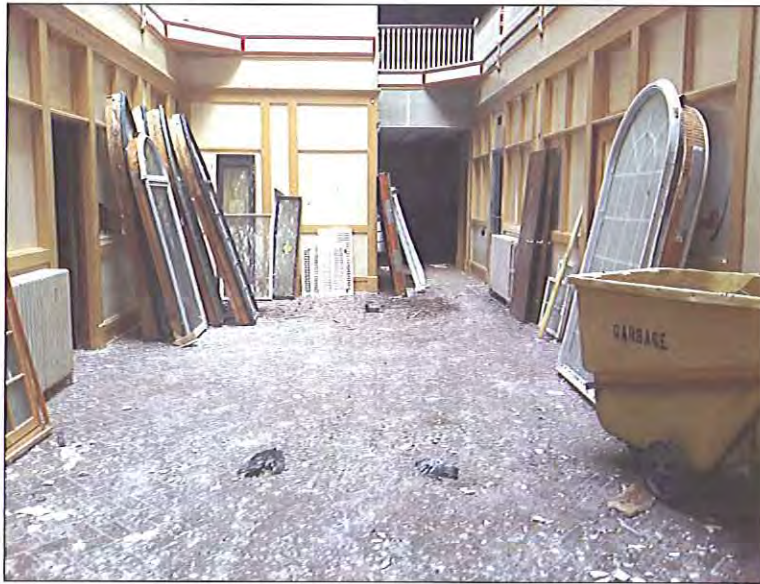
First Floor - Center location - Avian fecal matter present on surfaces throughout this area, in addition to multiple bird carcasses

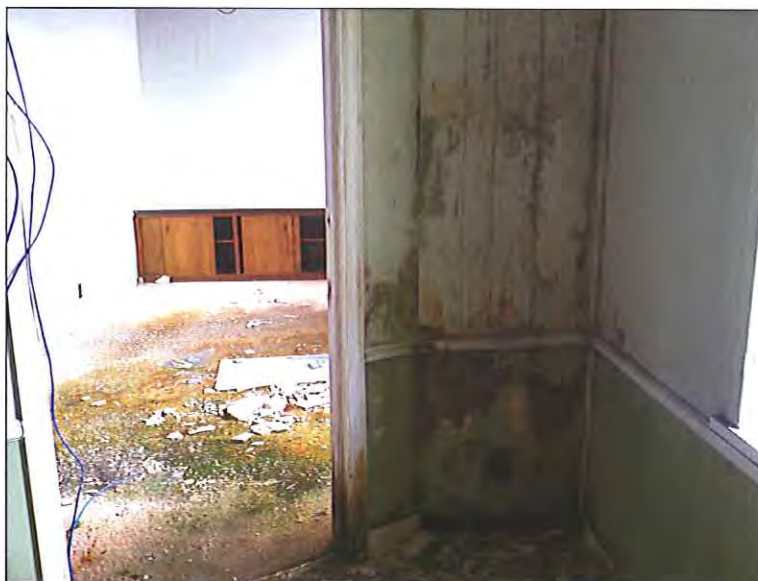
First Floor - West location - Moisture related staining/damage and microbial growth on wooden wall paneling and carpet

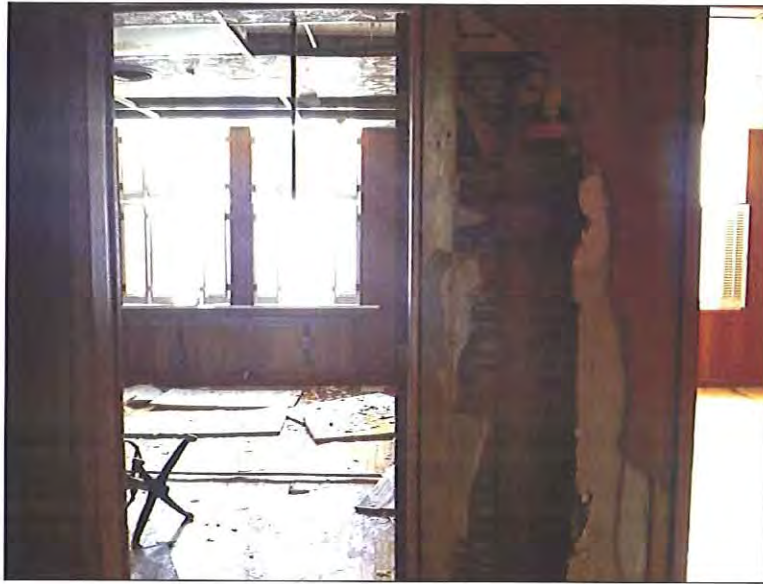
Second Floor - East location - Damaged ceiling and wall building materials

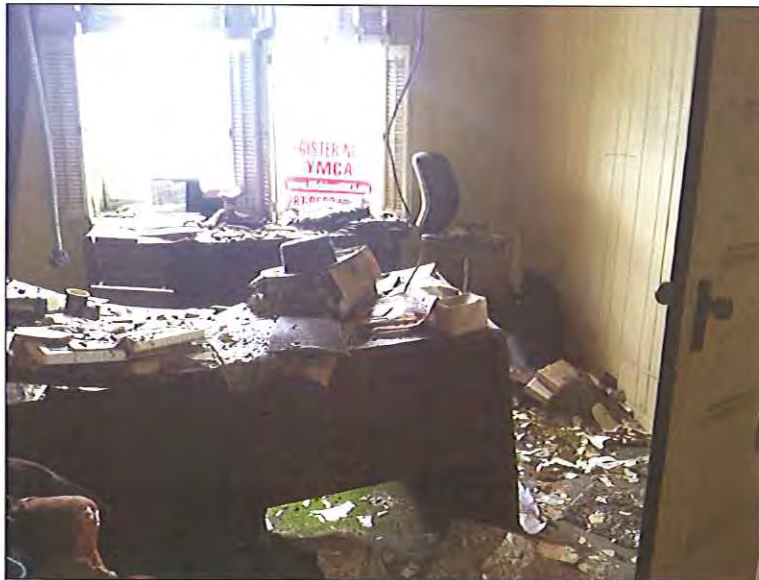
Second Floor - West location - Visible microbial growth and moisture related staining/damage present on multiple building materials and contents

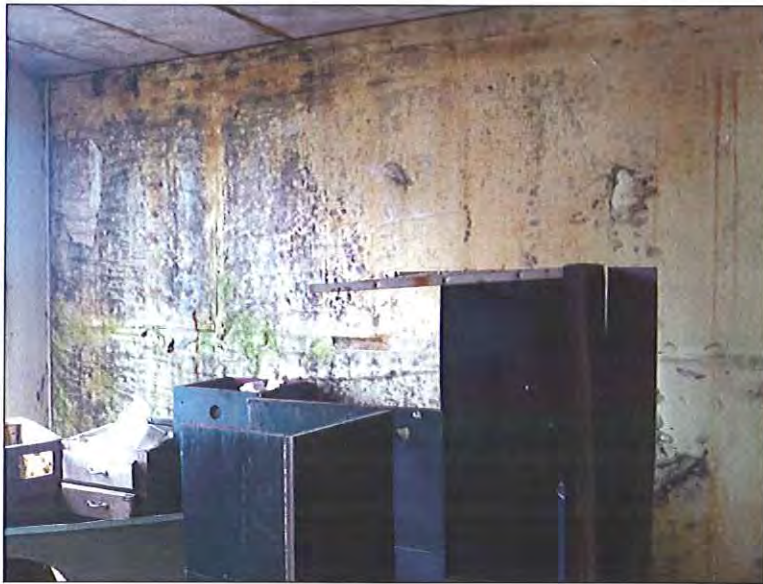
Second Floor - Southwest location - Visible microbial growth and moisture related staining/damage present on multiple building materials and contents

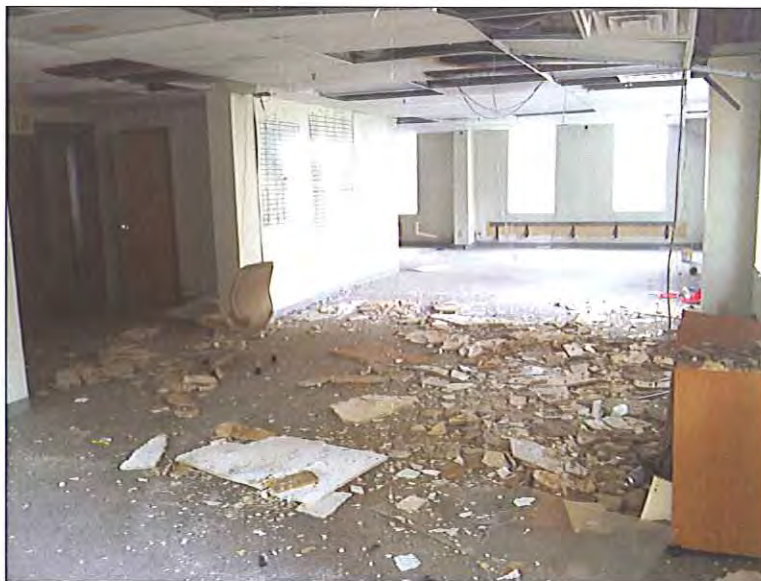
Third Floor - East location - Moisture staining/damaged ceiling tiles on the floor

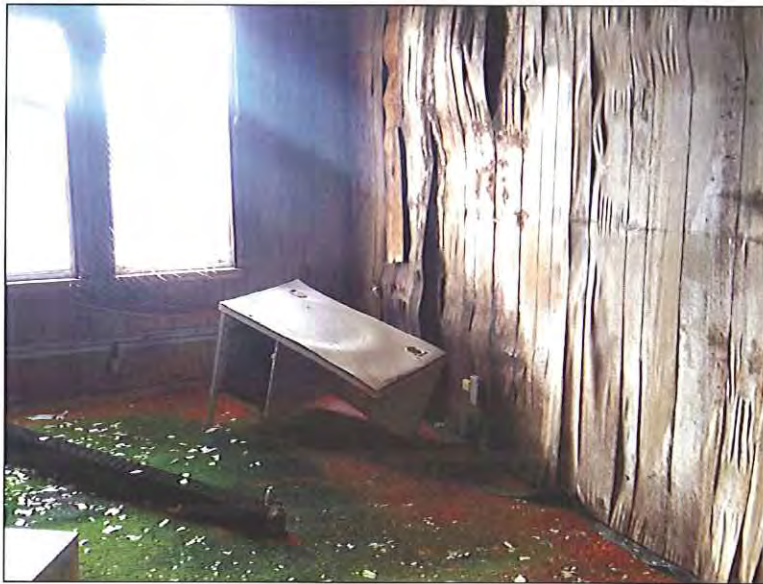
Third Floor - Southwest location - Moisture related staining/damage and visible microbial growth on various building materials and contents.

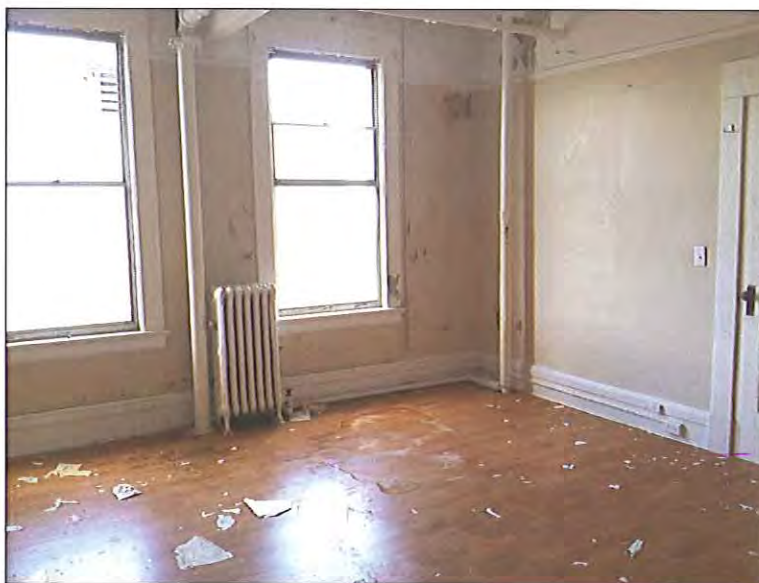
Fourth Floor - North location - Moisture related staining/damage on building materials

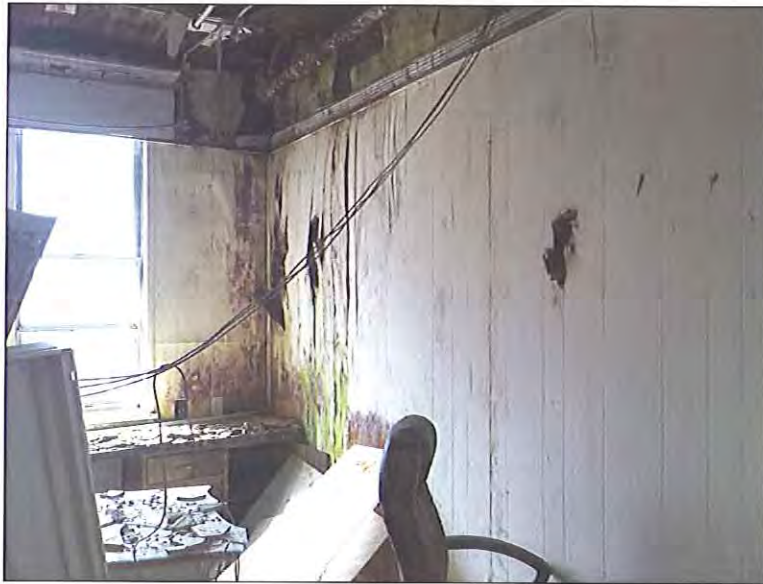
Fourth Floor - Southwest location - Visible mold growth with moisture related staining/damage on multiple building materials and contents

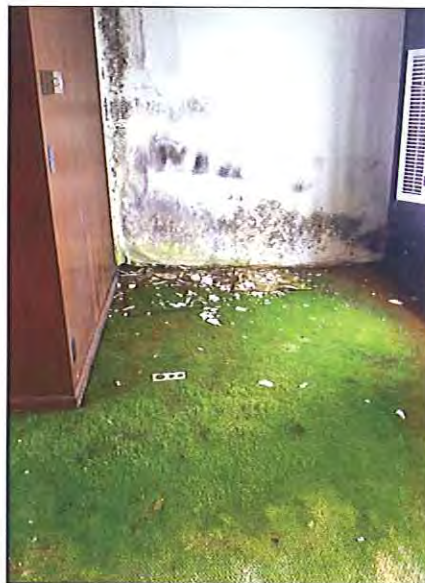
Fifth Floor - Northwest corner room - Visible microbial growth on the wall and carpet

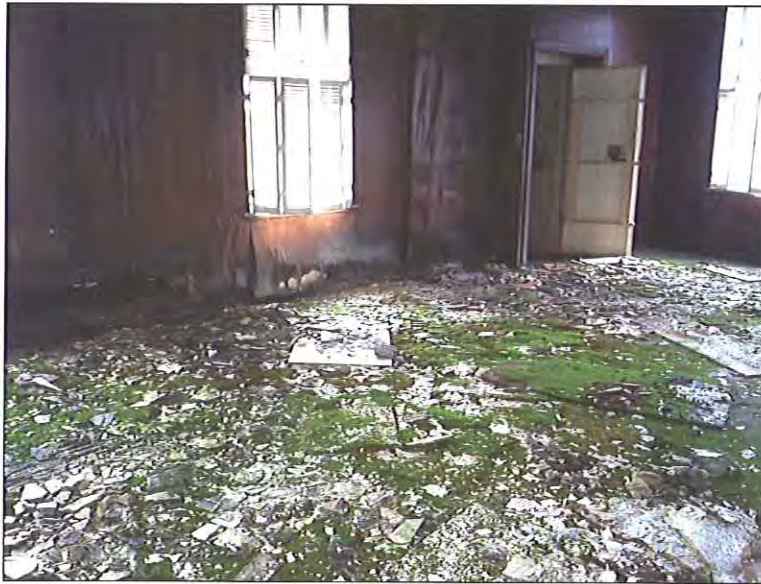
Fifth Floor - West location - Visible microbial growth as well as moisture related staining/damage on multiple building materials and contents

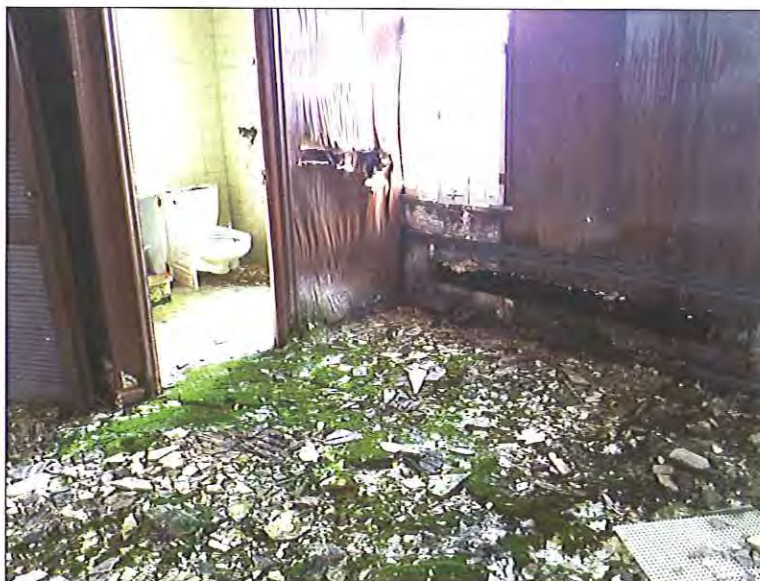
Fifth Floor - West location - Visible microbial growth as well as moisture related staining/damage on multiple building materials and contents

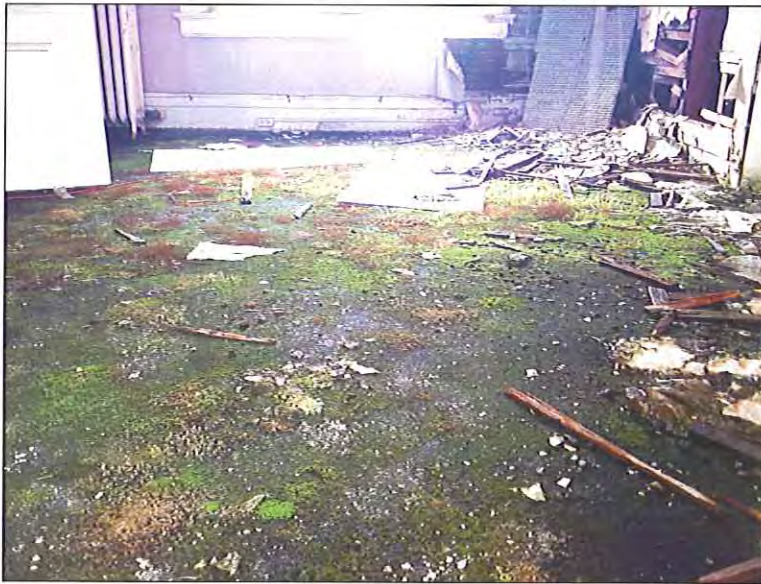
Fifth Floor - Southwest location - Visible microbial growth as well as moisture related staining/damage on multiple building materials and contents

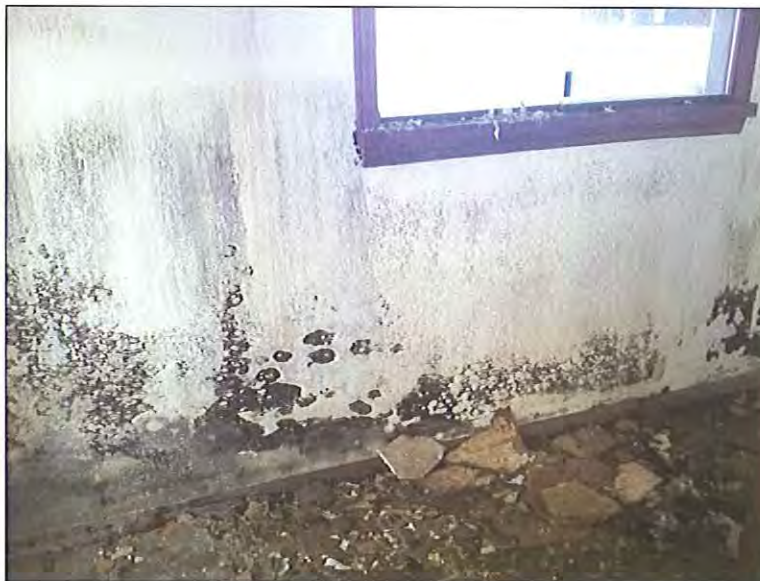
Fifth Floor - South location - Room 512 - Visible mold growth as well as moisture related staining/damage on multiple building materials.
