PHASE I ENVIRONMENTAL SITE ASSESSMENT

OF THE:
PROPERTY LOCATED AT:
521 ECLIPSE PLACE
SOUTH BEND, INDIANA, 46628

PREPARED FOR:
CITY OF SOUTH BEND DEPARTMENT OF COMMUNITY
AND ECONOMIC DEVELOPMENT
227 W. JEFFERSON BOULEVARD
SUITE 1200 S
SOUTH BEND, INDIANA 46601

JULY 2008

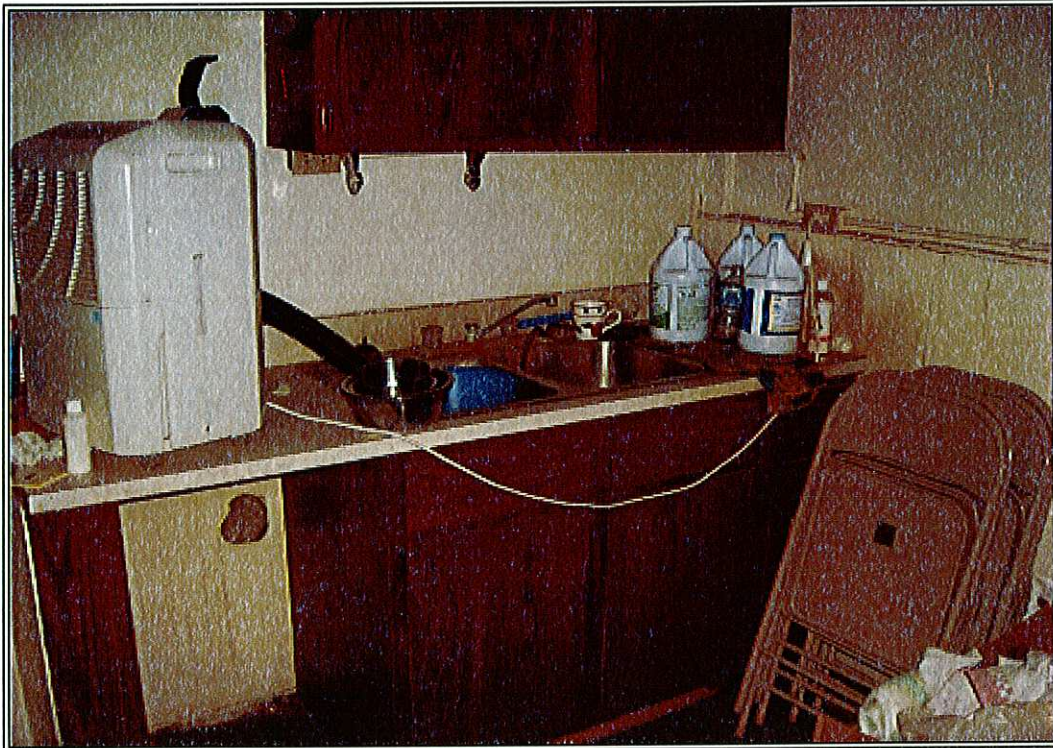
Numerous containers of various sizes were observed within the interior of the Site building on both the ground floor and basement levels. Different types of paint and household cleaners were noted throughout the building's basement and ground floor. Although the cleaners were scattered throughout the building, they did not appear to be stored haphazardly (i.e., the containers were stored upright, and did not appear to be knocked over or leaking). No staining was noted on the ground floor during the Site reconnaissance, however, debris and clutter prevented a clear view of the floor in most locations. A pipe exhibiting a film with a petroleum odor around one of the junctions was observed in the basement. Mr. Libbey stated that he believed that the pipe was connected to a UST, likely formerly used for storage of fuel oil. The presence of this pipe with a petroleum odor inside the basement constitutes a REC in this Phase I ESA.

PHOTO 3: Cleaning supplies were found throughout the ground floor and the basement in the main building.

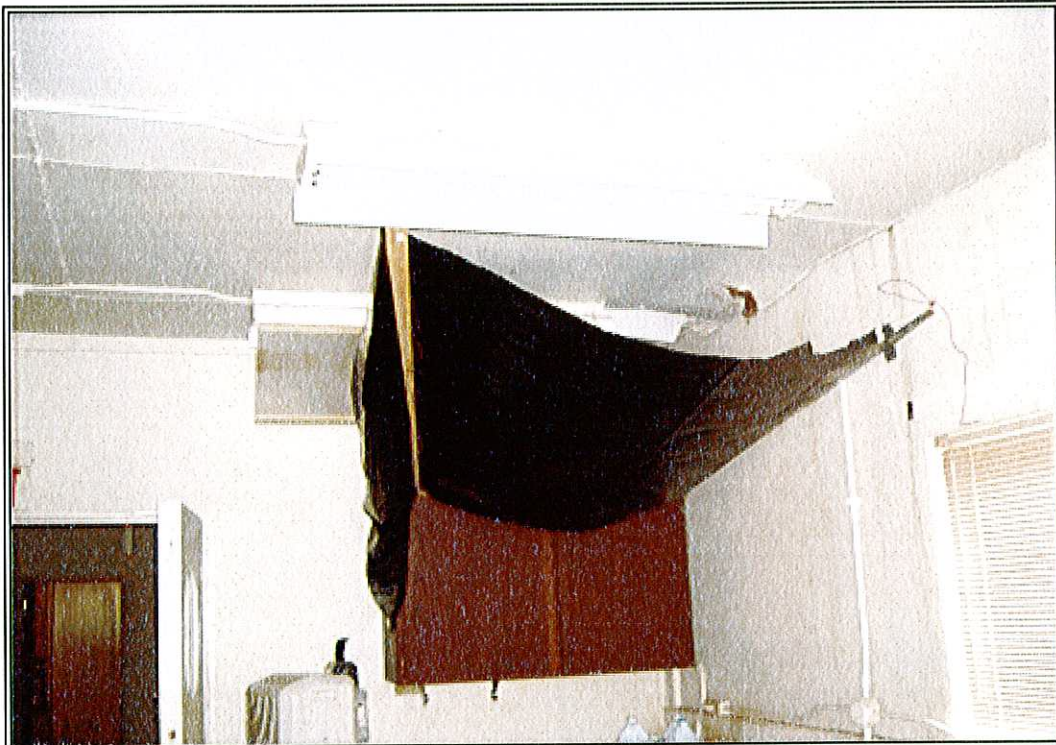
PHOTO 4: Tarp erected in a room of the main building where the roof leaks.

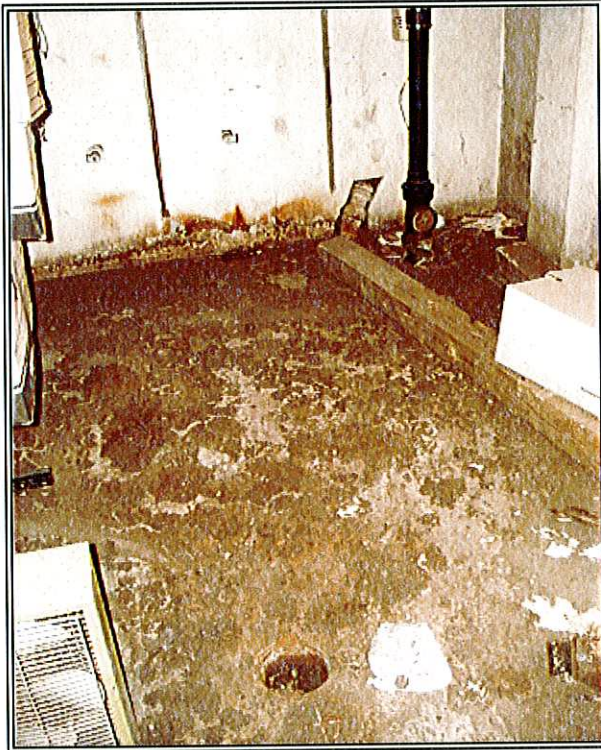
PHOTO 7: Drain in basement of the building.

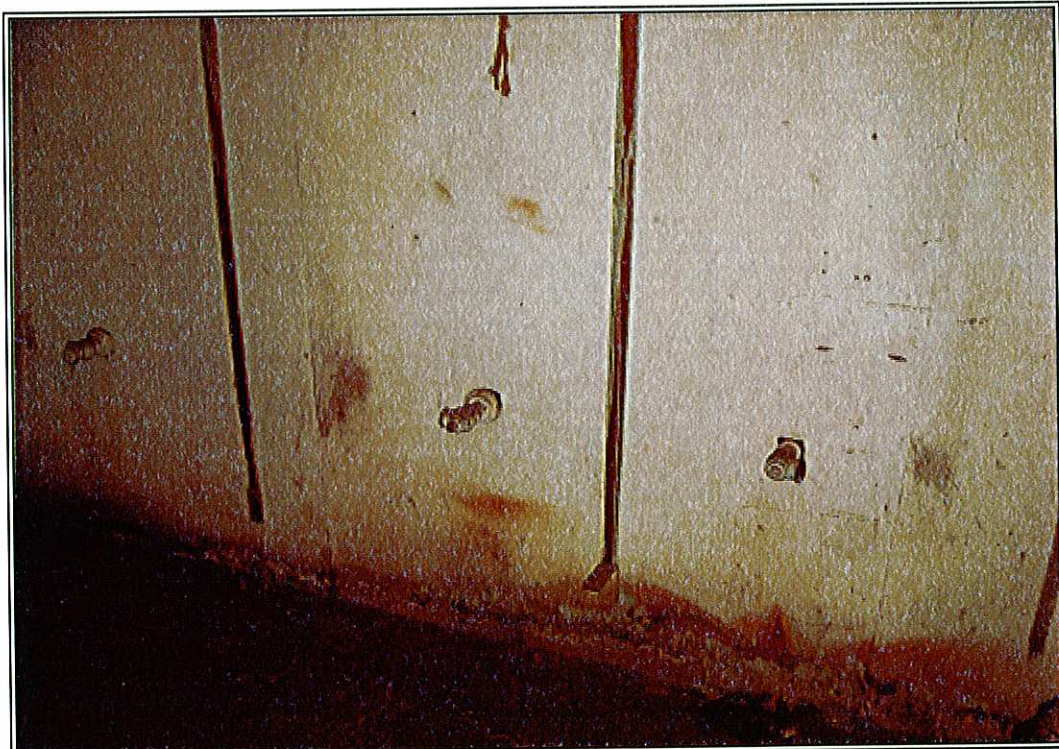
PHOTO 8: Walls exhibit staining from possible flooding.

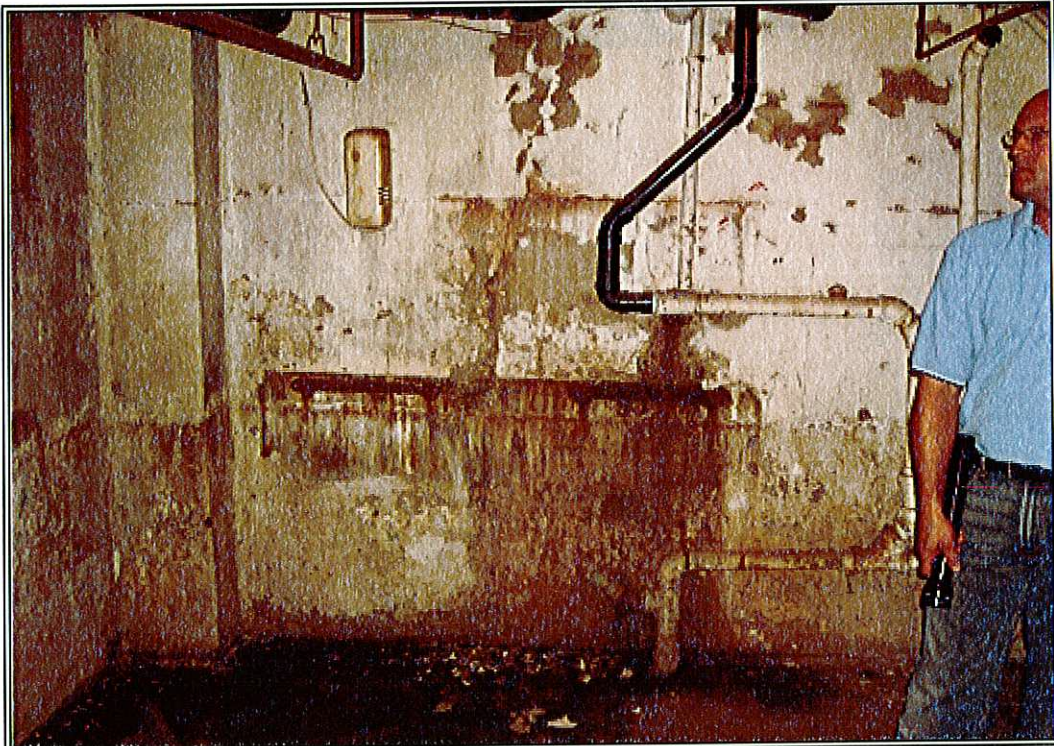
PHOTO 9: Staining on walls where water appears to seep in through the concrete.

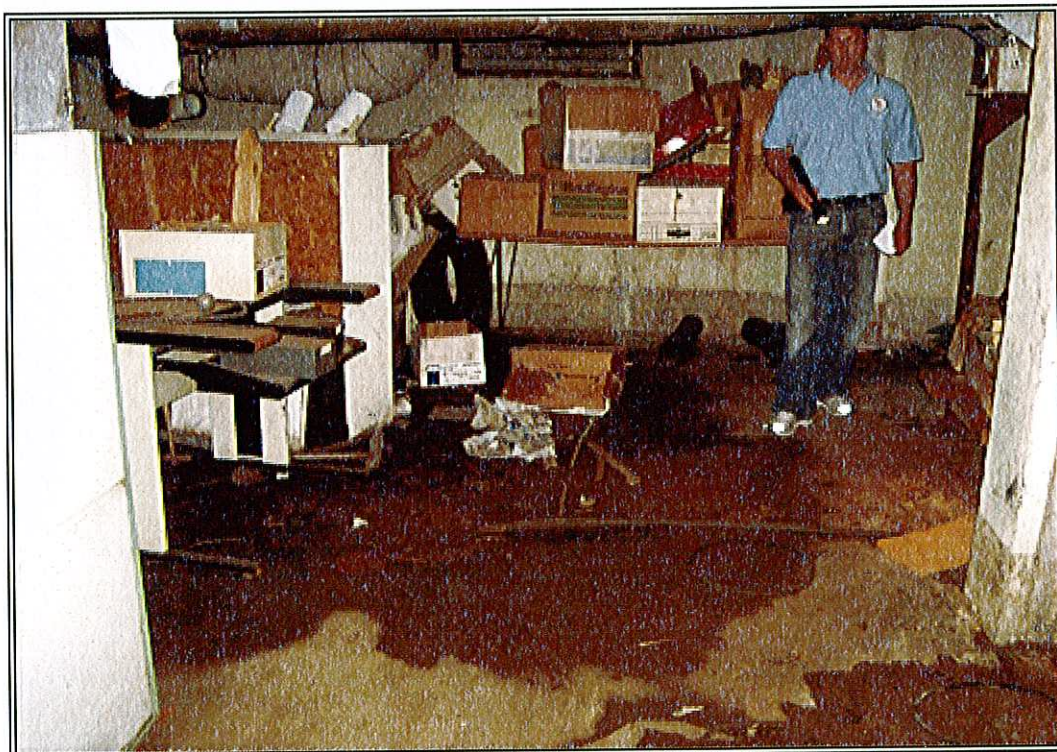
Several drains were observed in the main building and Bendix lots which drain stormwater off the Site. As mentioned in Section 7.1.8, water was noted on the floor in the area of the drains, but no staining was observed.

PHOTO 12: Floor in basement damp from flooding through drains.

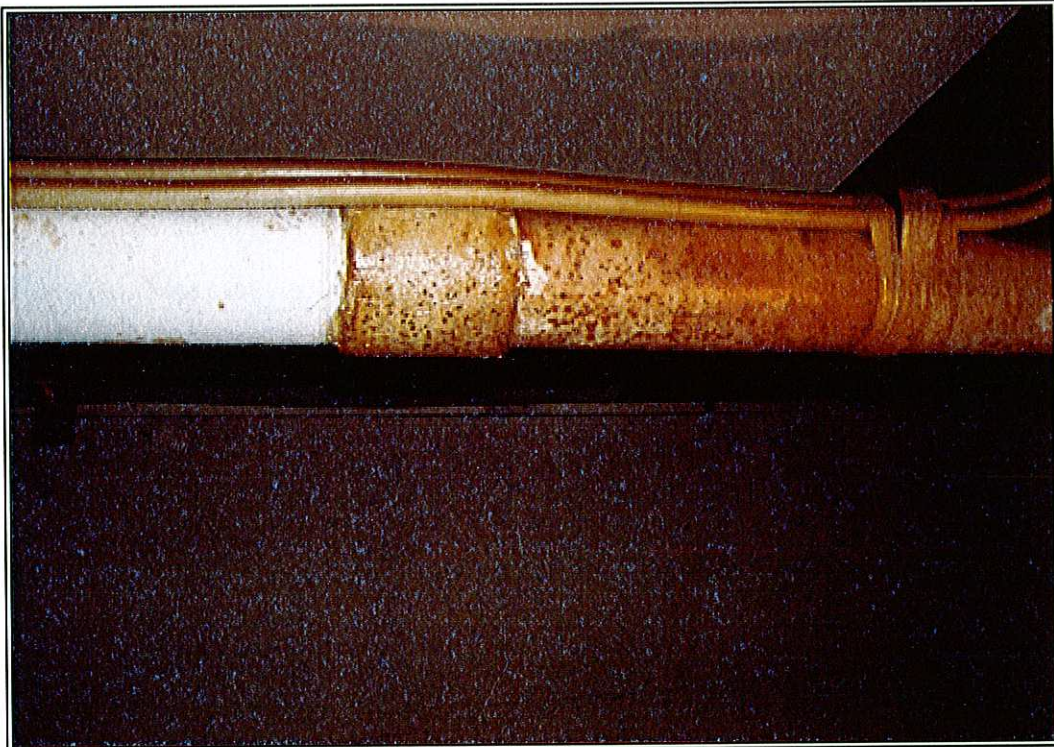
- Vent piping was observed on the south side of the main building. A pipe suspected to be associated with a UST was found running across the interior of the basement. This pipe was also secreting a film exhibiting a petroleum odor at one of its junctions. Additionally, a representative with the City of South Bend assisted Hull with visually confirming the presence of a fluid exhibiting a petroleum odor from within the vent pipes. The current presence of vent piping, and the observation of a petroleum odor on the basement piping and from the fluid extracted from the vent piping indicate the possible presence of a UST and constitutes a REC in this Phase I ESA.

PHOTO 14: Junction in suspected UST pipe where it appears to be leaking.
Film on pipe has a petroleum odor.

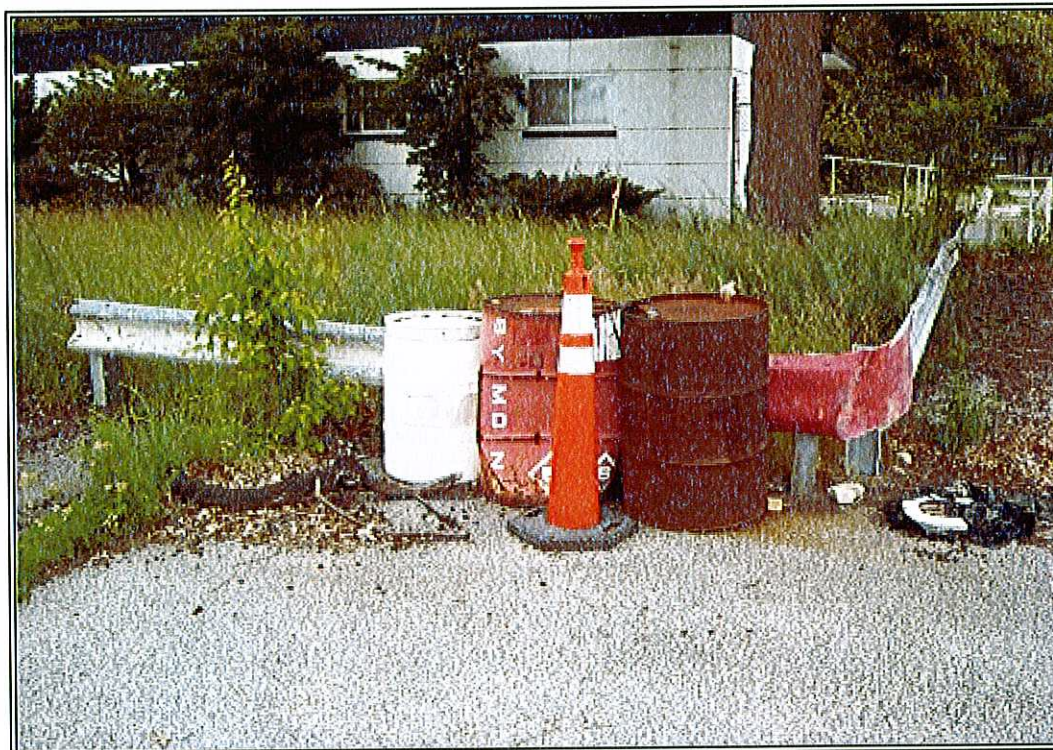
Two 55-gallon steel drums were observed on the exterior of the Site, near the southeast corner of the building. The two 55 gallon steel drums appeared rusted and warped, but no staining, odors, or stressed vegetation were noted in the vicinity of these containers. These containers were not labeled with the exception of one of the 55 gallon-drums which read, "DOT Diesel Fuel Solution".

PHOTO 18: Three drums stored on-Site. The drums did not have any evidence of leaking, although they were bulging and warped. The only drum with a discernible label was the faded red drum, which was labeled "diesel fuel solution".

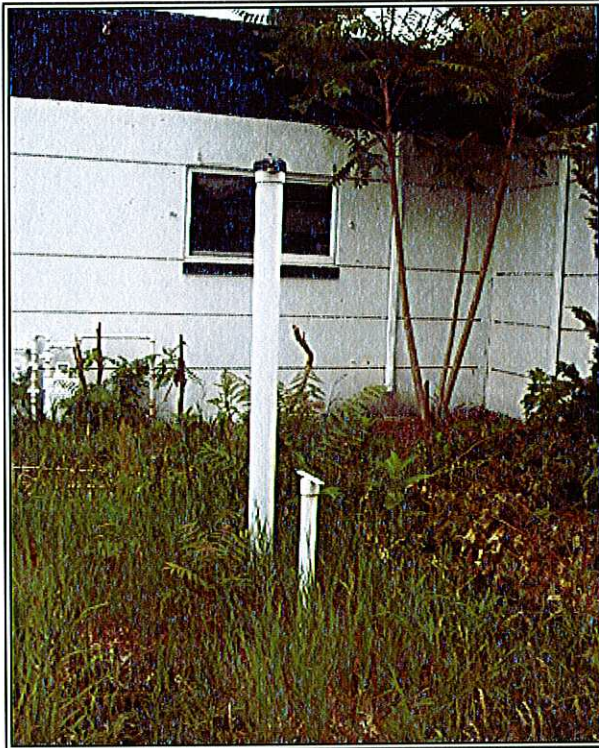
2. Vent piping was observed on the south side of the main building. A pipe suspected to be associated with a UST was found running along the interior of the basement. This pipe was also secreting a film at one of its junctures that exhibited an apparent petroleum odor. Additionally, a representative with the City of South Bend assisted Hull with visually confirming the presence of a fluid exhibiting a petroleum odor from within the vent pipes. The current presence of vent piping, and the observation of a petroleum odor on the basement piping and from fluid extracted from the vent piping indicate the possible presence of a UST and constitutes a REC in this Phase I ESA.

PHOTO 21: Suspected fill and vent pipes on the southern portion of the building.
