**Re: Former Studebaker Plant
Prairie Avenue, South Bend, IN
Demolition Procedures**

Subject: Studebaker Area A Demolition Phase IV
Project 109-032
1100 Prairie Avenue
South Bend, IN 46601

Studebaker Facility – Building #85

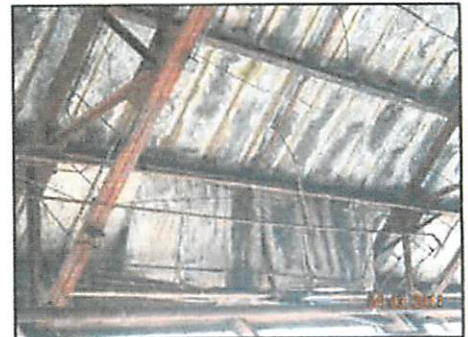
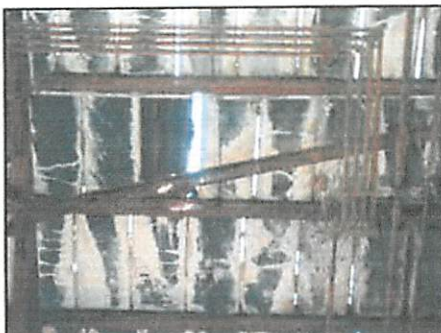
The roof system appears to be constructed of large steel trusses spaced at approximately 20' on center with steel roof beams that span between the trusses and are spaced at the panel points of the truss which is approximately 5'-6" o.c. A 3" thick precast concrete panel spans between the steel roof beams to form the roof deck. These 3" precast concrete panels are 2'-0" wide with a 1" thick top and bottom and a 1" void at the center.

The concrete panels also have a 1" thick longitudinal web and a 1" thick diaphragm at midspan. The panels are reinforced with welded wire fabric.

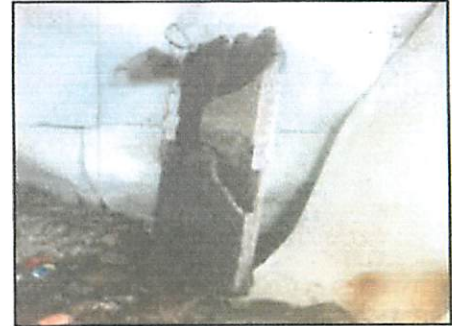
These precast concrete panels are in very poor condition with multiple signs of deterioration, water intrusion, rusting welded wire fabric and in many cases they have already failed. For the reasons stated above it would not be safe to walk on these panels or load them in any way because failure could occur suddenly.

The steel members that support these precast concrete panels are also severely deteriorated and show varying signs of section loss.

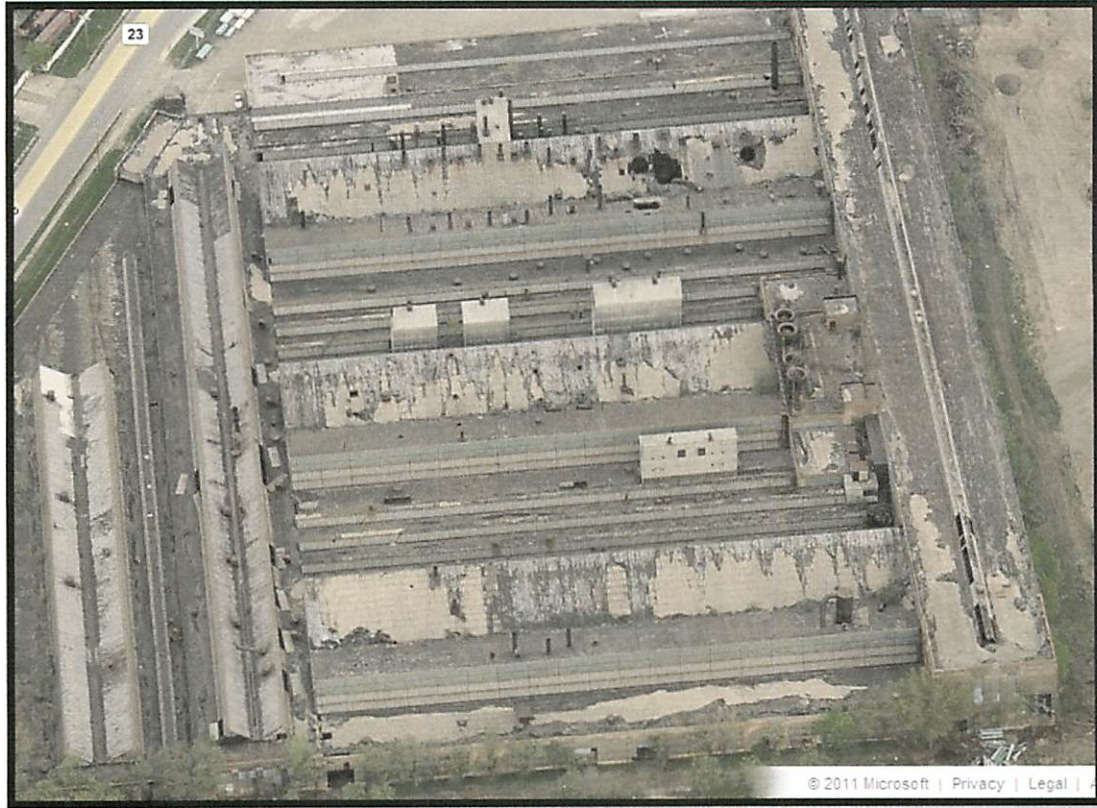
View of Building From South, Looking North

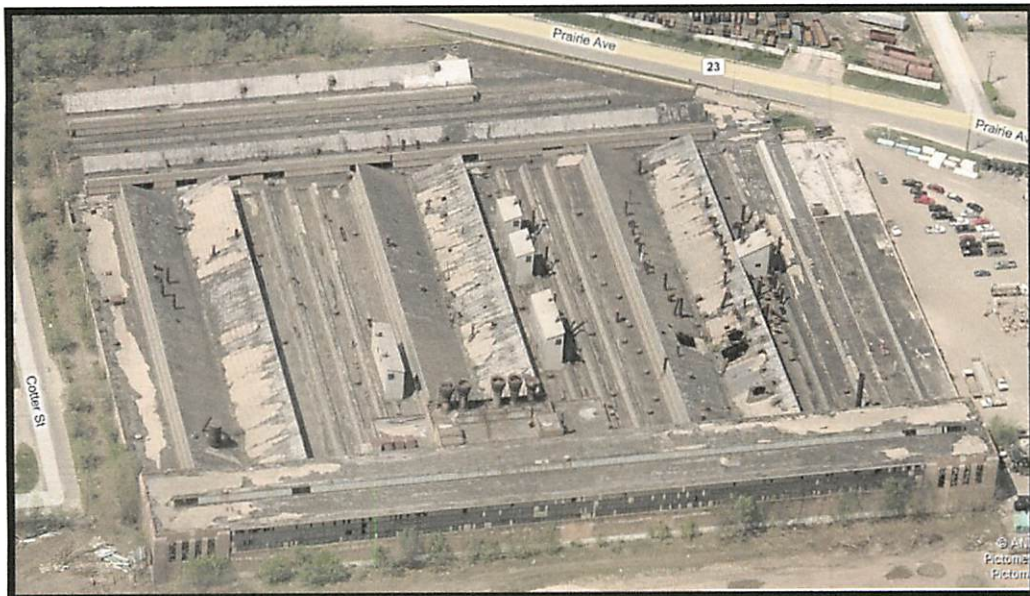
View of Building From East, Looking West
