**Final Report**

# **Bldg. 103 Characterization Report**

Robert Bosch Corporation  
South Bend, Indiana

December 2000

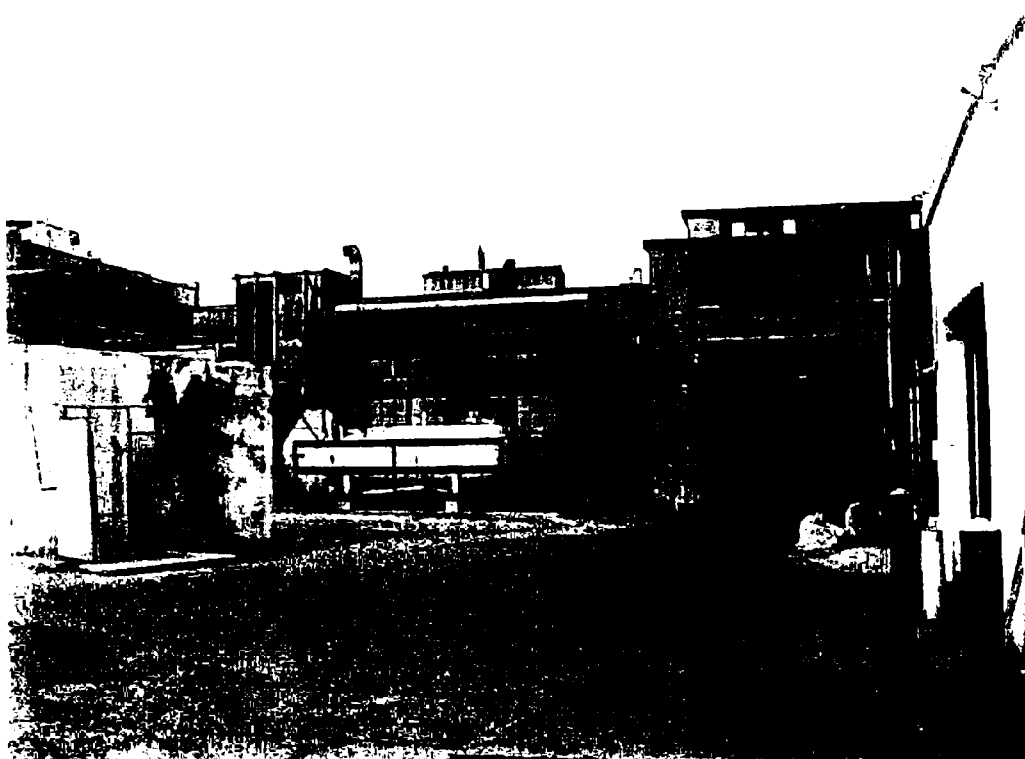
Photo #1: Exterior of the southwest side of Building 103 (near Building 104). Photograph shows, from left to right, former sulfuric acid area (white structure), 1,000-gal ammonia AST, and entrance to Building 103

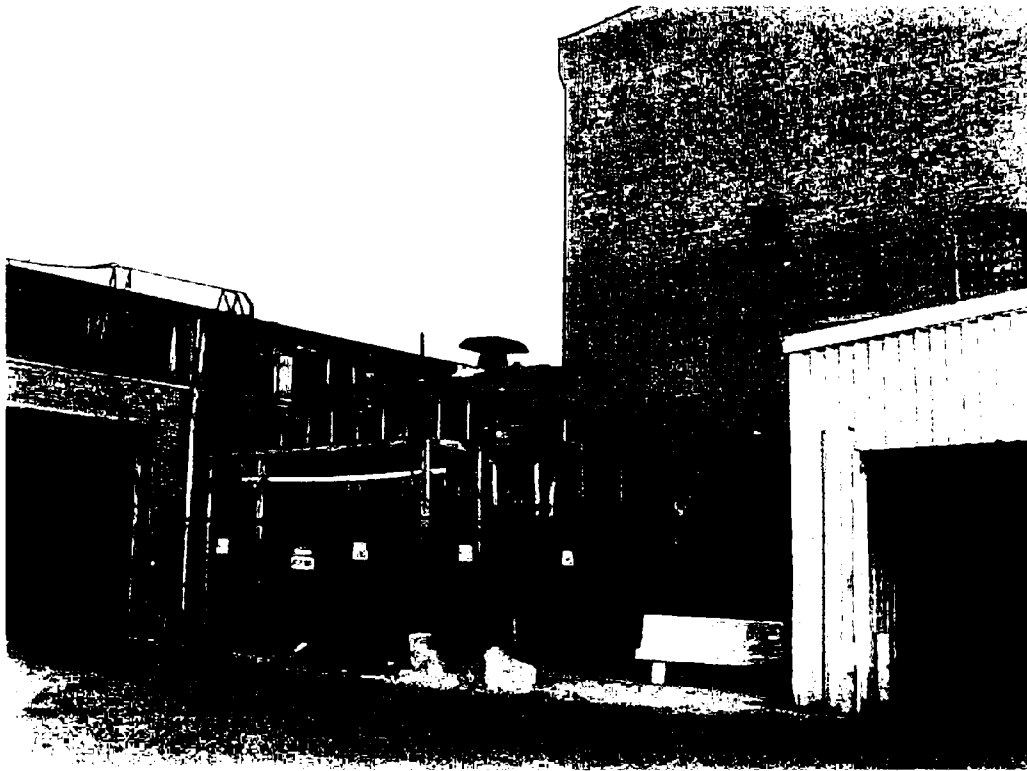
Photo #2: Transformer area outside the southwest side of Building 103 (Building 104 is the red brick building on the right). There are six transformers and related equipment located inside the area.

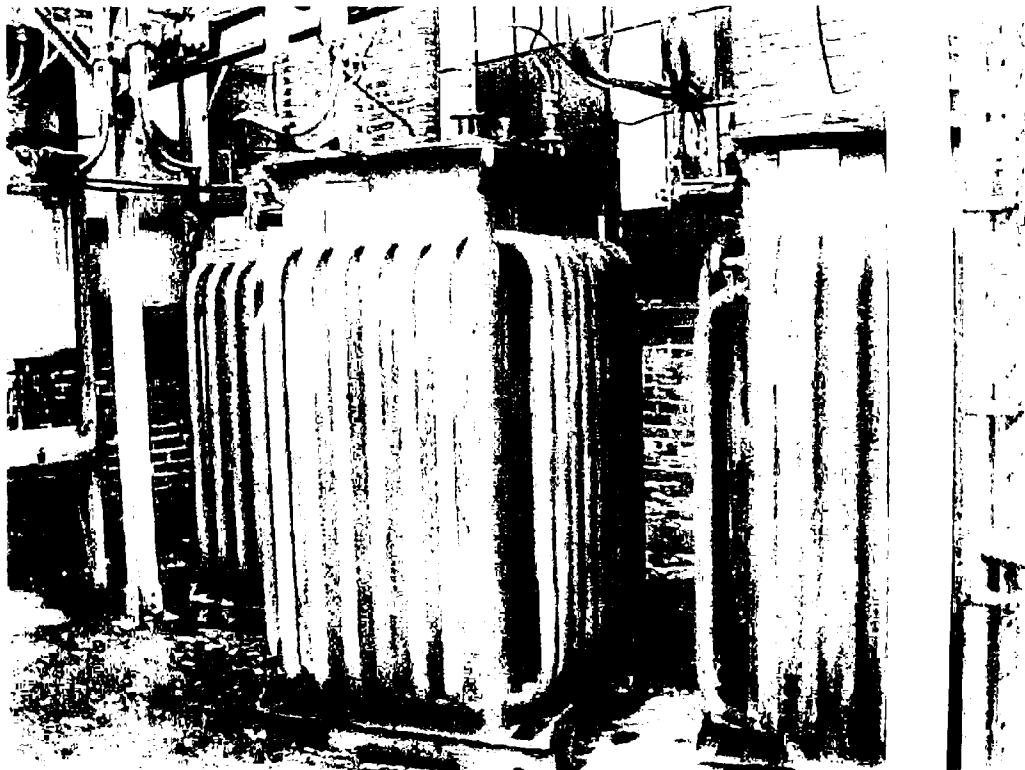
Photo #3: Close-up of three of the transformers within the fenced area outside the southwest side of Building 103 (near Building 104). Condition of transformers and concrete pad is typical of the area.

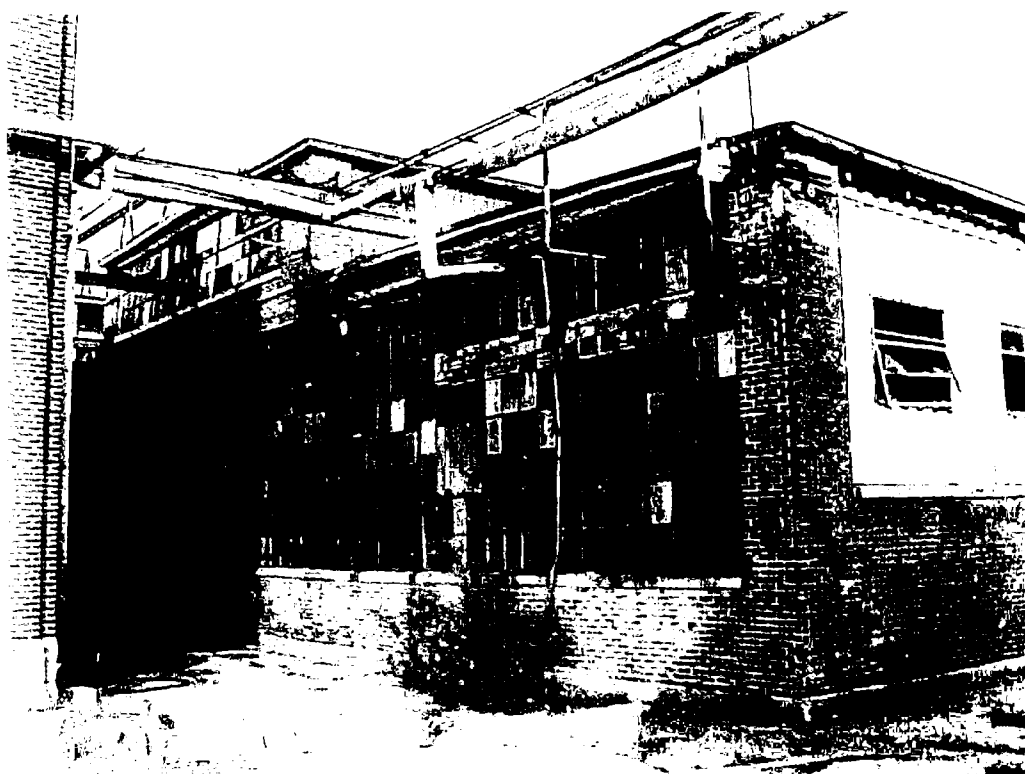
Photo #4: Southwest corner of Building 103 (near Powerhouse located on the left side of photo). Note overhead piping to be removed at the Powerhouse. Exterior ground is typical of area outside of Building 103.

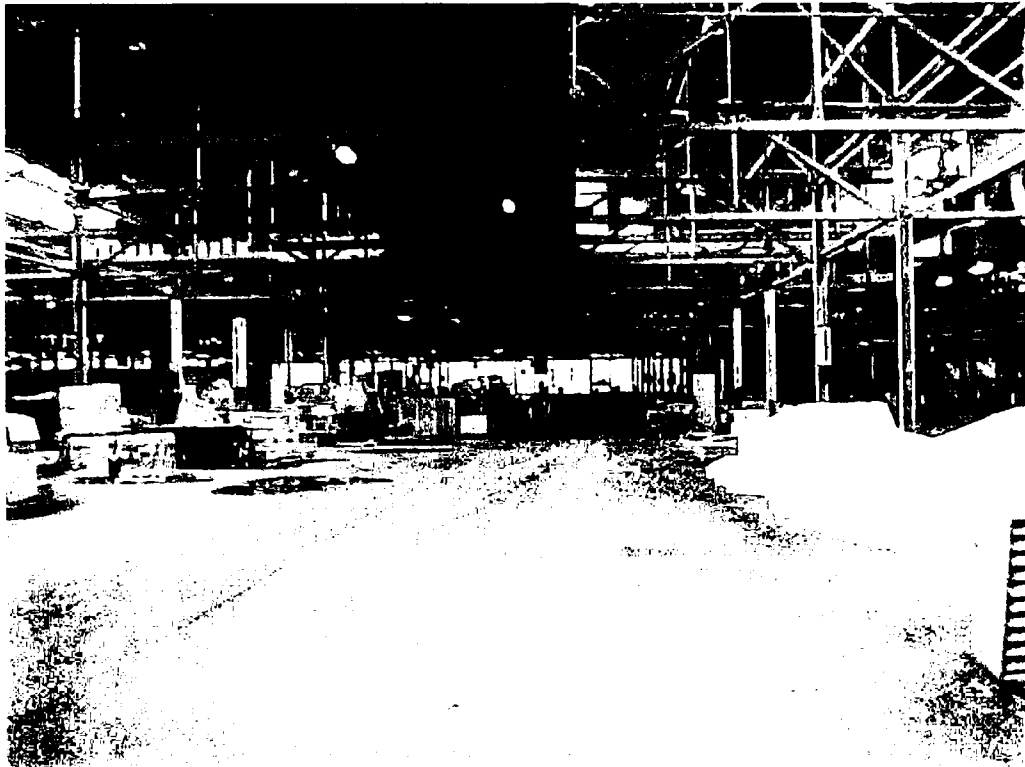
Photo #5: Looking west down Column G inside Building 103. Area in the foreground is typical of area that will remain following demolition.

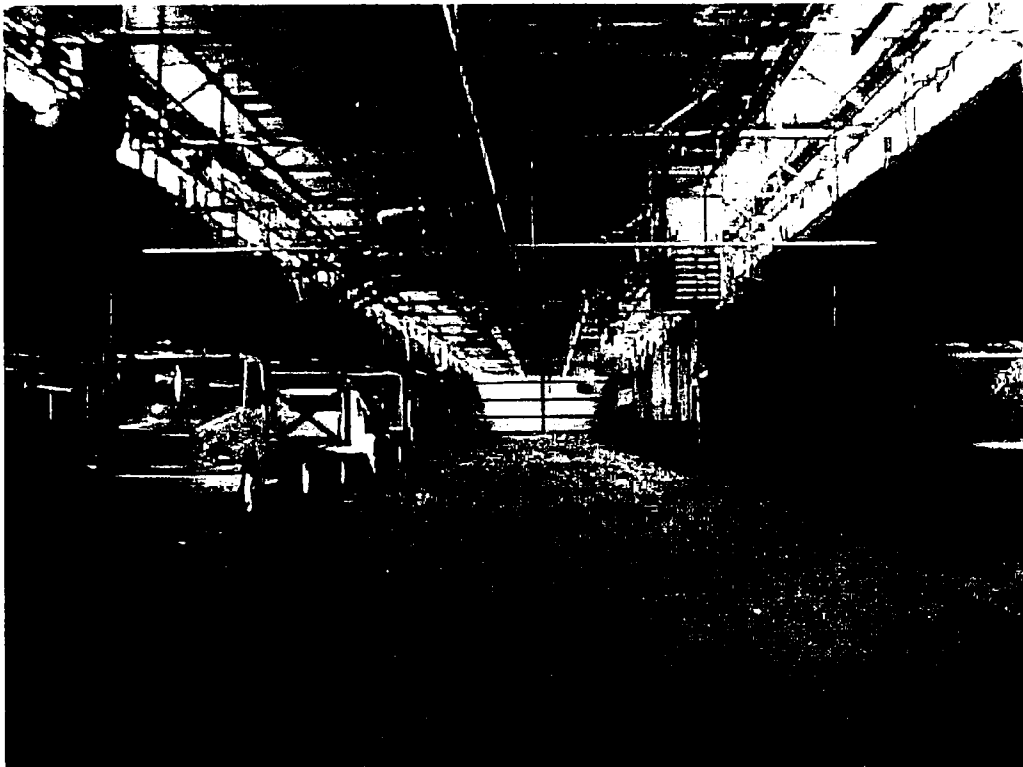
Photo #6: Picture taken looking west down column M. Area in foreground is area that will remain following demolition activities.

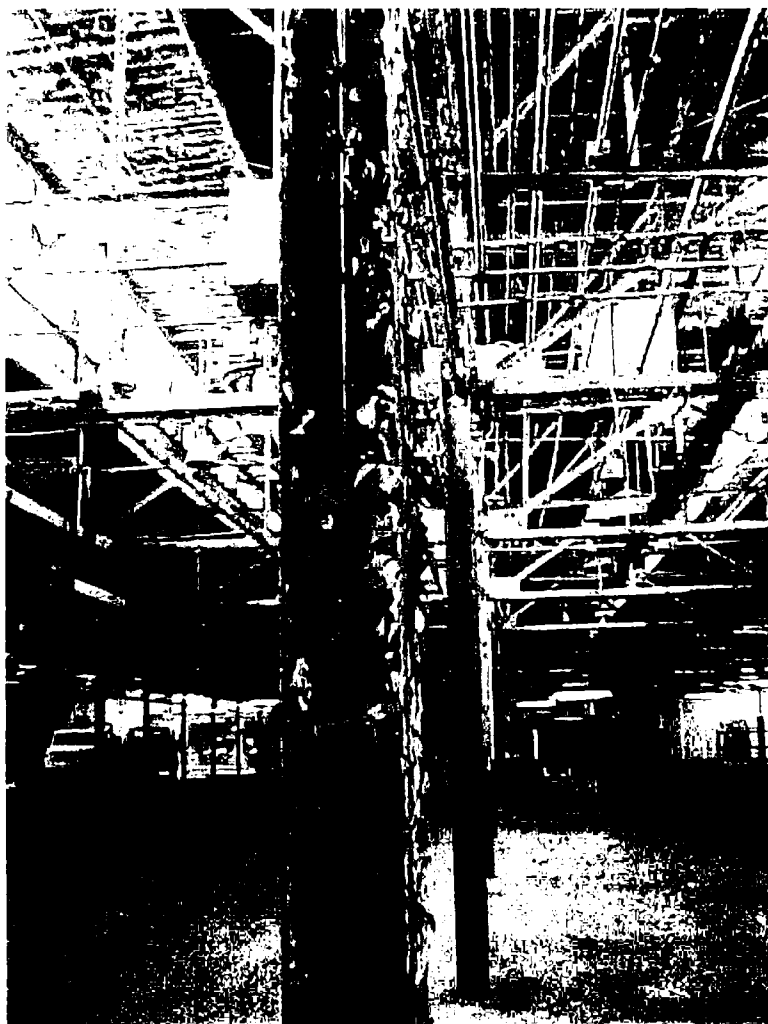
Photo #7: Typical condition of paint on approximately 50% of the columns inside Building 103. Paint is considered to be lead-based.

- Lead-based paint was identified on walls, ceilings, and columns throughout the building. Lead paint that is loose, flaking, or has fallen on floors, ceilings, etc. should be abated prior to demolition or renovation.

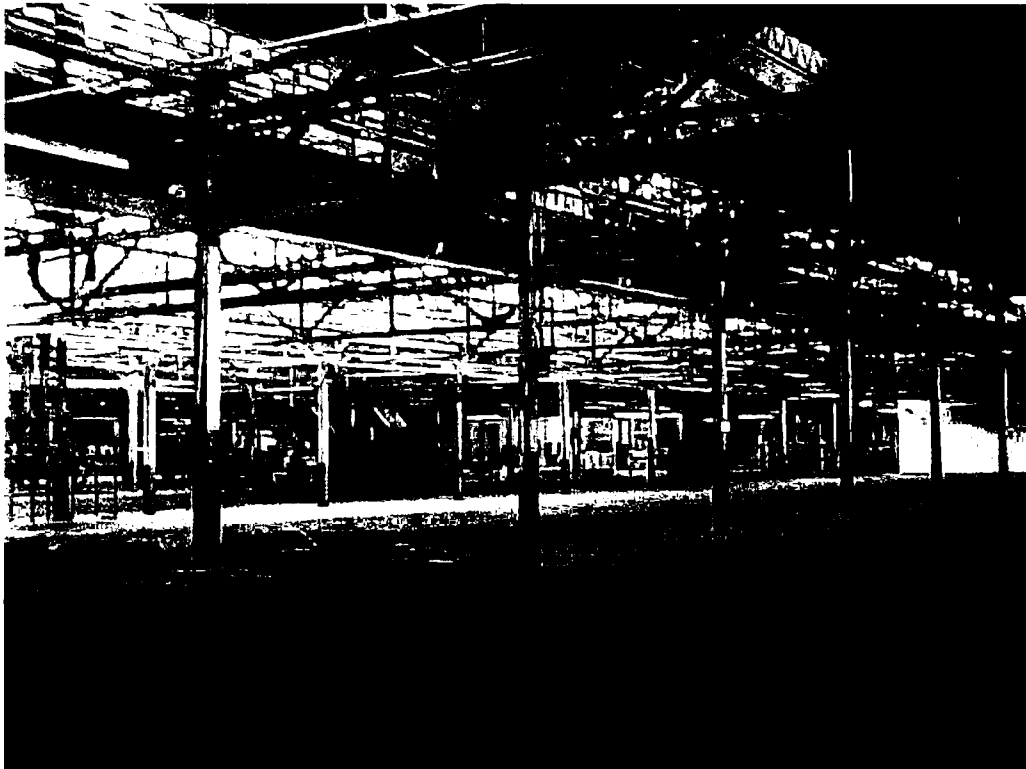
Photo #9: Condition of portion of Building 103 that will remain following demolition. Picture was taken from Bay H-22 facing northeast.
