33 PRESERVATION BRIEFS

The Preservation and Repair of Historic Stained and Leaded Glass

Neal A. Vogel and Rolf Achilles

National Park Service
U.S. Department of the Interior

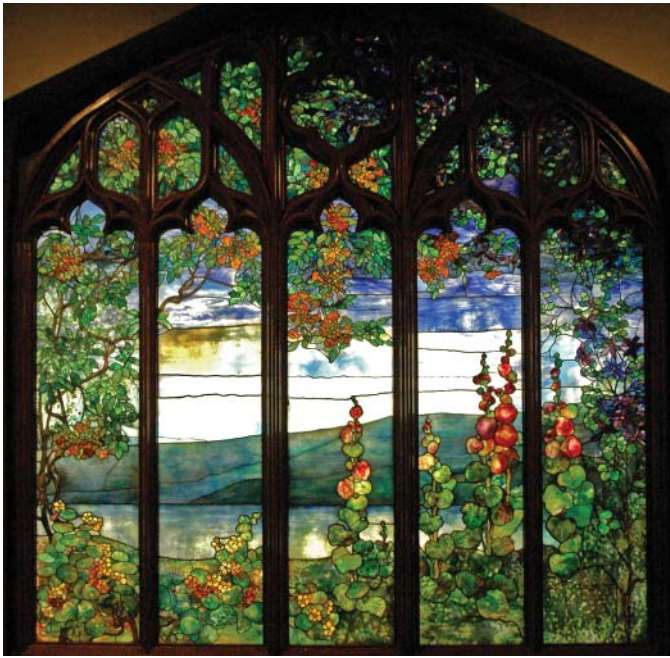
Figure 6. This 1907 landscape window is typical of those produced by Tiffany Studios. Characteristics include the use of opalescent glass, intricate leading and organic copper foil work, acid-etching, plating (i.e., several layers of glass), and a sense of perspective.

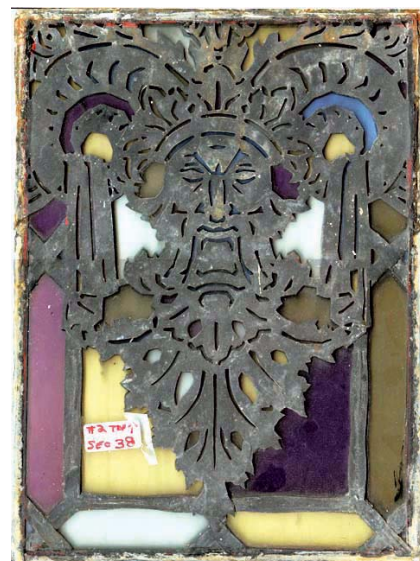
Figure 10. This lead-silhouette stained glass face graces a 1928 coach house in Buffalo, and is attributed to D'Ascenzo Studios of Philadelphia.

Some creative efforts expanded leaded glass media in new directions. Lead-overlay or “silhouette” glass was one novelty that climaxed in the late 1920s and early 1930s. Some designers sandwiched glass between layers of hand-cut sheet lead, while others sandwiched the perforated sheet lead between layers of glass. These windows present a playful reversal from traditional stained glass; in “silhouette” glass the lead metalwork, rather than the glass, becomes the primary art form (Fig. 10). However, such novelties failed to catch on during the Depression. World War II delivered the final blow and ornamental glass is seldom found in residential, commercial, and secular architecture after circa 1940. The great age of American stained glass was over. Fortunately, leaded glass panels survived in uncounted numbers throughout the country, and are now once again appreciated as virtually irreplaceable features of historic buildings.

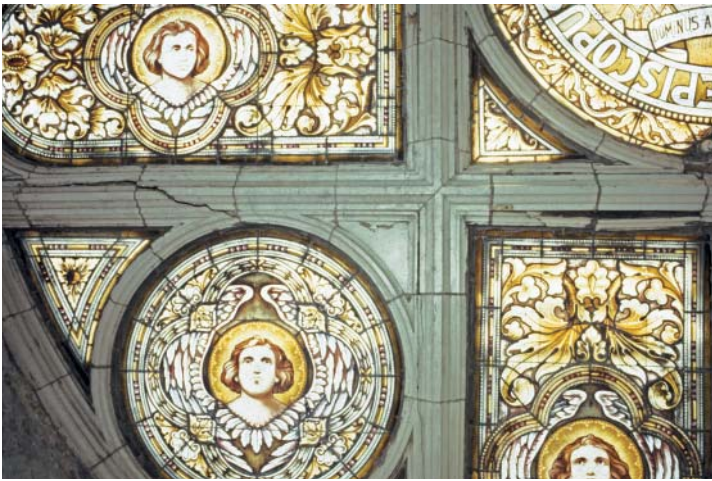
Figure 12. Stained glass frames are typically wood, steel or stone; however, other materials, and their inherent problems, can also be found as seen in this photograph of cracked terra cotta frames from 1926.

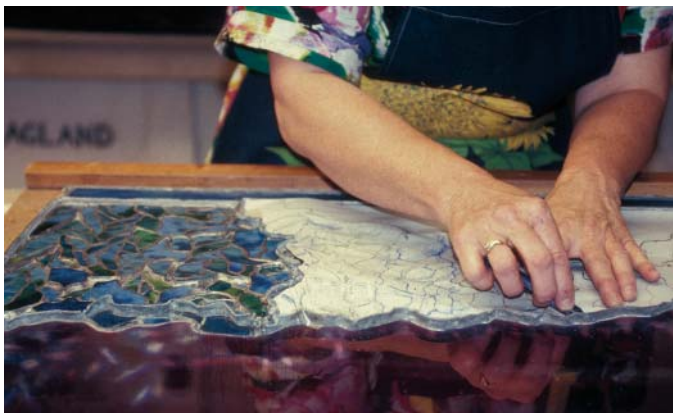
Figure 14. The external glass plate has been removed to clean the interlayer of this plated Tiffany Studios window.
