**Counsilman - Hunsaker**  
AQUATICS FOR LIFE

*Frost*  
ENGINEERING & CONSULTING

# Pool Structure & Finish

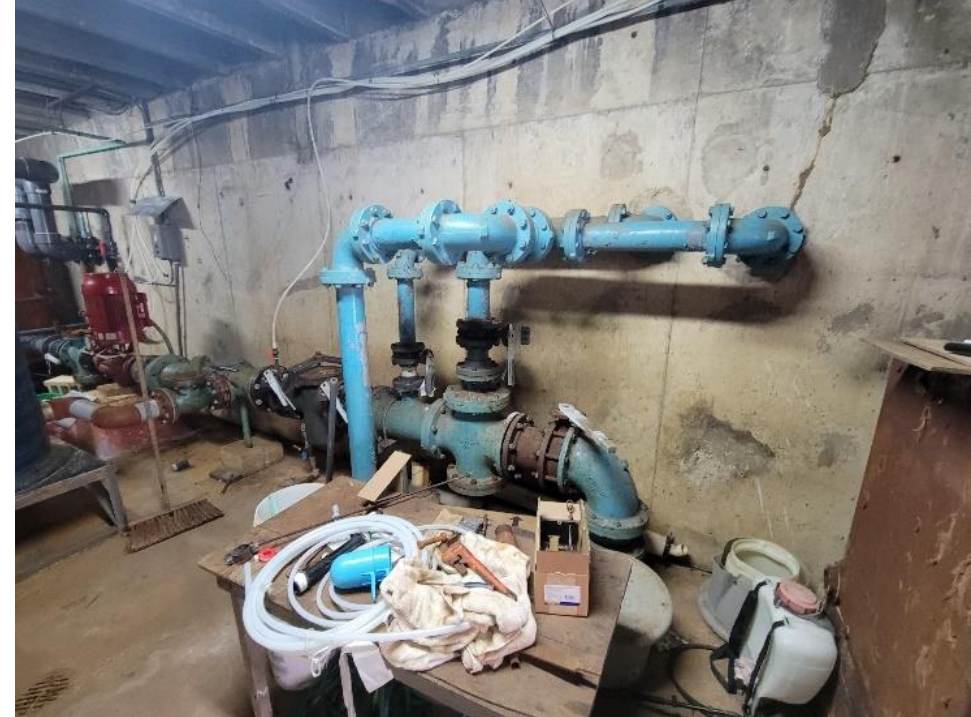
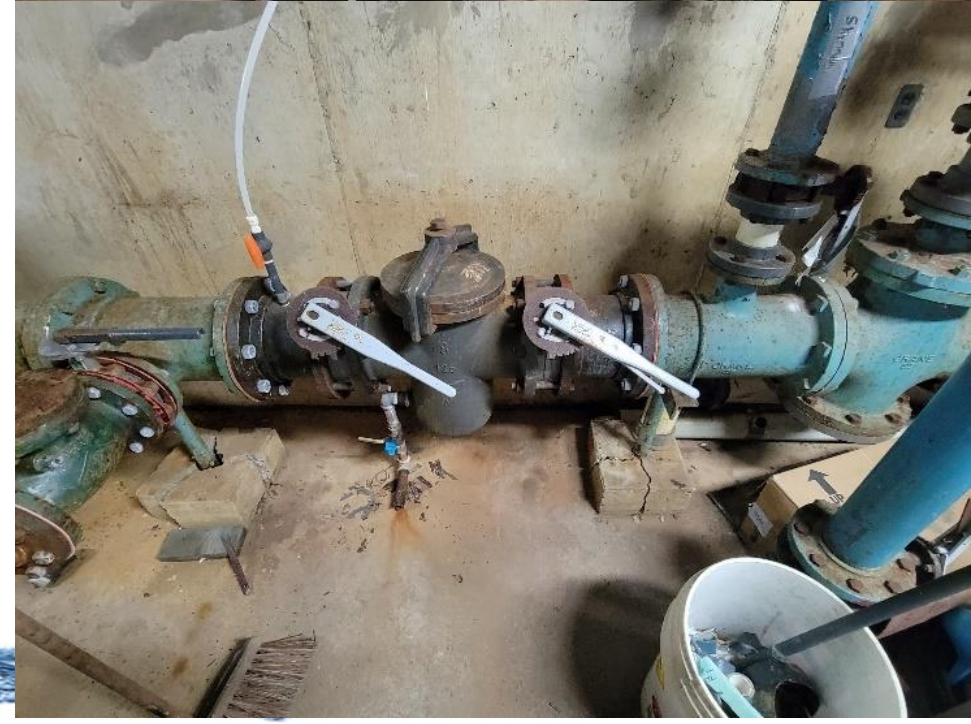
# Pool Piping & Water Loss

- 14,000 gallons / day
- Buried cast iron piping and fittings original to 1955 construction transitions to PVC once in the basement mechanical room
- No visible signs of settling or subsurface issues
- Piping undersized based on current code, especially for perimeter overflow
