STAFF REPORT

CERTIFICATE OF APPROPRIATENESS

Application Number: 2018-0416B **Property Location:** 62290 Miami

APPLICATION ITEMS: "Emergency removal of silo."

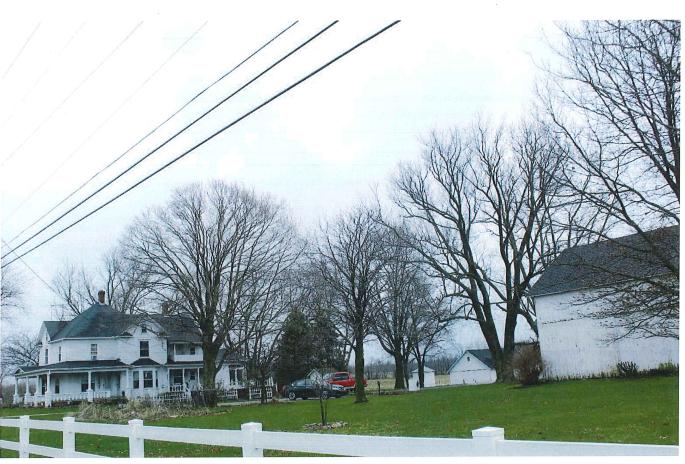
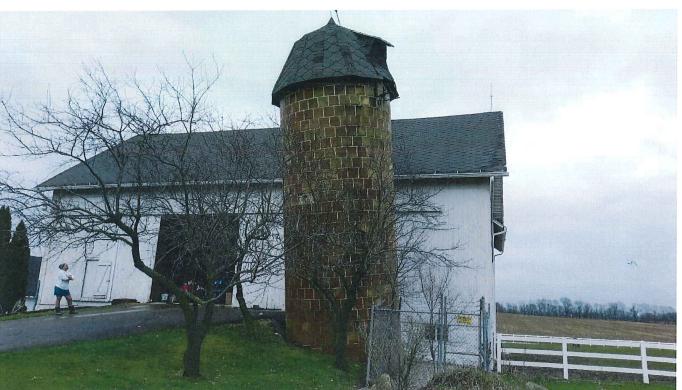
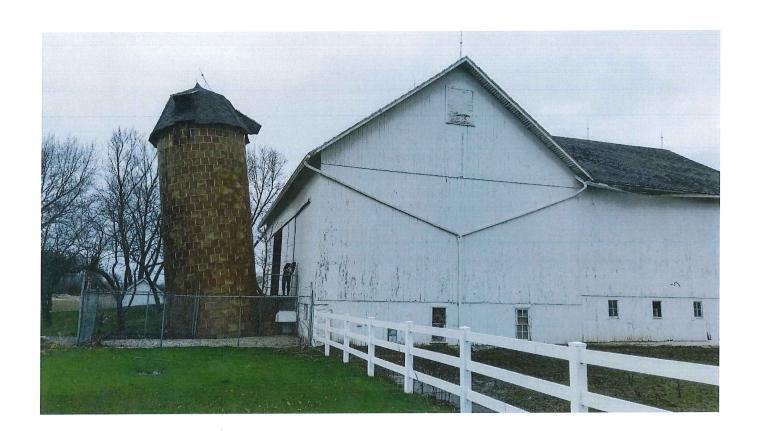
<u>DESCRIPTION OF PROPOSED PROJECT:</u> The foundation of the silo has failed causing the structure to begin collapsing toward the driveway. An unusually high amount of water saturation near the barn and silo is a contributing factor. There is evidence of an attempt to preserve the structure in the past by strapping the silo to the barn. The silo will need to be removed proactively to prevent damage to the barn foundation. As the silo is not being utilized, there is no plan to rebuild. There is a possibility for architectural salvage, including: a lighting rod, wall tiles, and perhaps the roof. The ground will be filled and landscaped accordingly.

May 7, 2018 This is a follow up to my visit on April 17, 2018. The department administrator, preservation specialist, and myself visited the site and inspected the tile-walled silo. The silo base foundation has failed and the silo has begun to lean and at the time was eight to ten feet out of square. The silo is a separate structure from the barn, but does have a feed room connection that runs to the lower level of the barn. The silo has moved away from the barn and the concrete drive approach. Elements are entering at this separation and is advancing the movement of the silo. Steve Szaday, Preservation Inspection

STAFF RECOMMENDATION: Staff recommends approval of the silo to be dismantled and advocates for reclamation of the lighting rod, wall tiles, and roof, if possible. Per the Standards and Guidelines, staff recommends that owner provide the Commission with comprehensive interior and exterior documentation for the file.
