STAFF REPORT
CONCERNING APPLICATION FOR A
CERTIFICATE OF APPROPRIATENESS

Application Number: 2018-0427

Property Location: 736 Portage Avenue

DESCRIPTION OF PROPOSED PROJECT: Replace four original wood 6/1 windows in front on basement level with new black aluminum full light casement windows, by Vinyl Craft, to match two windows replaced previously (without COA). The replacement windows will not reduce the overall size of the opening but will change the light pattern from 6/1 to full light. The existing windows have been deemed deteriorated beyond repair by Preservation Inspector and window repair contractor.

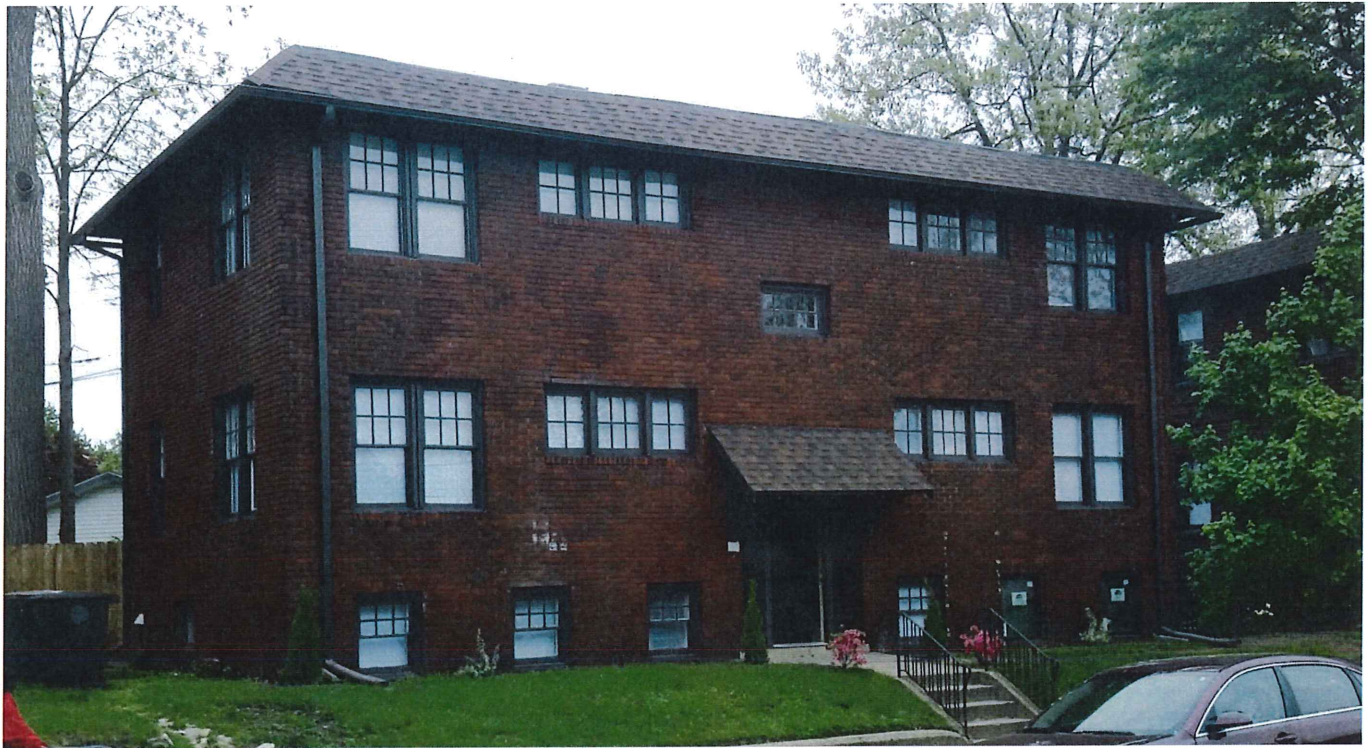
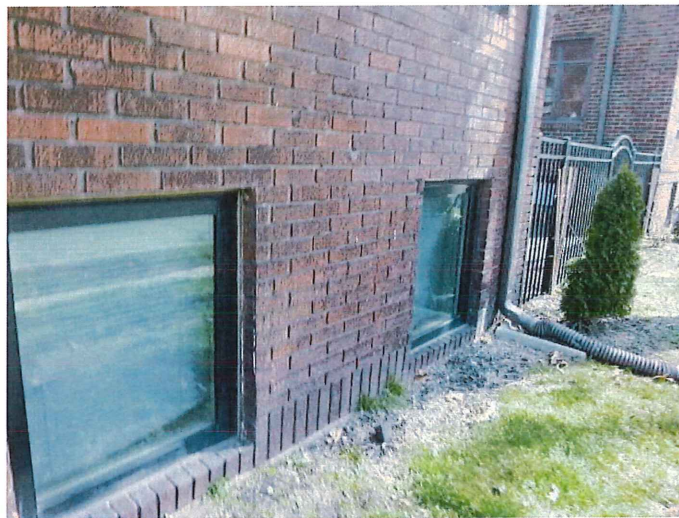
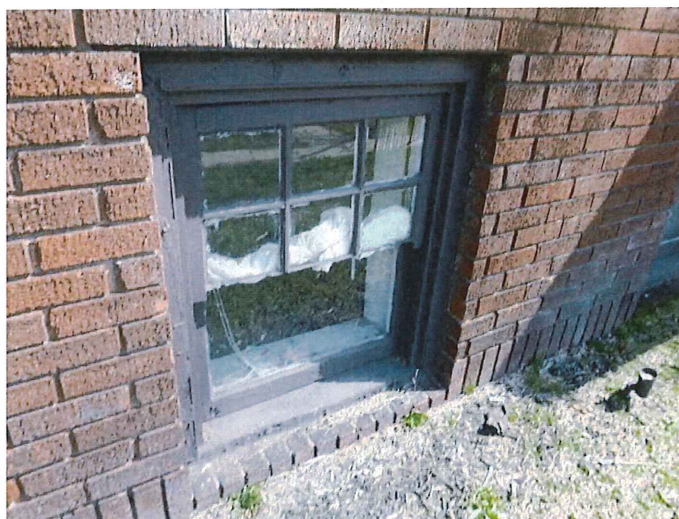
DESCRIPTION OF STRUCTURE/SITE: The apartment building is three stories with a rectangular plan and is constructed of brick. Roof is hip covered in asphalt shingles. Most windows are original wood with a variety of patterns including: casement, 6/1, and 1/1. Front entry features divided light sidelights on either side of wood door with shed roof supported by wood brackets.

ALTERATIONS: Two original wood 6/1 windows were replaced with black aluminum full light casement without COA.

March 21, 2018 I met with the property manager of 736 Portage, Valerie of VPM at the location. We discussed window replacement for the basement windows at 736. Some windows at both buildings at the lower level have already been replaced from the wood double hung to aluminum casements. Four windows are wood double hung are not functioning and are damaged beyond repair. One sash is missing the meeting rail and another is completely missing the mortise and tenon joint. The casement windows also allow a legal egress.
Steve Szaday, Preservation Inspector

STAFF RECOMMENDATION: Staff recommends approval.

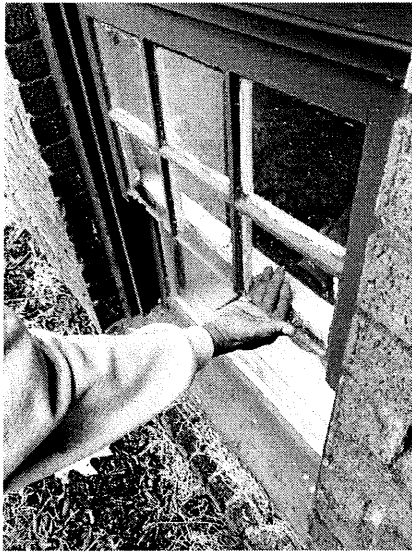
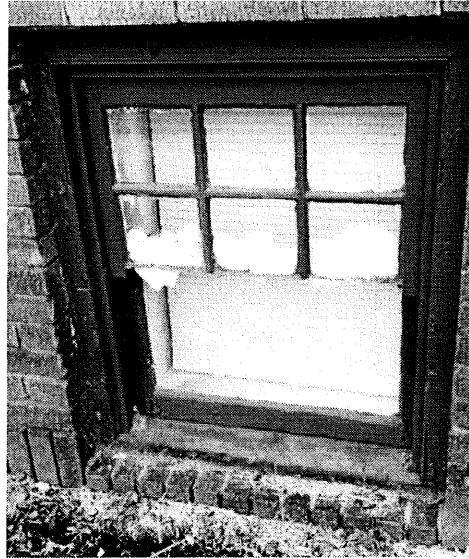
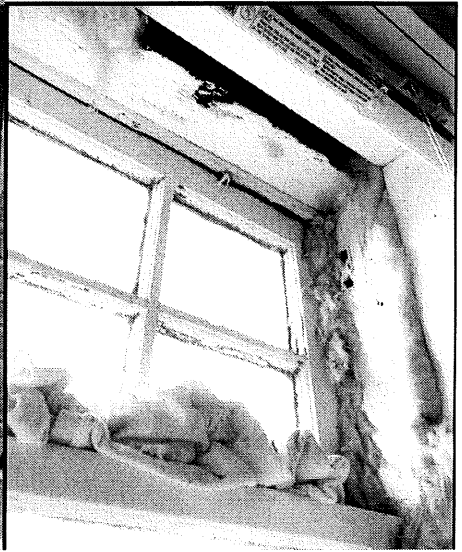
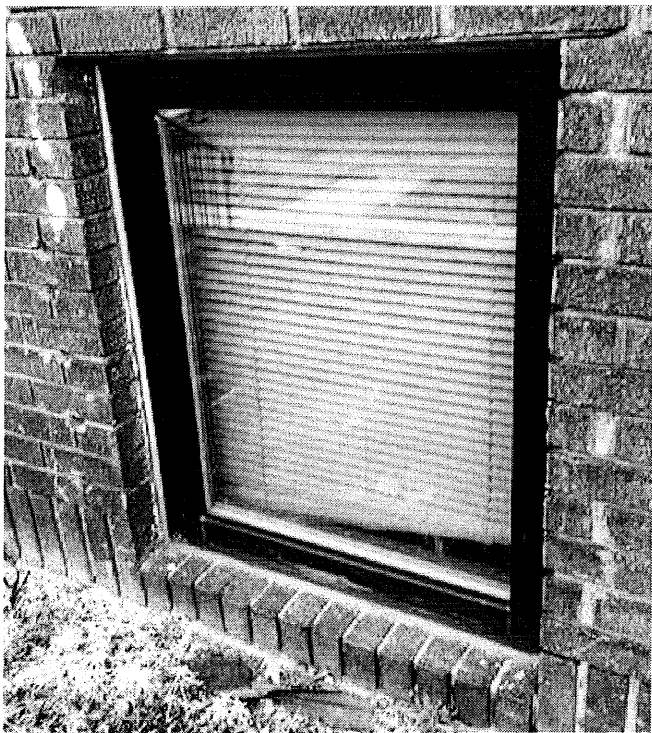
There are 4 windows on the basement level of the building that face the front of the building that are in very bad condition. All 4 windows face the front and are the original double hung wood windows. Two of these windows have frames that are cracked/broken and/or completely missing.

The old rotted windows are a safety hazard since they aren't secure, they are a health hazard because mice and other pests can easily come in to the building and that apartment. Randy from Indiana Glass has already looked at the older windows and due to the severity of the condition of them he recommended having them replaced to match the 2 newer windows.

Valerie Swihart,
Inspection of Windows at 736 Portage Ave.
The wood double hung windows at front elevation
on lower level are past the point of repair.
I would not attempt to try repairs because
windows will still be an inefficient energy
savings.

We just took over the management of this building as of March 1, 2018 and so that is why we are just now addressing the building. We want to replace the 4 original windows with the exact same windows that were already replaced. The 2 most south basement windows on the building have already been replaced with aluminum casement windows. We simply want to match these windows. The measurements of the windows are 30 inches wide and 39 ¾ inches tall. The windows would be black to match the ones that have already been installed.

I recommend a Casement window to match
the windows next to them.

These Casement Sash open easy for full exit
in case of fire emergency.

The use of LOW E + Argon gas Insulated Units
are advised.
