**Re: Comfort Letter Request
Former Hurwich Iron Company, Inc. / HIC Investments, LLC Property
1610, 1628 & 1636 Circle Avenue in South Bend, St. Joseph County, Indiana 46628
IDEM State Cleanup Program Site #0000923
Heartland Project #'s 5089-22-04 / 5089-22-05**

**HAZARDOUS WASTE
INSPECTION REPORT**
INDIANA DEPARTMENT OF
ENVIRONMENTAL MANAGEMENT

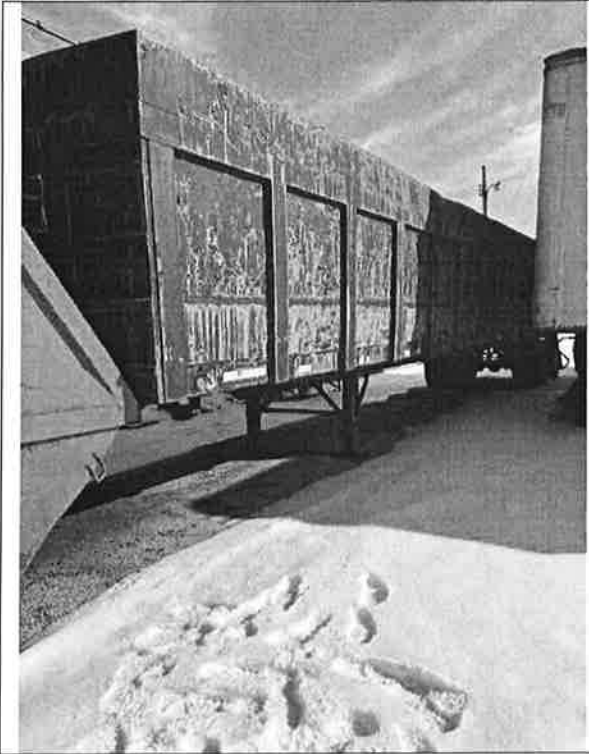
Number	1
	Description	Trailer 2 as identified in attachment B that has not moved since 2007, reference photo 67.
	Photographer	Hannah Hack
	Facility Name	HIC Investments, LLC
	Photo Date	01/31/2023
Others	Charles Breitenfeldt - IDEM Ken McDaniel - IDEM Mark Espich - St. Joseph County Department of Health Alex Bowman - Krieg DeVault LLP Mike Jones - Property Caretaker

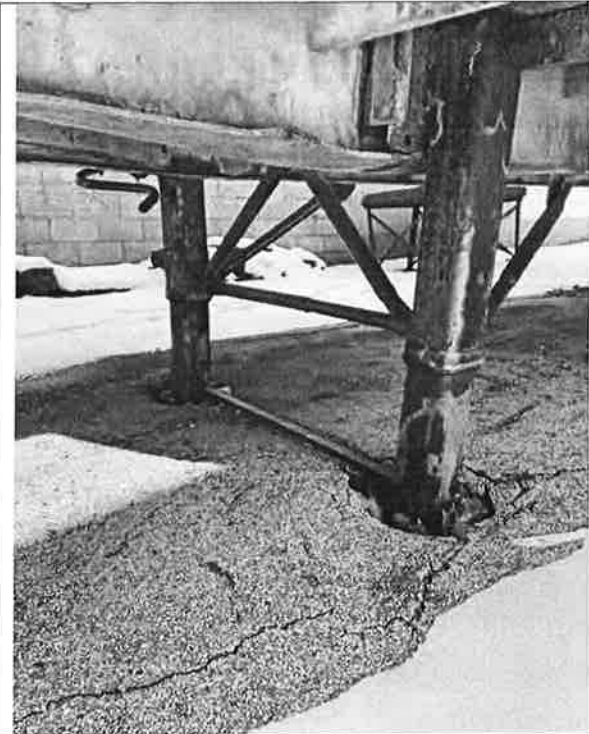
Number	2
	Description	Trailer 2 sinking into the ground, indication that the drums inside of it are at least all partially full.
	Photographer	Hannah Hack
	Facility Name	HIC Investments, LLC
	Photo Date	01/31/2023
Others	Charles Breitenfeldt - IDEM Ken McDaniel - IDEM Mark Espich - St. Joseph County Department of Health Alex Bowman - Krieg DeVault LLP Mike Jones - Property Caretaker

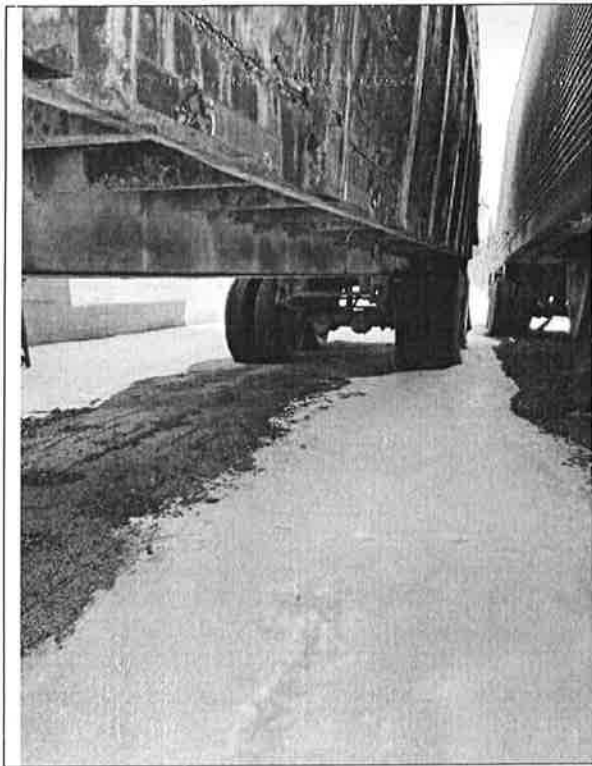
Number	3
Description	Trailer 2 rear axles, also sinking into the ground.
Photographer	Hannah Hack
Facility Name	HIC Investments, LLC
Photo Date	01/31/2023
Others	Charles Breitenfeldt - IDEM Ken McDaniel - IDEM Mark Espich - St. Joseph County Department of Health Alex Bowman - Krieg DeVault LLP Mike Jones - Property Caretaker

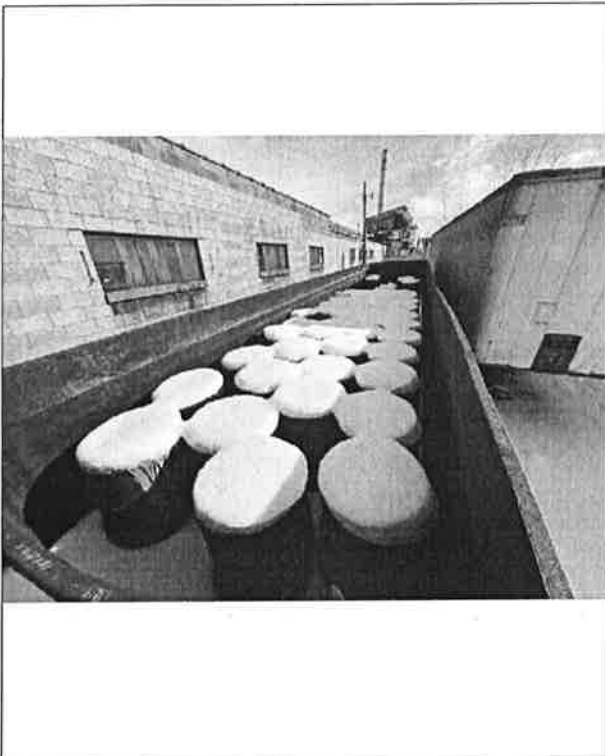
Number	4
Description	Inside of trailer 2, approximately 50 metal 55-gallon drums full of unknown contents, all are unlabeled.
Photographer	Hannah Hack
Facility Name	HIC Investments, LLC
Photo Date	01/31/2023
Others	Charles Breitenfeldt - IDEM Ken McDaniel - IDEM Mark Espich - St. Joseph County Department of Health Alex Bowman - Krieg DeVault LLP Mike Jones - Property Caretaker

Determine whether the containers listed in Attachment D are hazardous wastes as defined by 40 CFR 261.

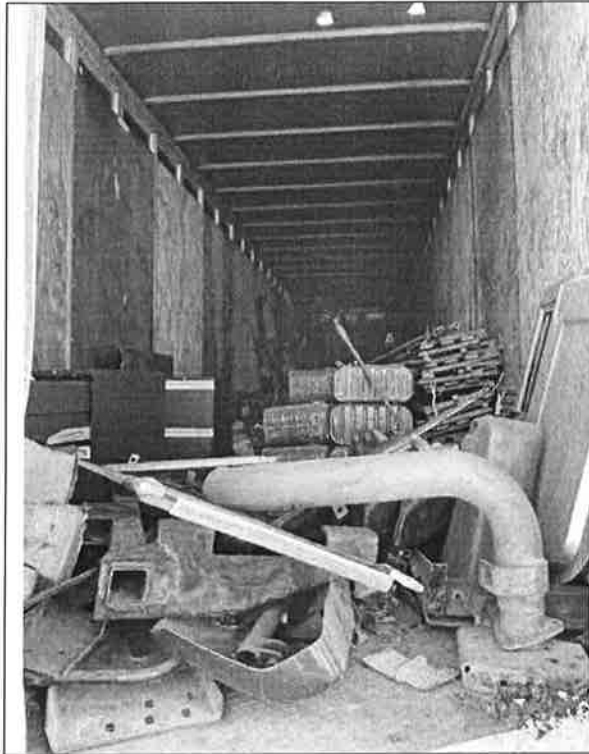
Number	5
Description	Trailer 3 full of old card parts and other scrap metal
Photographer	Hannah Hack
Facility Name	HIC Investments, LLC
Photo Date	01/31/2023
Others	Charles Breitenfeldt - IDEM Ken McDaniel - IDEM Mark Espich - St. Joseph County Department of Health Alex Bowman - Krieg DeVault LLP Mike Jones - Property Caretaker

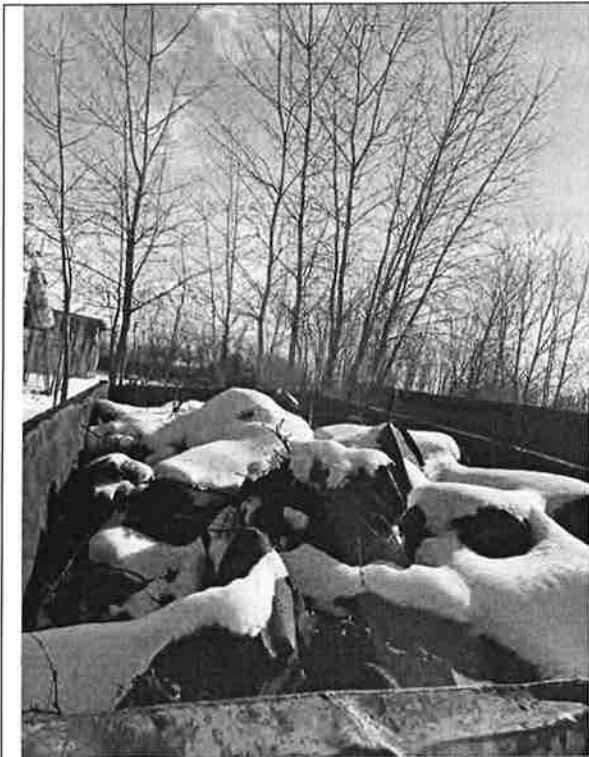
Number	6
Description	Steel roll-off dumpster to the east of trailers 4 and 5 that is full of decaying metal 55-gallon drums.
Photographer	Hannah Hack
Facility Name	HIC Investments, LLC
Photo Date	01/31/2023
Others	Charles Breitenfeldt - IDEM Ken McDaniel - IDEM Mark Espich - St. Joseph County Department of Health Alex Bowman - Krieg DeVault LLP Mike Jones - Property Caretaker

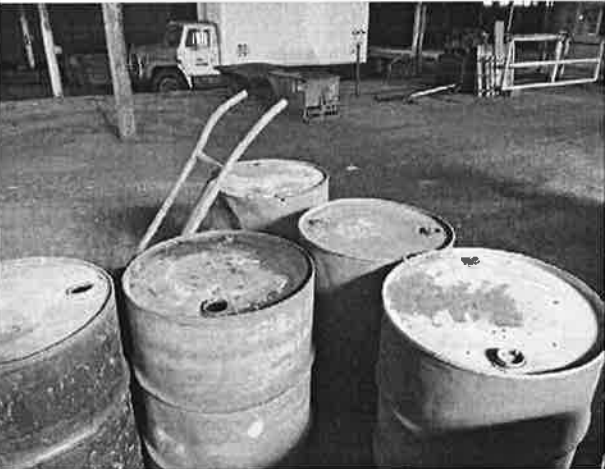
Number	8
	Description	Inside of Hurwich, 1628 Circle Ave. building (Hurwich 1628) on south wall. Five (5) drums with unknown contents in them and none of them are labeled: two of them were open, one has unknown green liquid on top of it, two appear to have an unknown liquid leaking from them, two of them were damaged, and two of them had holes in them.
	Photographer	Charles Breitenfeldt
	Facility Name	HIC Investments, LLC
	Photo Date	01/31/2023
	Others	Charles Breitenfeldt - IDEM Ken McDaniel - IDEM Mark Espich - St. Joseph County Department of Health Alex Bowman - Krieg DeVault LLP Mike Jones - Property Caretaker

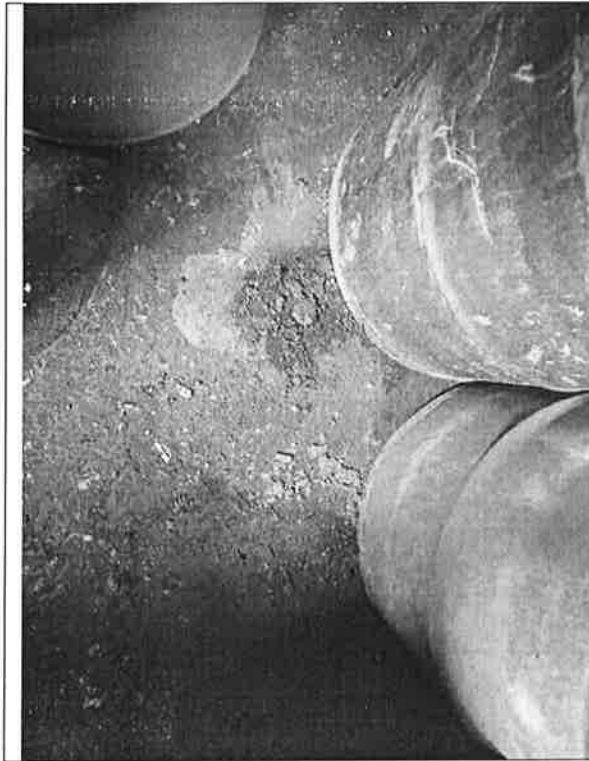
Number	9
Description	Same drums as in photo 8, this is the drum that appears to have an unknown liquid leaking from it.
Photographer	Hannah Hack
Facility Name	HIC Investments, LLC
Photo Date	01/31/2023
Others	Charles Breitenfeldt - IDEM Ken McDaniel - IDEM Mark Espich - St. Joseph County Department of Health Alex Bowman - Krieg DeVault LLP Mike Jones - Property Caretaker

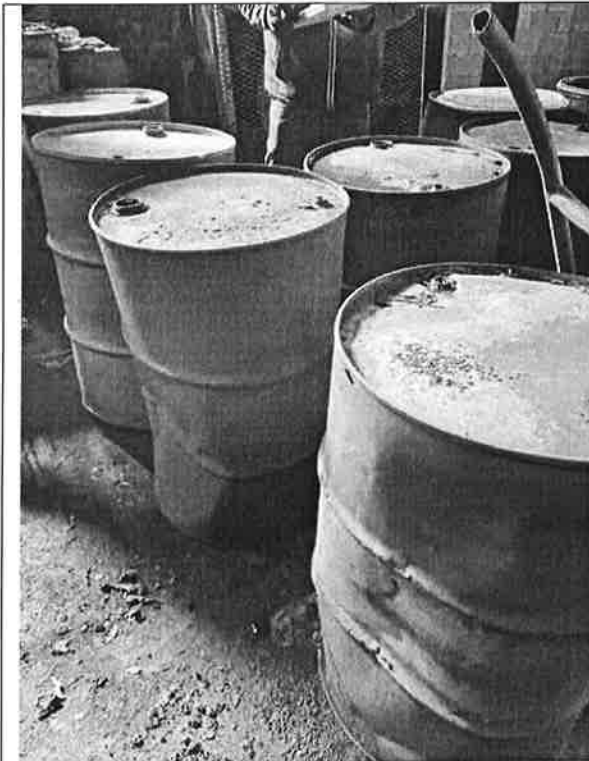
Number	10
Description	Same drums as in photo 8, showing damaged drums with unknown liquids inside of them and another drum that has an unknown liquid leaking from it.
Photographer	Hannah Hack
Facility Name	HIC Investments, LLC
Photo Date	01/31/2023
Others	Charles Breitenfeldt - IDEM Ken McDaniel - IDEM Mark Espich - St. Joseph County Department of Health Alex Bowman - Krieg DeVault LLP Mike Jones - Property Caretaker

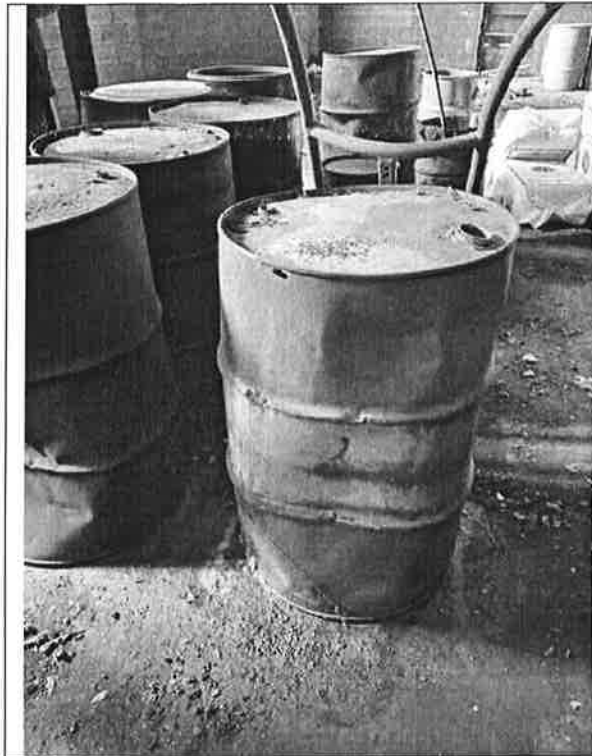
Number	11
Description	Same drum as in photo 10 showing drum is damaged, open, unlabeled, has an unknown liquid leaking from it.
Photographer	Hannah Hack
Facility Name	HIC Investments, LLC
Photo Date	01/31/2023
Others	Charles Breitenfeldt - IDEM Ken McDaniel - IDEM Mark Espich - St. Joseph County Department of Health Alex Bowman - Krieg DeVault LLP Mike Jones - Property Caretaker

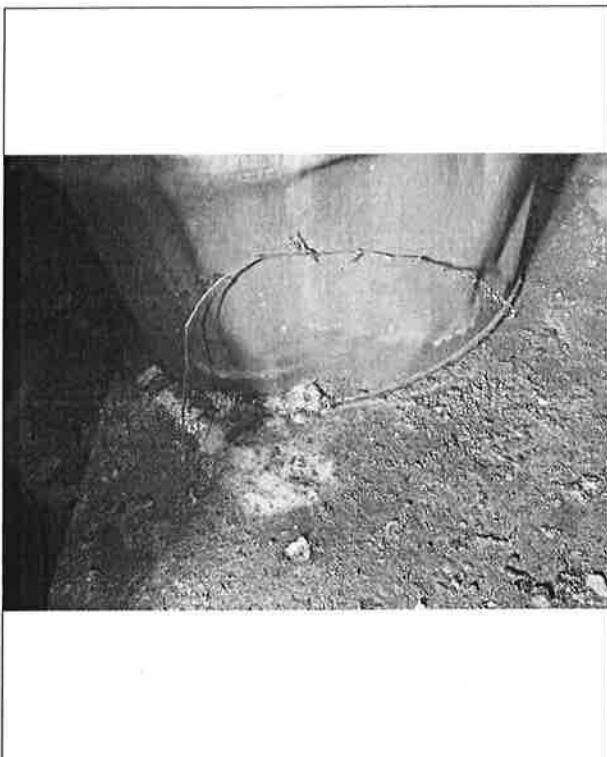
Number	12
Description	Close up from photo 11 of the unknown liquid leaking out of the drum.
Photographer	Hannah Hack
Facility Name	HIC Investments, LLC
Photo Date	01/31/2023
Others	Charles Breitenfeldt - IDEM Ken McDaniel - IDEM Mark Espich - St. Joseph County Department of Health Alex Bowman - Krieg DeVault LLP Mike Jones - Property Caretaker

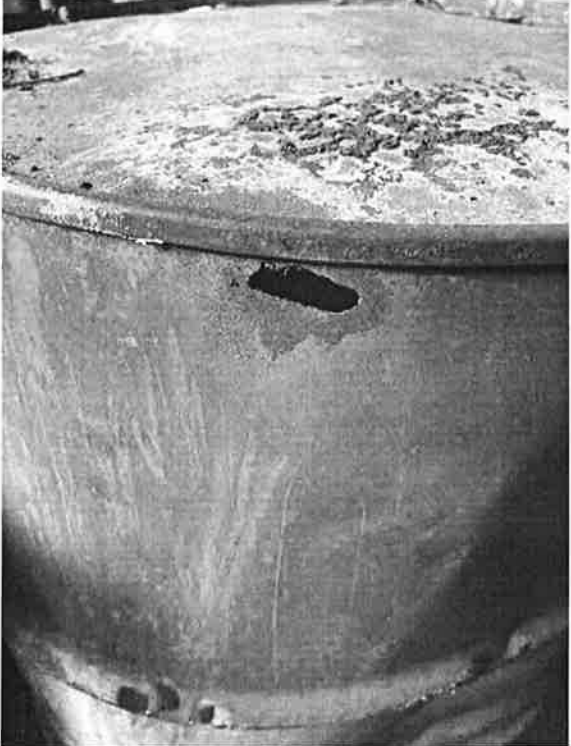
Number	13
	Description	Drum from photo 8 that is badly damaged, with a hole in it. Has unknown liquid inside of it and is unlabeled.
	Photographer	Hannah Hack
	Facility Name	HIC Investments, LLC
	Photo Date	01/31/2023
	Others	Charles Breitenfeldt - IDEM Ken McDaniel - IDEM Mark Espich - St. Joseph County Department of Health Alex Bowman - Krieg DeVault LLP Mike Jones - Property Caretaker

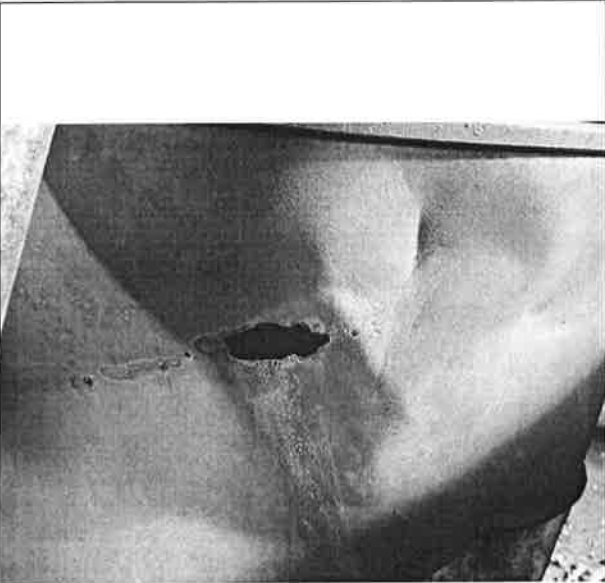
Number	14
	Description	A different drum from photo 8 that is badly damaged, with a hole in it. Has unknown liquid inside of it and is unlabeled.
	Photographer	Hannah Hack
	Facility Name	HIC Investments, LLC
	Photo Date	01/31/2023
	Others	Charles Breitenfeldt - IDEM Ken McDaniel - IDEM Mark Espich - St. Joseph County Department of Health Alex Bowman - Krieg DeVault LLP Mike Jones - Property Caretaker

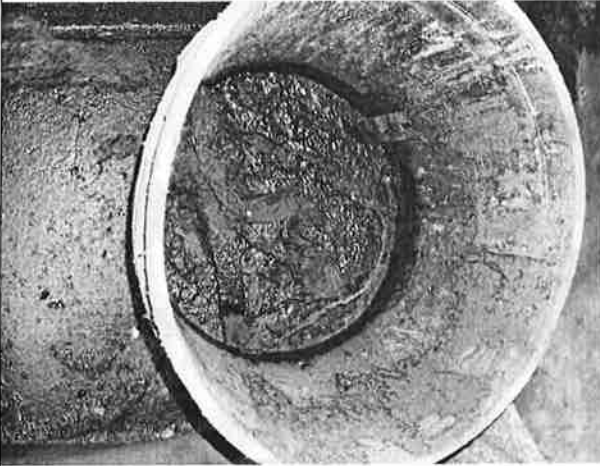
Number	15
	Description	5-gallon plastic bucket in front of “the Big Squeeze” that is open, unlabeled, and has an unknown liquid inside of it mixed with municipal trash found in Hurwich 1628.
	Photographer	Hannah Hack
	Facility Name	HIC Investments, LLC
	Photo Date	01/31/2023
	Others	Charles Breitenfeldt - IDEM Ken McDaniel - IDEM Mark Espich - St. Joseph County Department of Health Alex Bowman - Krieg DeVault LLP Mike Jones - Property Caretaker

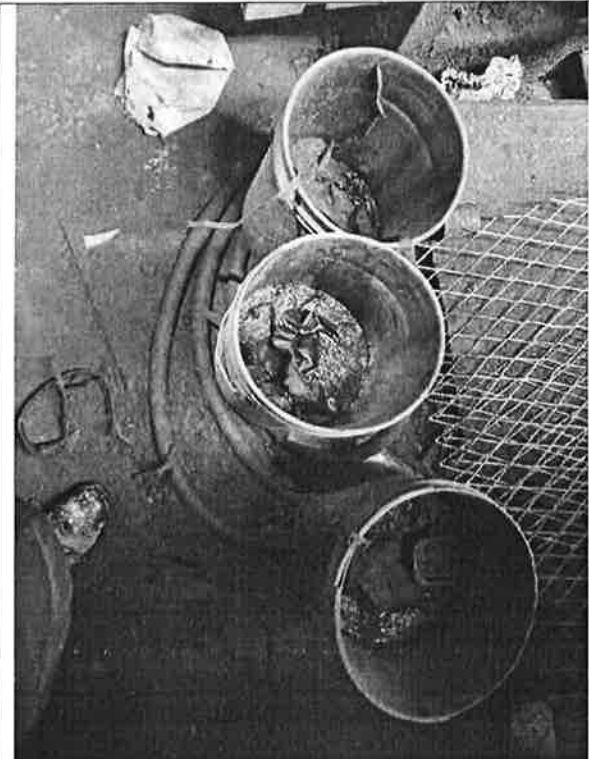
Number	16
	Description	Three 5-gallon plastic buckets that are open, unlabeled and have an unknown grease like substance in them mixed with municipal trash found in Hurwich 1628.
	Photographer	Hannah Hack
	Facility Name	HIC Investments, LLC
	Photo Date	01/31/2023
	Others	Charles Breitenfeldt - IDEM Ken McDaniel - IDEM Mark Espich - St. Joseph County Department of Health Alex Bowman - Krieg DeVault LLP Mike Jones - Property Caretaker

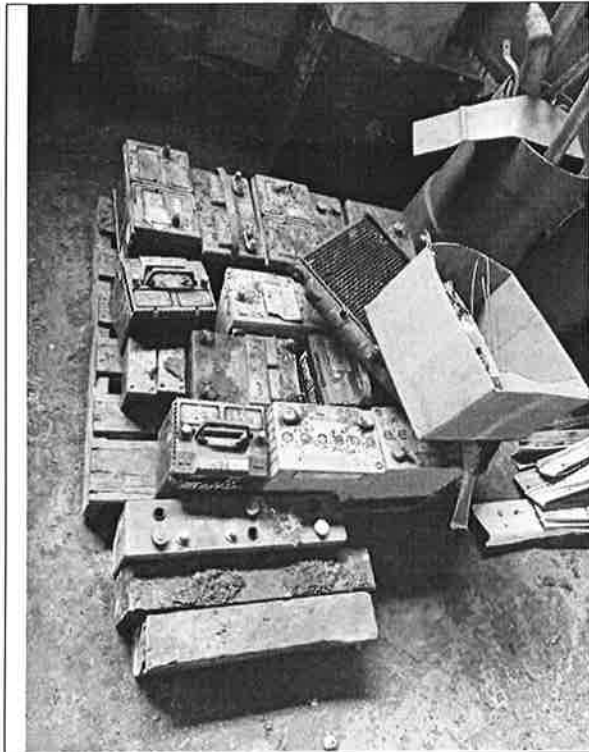
Number	17
Description	Pallet of 20 degrading batteries of varying sizes that are not labeled nor dated found in Hurwich 1628.
Photographer	Charles Breitenfeldt
Facility Name	HIC Investments, LLC
Photo Date	01/31/2023
Others	Charles Breitenfeldt - IDEM Ken McDaniel - IDEM Mark Espich - St. Joseph County Department of Health Alex Bowman - Krieg DeVault LLP Mike Jones - Property Caretaker

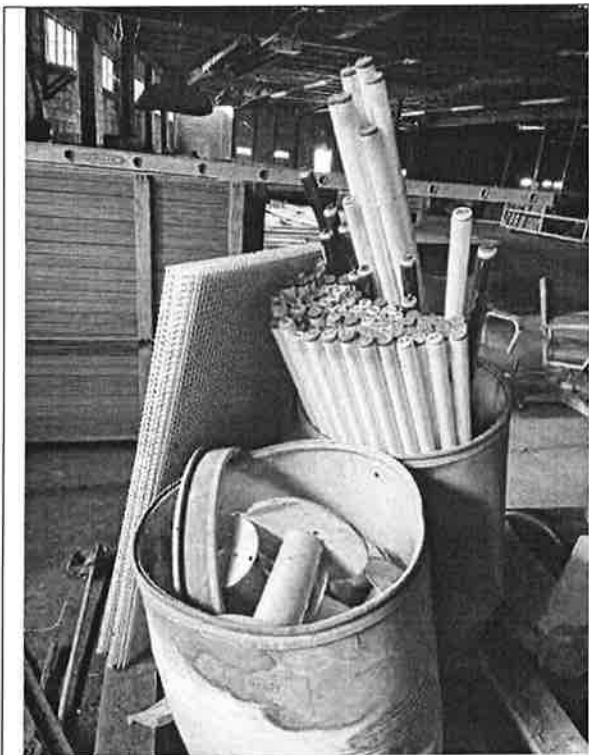
Number	18
Description	Damaged 55-gallon plastic drum containing used fluorescent lamps of varying sizes that are open, not labeled, nor dated found in Hurwich 1628.
Photographer	Charles Breitenfeldt
Facility Name	HIC Investments, LLC
Photo Date	01/31/2023
Others	Charles Breitenfeldt - IDEM Ken McDaniel - IDEM Mark Espich - St. Joseph County Department of Health Alex Bowman - Krieg DeVault LLP Mike Jones - Property Caretaker

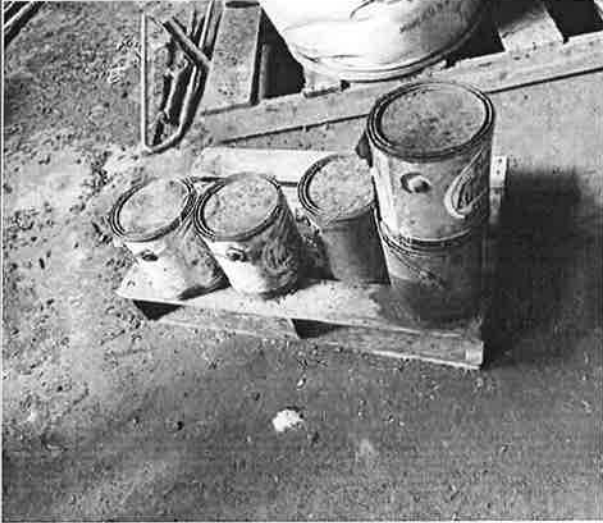
Number	19
	Description	Small pallet found in Hurwich 1628 containing five 1-gallon containers of Plastic Magi-Lux. The containers are degrading, and the contents of the containers are unknown.
	Photographer	Hannah Hack
	Facility Name	HIC Investments, LLC
	Photo Date	01/31/2023
	Others	Charles Breitenfeldt - IDEM Ken McDaniel - IDEM Mark Espich - St. Joseph County Department of Health Alex Bowman - Krieg DeVault LLP Mike Jones - Property Caretaker

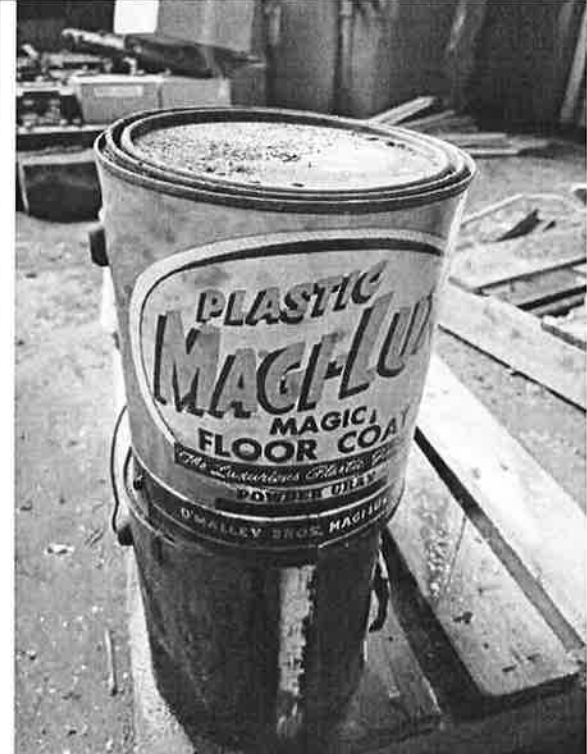
Number	20
	Description	Close up of one of the containers in photo 19.
	Photographer	Hannah Hack
	Facility Name	HIC Investments, LLC
	Photo Date	01/31/2023
	Others	Charles Breitenfeldt - IDEM Ken McDaniel - IDEM Mark Espich - St. Joseph County Department of Health Alex Bowman - Krieg DeVault LLP Mike Jones - Property Caretaker

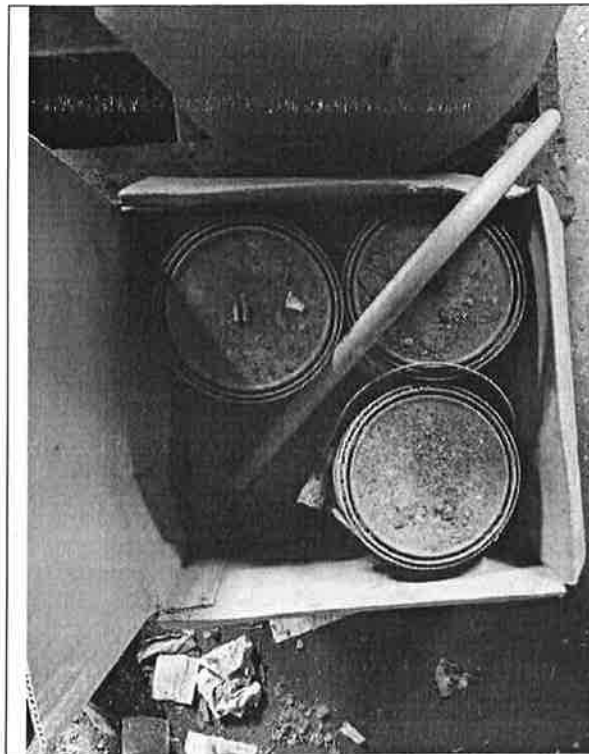
Number	21
Description	Box containing three 1-gallon containers of Plastic Magi-Lux found on the ground next to the 55-gallon drum of used lamps found in Hurwich 1628.
Photographer	Hannah Hack
Facility Name	HIC Investments, LLC
Photo Date	01/31/2023
Others	Charles Breitenfeldt - IDEM Ken McDaniel - IDEM Mark Espich - St. Joseph County Department of Health Alex Bowman - Krieg DeVault LLP Mike Jones - Property Caretaker

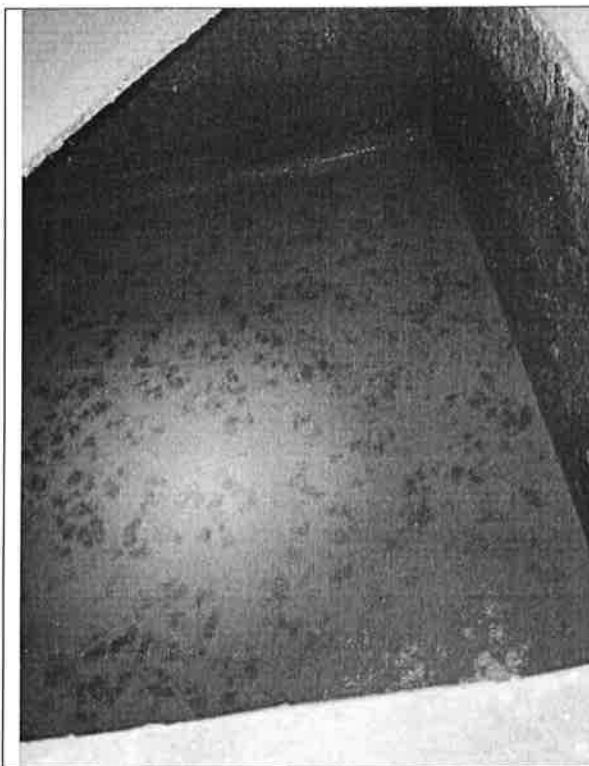
Number	22
Description	Vat of unknown green liquid that is open to the environment and is not labeled nor dated found in a separate small room in Hurwich 1628 along the southern wall.
Photographer	Hannah Hack
Facility Name	HIC Investments, LLC
Photo Date	01/31/2023
Others	Charles Breitenfeldt - IDEM Ken McDaniel - IDEM Mark Espich - St. Joseph County Department of Health Alex Bowman - Krieg DeVault LLP Mike Jones - Property Caretaker

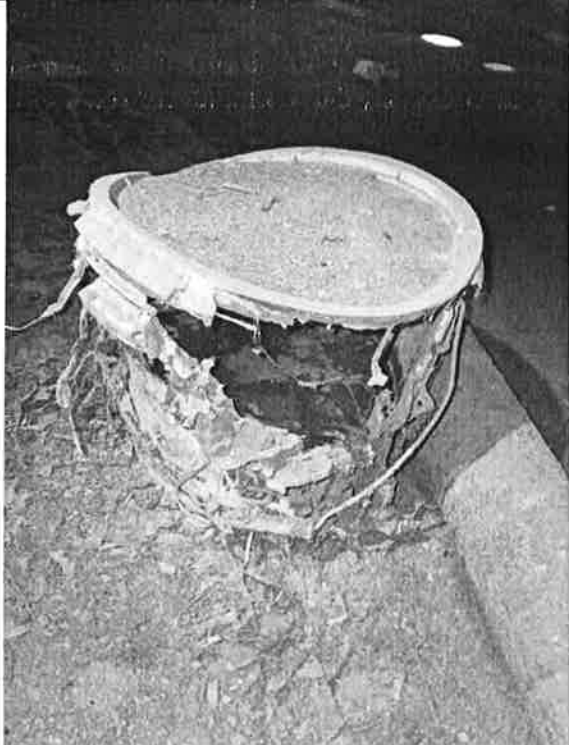
Number	23
	Description	Found in Hurwich 1628 in the southeast corner of the building was this highly degraded 5-gallon plastic bucket, it is unknown what was in the bucket or how this bucket came to be so degraded.
	Photographer	Hannah Hack
	Facility Name	HIC Investments, LLC
	Photo Date	01/31/2023
	Others	Charles Breitenfeldt - IDEM Ken McDaniel - IDEM Mark Espich - St. Joseph County Department of Health Alex Bowman - Krieg DeVault LLP Mike Jones - Property Caretaker

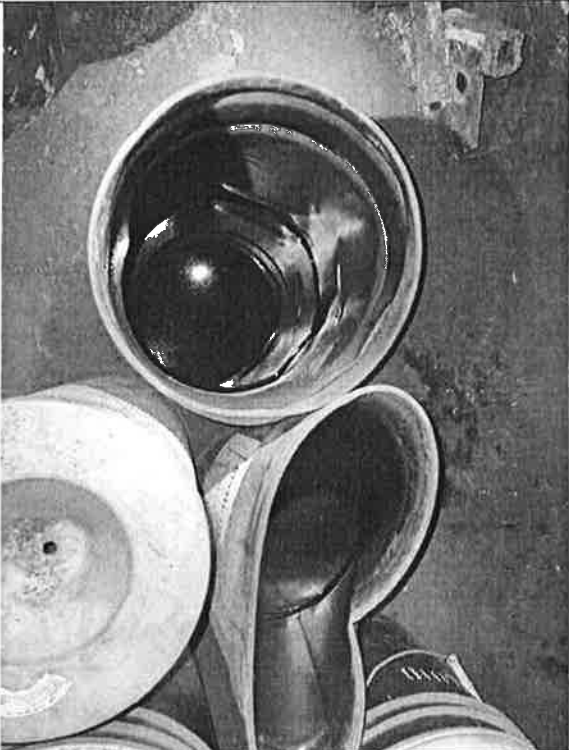
Number	24
	Description	Two metal 5-gallon buckets (with one that is severely compromised) containing unknown liquids. Both are open and unlabeled, found in Hurwich 1628 southeast corner of the building.
	Photographer	Hannah Hack
	Facility Name	HIC Investments, LLC
	Photo Date	01/31/2023
	Others	Charles Breitenfeldt - IDEM Ken McDaniel - IDEM Mark Espich - St. Joseph County Department of Health Alex Bowman - Krieg DeVault LLP Mike Jones - Property Caretaker

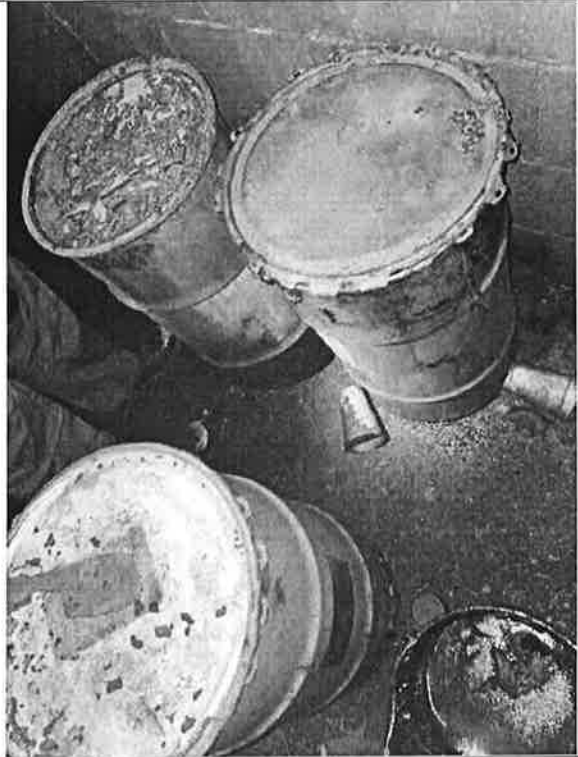
Number	25
	Description	Found in Hurwich 1628 maintenance crib. Three metal 20-gallon containers that are unlabeled and filled with an unknown substance.
	Photographer	Hannah Hack
	Facility Name	HIC Investments, LLC
	Photo Date	01/31/2023
Others	Charles Breitenfeldt - IDEM Ken McDaniel - IDEM Mark Espich - St. Joseph County Department of Health Alex Bowman - Krieg DeVault LLP Mike Jones - Property Caretaker

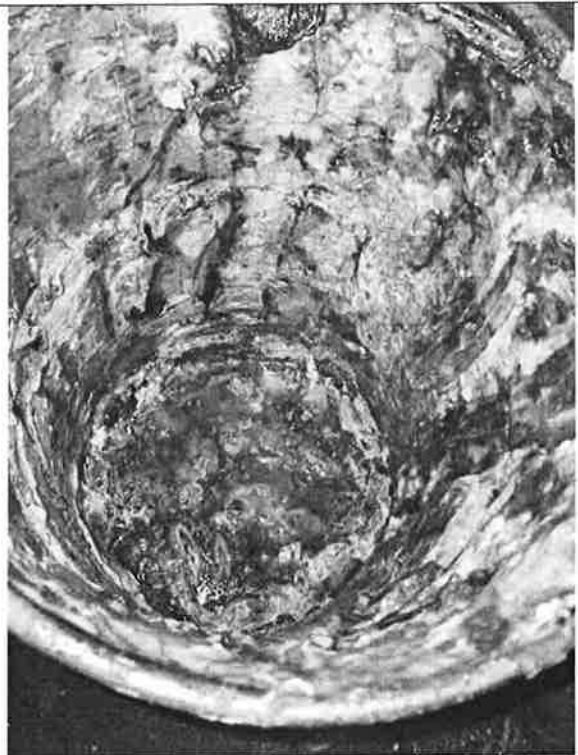
Number	26
	Description	Found in Hurwich 1628 maintenance crib; 5-gallon plastic bucket filled with an unknown substance that is unlabeled and open.
	Photographer	Hannah Hack
	Facility Name	HIC Investments, LLC
	Photo Date	01/31/2023
Others	Charles Breitenfeldt - IDEM Ken McDaniel - IDEM Mark Espich - St. Joseph County Department of Health Alex Bowman - Krieg DeVault LLP Mike Jones - Property Caretaker

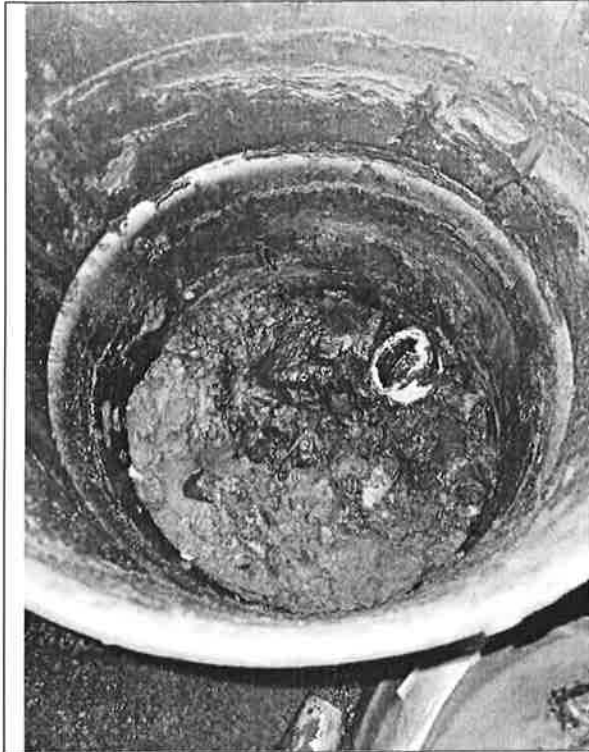
Number	27
Description	Found in Hurwich 1628 maintenance crib; 5-gallon plastic bucket filled with an unknown substance that is unlabeled and open.
Photographer	Hannah Hack
Facility Name	HIC Investments, LLC
Photo Date	01/31/2023
Others	Charles Breitenfeldt - IDEM Ken McDaniel - IDEM Mark Espich - St. Joseph County Department of Health Alex Bowman - Krieg DeVault LLP Mike Jones - Property Caretaker

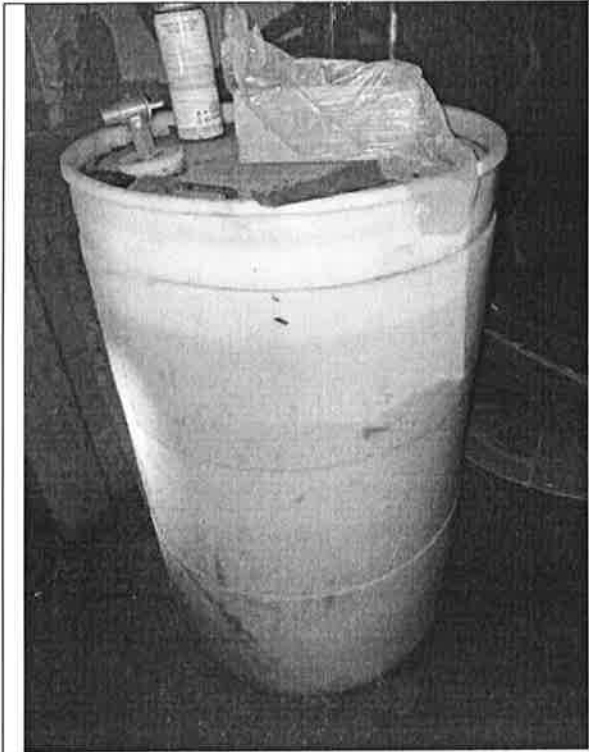
Number	28
Description	Found in Hurwich 1628 maintenance crib; plastic 55-gallon drum filled with an unknown liquid that is unlabeled.
Photographer	Hannah Hack
Facility Name	HIC Investments, LLC
Photo Date	01/31/2023
Others	Charles Breitenfeldt - IDEM Ken McDaniel - IDEM Mark Espich - St. Joseph County Department of Health Alex Bowman - Krieg DeVault LLP Mike Jones - Property Caretaker

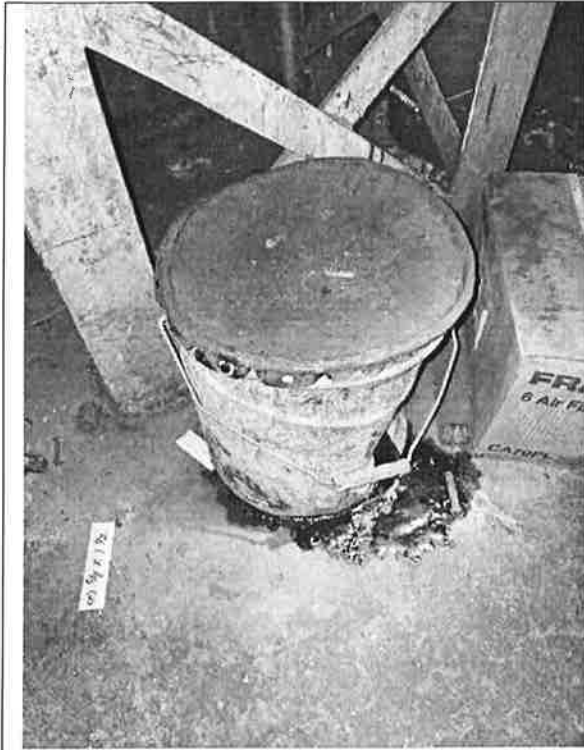
Number	29
Description	Found in Hurwich 1628 maintenance crib-back room; 5-gallon metal bucket that is damaged and leaking an unknown purple liquid. The bucket is also unlabeled.
Photographer	Hannah Hack
Facility Name	HIC Investments, LLC
Photo Date	01/31/2023
Others	Charles Breitenfeldt - IDEM Ken McDaniel - IDEM Mark Espich - St. Joseph County Department of Health Alex Bowman - Krieg DeVault LLP Mike Jones - Property Caretaker

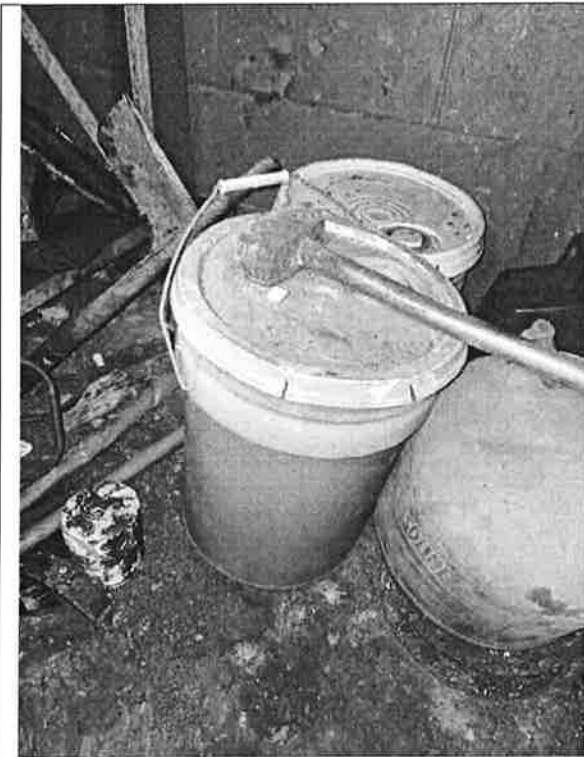
Number	30
Description	Found in Hurwich 1628 maintenance crib, by the entrance, two 5-gallon plastic buckets filled with an unknown purple liquid, both buckets are not labeled.
Photographer	Hannah Hack
Facility Name	HIC Investments, LLC
Photo Date	01/31/2023
Others	Charles Breitenfeldt - IDEM Ken McDaniel - IDEM Mark Espich - St. Joseph County Department of Health Alex Bowman - Krieg DeVault LLP Mike Jones - Property Caretaker

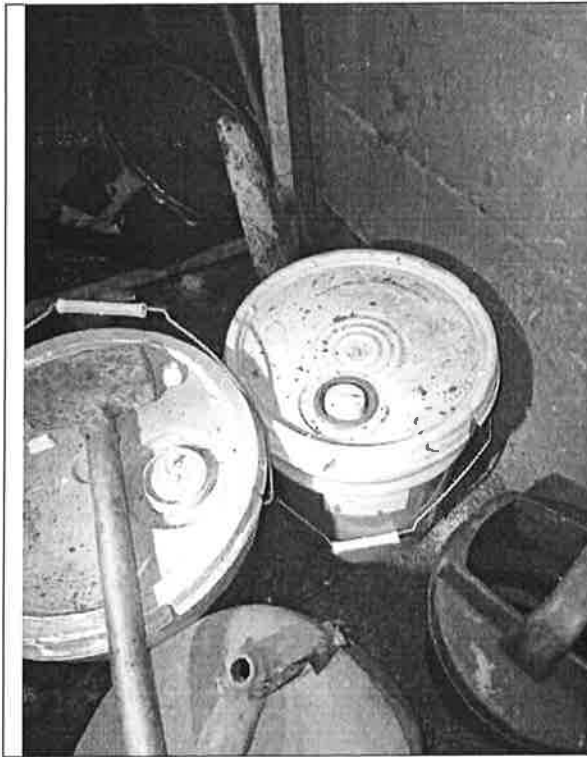
Number	31
Description	Top view of photo 30 showing the second bucket better.
Photographer	Hannah Hack
Facility Name	HIC Investments, LLC
Photo Date	01/31/2023
Others	Charles Breitenfeldt - IDEM Ken McDaniel - IDEM Mark Espich - St. Joseph County Department of Health Alex Bowman - Krieg DeVault LLP Mike Jones - Property Caretaker

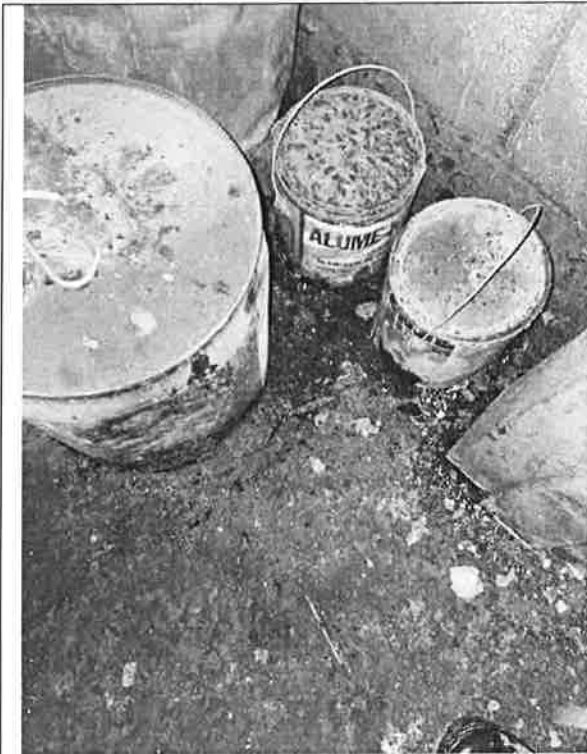
Number	32
Description	Found in Hurwich 1628 maintenance crib, by the entrance, 5-gallon metal container that was closed, but unlabeled and had an unknown substance leaking out of the bottom of it. Also two 1-gallon cans, waste status unknown.
Photographer	Hannah Hack
Facility Name	HIC Investments, LLC
Photo Date	01/31/2023
Others	Charles Breitenfeldt - IDEM Ken McDaniel - IDEM Mark Espich - St. Joseph County Department of Health Alex Bowman - Krieg DeVault LLP Mike Jones - Property Caretaker

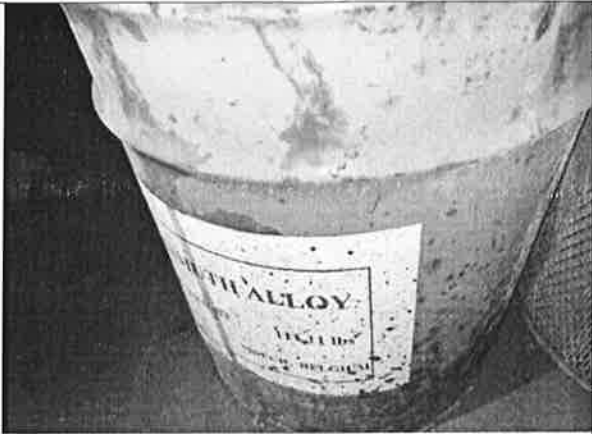
Number	33
	Description	Found in Hurwich 1628 maintenance crib, to the left of the entrance.
	Photographer	Hannah Hack
	Facility Name	HIC Investments, LLC
	Photo Date	01/31/2023
	Others	Charles Breitenfeldt - IDEM Ken McDaniel - IDEM Mark Espich - St. Joseph County Department of Health Alex Bowman - Krieg DeVault LLP Mike Jones - Property Caretaker

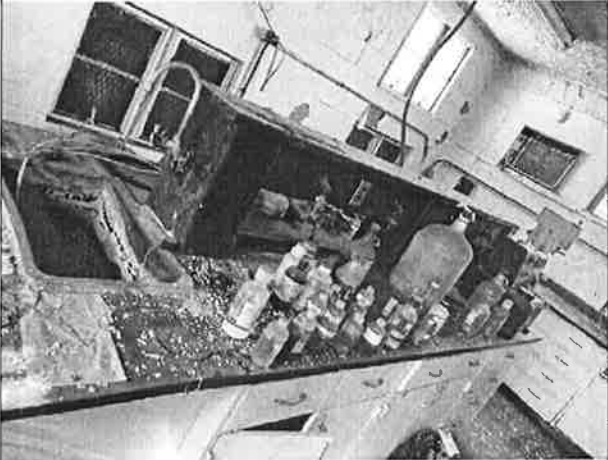
Number	34
	Description	Quality control lab found in the upstairs part of Hurwich 1628. These are several unknown chemicals in containers of varying size. Some are glass and some are plastic. See attachment C for a full list and approximate sizes.
	Photographer	Hannah Hack
	Facility Name	HIC Investments, LLC
	Photo Date	01/31/2023
	Others	Charles Breitenfeldt - IDEM Ken McDaniel - IDEM Mark Espich - St. Joseph County Department of Health Alex Bowman - Krieg DeVault LLP Mike Jones - Property Caretaker

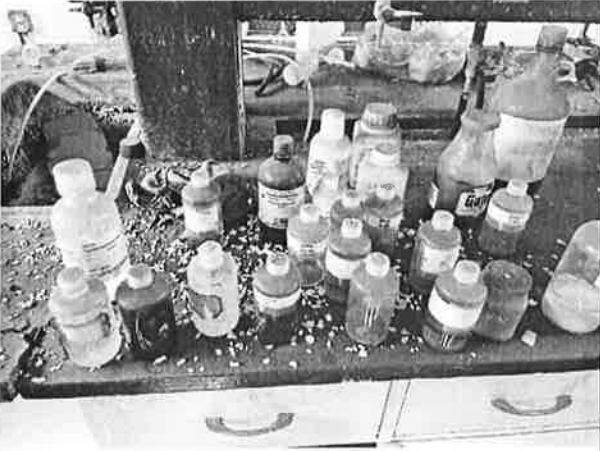
Number	35
	Description	Close up of the bench area in photo 34
	Photographer	Hannah Hack
	Facility Name	HIC Investments, LLC
	Photo Date	01/31/2023
	Others	Charles Breitenfeldt - IDEM Ken McDaniel - IDEM Mark Espich - St. Joseph County Department of Health Alex Bowman - Krieg DeVault LLP Mike Jones - Property Caretaker

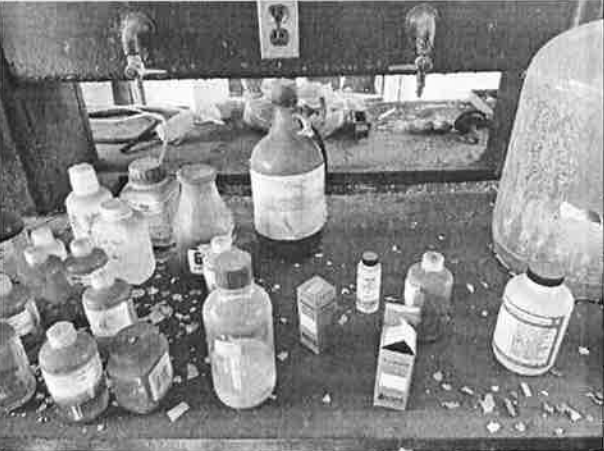
Number	36
	Description	Close up of the bench area in photo 34
	Photographer	Charles Breitenfeldt
	Facility Name	HIC Investments, LLC
	Photo Date	01/31/2023
	Others	Charles Breitenfeldt - IDEM Ken McDaniel - IDEM Mark Espich - St. Joseph County Department of Health Alex Bowman - Krieg DeVault LLP Mike Jones - Property Caretaker

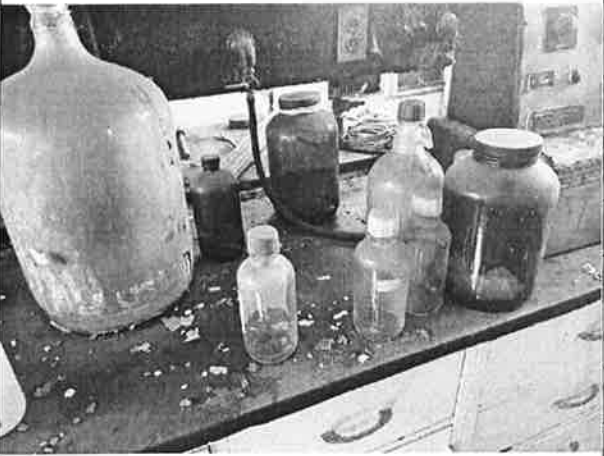
Number	37
	Description	Close up of the bench area in photo 34
	Photographer	Charles Breitenfeldt
	Facility Name	HIC Investments, LLC
	Photo Date	01/31/2023
	Others	Charles Breitenfeldt - IDEM Ken McDaniel - IDEM Mark Espich - St. Joseph County Department of Health Alex Bowman - Krieg DeVault LLP Mike Jones - Property Caretaker

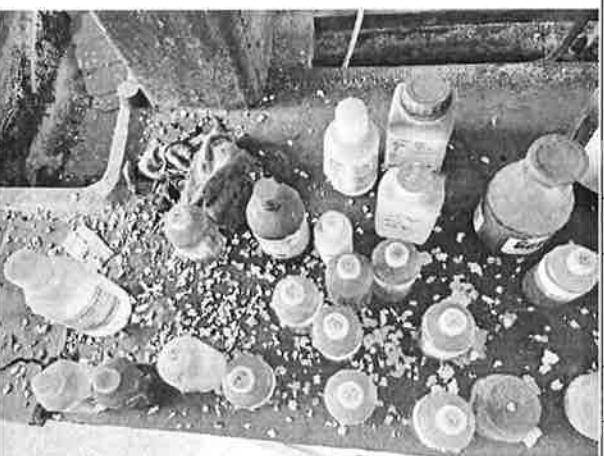
Number	38
	Description	Close up, top view, of the bench area in photo 34
	Photographer	Charles Breitenfeldt
	Facility Name	HIC Investments, LLC
	Photo Date	01/31/2023
Others	Charles Breitenfeldt - IDEM Ken McDaniel - IDEM Mark Espich - St. Joseph County Department of Health Alex Bowman - Krieg DeVault LLP Mike Jones - Property Caretaker

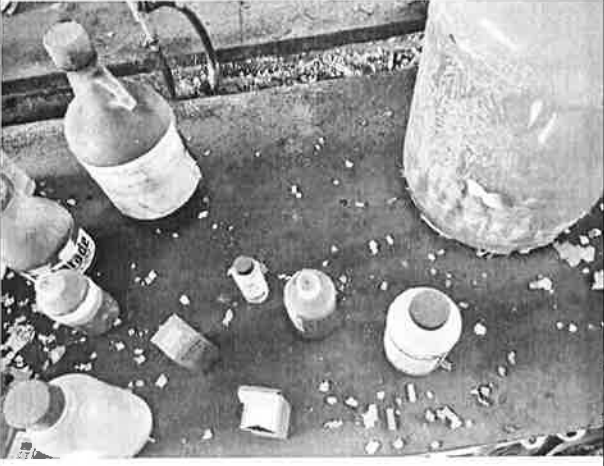
Number	39
	Description	Close up, top view, of the bench area in photo 34
	Photographer	Hannah Hack
	Facility Name	HIC Investments, LLC
	Photo Date	01/31/2023
	Others	Charles Breitenfeldt - IDEM Ken McDaniel - IDEM Mark Espich - St. Joseph County Department of Health Alex Bowman - Krieg DeVault LLP Mike Jones - Property Caretaker

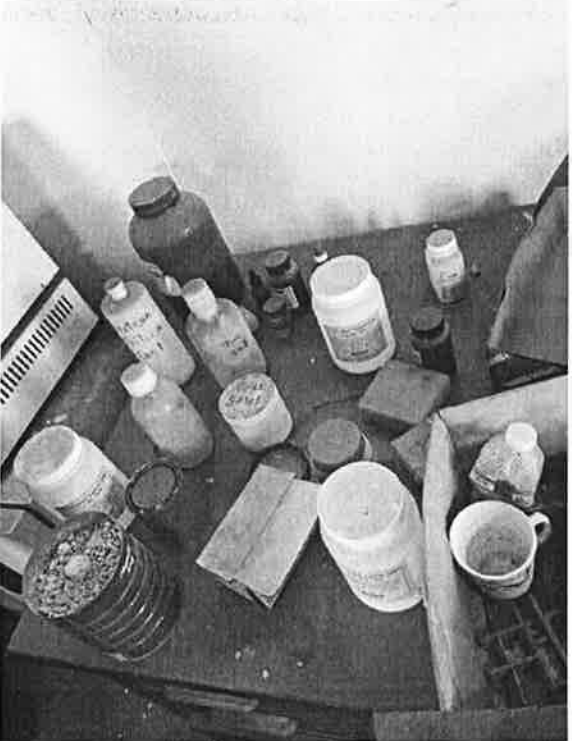
Number	40
	Description	Quality control lab found in the upstairs part of Hurwich 1628, this is on a desk around the corner from the main bench area shown in the previous photos. Several other containers of varying sizes and materials containing unknowns. A complete list of these can be found in attachment C.
	Photographer	Charles Breitenfeldt
	Facility Name	HIC Investments, LLC
	Photo Date	01/31/2023
Others	Charles Breitenfeldt - IDEM Ken McDaniel - IDEM Mark Espich - St. Joseph County Department of Health Alex Bowman - Krieg DeVault LLP Mike Jones - Property Caretaker

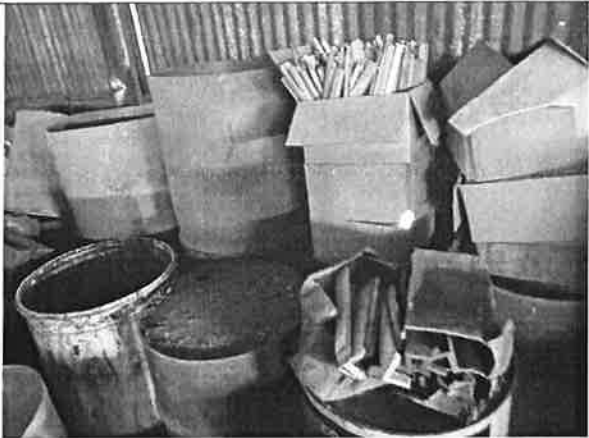
Number	41
	Description	Found inside of Hurwich building 1610 Circle Ave. against the far wall. Unknown waste inside of drums covered with municipal waste. No drums are labeled or dated.
	Photographer	Hannah Hack
	Facility Name	HIC Investments, LLC
	Photo Date	01/31/2023
	Others	Charles Breitenfeldt - IDEM Ken McDaniel - IDEM Mark Espich - St. Joseph County Department of Health Alex Bowman - Krieg DeVault LLP Mike Jones - Property Caretaker

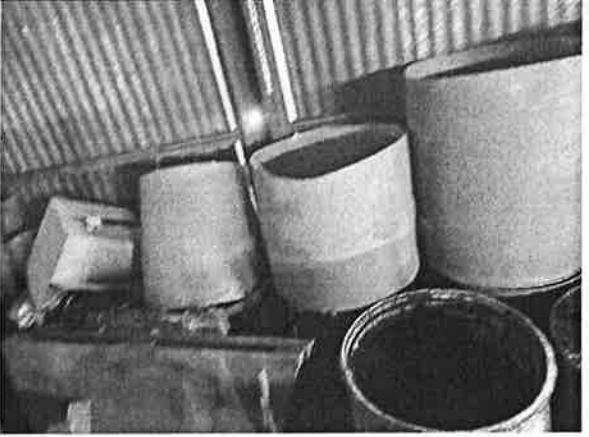
Number	42
	Description	Found inside of Hurwich building 1610 Circle Ave. against the far wall. Unknown waste inside of drums covered with municipal waste. No drums are labeled or dated.
	Photographer	Hannah Hack
	Facility Name	HIC Investments, LLC
	Photo Date	01/31/2023
	Others	Charles Breitenfeldt - IDEM Ken McDaniel - IDEM Mark Espich - St. Joseph County Department of Health Alex Bowman - Krieg DeVault LLP Mike Jones - Property Caretaker

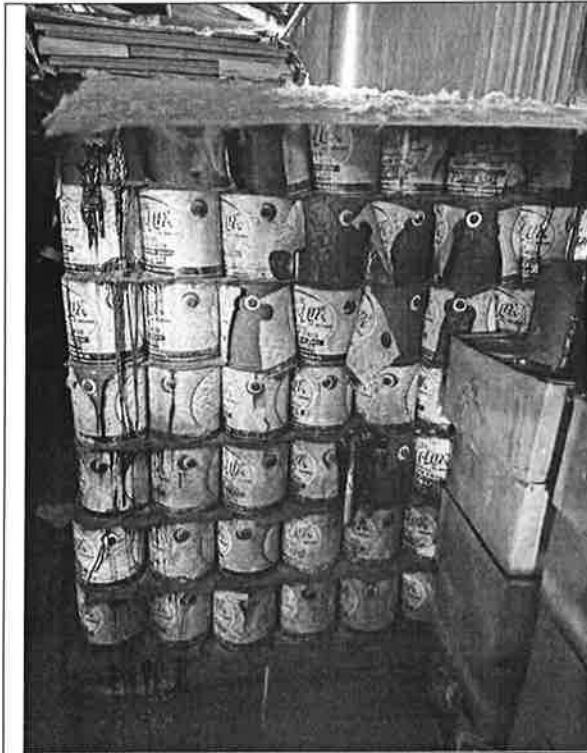
Number	43
Description	Found inside of Hurwich building 1610 Circle Ave. against the far wall: pallet containing 343 deteriorating 1-gallon cans of Plastic Magi-Lux and 12 boxes each containing four 1-gallon cans of Plastic Magi-Lux. Several cans are leaking waste onto the concrete floor.
Photographer	Hannah Hack
Facility Name	HIC Investments, LLC
Photo Date	01/31/2023
Others	Charles Breitenfeldt - IDEM Ken McDaniel - IDEM Mark Espich - St. Joseph County Department of Health Alex Bowman - Krieg DeVault LLP Mike Jones - Property Caretaker

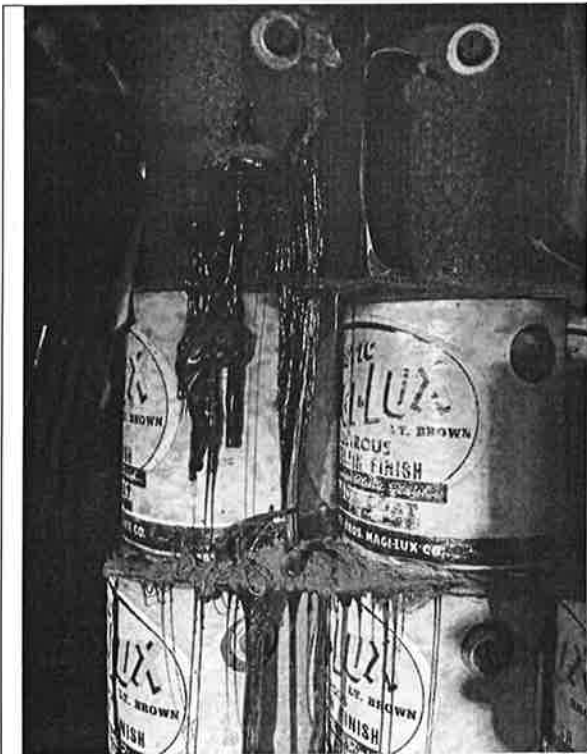
Number	44
Description	Close up picture of cans leaking from photo 43.
Photographer	Hannah Hack
Facility Name	HIC Investments, LLC
Photo Date	01/31/2023
Others	Charles Breitenfeldt - IDEM Ken McDaniel - IDEM Mark Espich - St. Joseph County Department of Health Alex Bowman - Krieg DeVault LLP Mike Jones - Property Caretaker

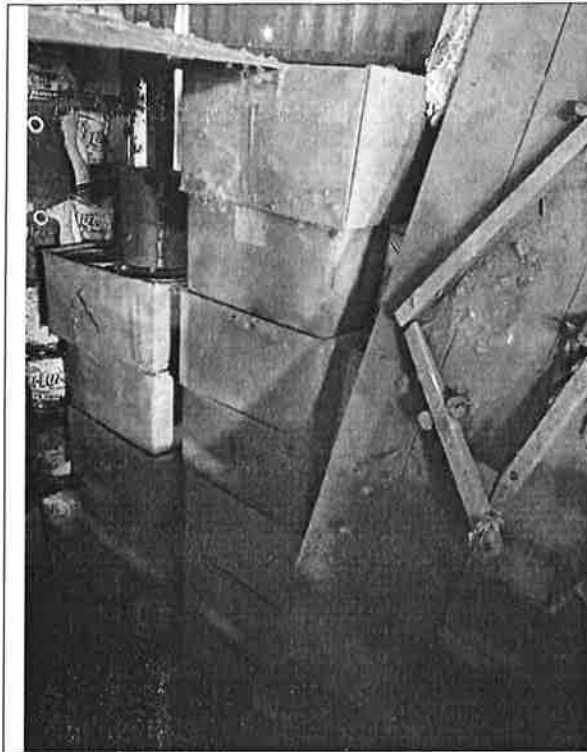
Number	45
Description	12 boxes each containing four 1-gallon cans of Plastic Magi-Lux. Same boxes as partially shown in photo 43.
Photographer	Hannah Hack
Facility Name	HIC Investments, LLC
Photo Date	01/31/2023
Others	Charles Breitenfeldt - IDEM Ken McDaniel - IDEM Mark Espich - St. Joseph County Department of Health Alex Bowman - Krieg DeVault LLP Mike Jones - Property Caretaker
