**Re: Comfort Letter Request
Former Hurwich Iron Company, Inc. / HIC Investments, LLC Property
1610, 1628 & 1636 Circle Avenue in South Bend, St. Joseph County, Indiana 46628
IDEM State Cleanup Program Site #0000923
Heartland Project #'s 5089-22-04 / 5089-22-05**

**HAZARDOUS WASTE
INSPECTION REPORT**
INDIANA DEPARTMENT OF
ENVIRONMENTAL MANAGEMENT

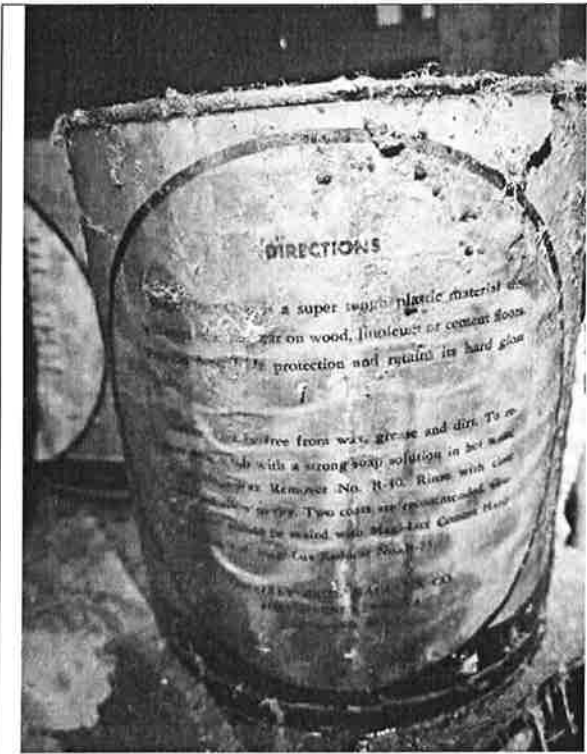
Number	46
Description	Close up photo of the label on the back of the Plastic Magi-Lux cans.
Photographer	Charles Breitenfeldt
Facility Name	HIC Investments, LLC
Photo Date	01/31/2023
Others	Charles Breitenfeldt - IDEM Ken McDaniel - IDEM Mark Espich - St. Joseph County Department of Health Alex Bowman - Krieg DeVault LLP Mike Jones - Property Caretaker

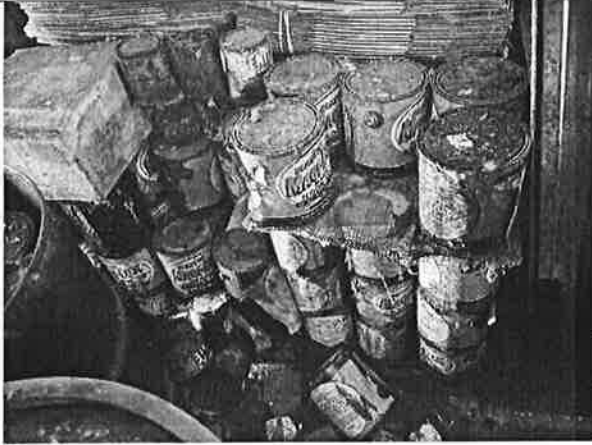
Number	47
	Description	Found inside of Hurwich building 1610 Circle Ave. against the far wall. Approximately 52 1-gallon cans of Plastic Magi-Lux. Some have fallen onto concrete floor and spilled open.
	Photographer	Hannah Hack
	Facility Name	HIC Investments, LLC
	Photo Date	01/31/2023
	Others	Charles Breitenfeldt - IDEM Ken McDaniel - IDEM Mark Espich - St. Joseph County Department of Health Alex Bowman - Krieg DeVault LLP Mike Jones - Property Caretaker

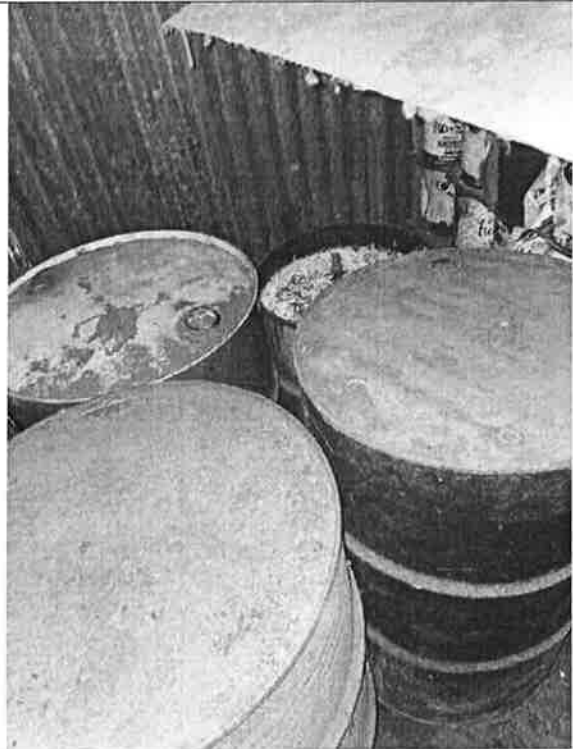
Number	48
	Description	Found inside of Hurwich building 1610 Circle Ave. against the far wall. Three metal 55-gallon drums filled with an unknown waste and one 20-gallon open metal container with an unknown waste inside, none of the drums were labeled.
	Photographer	Hannah Hack
	Facility Name	HIC Investments, LLC
	Photo Date	01/31/2023
	Others	Charles Breitenfeldt - IDEM Ken McDaniel - IDEM Mark Espich - St. Joseph County Department of Health Alex Bowman - Krieg DeVault LLP Mike Jones - Property Caretaker

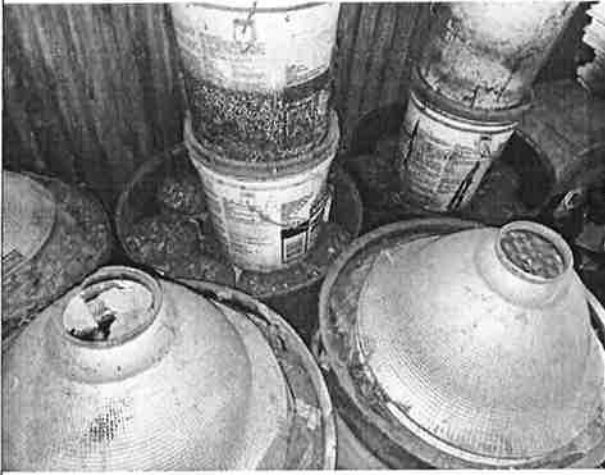
Number	49
	Description	Found inside of Hurwich building 1610 Circle Ave. against the far wall. This is part of seven-plastic and eight metal 55-gallon drums that each contained approximately 24 1-gallon cans of Plastic Magi-Lux
	Photographer	Hannah Hack
	Facility Name	HIC Investments, LLC
	Photo Date	01/31/2023
	Others	Charles Breitenfeldt - IDEM Ken McDaniel - IDEM Mark Espich - St. Joseph County Department of Health Alex Bowman - Krieg DeVault LLP Mike Jones - Property Caretaker

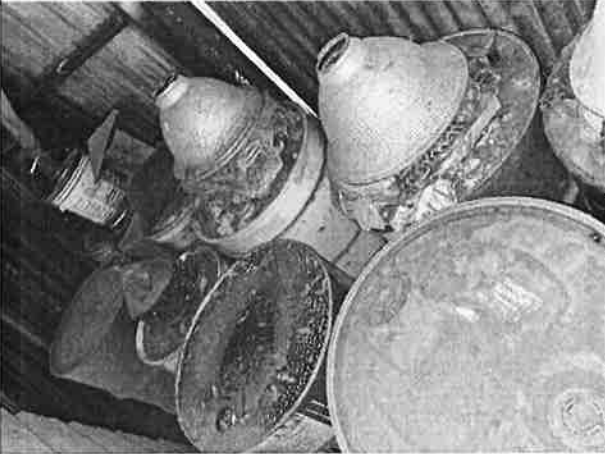
Number	50
	Description	Found inside of Hurwich building 1610 Circle Ave. against the far wall. This is more of the seven-plastic and eight metal 55-gallon drums that each contained approximately 24 1-gallon cans of Plastic Magi-Lux continued from photo 49.
	Photographer	Hannah Hack
	Facility Name	HIC Investments, LLC
	Photo Date	01/31/2023
	Others	Charles Breitenfeldt - IDEM Ken McDaniel - IDEM Mark Espich - St. Joseph County Department of Health Alex Bowman - Krieg DeVault LLP Mike Jones - Property Caretaker

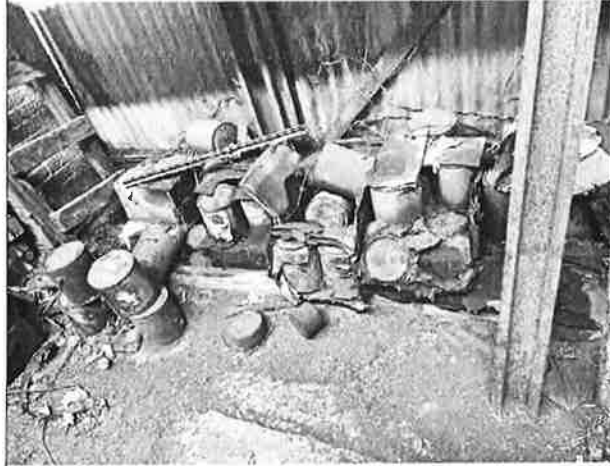
Description	Found inside of Hurwich building 1610 Circle Ave. in the northeast corner of the building. Several 1-gallon metal containers with unknown wastes inside of them. No labels or dates were found.
	Photographer	Charles Breitenfeldt
	Facility Name	HIC Investments, LLC
	Photo Date	01/31/2023
	Others	Charles Breitenfeldt - IDEM Ken McDaniel - IDEM Mark Espich - St. Joseph County Department of Health Alex Bowman - Krieg DeVault LLP Mike Jones - Property Caretaker

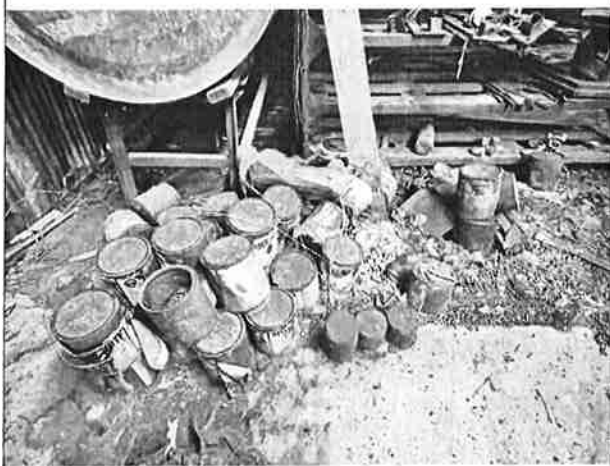
Description	Found inside of Hurwich building 1610 Circle Ave. in the northeast corner of the building. Several 1-gallon metal containers with unknown wastes inside of them. No labels or dates were found.
	Photographer	Charles Breitenfeldt
	Facility Name	HIC Investments, LLC
	Photo Date	01/31/2023
	Others	Charles Breitenfeldt - IDEM Ken McDaniel - IDEM Mark Espich - St. Joseph County Department of Health Alex Bowman - Krieg DeVault LLP Mike Jones - Property Caretaker

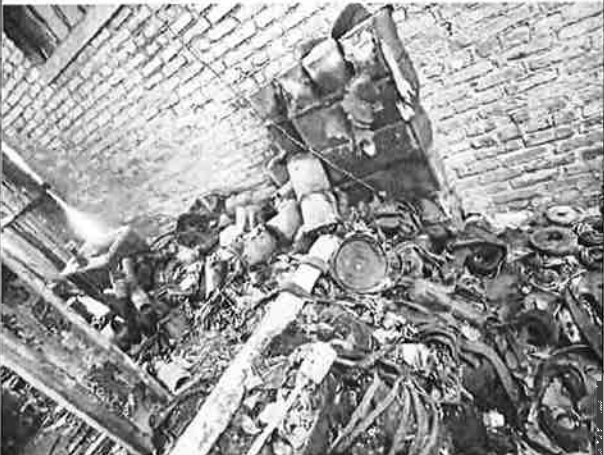
Number	53
	Description	Found inside of Hurwich building 1610 Circle Ave. in the northwest corner of the building. Several 1-gallon metal containers with unknown wastes inside of them. No labels or dates were found.
	Photographer	Charles Breitenfeldt
	Facility Name	HIC Investments, LLC
	Photo Date	01/31/2023
	Others	Charles Breitenfeldt - IDEM Ken McDaniel - IDEM Mark Espich - St. Joseph County Department of Health Alex Bowman - Krieg DeVault LLP Mike Jones - Property Caretaker

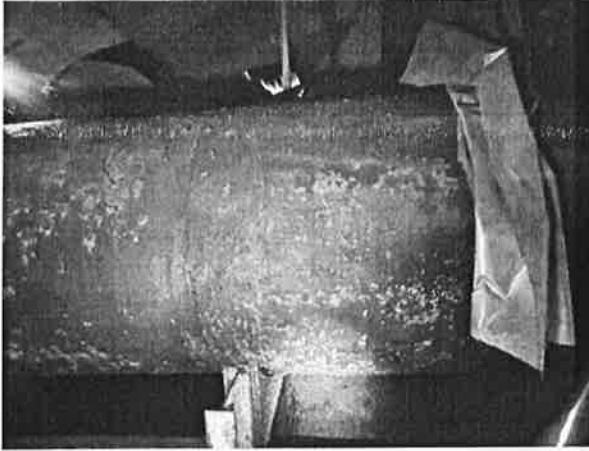
Number	57
	Description	Same vessel as in photo 56 showing the front and middle sections of it.
	Photographer	Hannah Hack
	Facility Name	HIC Investments, LLC
	Photo Date	01/31/2023
	Others	Charles Breitenfeldt - IDEM Ken McDaniel - IDEM Mark Espich - St. Joseph County Department of Health Alex Bowman - Krieg DeVault LLP Mike Jones - Property Caretaker

Next to these four (4) drums was another pallet containing approximately 52 1-gallon metal containers of "Plastic Magi-Lux". These containers were in deteriorating condition and improperly stacked. Some of the containers were open with contents spilled onto the ground (Photo 47). Continuing northwest along the far wall IDEM staff located seven (7) plastic and eight (8) 55-gallon metal drums, each containing approximately 24 1-gallon containers of Plastic Magi-Lux (Photos 49 and 50). Next to these drums and behind a bunch of metal debris, IDEM staff located one (1) 55-gallon plastic container with a flammable sticker on it. The drum appeared to be full, however, the drum was not labeled and its contents are unknown (Photo 55). In the far northwest portion of the production area IDEM staff located several more 1-gallon containers in deteriorating condition, some were labeled as Plastic Magi-Lux, but some were unlabeled (Photos 51-53). It is unknown what the contents in these containers are. In this same area IDEM staff located an approximate 500-gallon tank that was 5/8ths of the way full. The tank was unlabeled, and it was unknown what was inside of the tank (Photo 54). Next, IDEM staff inspected the area southeast from the door. At the far end of the building, they located an approximate 1000-1500-gallon vessel that was possibly a boiler. The vessel had some liquid in it; however, it was unlabeled, and its contents was unknown (Photos 56 and 57).

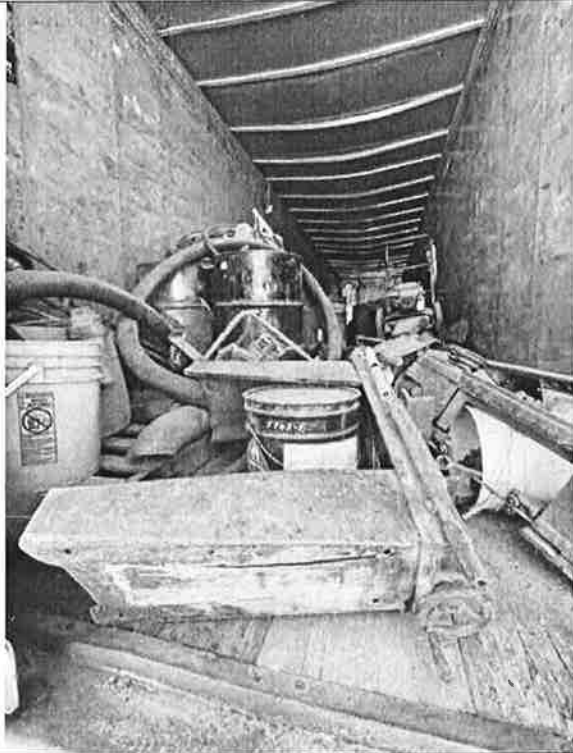
Number	58
	Description	Inside of Trailer 6.
	Photographer	Charles Breitenfeldt
	Facility Name	HIC Investments, LLC
	Photo Date	01/31/2023
	Others	Charles Breitenfeldt - IDEM Ken McDaniel - IDEM Mark Espich - St. Joseph County Department of Health Alex Bowman - Krieg DeVault LLP Mike Jones - Property Caretaker

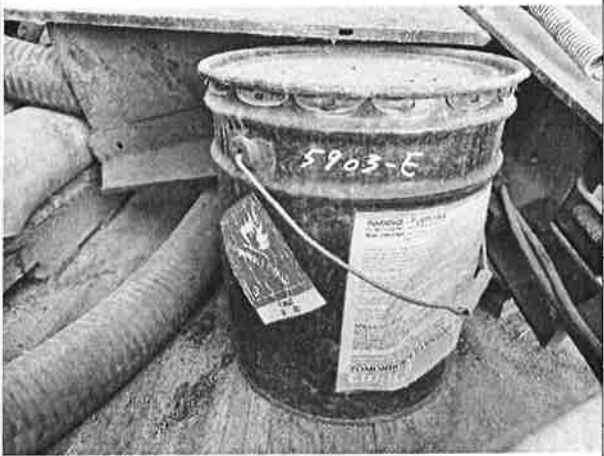
Number	59
	Description	Inside of trailer 6, 5-gallon metal bucket with a flammable label on it. Product label says it could contain alcohol, ester, and petroleum distillates. Actual substance inside is unknown.
	Photographer	Charles Breitenfeldt
	Facility Name	HIC Investments, LLC
	Photo Date	01/31/2023
	Others	Charles Breitenfeldt - IDEM Ken McDaniel - IDEM Mark Espich - St. Joseph County Department of Health Alex Bowman - Krieg DeVault LLP Mike Jones - Property Caretaker

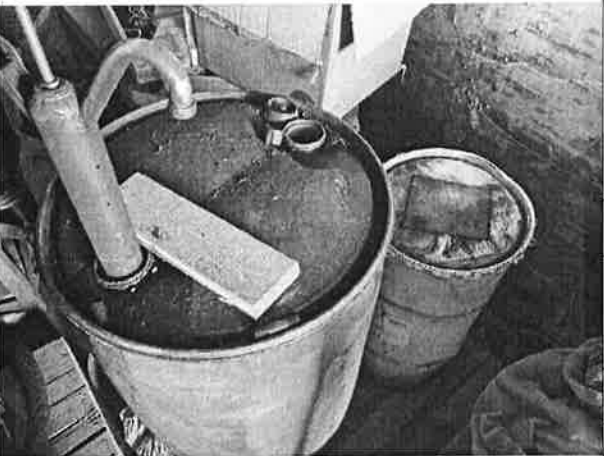
Number	60
	Description	Inside of trailer 6: 55-gallon plastic drum that is open and not labeled in any way. Unknown black liquid inside of it. Next to it is a 20-gallon metal container with an unknown substance inside of it that is not labeled.
	Photographer	Charles Breitenfeldt
	Facility Name	HIC Investments, LLC
	Photo Date	01/31/2023
	Others	Charles Breitenfeldt - IDEM Ken McDaniel - IDEM Mark Espich - St. Joseph County Department of Health Alex Bowman - Krieg DeVault LLP Mike Jones - Property Caretaker

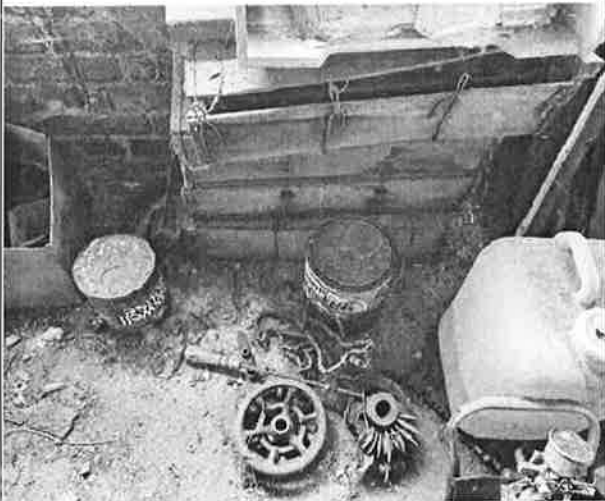
Number	63
	Description	Inside of Hurwich 1610, middle storage area: one 1-gallon container in deteriorating condition of Plastic Magi-Lux and one 5-gallon plastic container with an unknown clear liquid inside of it, this container is not labeled or dated.
	Photographer	Charles Breitenfeldt
	Facility Name	HIC Investments, LLC
	Photo Date	01/31/2023
	Others	Charles Breitenfeldt - IDEM Ken McDaniel - IDEM Mark Espich - St. Joseph County Department of Health Alex Bowman - Krieg DeVault LLP Mike Jones - Property Caretaker

After completing an inspection of the Production Area, IDEM staff moved on to the other two parts of the building. They first inspected the Storage Area. In this area they located one (1) 1-gallon container of Plastic Magi-Lux that was in deteriorating condition and one 5-gallon plastic jug that had a clear liquid inside of it and was unlabeled (Photo 63). The contents of both containers are unknown. IDEM then moved on to the office area of the building. In one of the offices, they found one box with four (4) used lamps inside of it, the box was open and unlabeled (Photos 64 and 65). In the same room, on a table, IDEM staff located a 1-gallon metal container in deteriorating condition, an open container of cleaner, and a container of "Liquid Fire" (photo 66). The status of these containers and what is inside of them is unknown.

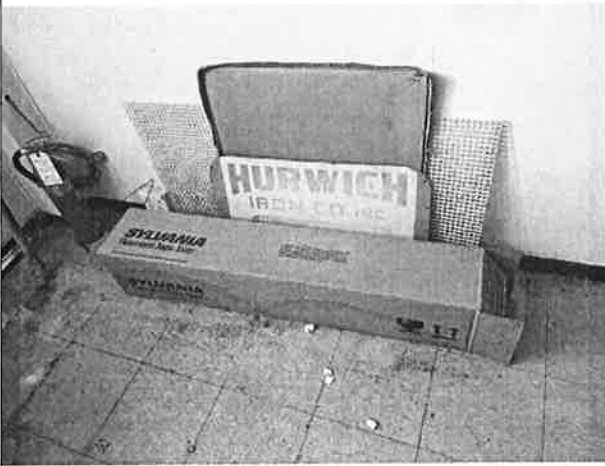
Number	64
	Description	Inside of Hurwich 1610, the front office part: one 4-foot box of waste lamps containing four lamps that is open and unlabeled.
	Photographer	Charles Breitenfeldt
	Facility Name	HIC Investments, LLC
	Photo Date	01/31/2023
Others	Charles Breitenfeldt - IDEM Ken McDaniel - IDEM Mark Espich - St. Joseph County Department of Health Alex Bowman - Krieg DeVault LLP Mike Jones - Property Caretaker

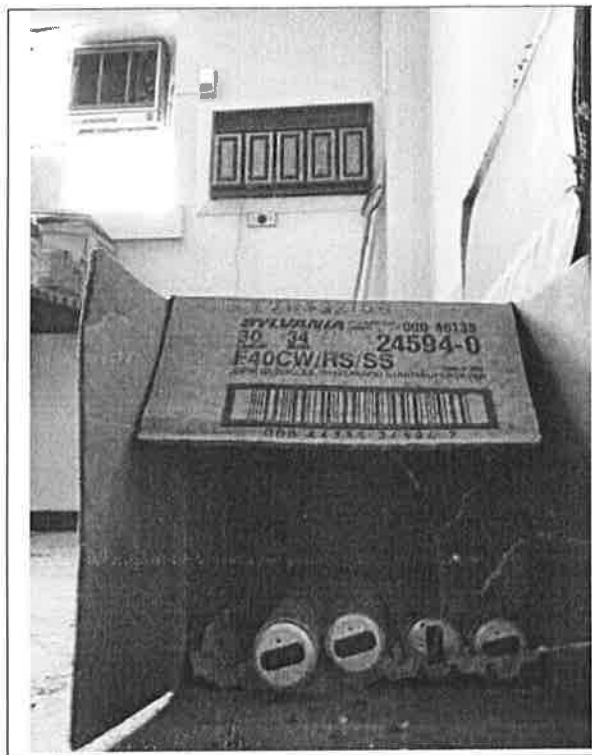
Number	65
Description	Same box of waste lamps as in photo 64 showing the waste lamps inside of the box
Photographer	Charles Breitenfeldt
Facility Name	HIC Investments, LLC
Photo Date	01/31/2023
Others	Charles Breitenfeldt - IDEM Ken McDaniel - IDEM Mark Espich - St. Joseph County Department of Health Alex Bowman - Krieg DeVault LLP Mike Jones - Property Caretaker

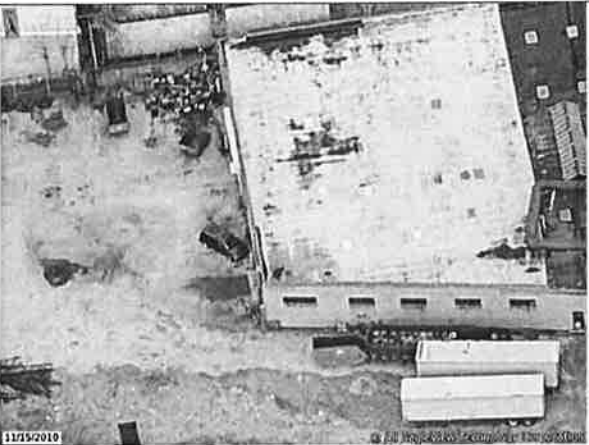
Number	68
	Description	Photo of Hurwich 1628 showing trailer 2 full of drums presumably same drums as shown in photo 4 as both trailer 2 and the orange dumpster in front of it are in the exact same place in this photo as they were found on the date of the inspection.
	Photographer	Photo courtesy of St. Joe County GIS program
	Facility Name	HIC Investments, LLC
	Photo Date	11/15/2010
	Others
