ASBESTOS INVESTIGATION REPORT
STUDEBAKER CORRIDOR PROJECT
SOUTH BEND, IN
JANUARY 10, 1991
ATEC PROJECT NO. 21-09340

DEPARTMENT OF ECONOMIC DEVELOPMENT
COUNTY-CITY BUILDING
SOUTH BEND, IN 46601

Re: Asbestos Investigation
Studebaker Corridor Project
South Bend, IN
ATEC Project No. 21-09340

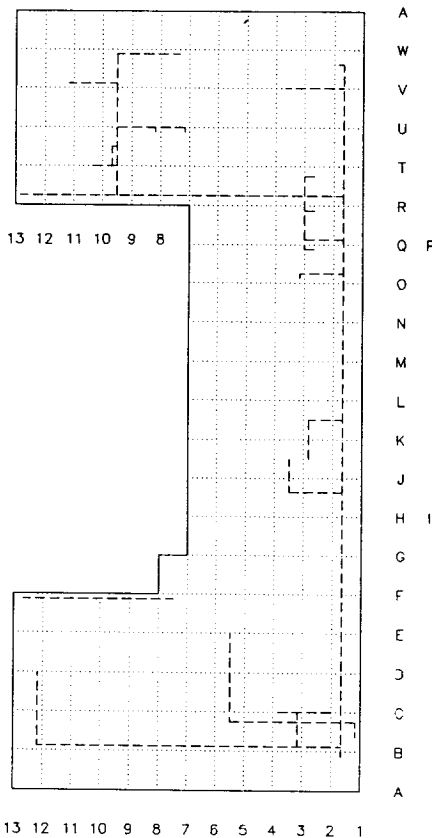
FIGURE NO.
 1A

Four samples were obtained from the two different types of pipe covering located throughout the building (mag block pipe covering - HA 6, layered paper pipe covering - HA 7). All four samples of pipe covering (Photograph B-2) contained amosite and chrysotile asbestos in concentrations ranging from 5-80%, therefore all pipe coverings other than those which are obviously fiberglass should be considered to be an ACM. The ACM pipe coverings have begun to delaminate (Photograph B-2) and fall off (Photograph B-3). (Figures 1A, 1B and 1C)

One sample was taken from the pipe fitting insulation (HA 8) located throughout the building. The sample contained 30-40% chrysotile asbestos. (Figures 1A, 1B and 1C, Photograph B-4)

Four samples (including one QC sample) were obtained from the various types of floor tile (HAS 1, 2 and 3) present in the office and restroom areas of the building. Only two types of floor tile were found to contain asbestos. Both ACM floor tiles (HAS 4 and 5) are located in the first-floor restroom in the northeast corner of the building. (Figure 1A, Photograph A-2)

One sample was taken from the linoleum (HA 9) located in the area at column R-6 of the first floor. The sample contained 20-30% chrysotile asbestos. (Figure 1A, Photograph A-3)

One sample was collected from each of the two types of dropped-ceiling tile (HAS 2 and 3) located in the building. Both samples tested negative for asbestos. (Figure 1A)

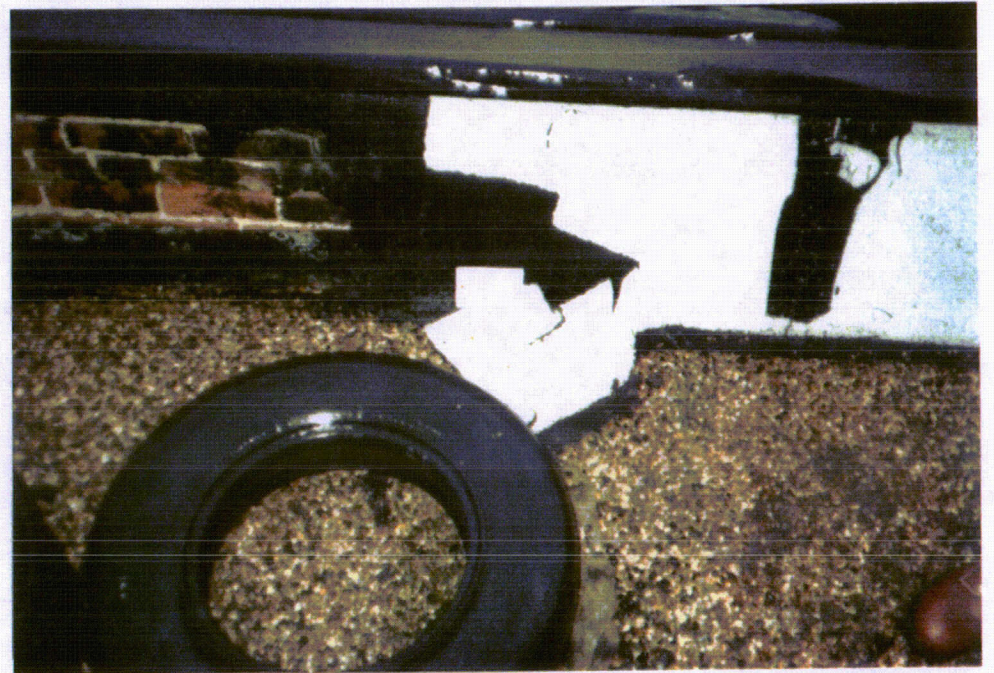
4

One sample each was taken from the older and newer sections of built-up asphalt roof material (HAS 10 and 12). Both samples tested positive for asbestos. (Figure 1E, Photographs A-4 and B-1)

One sample was obtained from the roof flashing material (HA 11). The sample contained 15-20% chrysotile asbestos. (Figure 1E, Photographs A-4 and B-1)

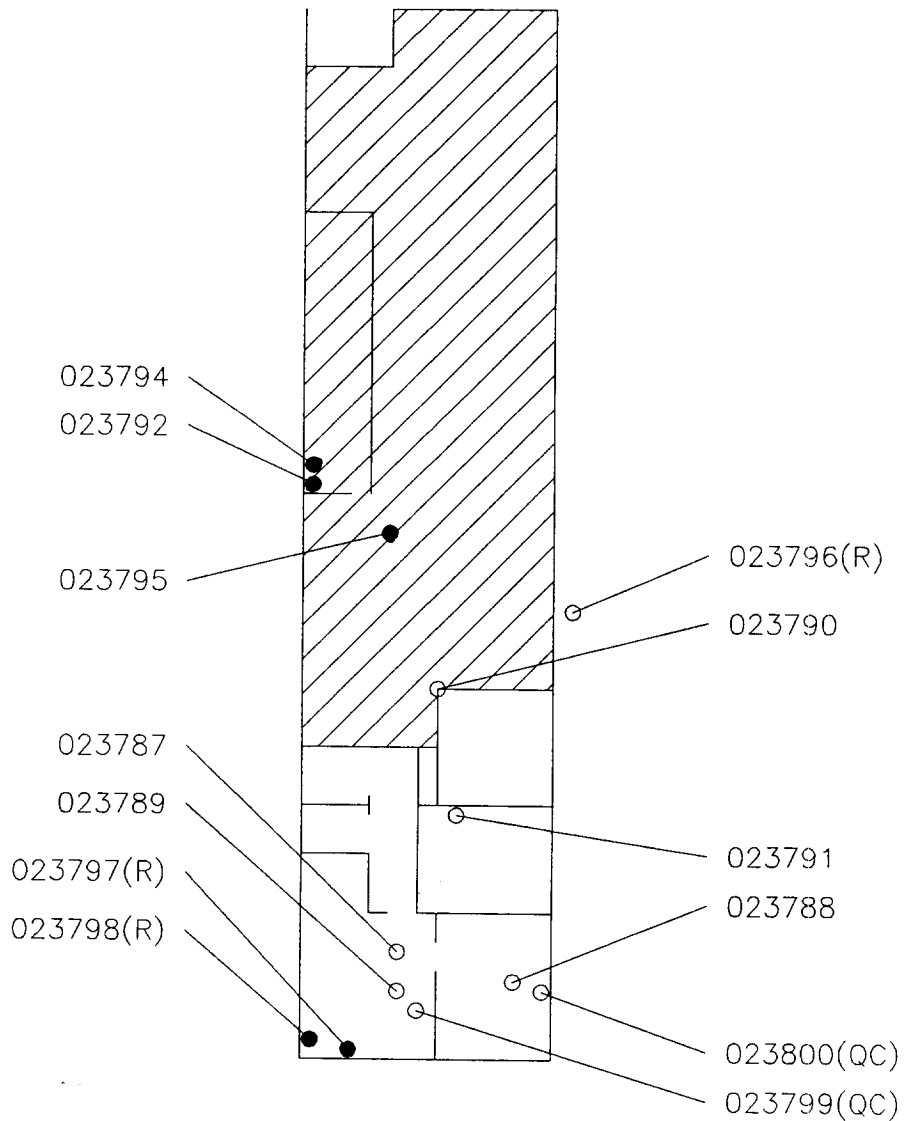
One sample was taken from each type of floor tile (HAs 1, 2, 3, 4 and 5) located throughout the building. The 9"x9" floor tile (HA 4) located in the north end of the building and the 12"x12" floor tile (HA 5) located on top of the 9"x9" floor tile in the north end of the building both contained chrysotile asbestos in concentrations ranging from 3-15%. (Figure 3, Photograph C-2)

One sample was taken from each of the two types of linoleum (HAs 7 and 8) located in the building. The linoleum located underneath the carpet in the bar area (HA 8) contained 15-20% chrysotile asbestos. (Figure 3)

One sample was taken from the dropped-ceiling tile (HA 6) located throughout the building. The sample tested negative for asbestos. (Figure 3)

One sample was obtained from the roof shingles (HA 9) located around the roof. The sample tested negative for asbestos. (Figure 3, Photograph C-3)

One sample was taken from the roof flashing (HA 10). The flashing contained 30-40% chrysotile asbestos. (Figure 3, Photograph C-4)

One sample was taken from the field of the built-up asphalt roof material (HA 11). The sample contained 20-30% chrysotile asbestos. (Figure 3)

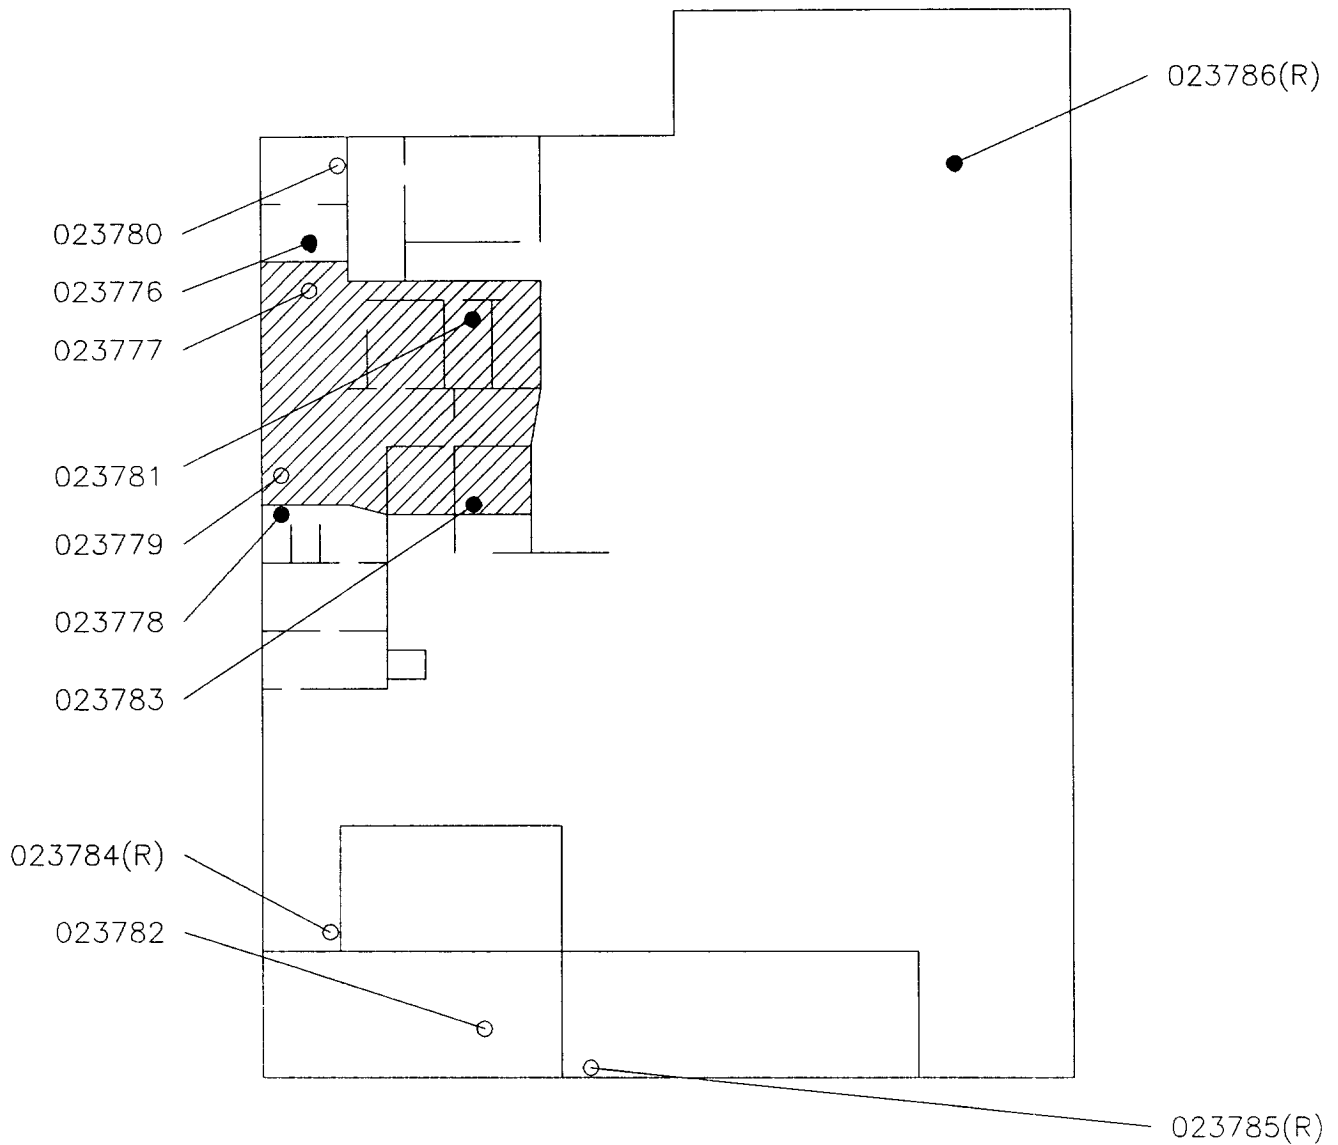
Three random samples were collected from the plaster (HA 8) located on the walls and ceilings in the old office areas. All three samples tested negative for asbestos. (Figure 7)

Five samples were taken from the various types of floor tile (HAs 1, 2, 3 and 4) located in the old office areas. Four of the five samples contained chrysotile asbestos in concentrations greater than 1%. The asbestos-containing floor tile (Photographs J-1, J-2 and J-3) is located throughout the front office area. (Figure 7)

One sample was taken from the roof shingles (HA 5) located around the raised sections of the roof. The sample tested negative for asbestos. (Figure 7, Photograph J-4)

One sample was taken from the roof flashing (HA 6). The sample tested negative for asbestos. (Figure 7, Photograph K-1)

One sample was taken from the built-up asphalt roof material (HA 7). The sample contained 20-30% chrysotile asbestos. (Figure 7, Photograph K-2)

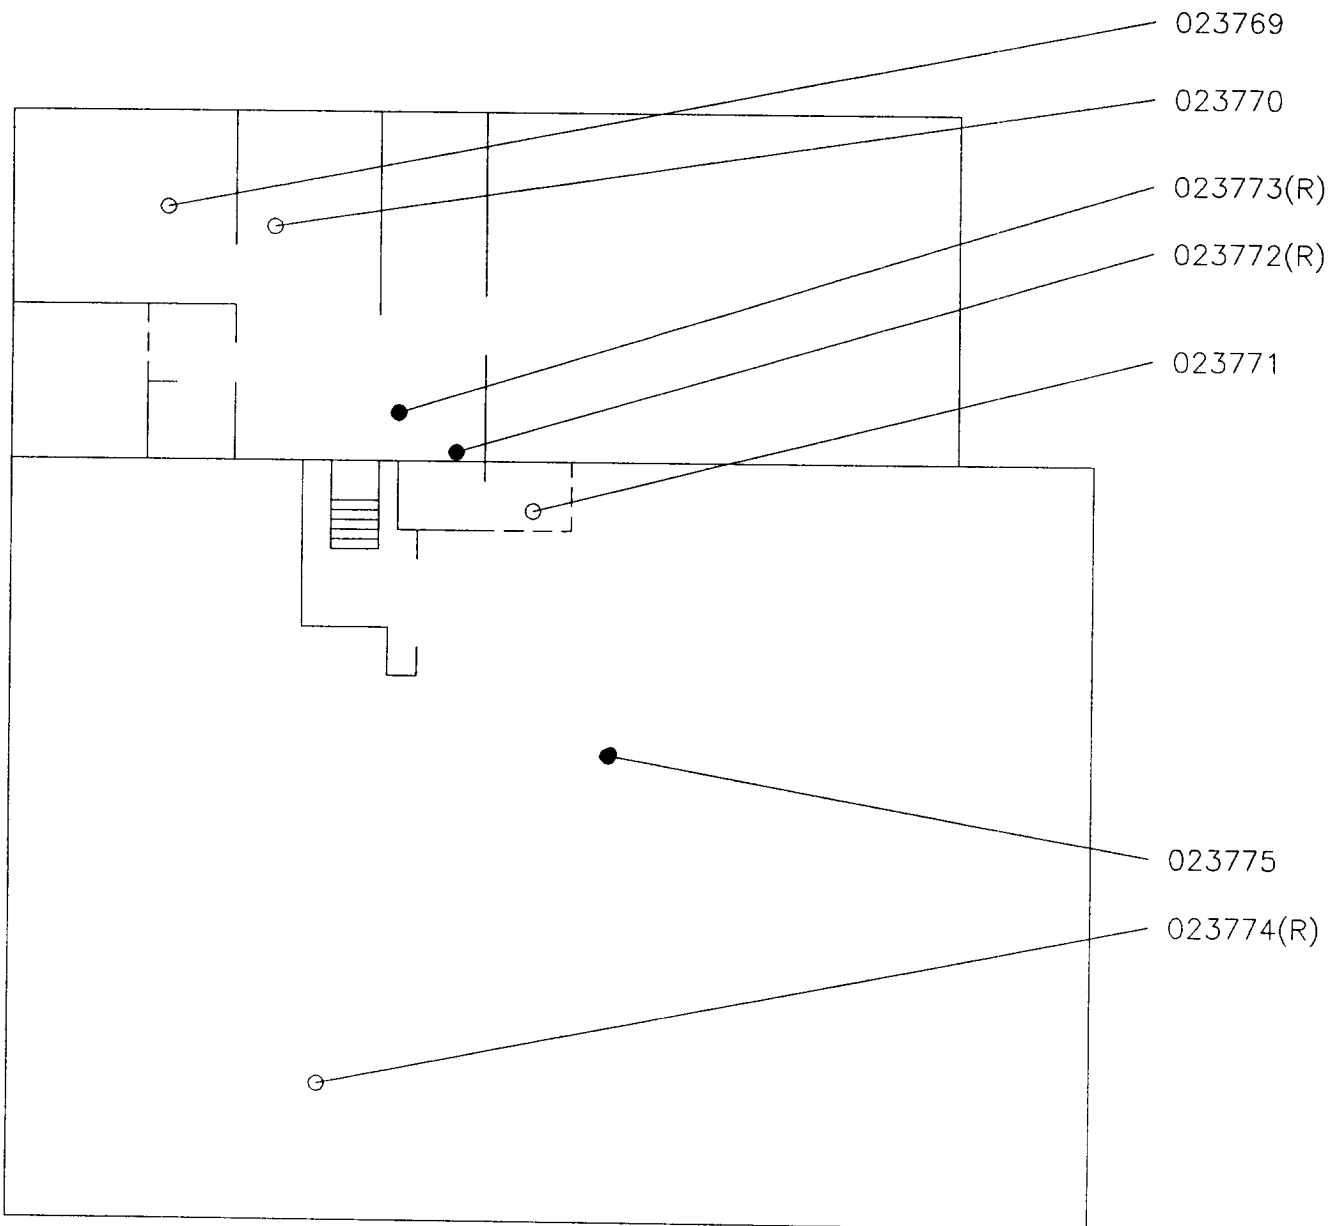
FIGURE NO.
 8

One sample was taken from the asbestos paper material (HA 7) in the housing of the overhead heating unit. The sample contained 70-80% chrysotile asbestos. (Figure 8, Photograph L-4)

One sample was taken from each of the two different types of floor tile (HAs 1 and 2) located throughout the building. Both samples tested negative for asbestos. (Figure 8, Photographs L-1 and L-2)

One representative sample was taken from the dropped-ceiling tile (HA 3) located throughout about half of the building. The sample tested negative for asbestos. (Figure 8)

One sample was taken from the roof flashing (HA 4) located around the built-up asphalt roof material. The sample contained 30-40% chrysotile asbestos. (Figure 8)

One sample each was collected from the built-up asphalt roof material on the west side (HA 5) and east side (HA 6) of the building. The sample taken from the west side (HA 5) contained 15-20% chrysotile asbestos. The sample taken from the east side (HA 6) contained less than 1% chrysotile asbestos, therefore the built-up asphalt roof material on the east side of the building can be considered a non-ACM. (Figure 8)

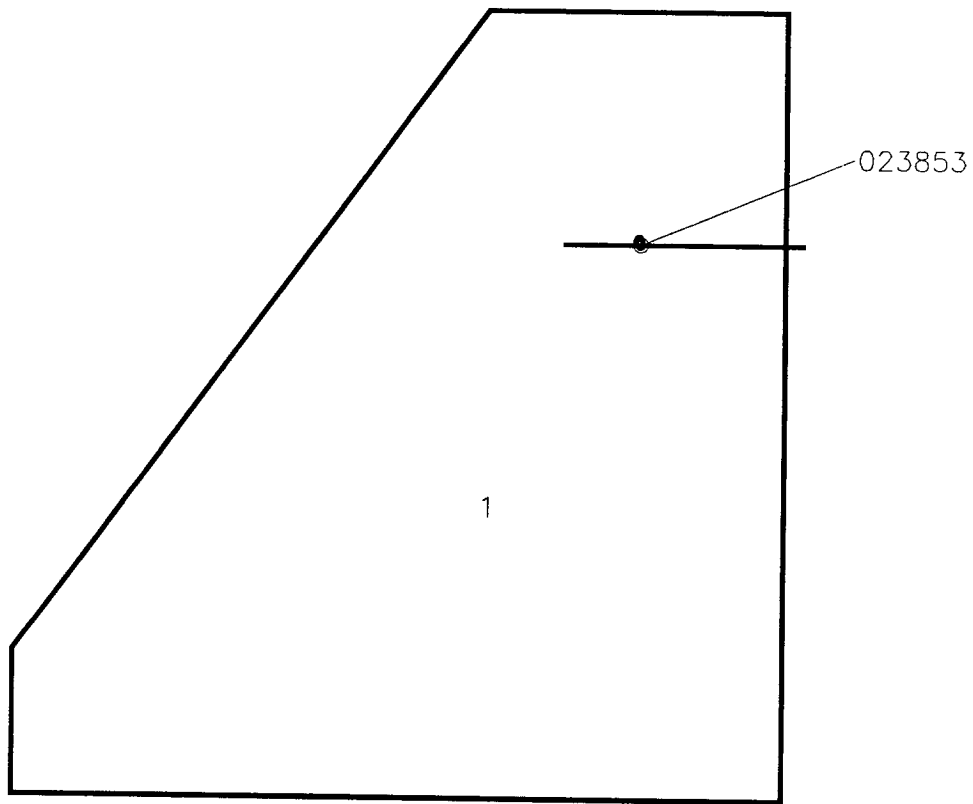
One sample was taken from the mag block pipe covering (HA 1) located on the first floor of Building 1. The sample contained 30-40% chrysotile asbestos. (Figure 10A, Photograph N-4)

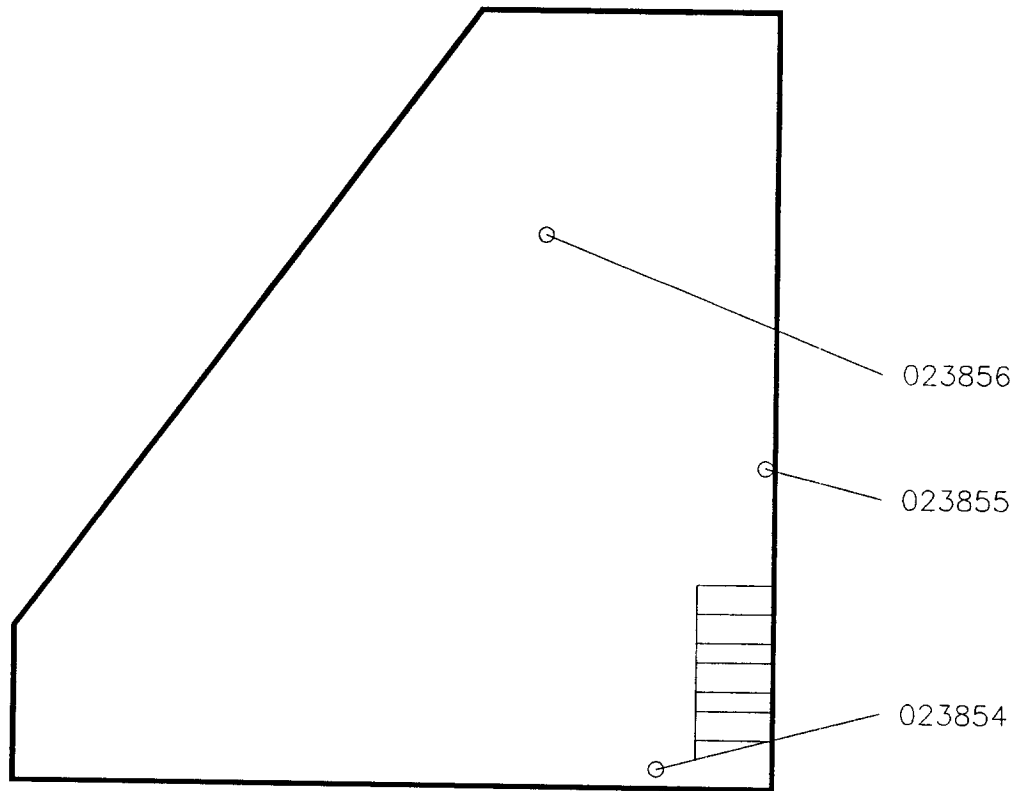
FIGURE NO.
10B

Three random samples were collected from the wall plaster (HA 5) located throughout the second floor of Building 1. All three samples tested negative for asbestos. (Figure 10B, Photograph N-1)

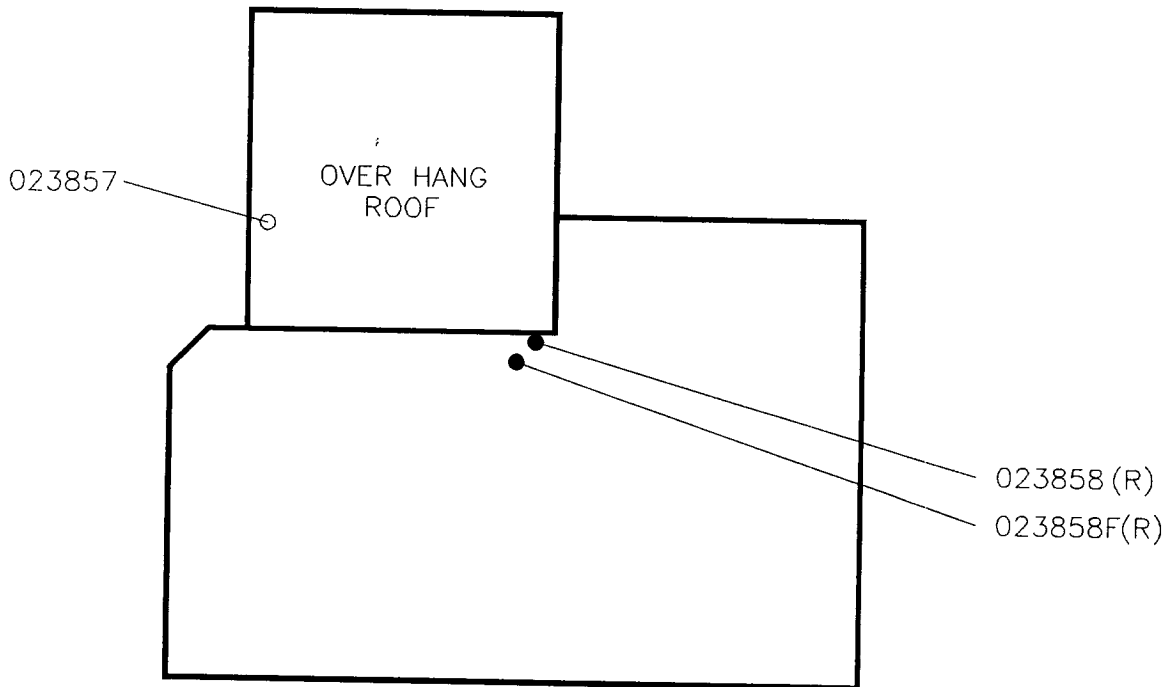
FIGURE NO.
10C

One sample was taken from the roof shingles (HA 2) located on the overhang of Building 2. The sample tested negative for asbestos. (Figure 10C)

Building 1, the built-up asphalt roof material on Building 1 is also assumed to be asbestos-containing. (Figure 10C, Photograph N-2)

One sample was taken from the roof flashing (HA 4) located on Building 2. The sample contained 20-30% chrysotile asbestos. Due to the lack of access to the roof of Building 1, the roof flashing on Building 1 is also assumed to be asbestos-containing. (Figure 10C, Photograph N-3)

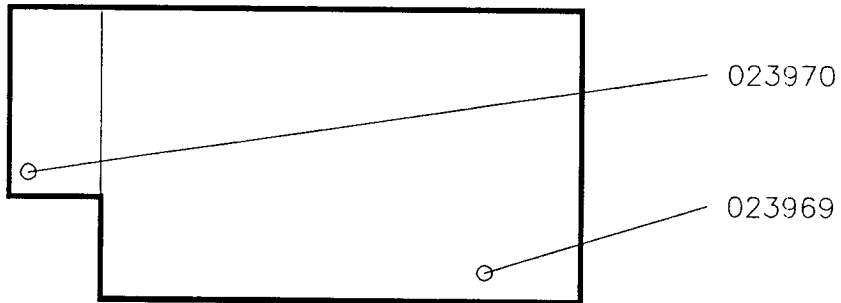
One sample was taken from each of the two different types of roof shingles (HAs 1 and 2) located on top of the main structure and overhang. Both samples tested negative for asbestos. (Figure 12)

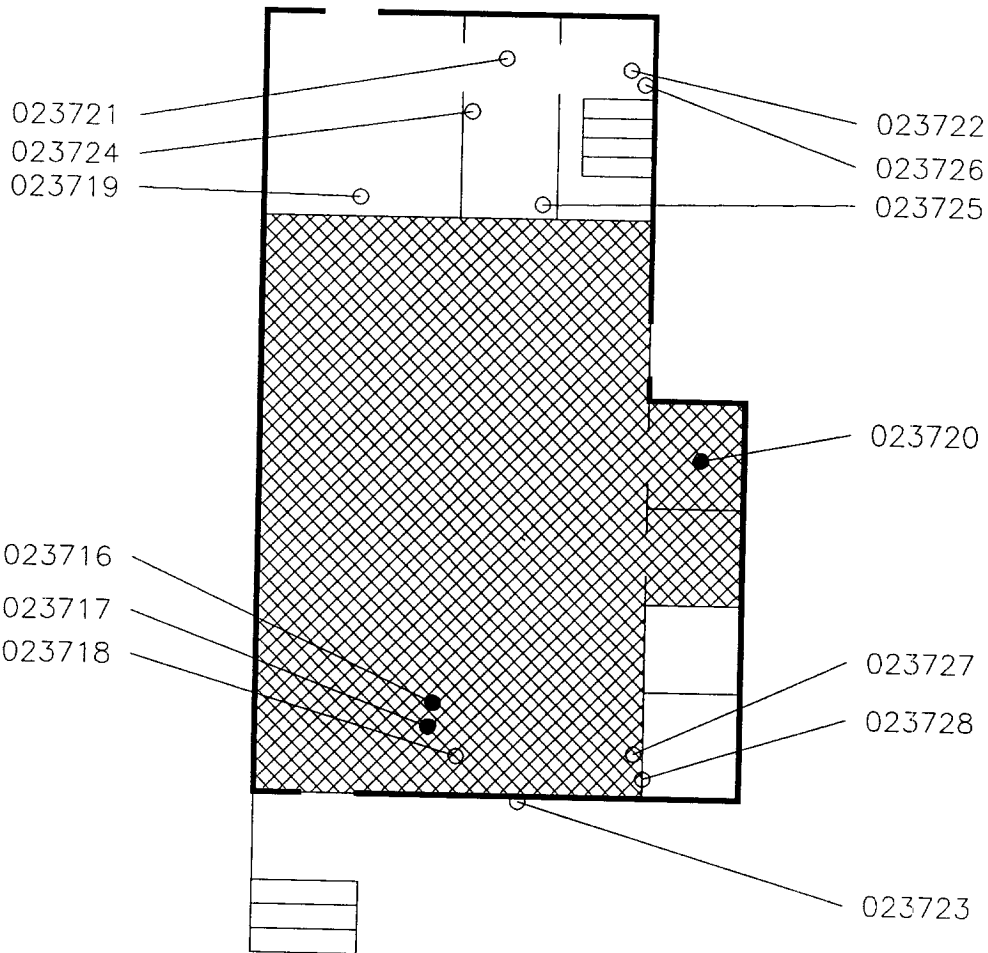
Three random samples were collected from the wall plaster (HA 9) located throughout the building. All three samples tested negative for asbestos. (Figure 13)

One sample was taken from each of the six different types of linoleum (HAs 1, 2, 3, 4, 5 and 6) located throughout the building (Figure 13). Three of the samples tested positive for asbestos. The following types of linoleum contain asbestos:

One sample was taken from the dropped-ceiling tile (HA 7) located in the bar area on the west side of the building. The sample tested negative for asbestos. (Figure 13)

One sample was taken from each of the three types of shingles (HA 8, 10 and 11) located on the roof and sides of the building. All three samples tested negative for asbestos. (Figure 13)
