City of South Bend, Indiana

***Post-Flooding Investigation of Four Neighborhoods
Along the St. Joseph River***

August 16, 2018

LAWSON-FISHER ASSOCIATES P.C.
CONSULTING ENGINEERS

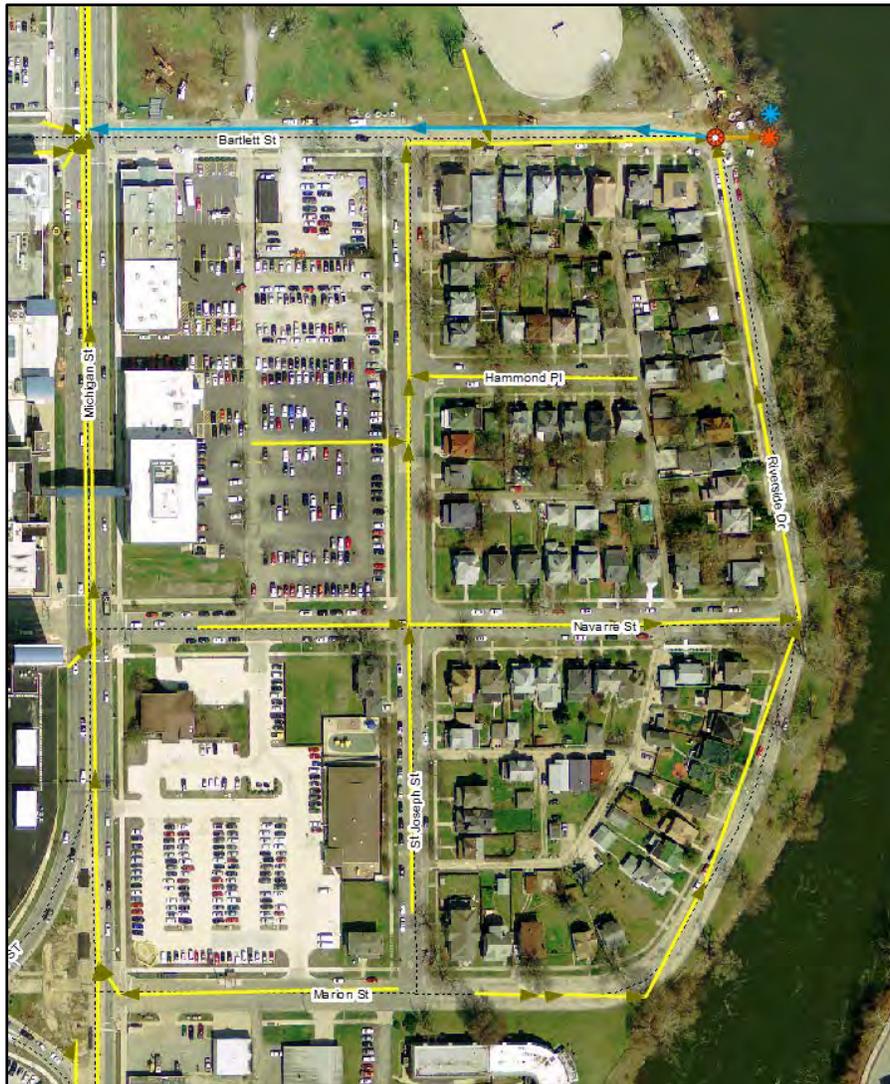
Photo 3-1
Overview of Riverside Drive Sewer Network

The yellow lines indicate combined sewer pipes. In general, flow travels from southwest to northeast within Riverside Drive. Once flow reaches the intersection of Riverside Drive and Bartlett Street, it flows through a 12" diameter throttle pipe that conveys flow to the combined sewer network along Michigan Street. If flow exceeds the capacity of the 12" diameter throttle line, overflow from the system will discharge into the St. Joseph River through Combined Sewer Overflow (CSO) 10 (indicated by the red icon along river).

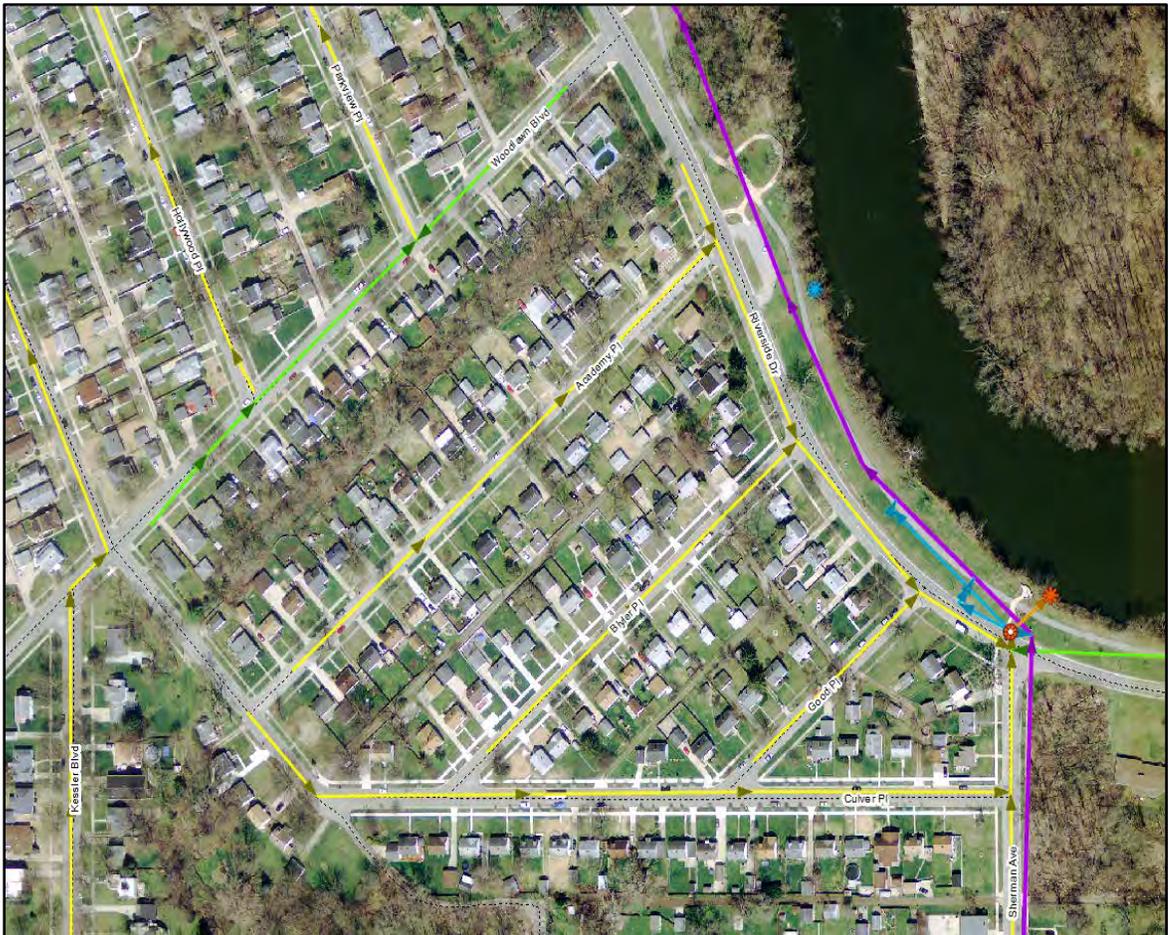
Photo 3-3
Overview of Keller Park Sewer Network

The yellow lines indicate combined sewer pipes. In general, flow travels from southwest to northeast within Keller Park. Once flow reaches the intersection of Sherman Avenue and Riverside Drive, it flows through a 21" diameter pipe (indicated in blue) and continues to the 96" combined sewer trunk line (indicated in purple) that runs parallel to the St. Joseph River. If flow exceeds the capacity of the 21" diameter pipe, the combined system will discharge into the Saint Joseph River through CSO 2 (indicated by the red icon along river).

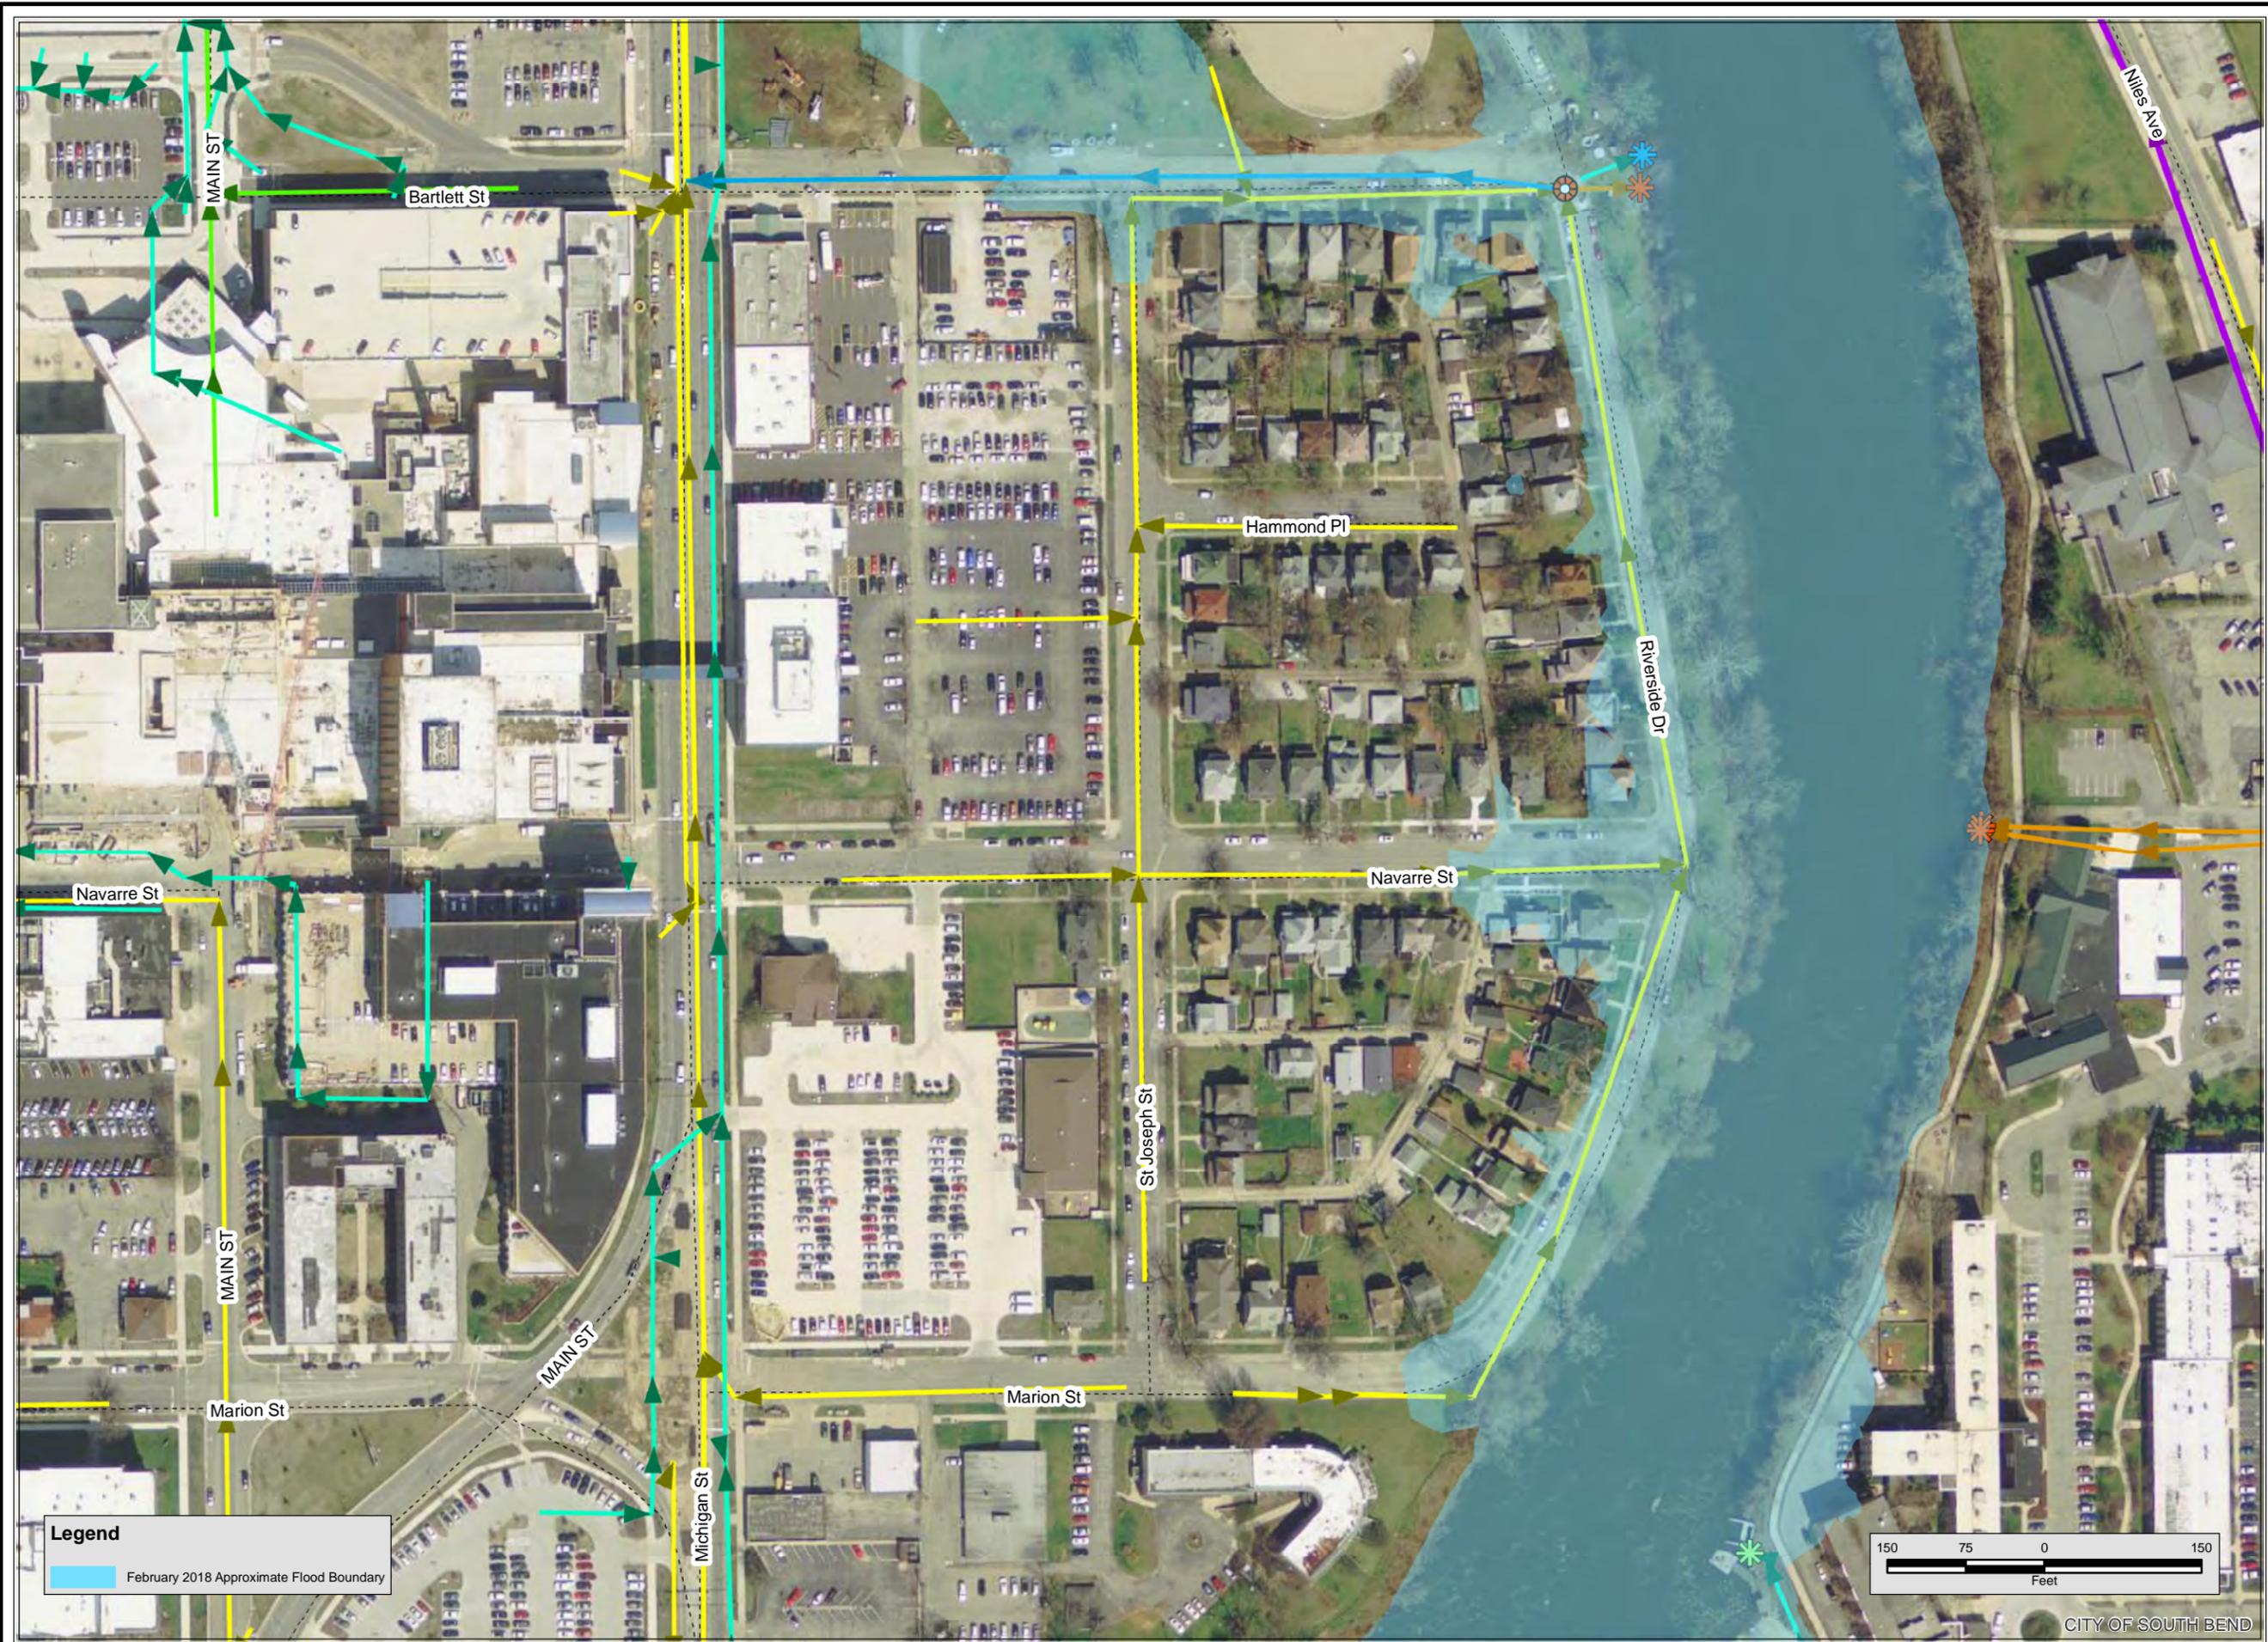
extreme flooding event as shown in Figure 2-4 in Appendix A, it is concluded that the flooding experienced during this time was due to the high water surface elevation of the St. Joseph River not allowing the relief for the system rather than an inadequate sewer system. It should also be noted that out of the five residents that noted flooding during 2018, none of them had backflow prevention devices installed and all but two (2) had identified some sort of cracking within either their basement walls, floor, or both.

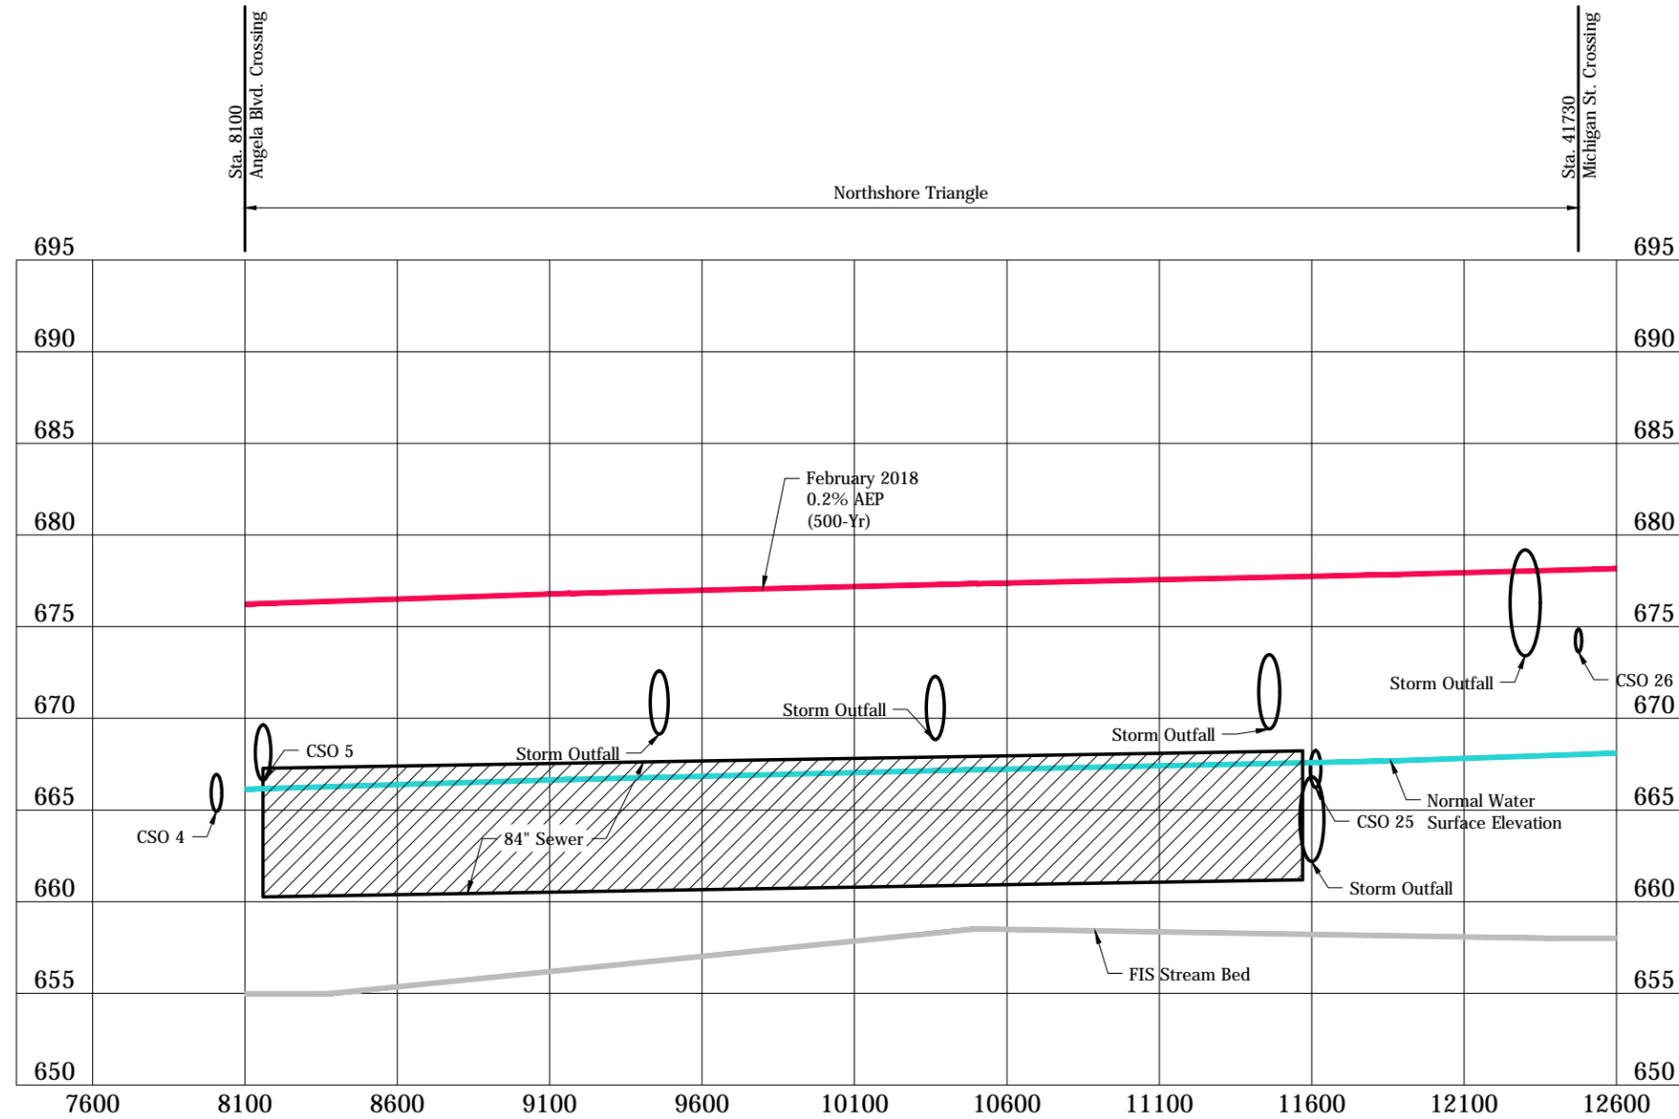
As previously stated, most municipalities, including the City of South Bend, design storm and combined sewer networks to withstand a 10 year-6 hour storm event. The February 2018 event, being estimated as a 500-year flood, greatly exceeded the design capacity of the sewer network. Figure 2-9 in Appendix A shows that the relief points (CSO 25, CSO 5 and storm outfalls) for the Northshore Triangle area were below the river water surface level and were unable to adequately relieve the storm and sewer networks for a considerable amount of time. Based on the as-built data of the invert of the pipes within the NST network, the sewer pipes would have most likely been completely full to the elevation of the river. Figure 2-5 in Appendix A shows the line for the 500-year event. This would have greatly limited any stormwater and sewage getting to the interceptor.

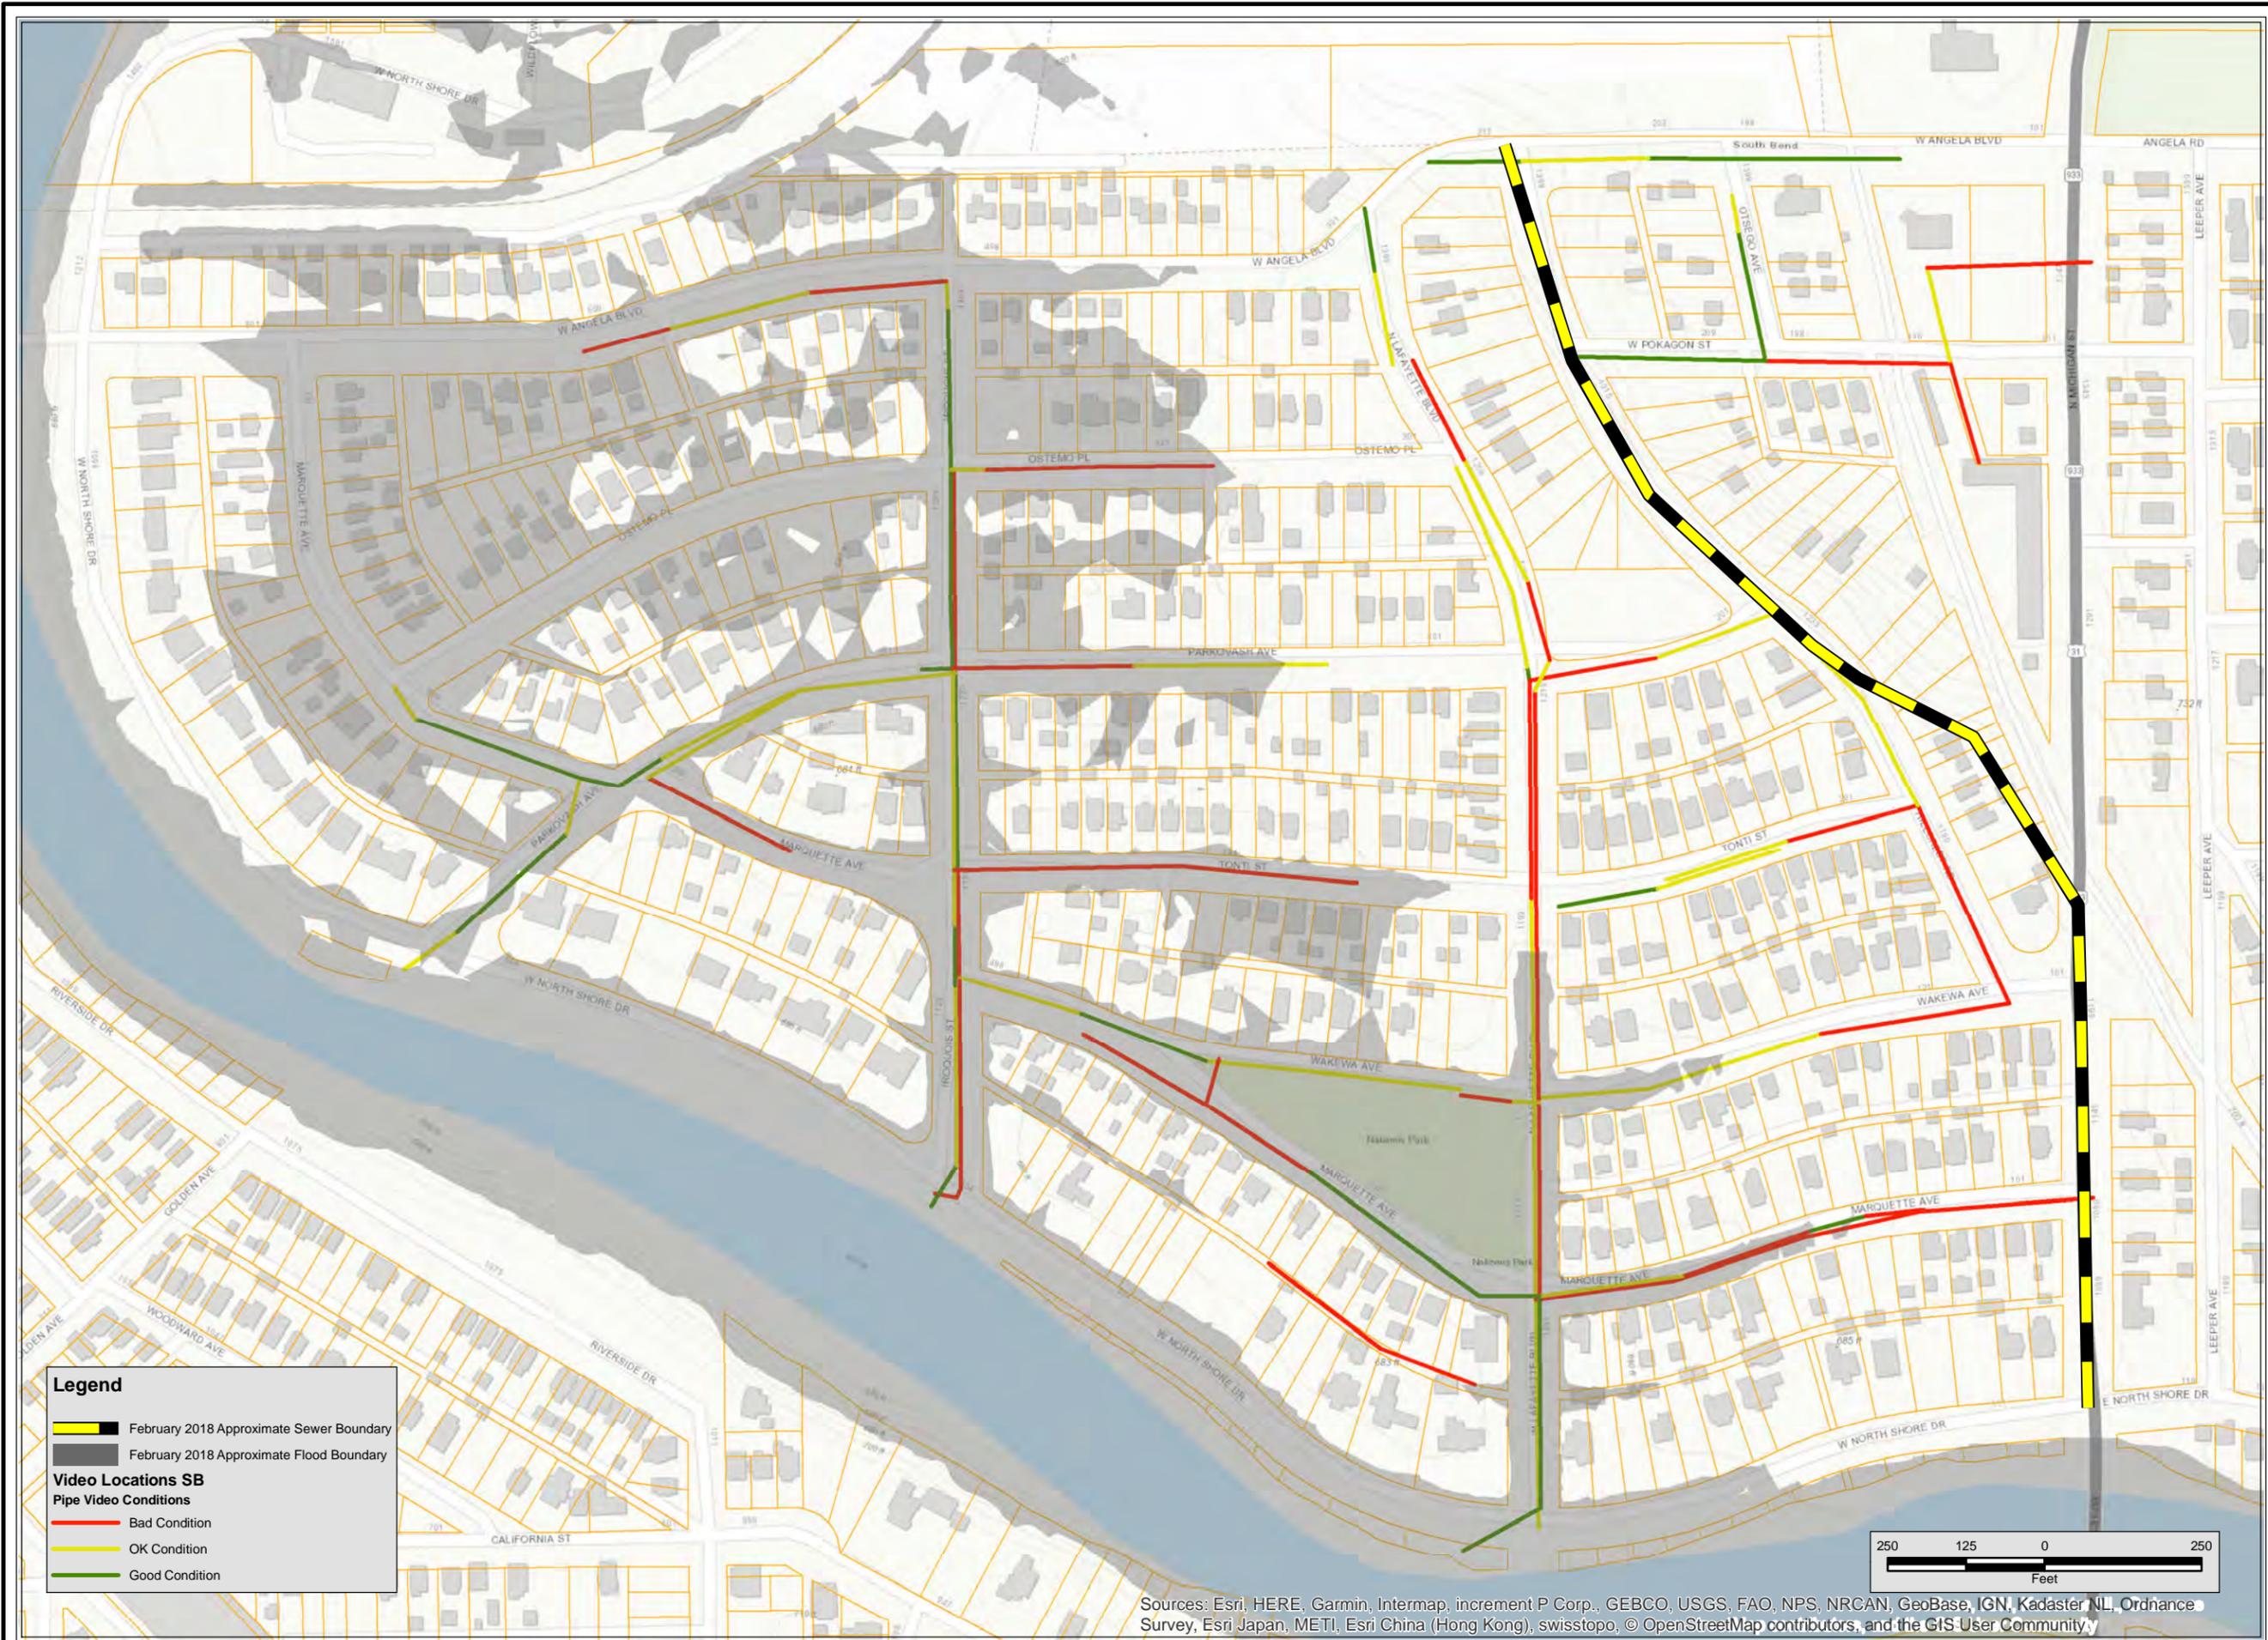
In addition, sewer video was made available for several stretches of pipe within this area. Lawson-Fischer and Associates (LFA) reviewed the video and categorized the pipes as either “Good”, “OK”, or “Bad Condition”. These ratings can be seen in Figure 6-1 in Appendix A. A pipe was assigned a “Bad” rating when cracking and/or significant blockage (i.e. roots, debris, etc.) was observed, an “OK” condition rating was given when there may be some minor buildup or blockage in the pipe, and a “Good” condition rating was applied where there was no issues identified in the video within the pipe. It should be noted that the video was only available for the North Shore Triangle area and that video of the whole area was not available. Cleaning and possible repair of some of the pipes identified as “Bad” could provide for better flow throughout those portions of sewer systems.

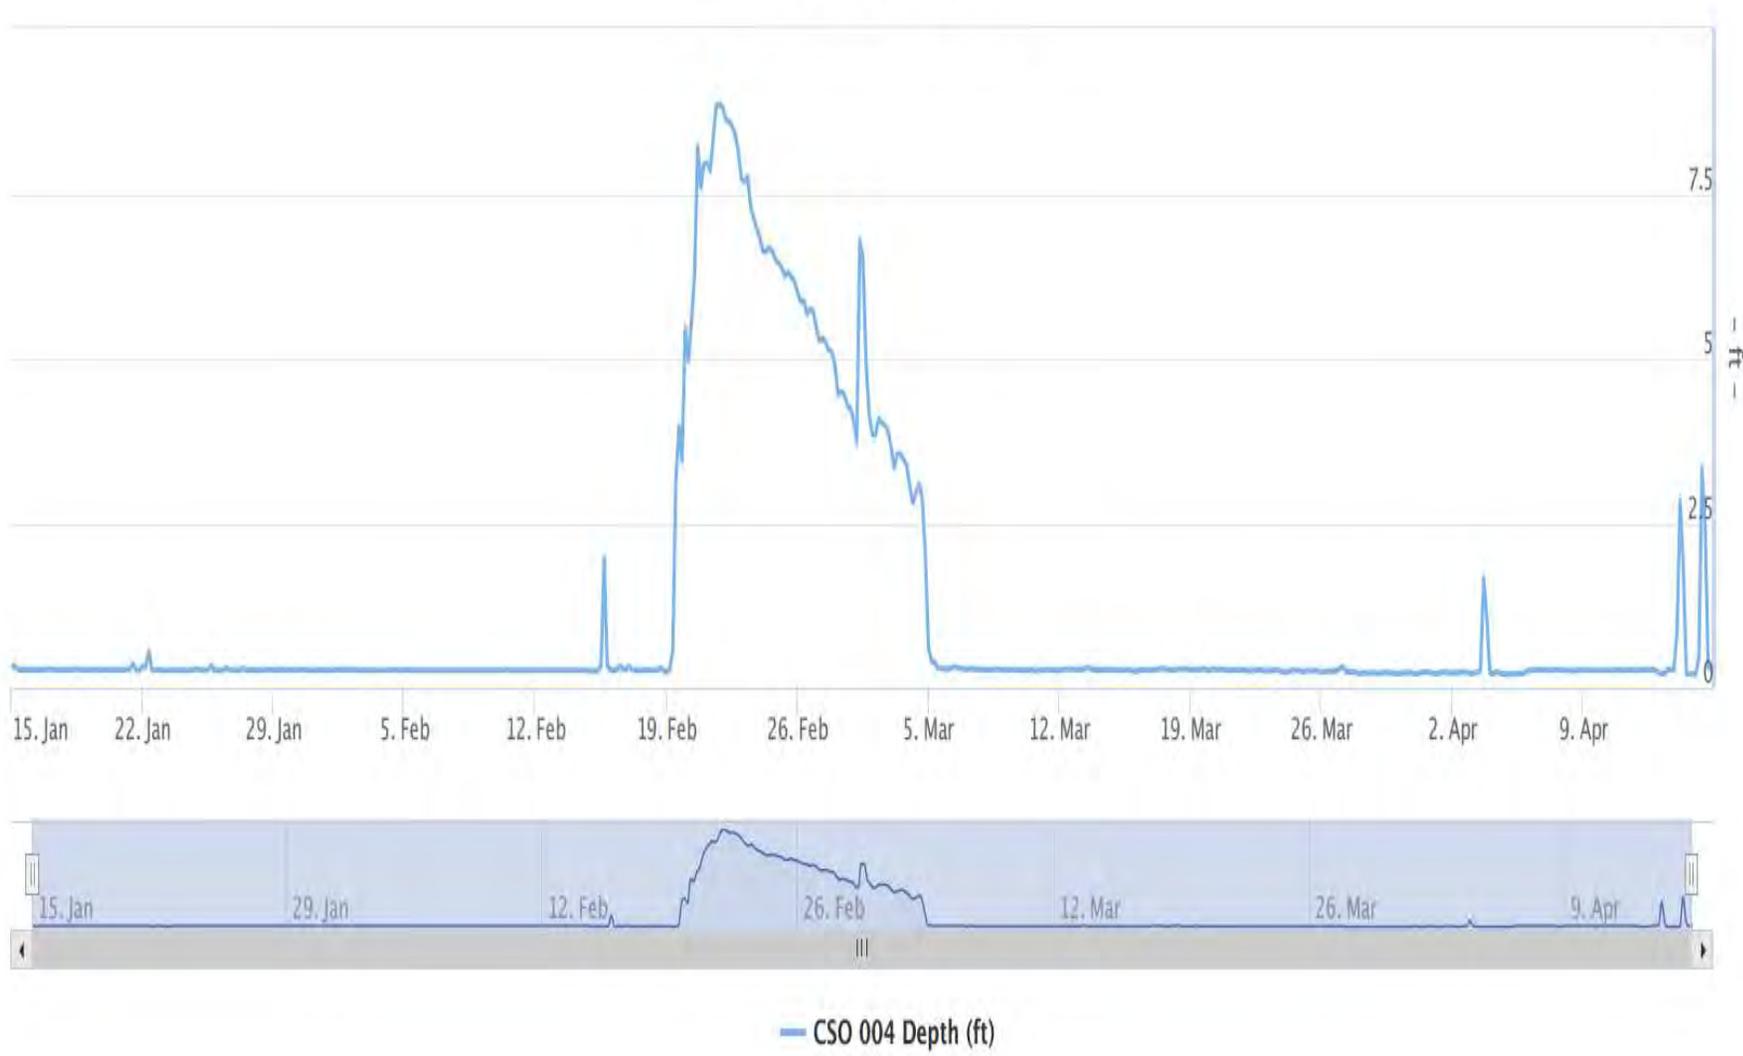
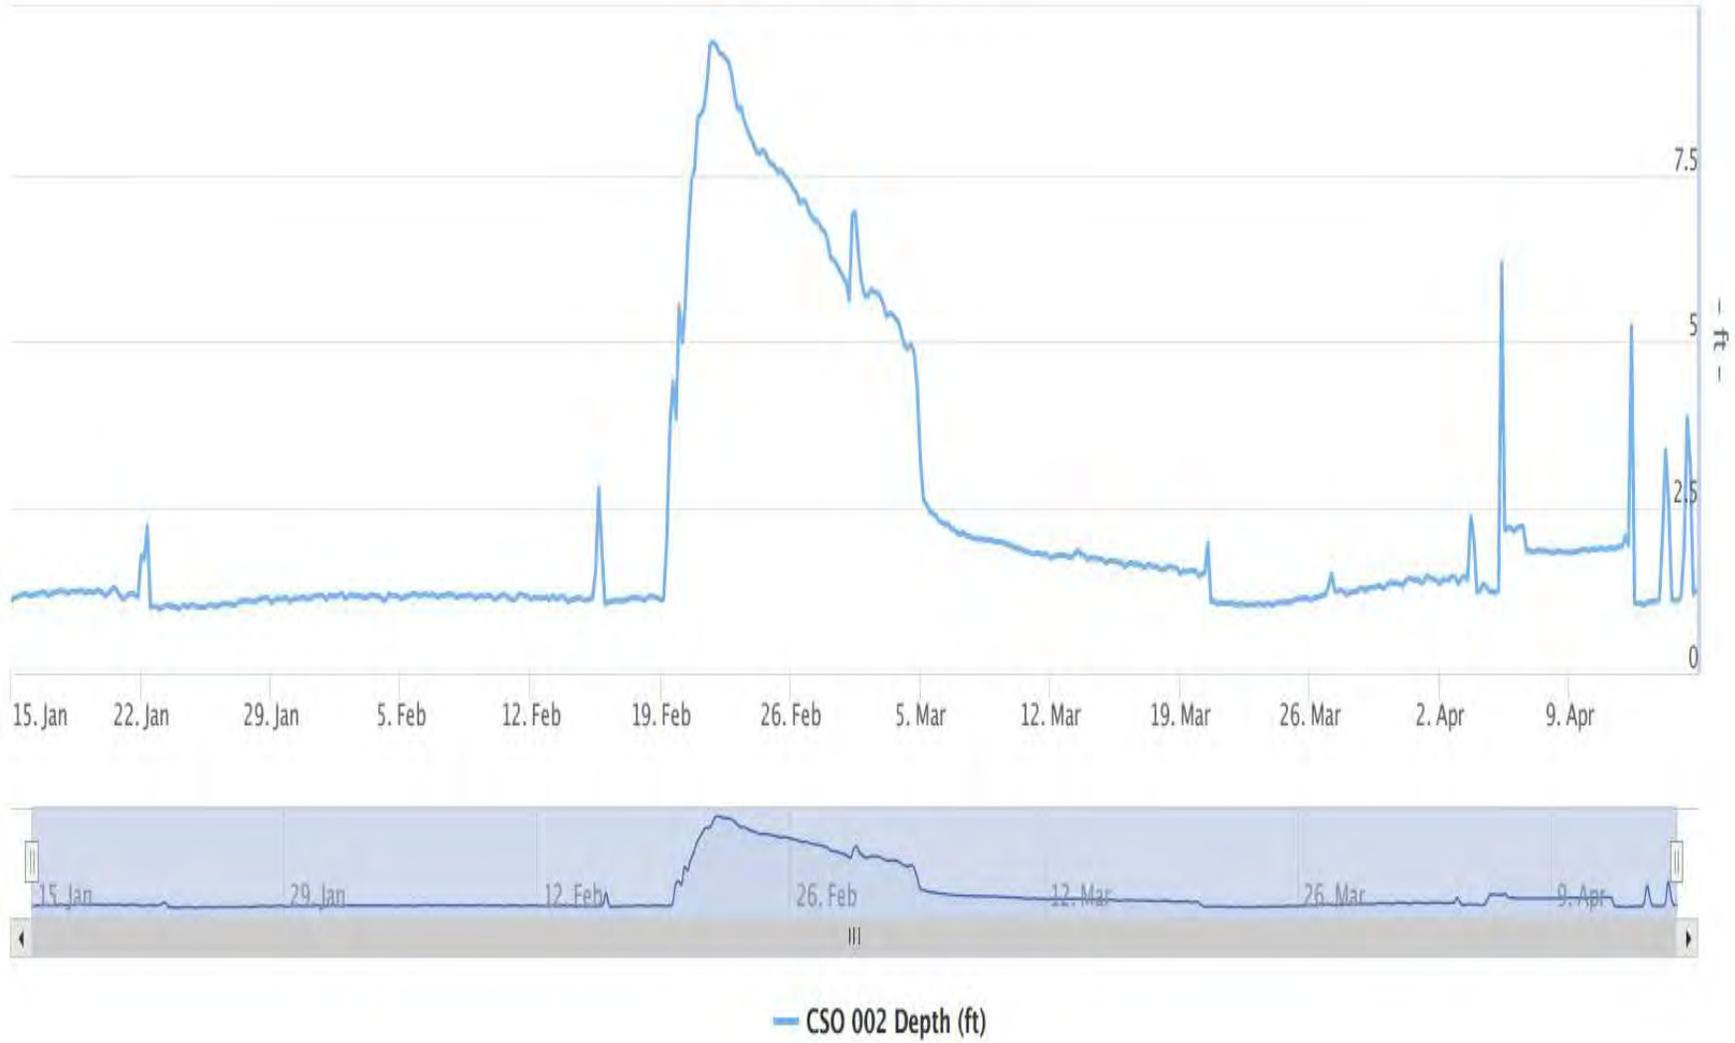
Figure 6-3
Keller Park Sewer Depth

throughout the upper reaches. Based on data from the Emnet network, the interceptor was at or near capacity for a long duration. This can be seen by the plots in Figure 6-3 of Appendix A. This limited the flow that could discharge from the upstream area during and after the event.
