**STAFF REPORT**  
CONCERNING APPLICATION FOR A  
**CERTIFICATE OF APPROPRIATENESS**

**Application Number:** 2019-0603A

**Property Location:** 1133 East Wayne Street

**APPLICATION ITEMS:** *“Replacement of the asbestos tile roof and galvanized gutters with the Classic Products Oxford metal shingle and new galvanized gutters”*

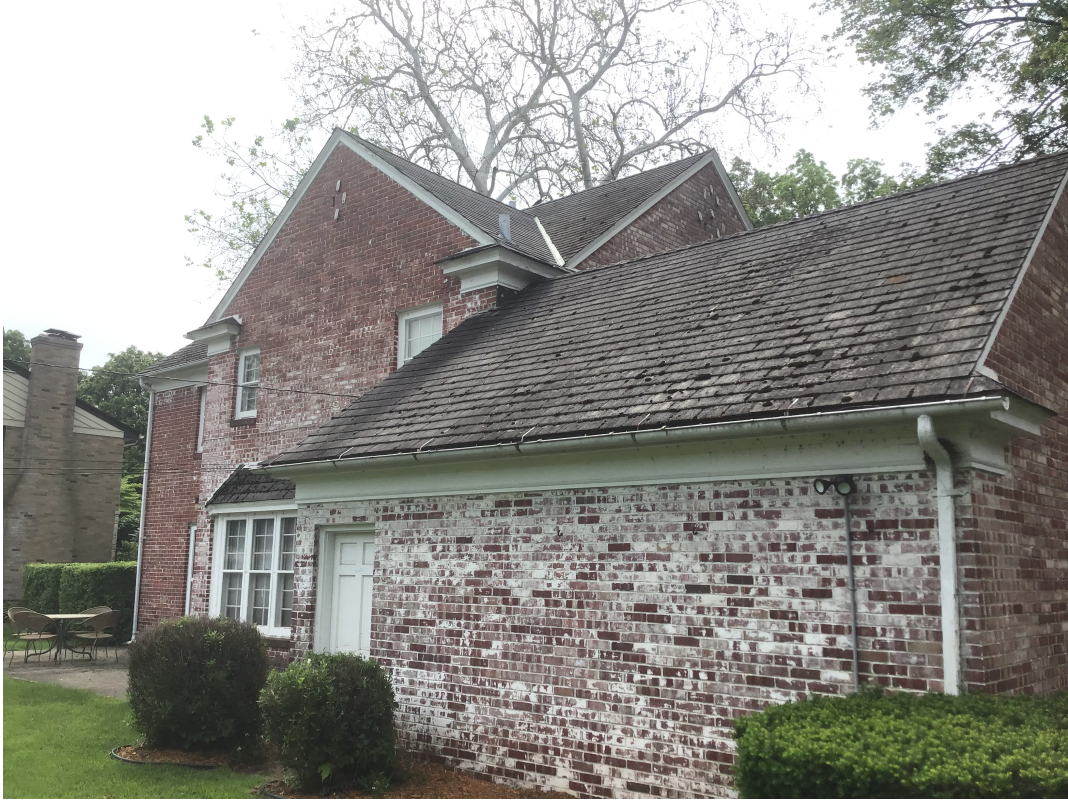
SIDE PICTURE (WEST) - Picture of the side of the building, June 2019.

There are missing or broken tiles in several locations. The owners and contractors have been using up a stockpile of matching tiles, but now that supply has been depleted. Patches of moss are everywhere on all sides of the roof. This would suggest that the existing underlayment under the asbestos tiles has failed so far as to allow moisture to pool. Not to mention the extra weight. The moss will need to be removed and the areas washed to prevent regrowth.

**STAFF RECOMMENDATION:** Staff does not recommend installing a new roof over the asbestos and would advocate for removal first. If all architectural features which give the roof its essential character can be retained, Staff recommends the metal shingle. Staff recommends new galvanized half round gutters.

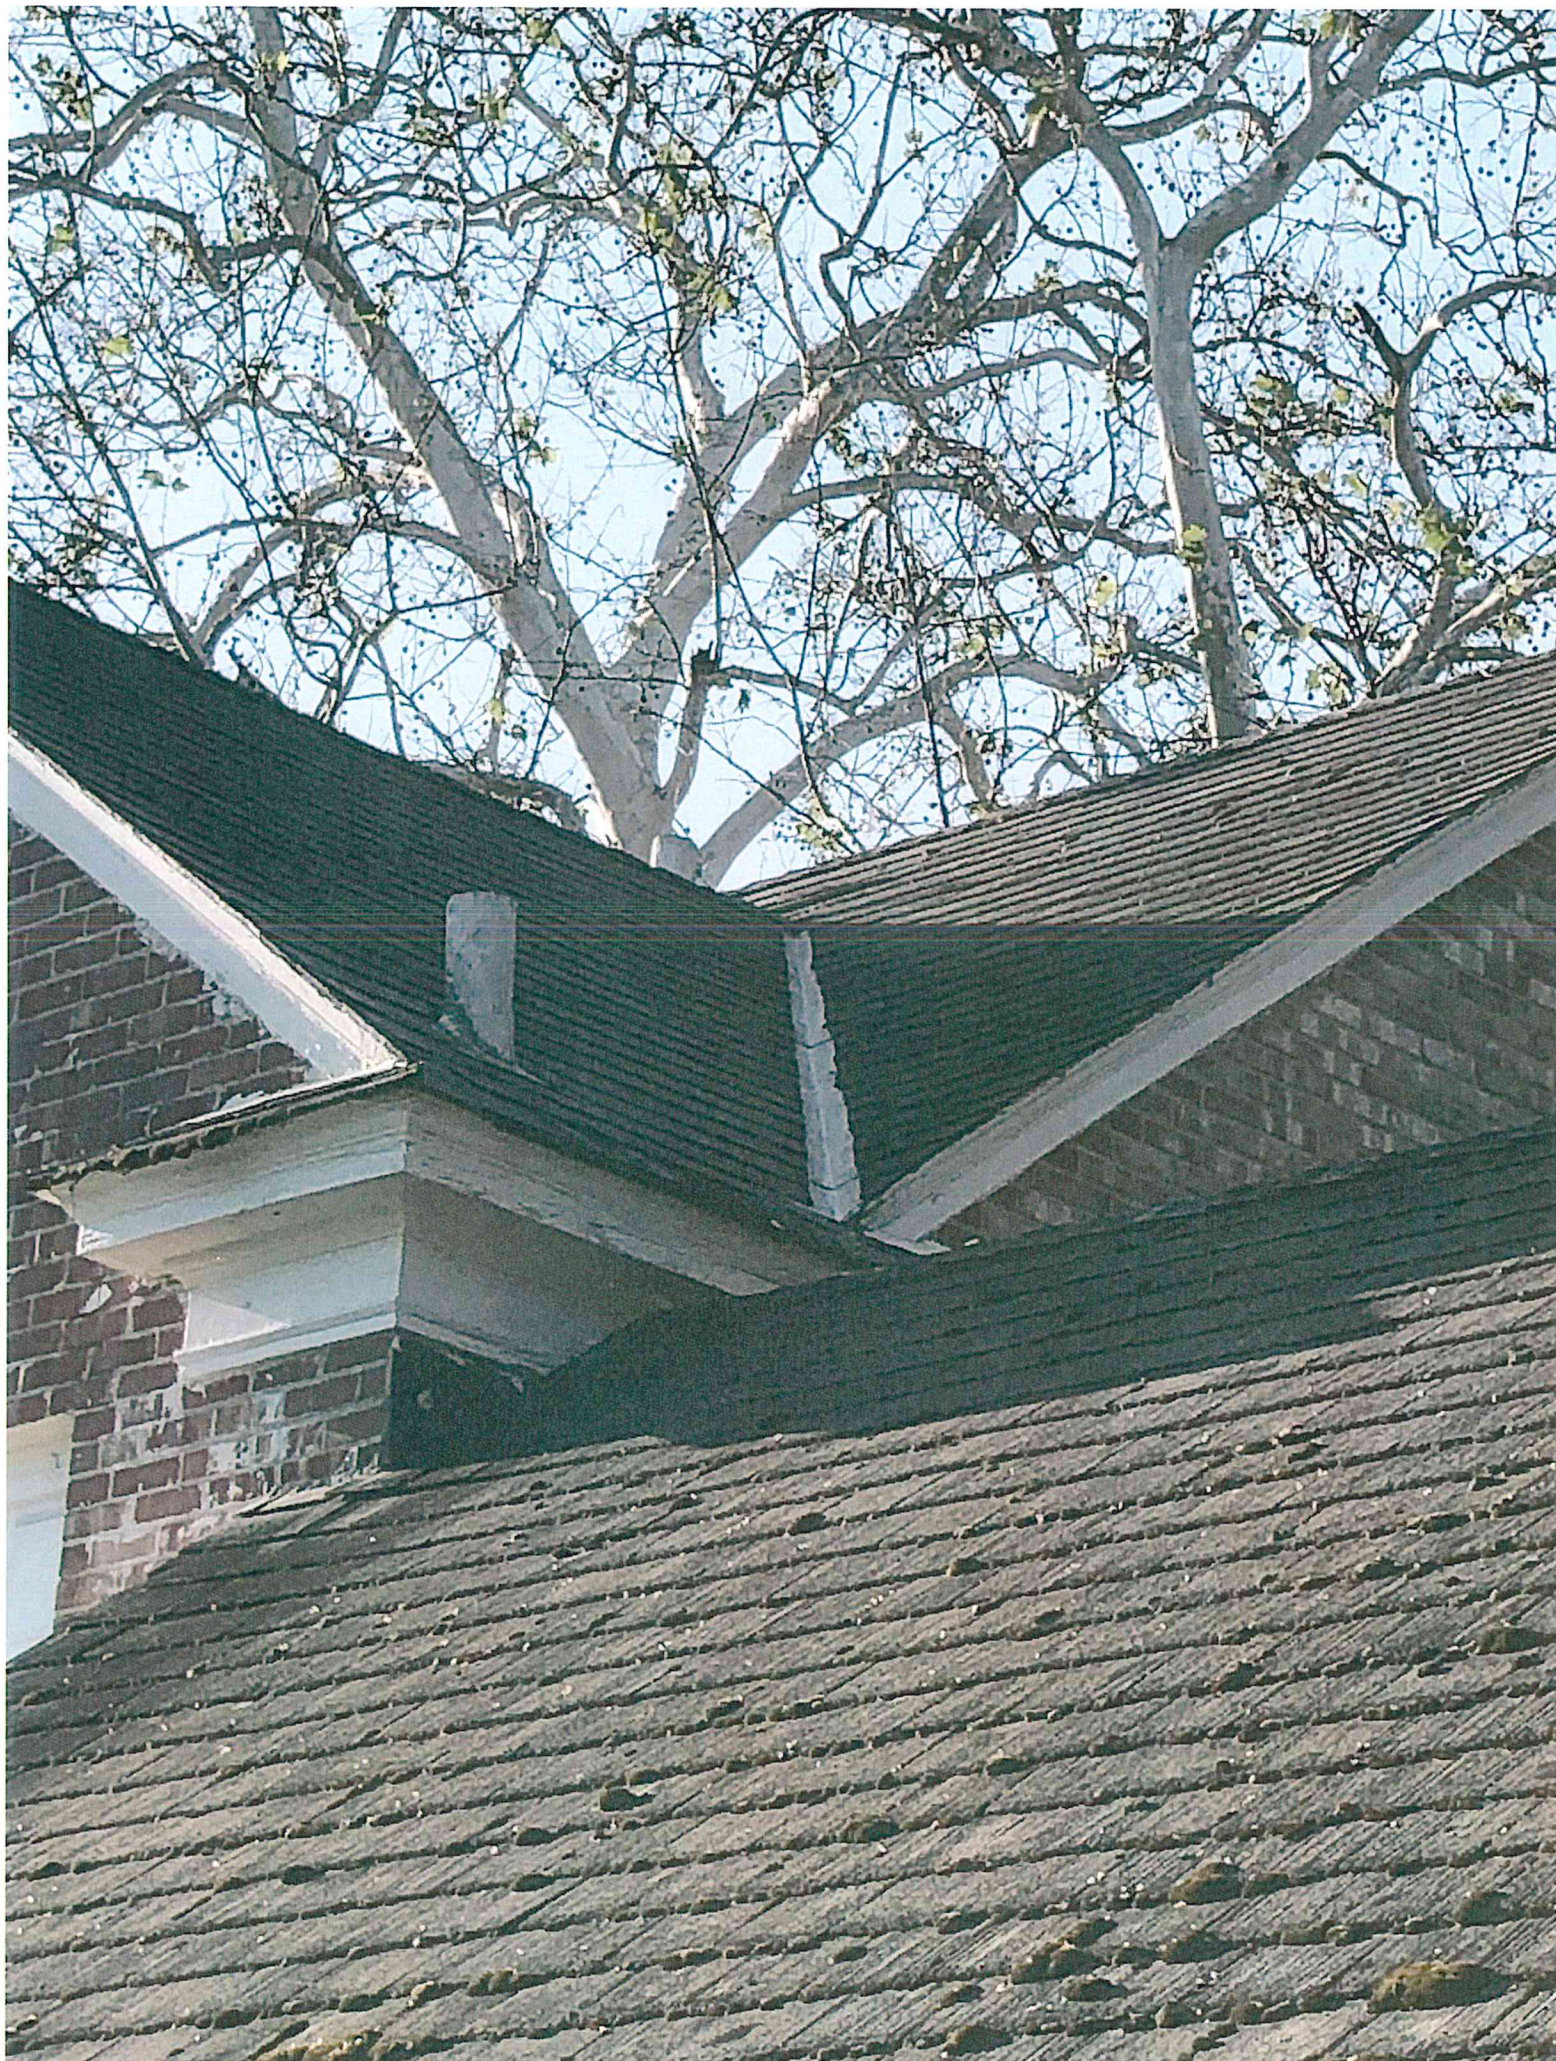
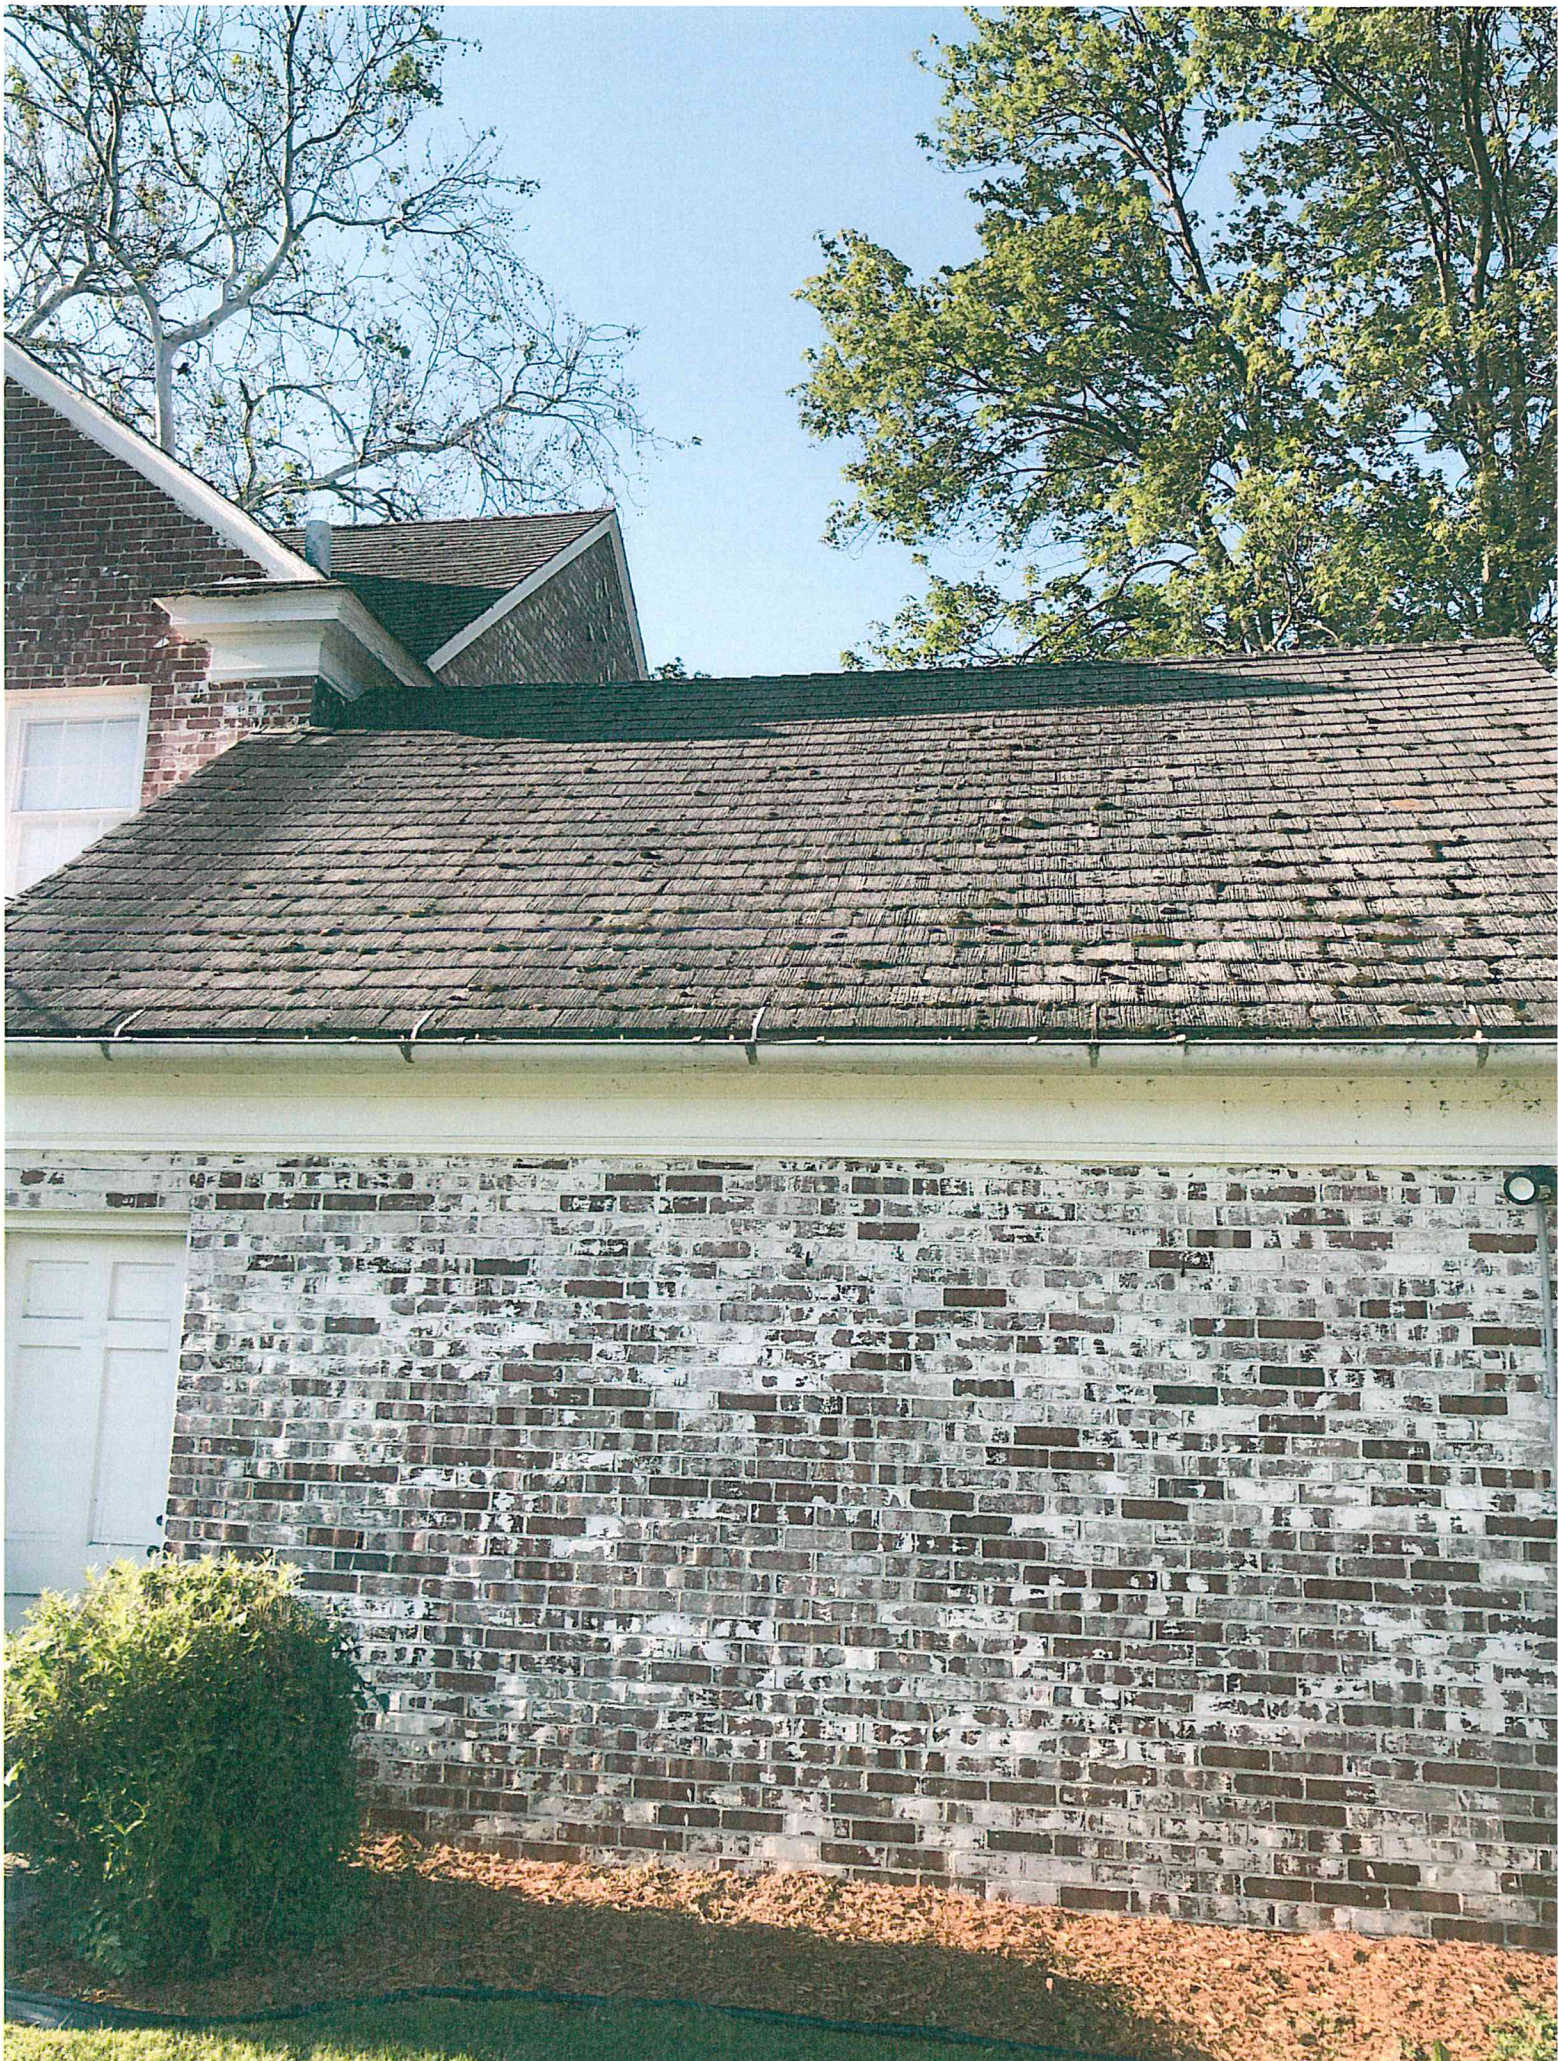
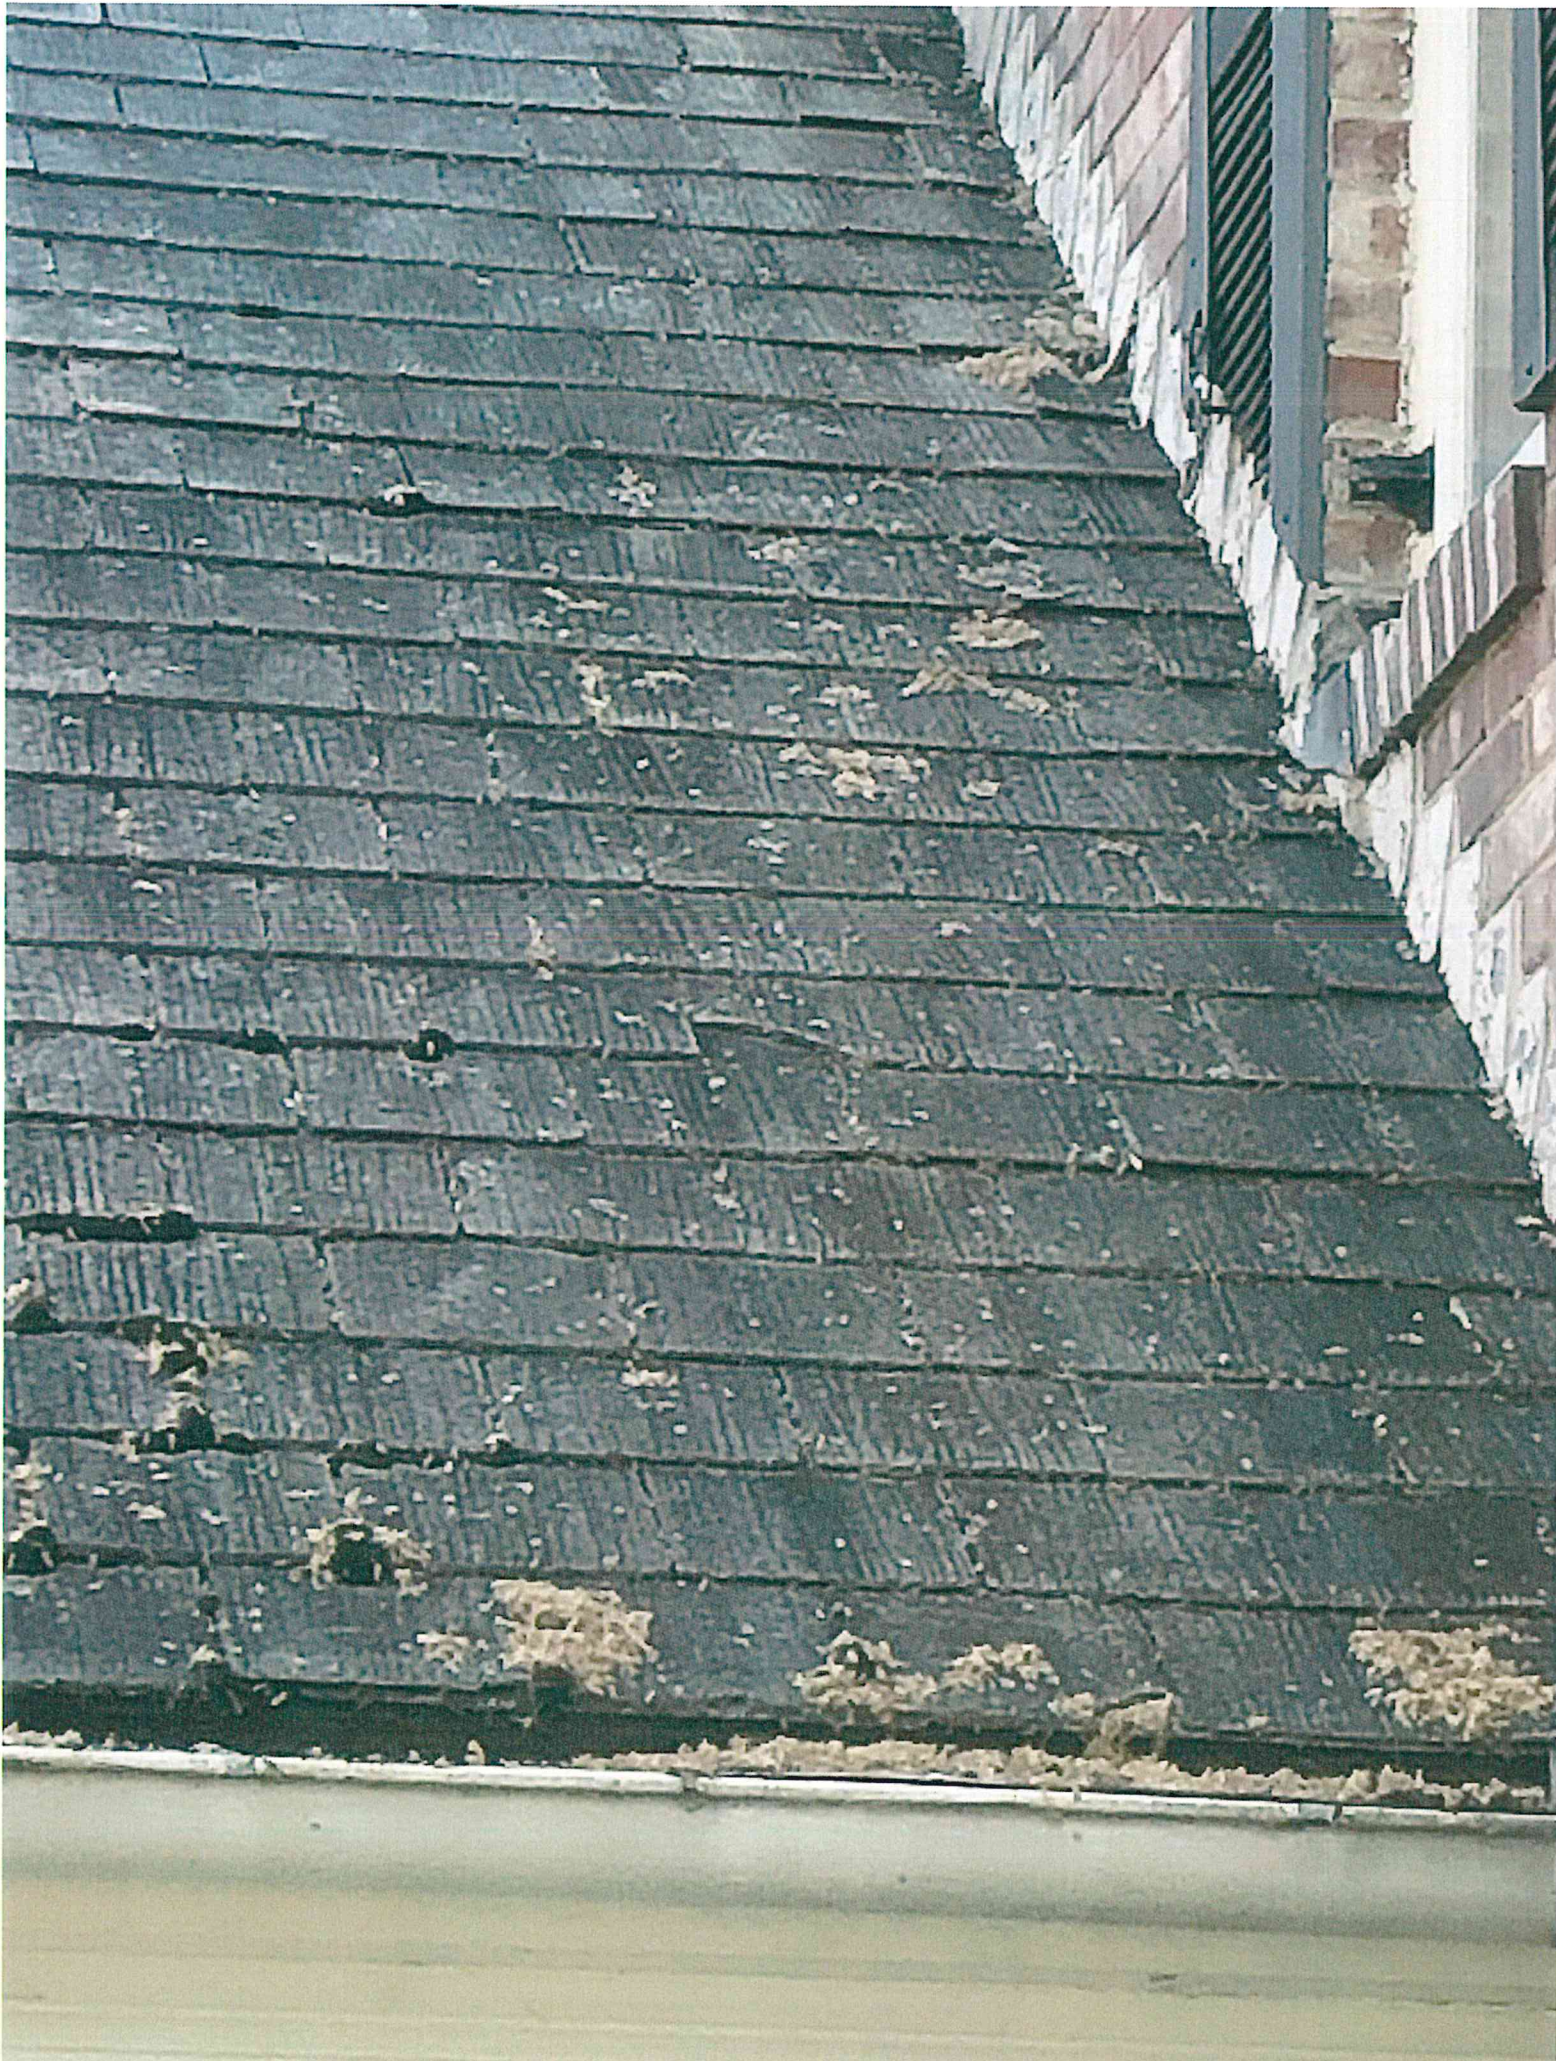
Site photographs submitted by Slatile

The current roof is an asbestos tile system. According to the owner, this is the original roof from when the house was built in 1938. Our company has been doing various repairs for the last 5+ years for missing or broken tile, miscellaneous flashings and such. At this time it is becoming more difficult to obtain replacement tile for these repairs. After inspection of the roof I found that there are currently 1-2 broken or missing tile but because of the pitch of the roof I am unable to see all of the north elevations. Mr. Nowicki informed me that he had found additional tile pieces in his yard so I am assuming there are more on that north side.
