**STAFF REPORT**  
CONCERNING APPLICATION FOR A  
**CERTIFICATE OF APPROPRIATENESS**

**Application Number:** 2019-0603A

**Property Location:** 1133 East Wayne Street

**APPLICATION ITEMS:** *“Replacement of the asbestos tile roof and galvanized gutters with the Classic Products Oxford metal shingle and new galvanized gutters”*

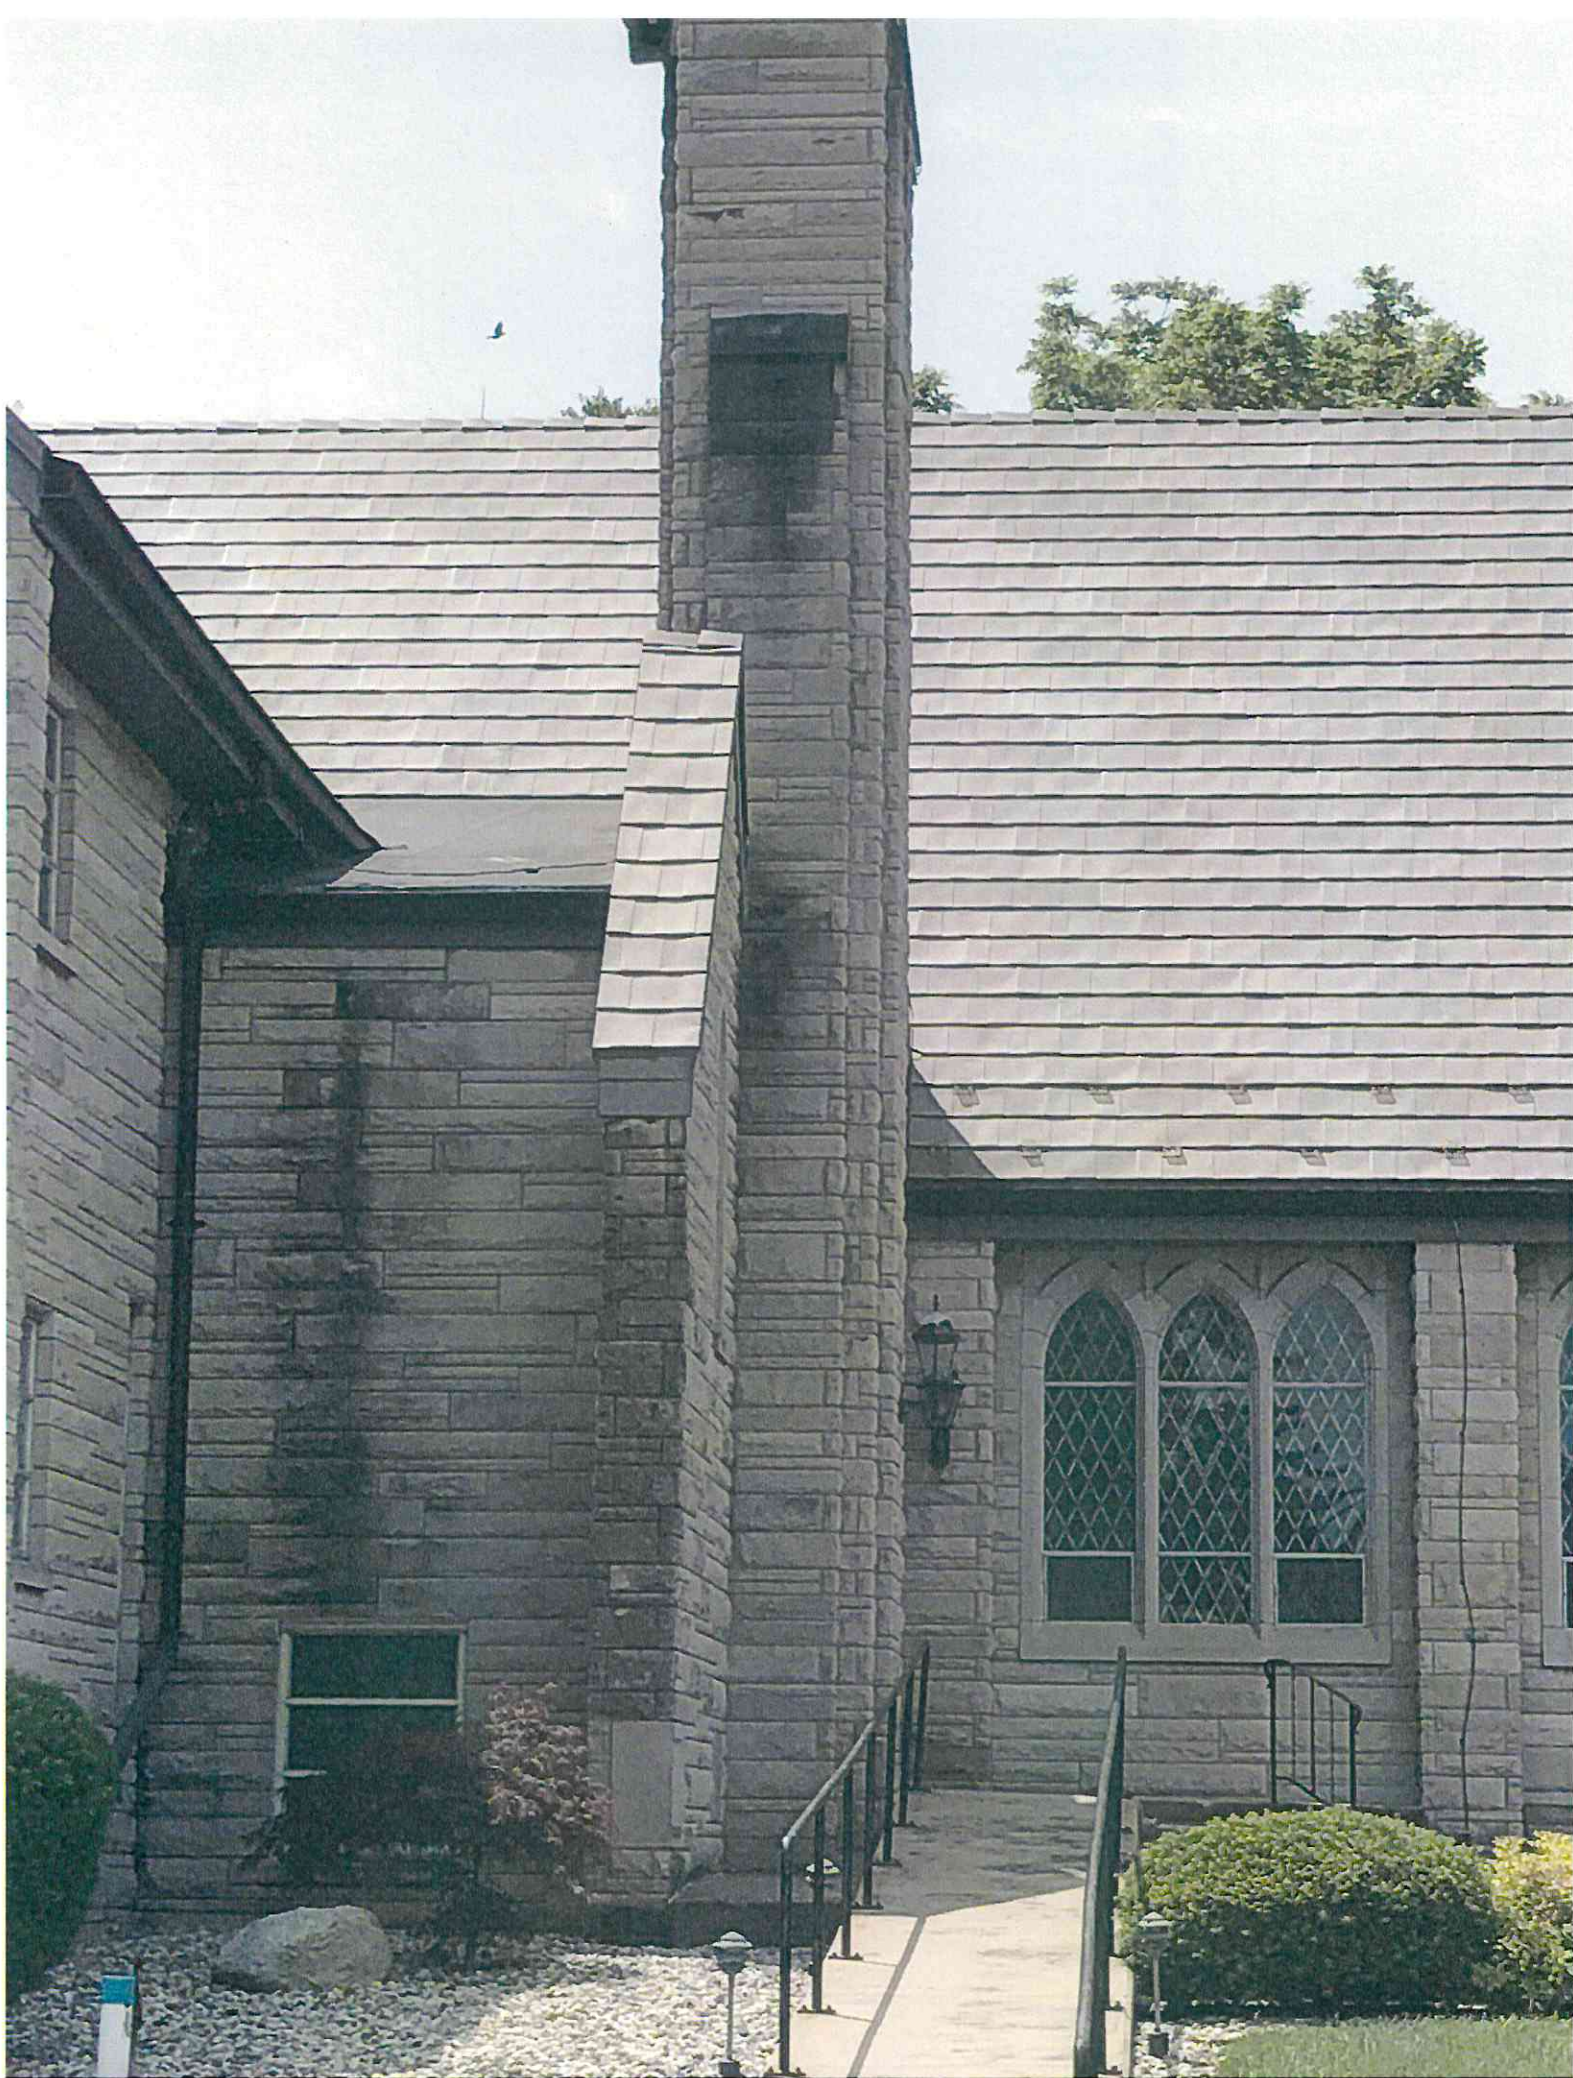
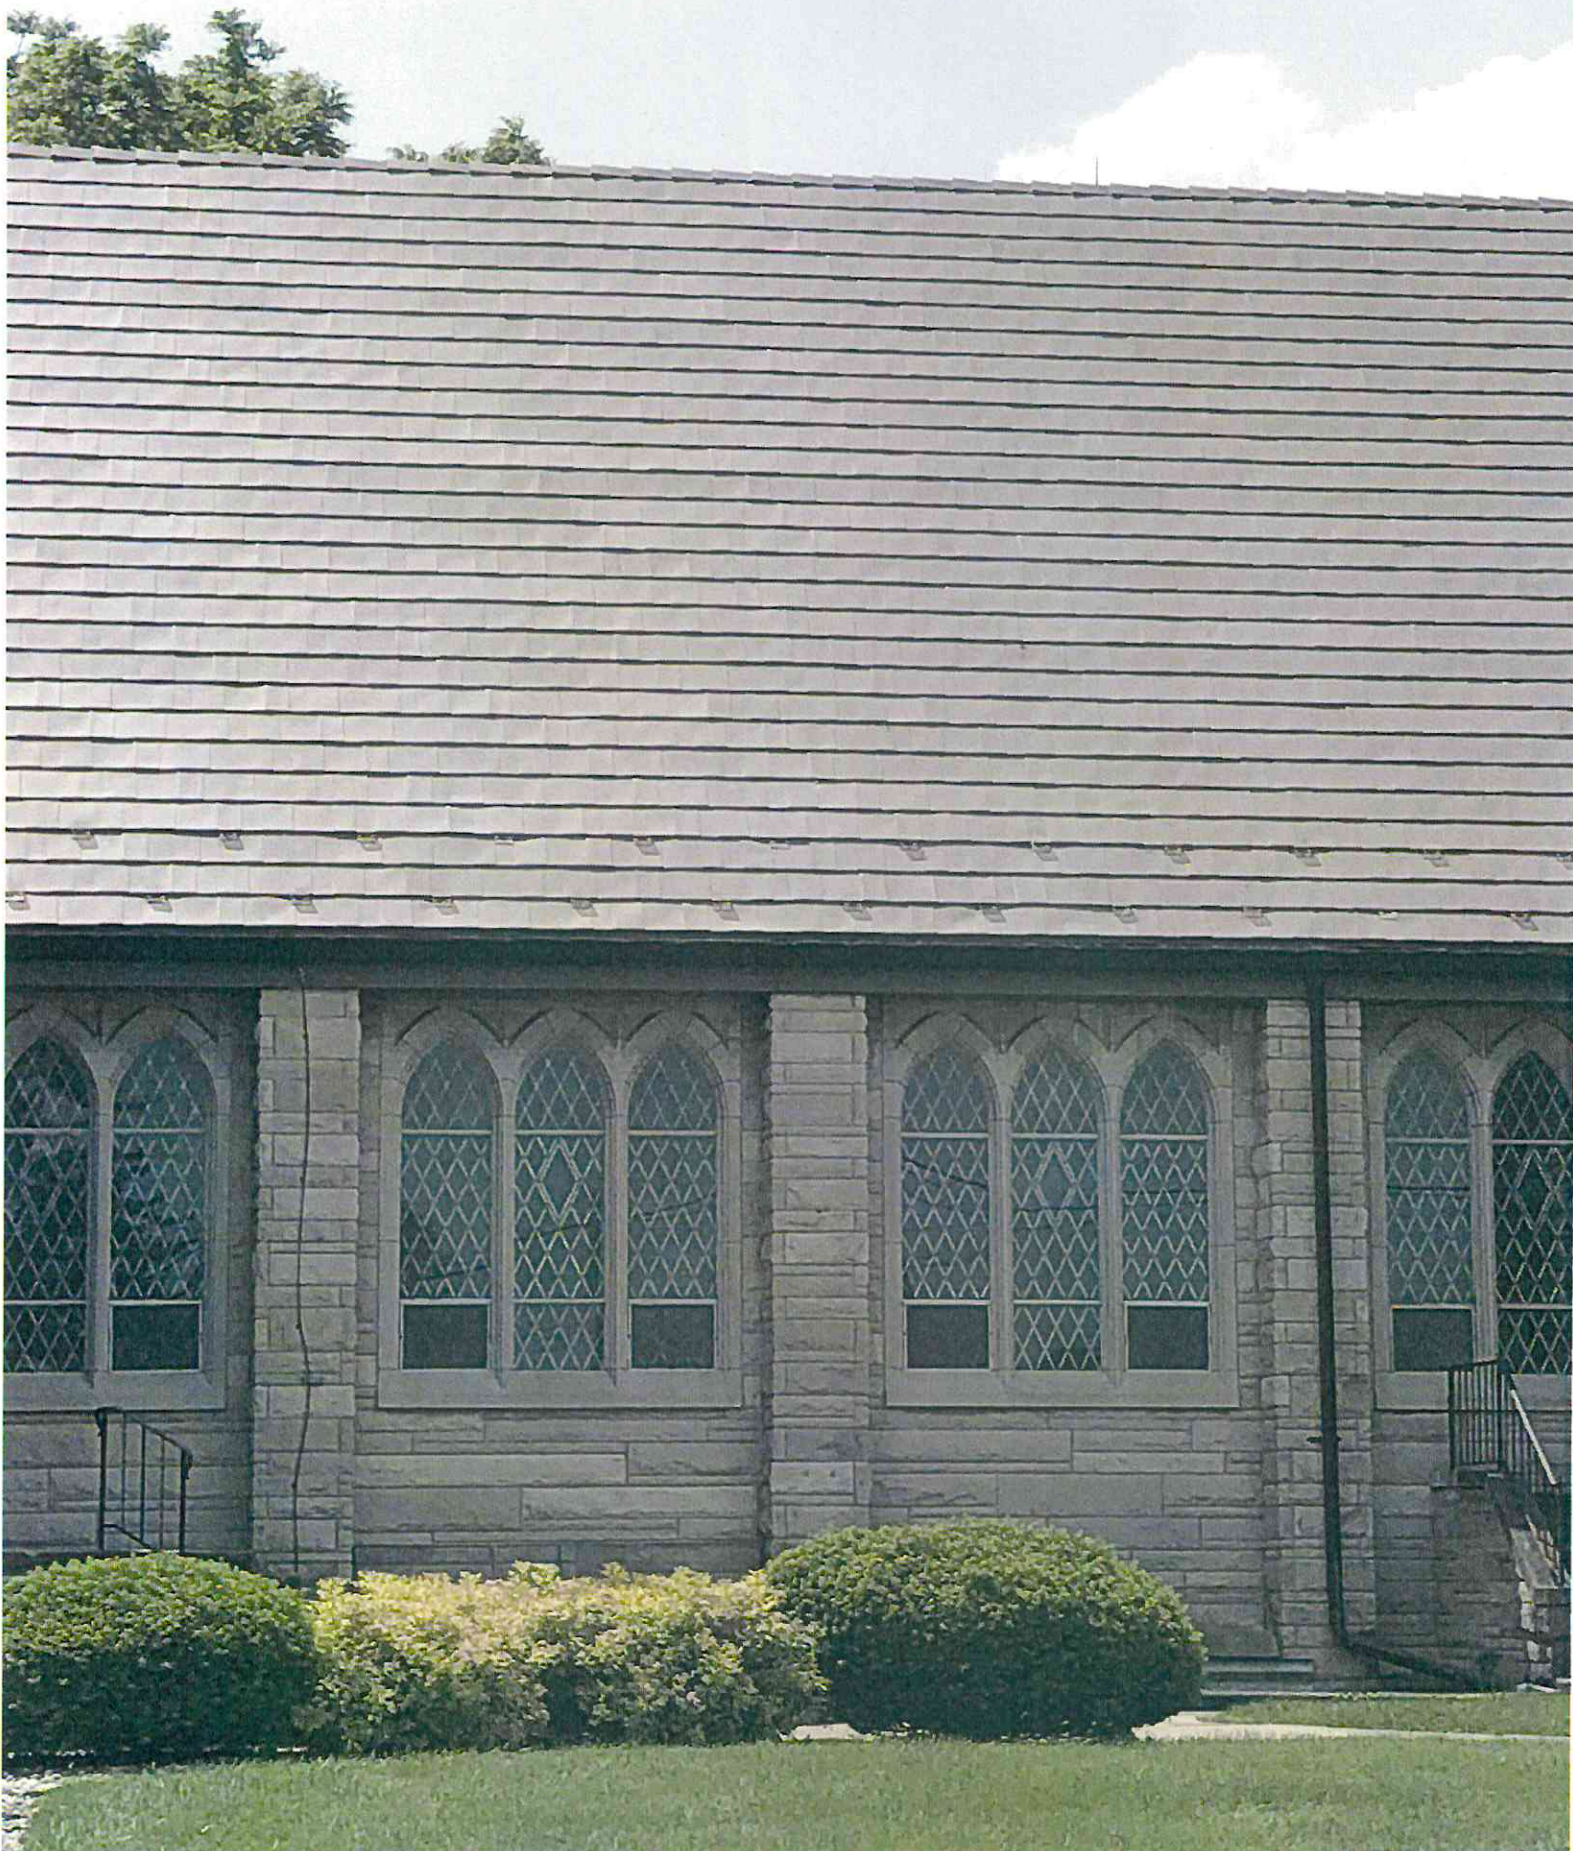
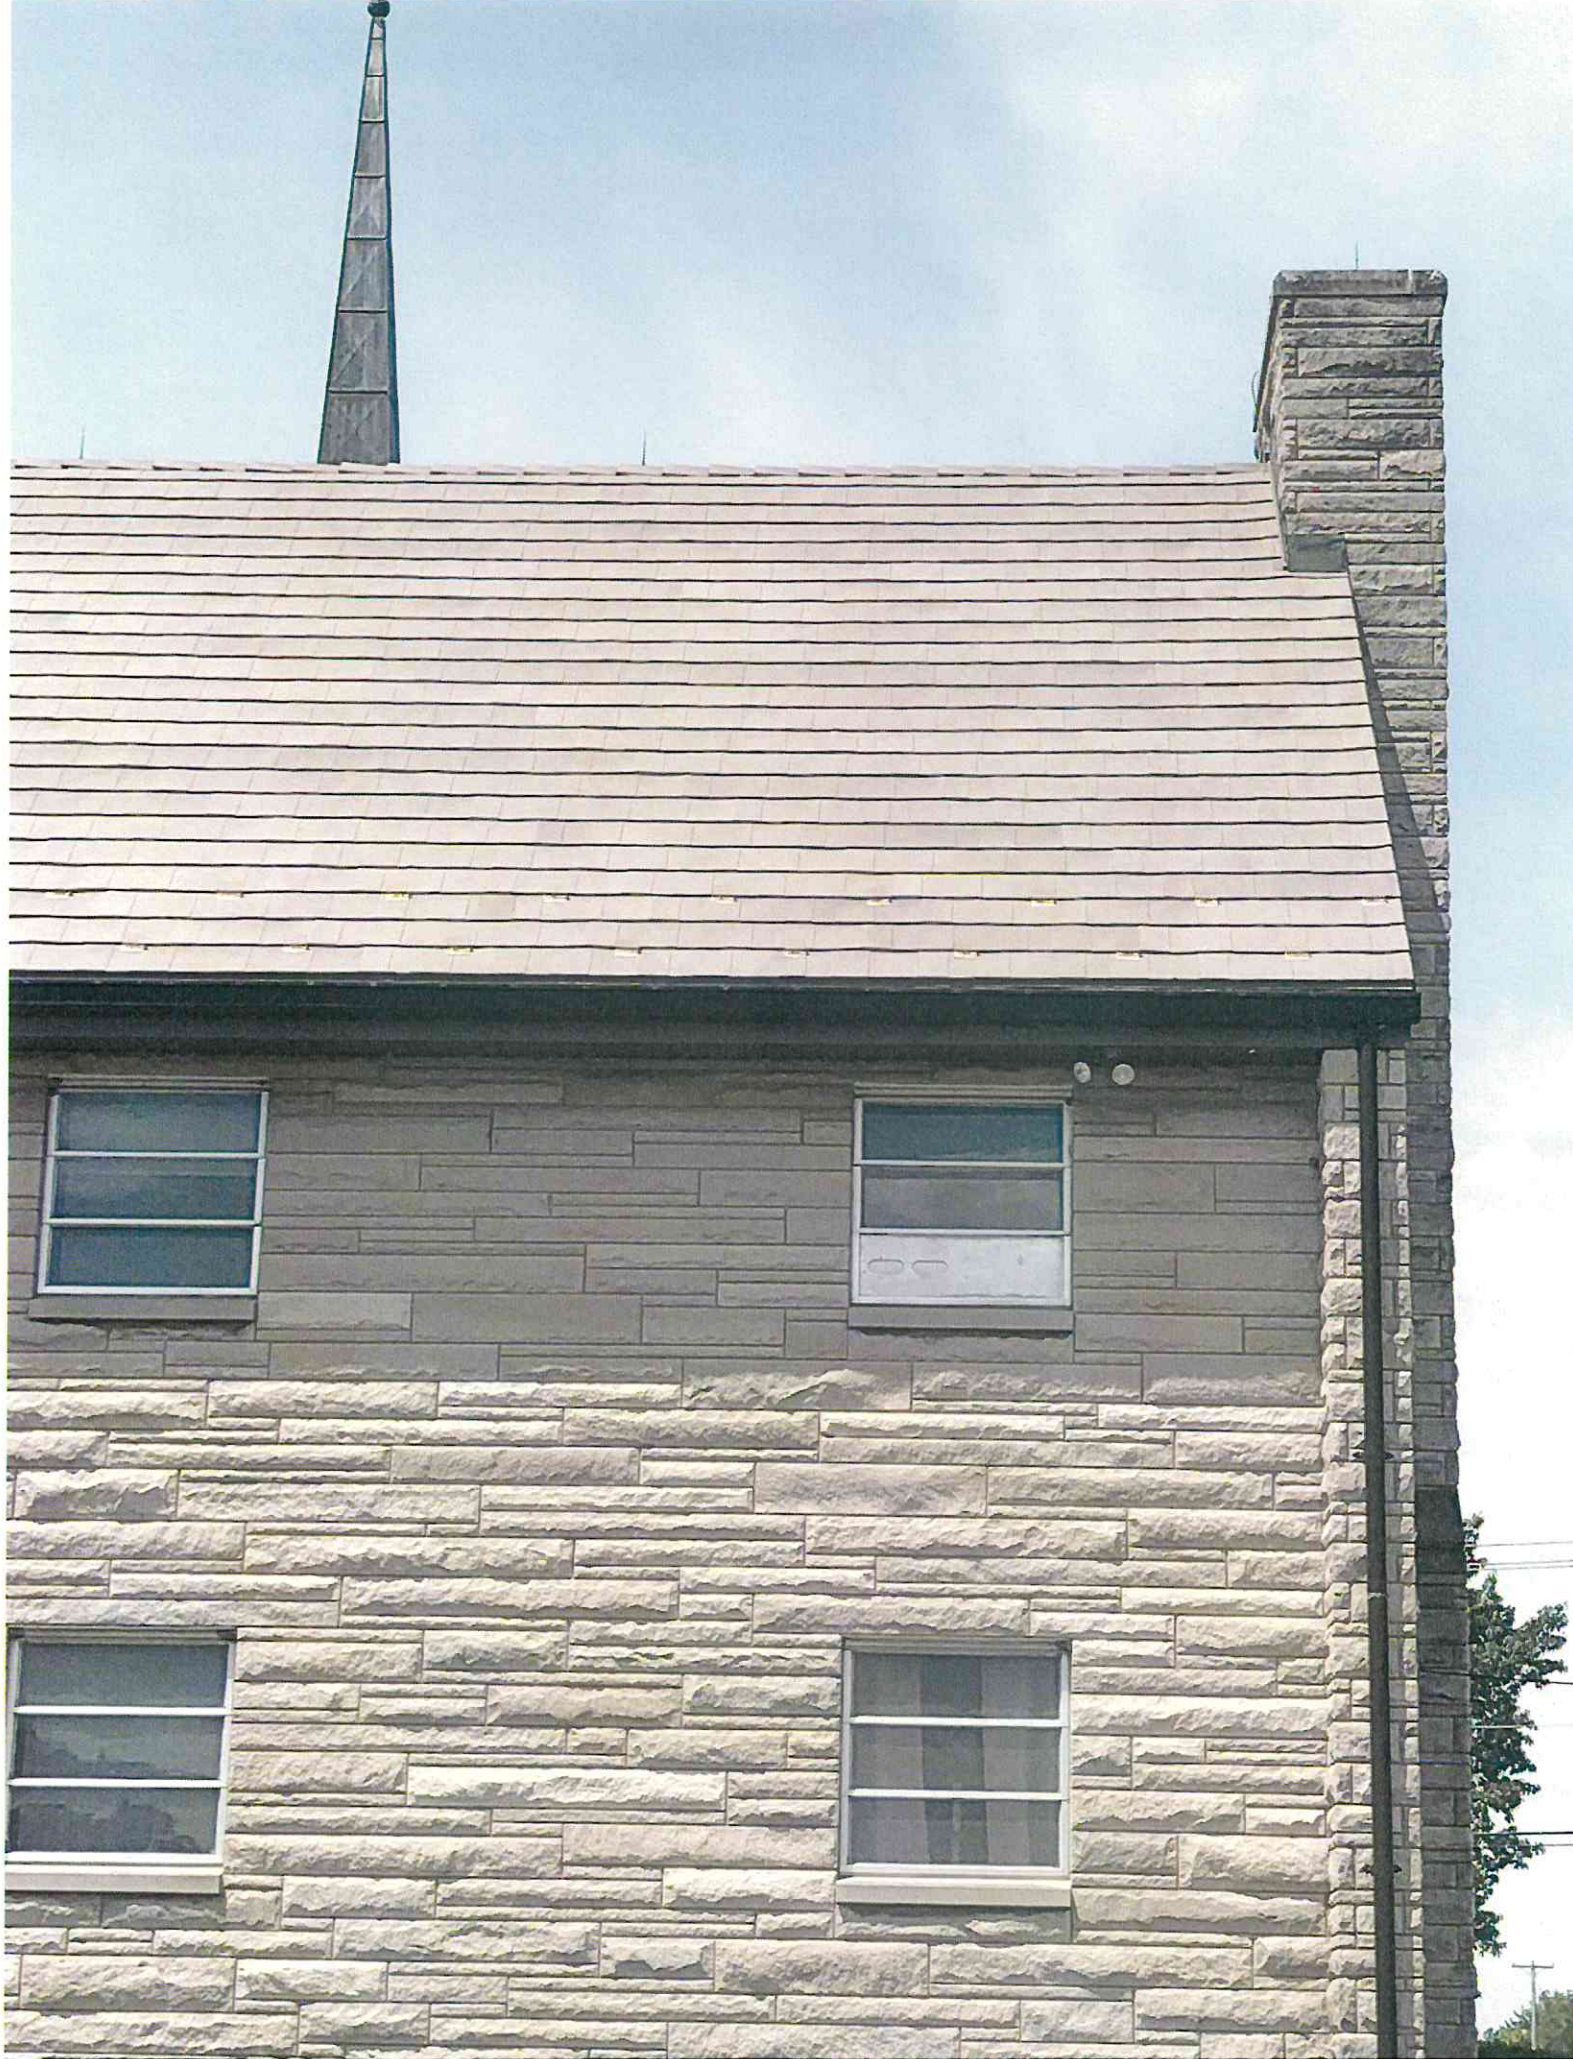
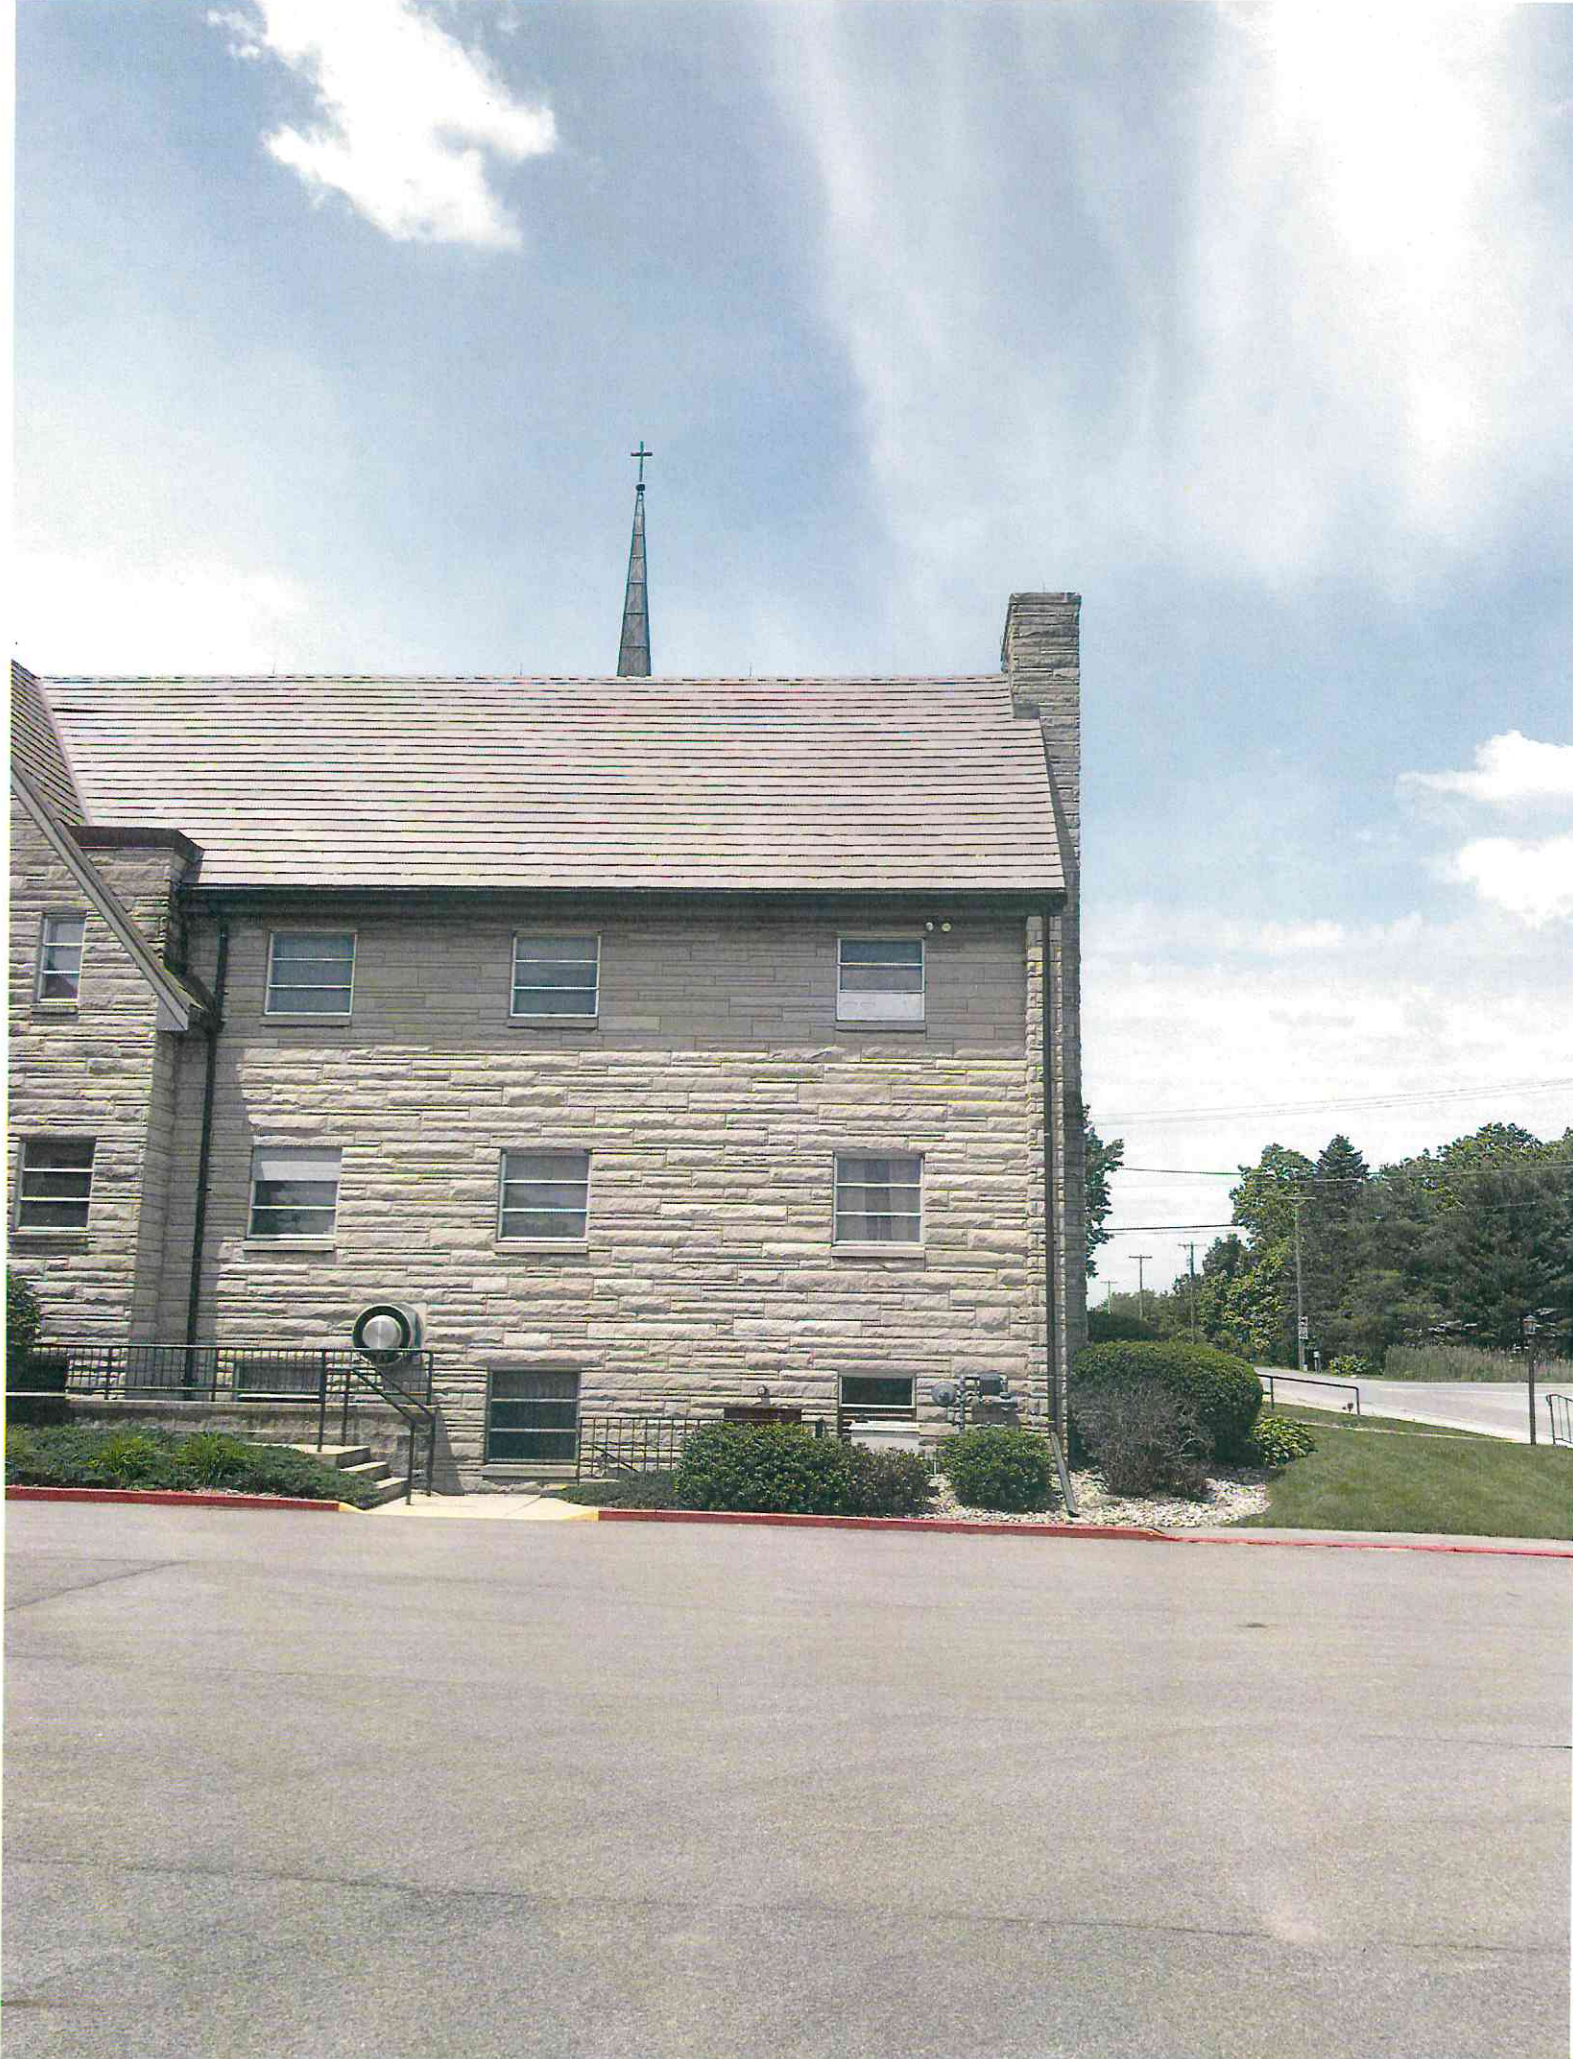
The current roof is an asbestos tile system. According to the owner, this is the original roof from when the house was built in 1938. Our company has been doing various repairs for the last 5+ years for missing or broken tile, miscellaneous flashings and such. At this time it is becoming more difficult to obtain replacement tile for these repairs. After inspection of the roof I found that there are currently 1-2 broken or missing tile but because of the pitch of the roof I am unable to see all of the north elevations. Mr. Nowicki informed me that he had found additional tile pieces in his yard so I am assuming there are more on that north side.
