STAFF REPORT

CONCERNING APPLICATION FOR A CERTIFICATE OF APPROPRIATENESS

Date: December 6, 2023
Application Number: 2023-1208i8i6
Property Location: 635 South Main Street
Architectural Style/Date/Architect or Builder: Renaissance Revival / 1910
Property Owner: Studebaker Center, LLC
Landmark or District Designation Local Landmark, #8267-92
Rating: *Significant/Notable*

STUDEBAKER ADMINISTRATION BUILDING EXTERIOR ENVELOP REHABILITATION SCOPE OF WORK PROPOSED:

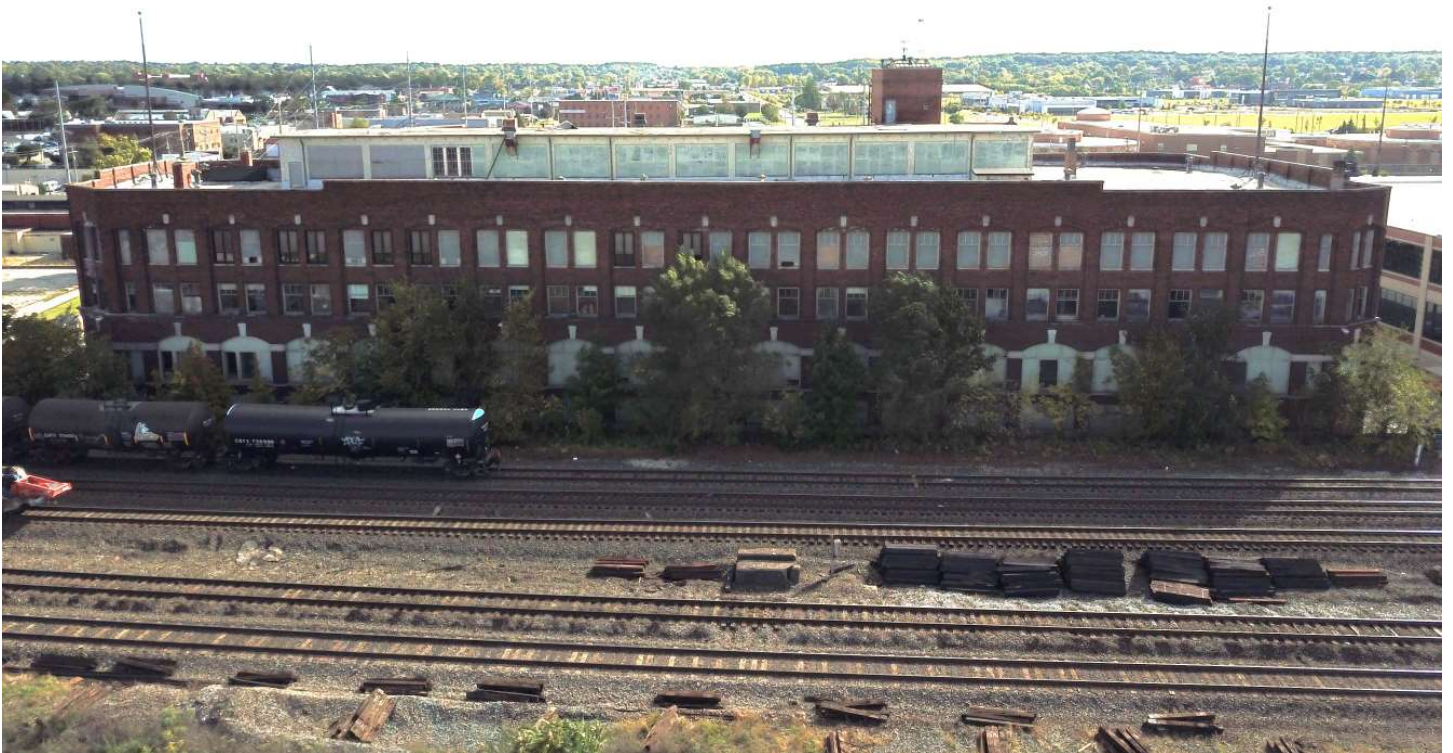
Photo 4 - North Facade

The existing wood windows are boarded up at the First and Second Floors with a handful of additional windows boarded up at the Third Floor. All original windows are drywalled over on the interior of the Fourth Floor, with the exception of seven, which have been replaced with incompatible aluminum replacements. Some of these are infilled openings with brick masonry as exposed from the exterior. These boarded openings in some cases cover the original windows (sash/frame/glass). These openings are boarded up due to glass breakage by rocks being thrown at the building from the tracks over the years. This design plan retains boarded-up window openings at the First and Second Floors of the North Façade given the proximity of these windows to the elevated tracks (25' to 30' away). The boarded up openings would retain the existing windows if they exist (sash/glass/frame). The NE and NW windows on the angled bays of the North Façade would be rehabilitated as wood windows (in like and kind) since they are visible from Main Street as well as Lafayette.

These new all-aluminum windows will be thermally broken and will incorporate dual pane Low-E glass. The north side windows will also include a glass specification that will reduce the noise transfer from the rail traffic at adjacent railroad with sound dampening/acoustic attenuation design. Exterior glass would most likely be a combination of laminated and/or tempered glass. Color would be a dark or medium bronze finish as proposed, exact color to be determined and coordinated with the exterior Sash and frame color of the restored windows on the East, South and West facades.

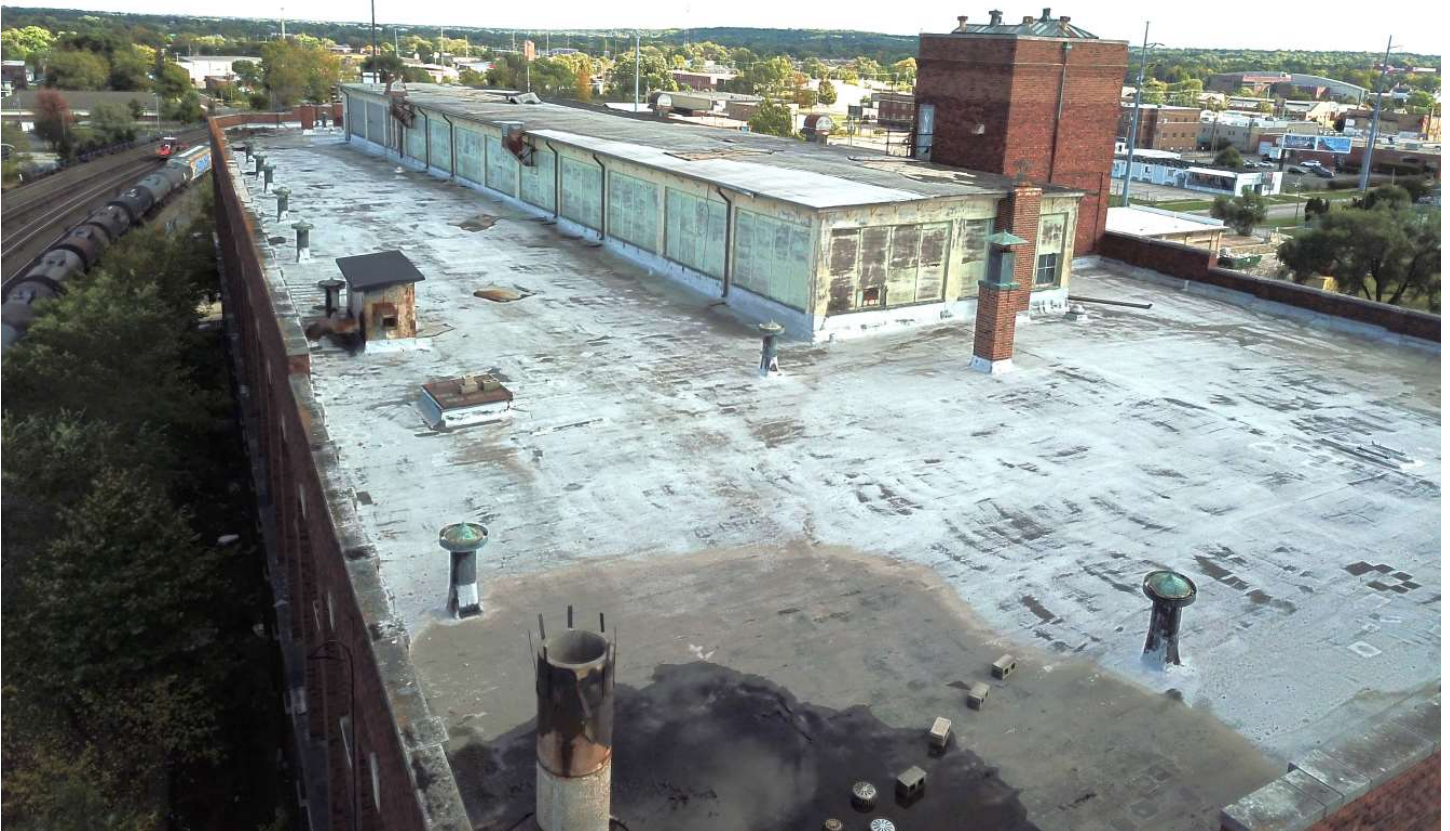
Photo 13 - Monitor Roof w/ Clerestory from NW

The clerestory windows are set back from the perimeter upper parapet and as such are not visible at grade. These window units are in very poor condition, and mostly boarded up. The windows are large double-hung units (4 over 4 lights). The proposed new all aluminum windows would be non-operable fixed windows but will match the 4 over 4 light pattern. Since these units would be visible from the interior double height atrium space, this geometry is important to replicate (muntin/sash/frame/glass geometry). These windows are visible two levels above

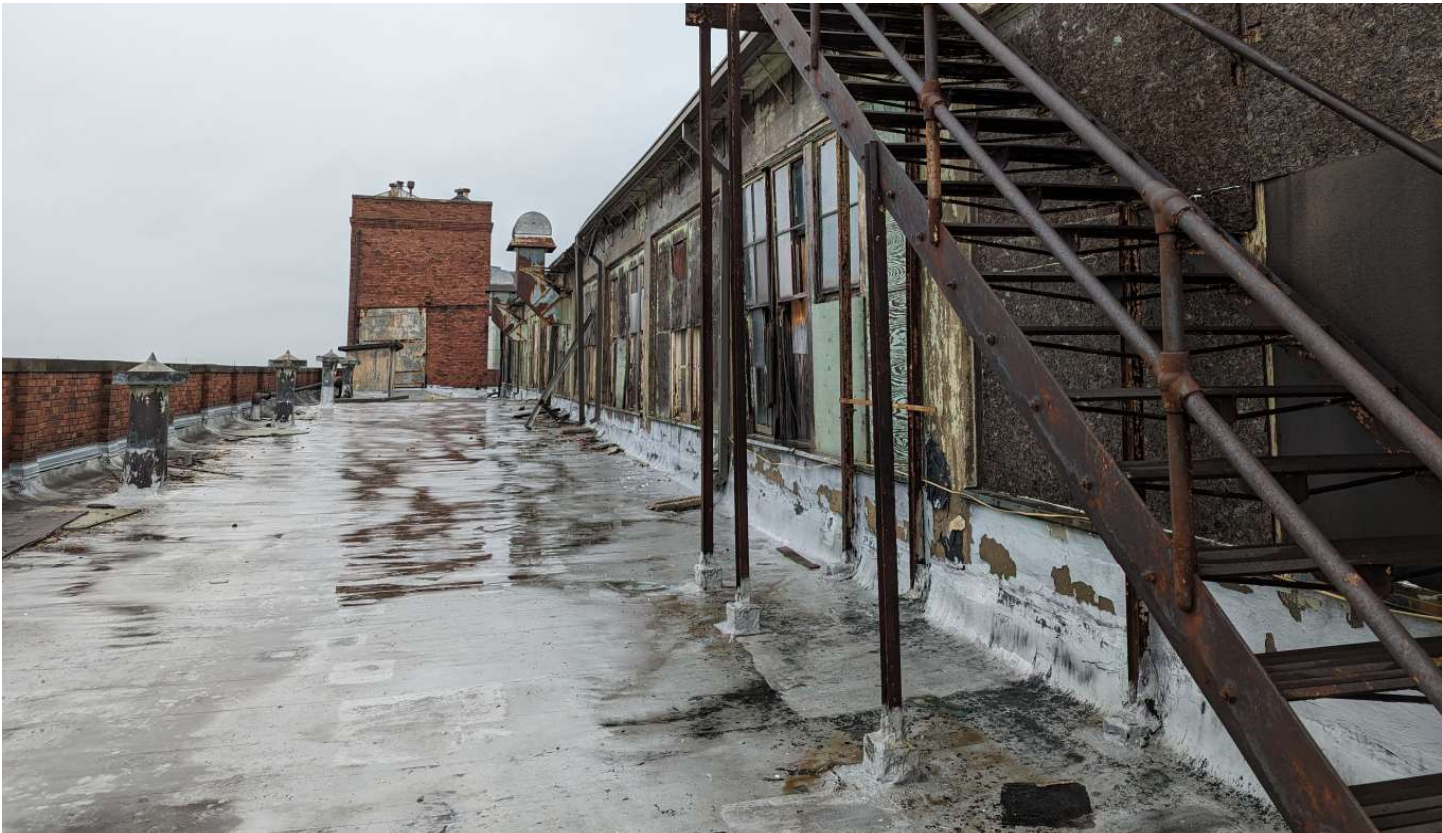
Photo 21 - View to W of Clerestory Windows and Roof

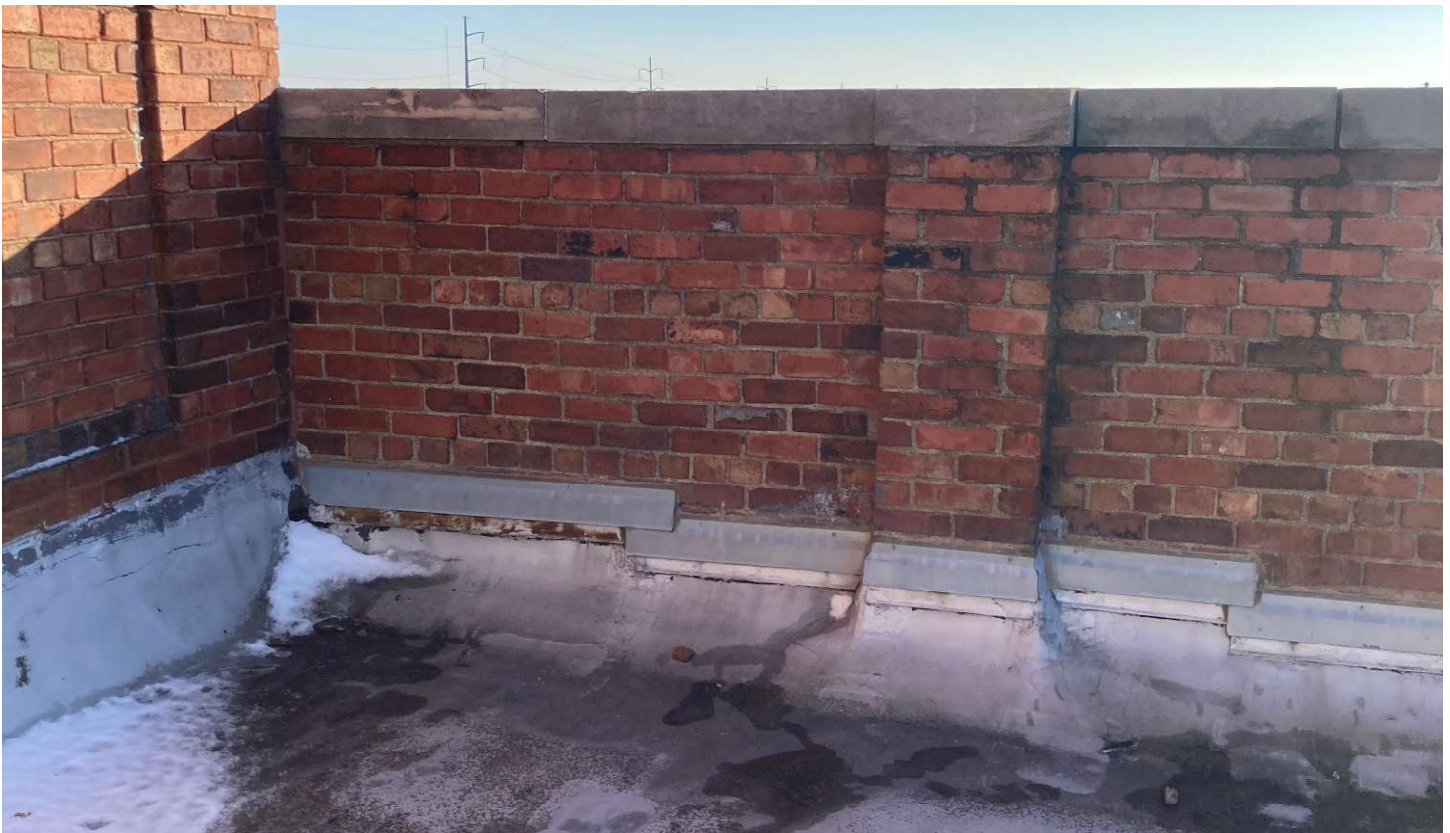
Photo 24 - Typical Stepped Flashing and Parapet Pier adjacent to Elevator Tower

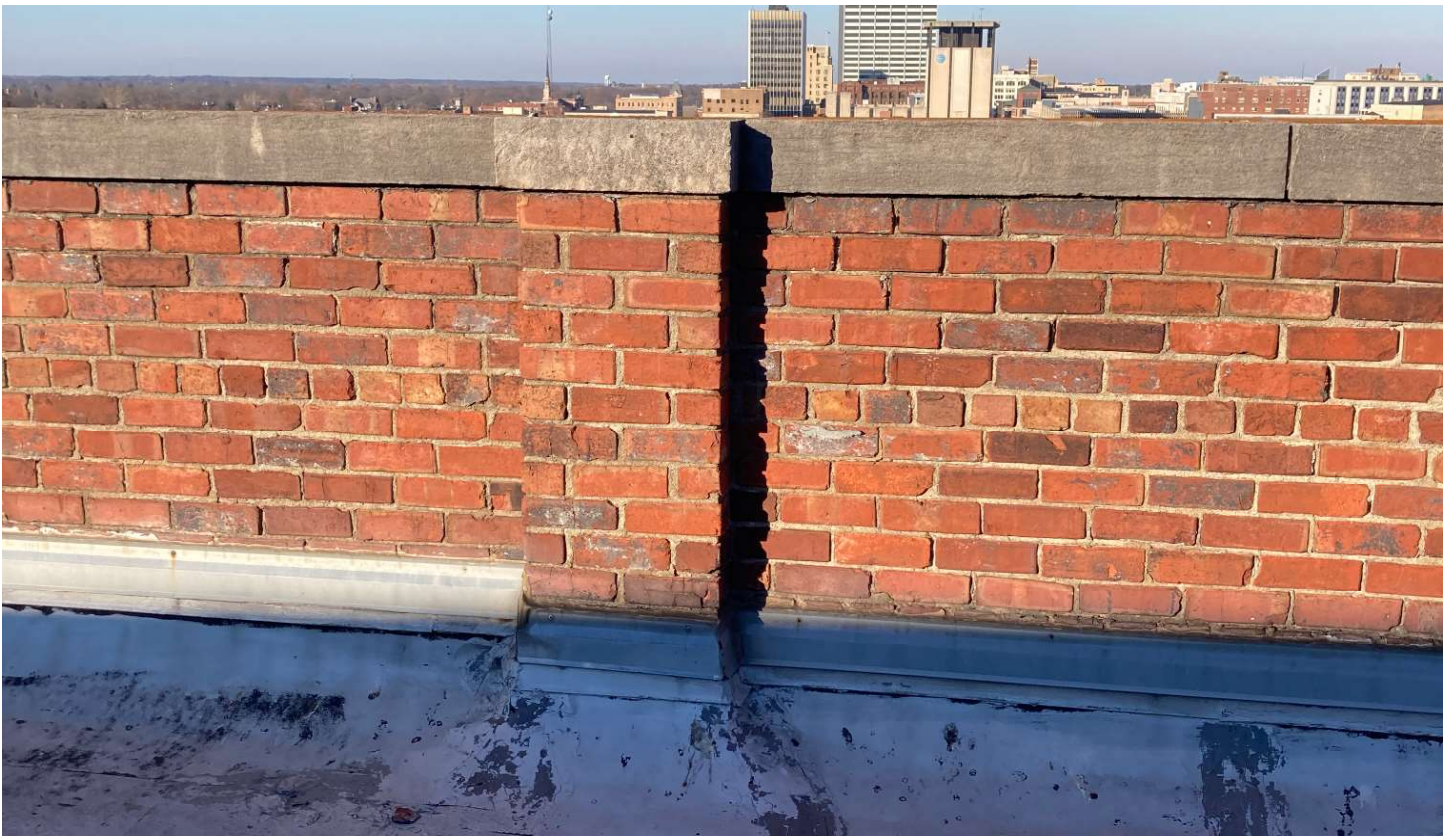
Photo 26 - Typical Parapet Wall at North Side of Roof

- d. *Copings and Parapet Walls*: Limestone copings over triple wythe parapet walls exist, but are not the original design. Corbelled brick, a stone cornice, and multi-layered shouldered copings were present in the building’s original condition, but were removed between 1941 and 1950, when the large illuminated cursive signs were also removed. The existing parapet walls be repaired, but the current design will not be modified.

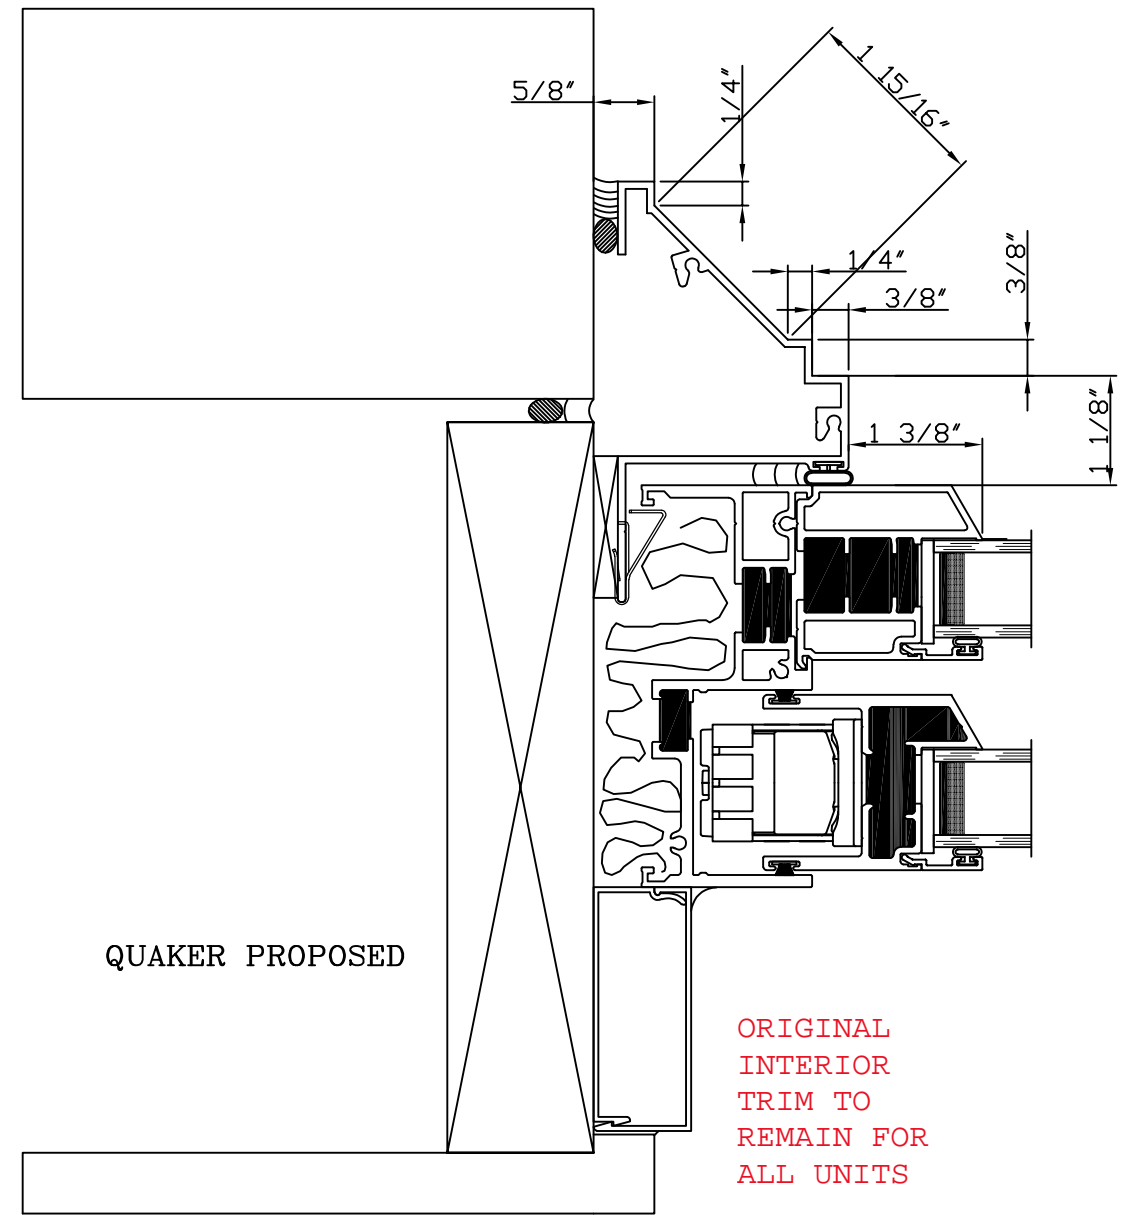
ORIGINAL
INTERIOR
TRIM TO
REMAIN FOR
ALL UNITS
