STAFF REPORT

CONCERNING APPLICATION FOR A CERTIFICATE OF APPROPRIATENESS

Application Number: 2018-0911A

Property Location: 510 S Carroll

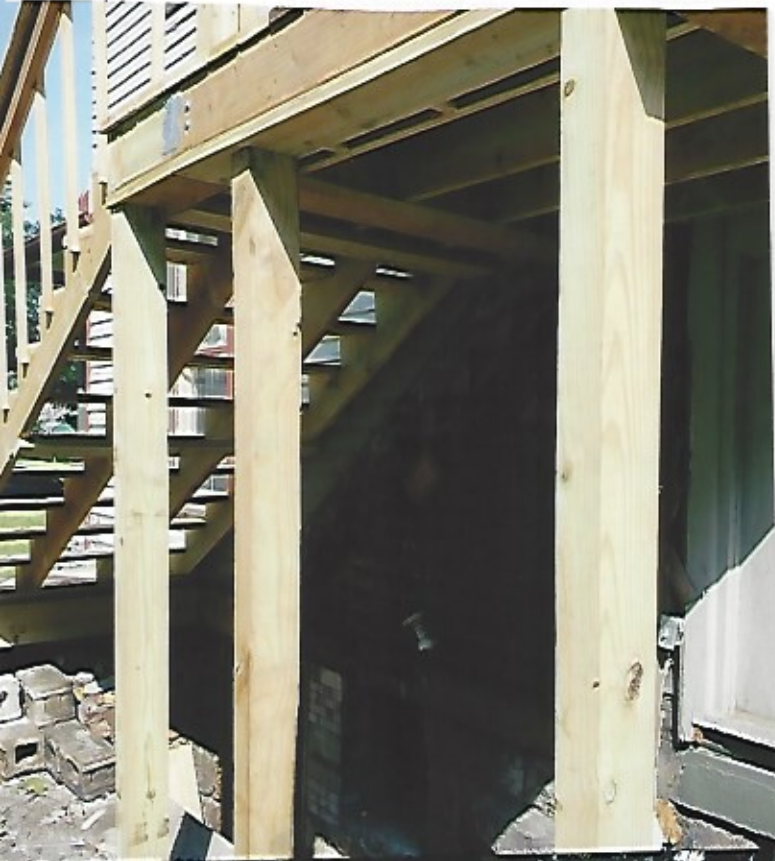
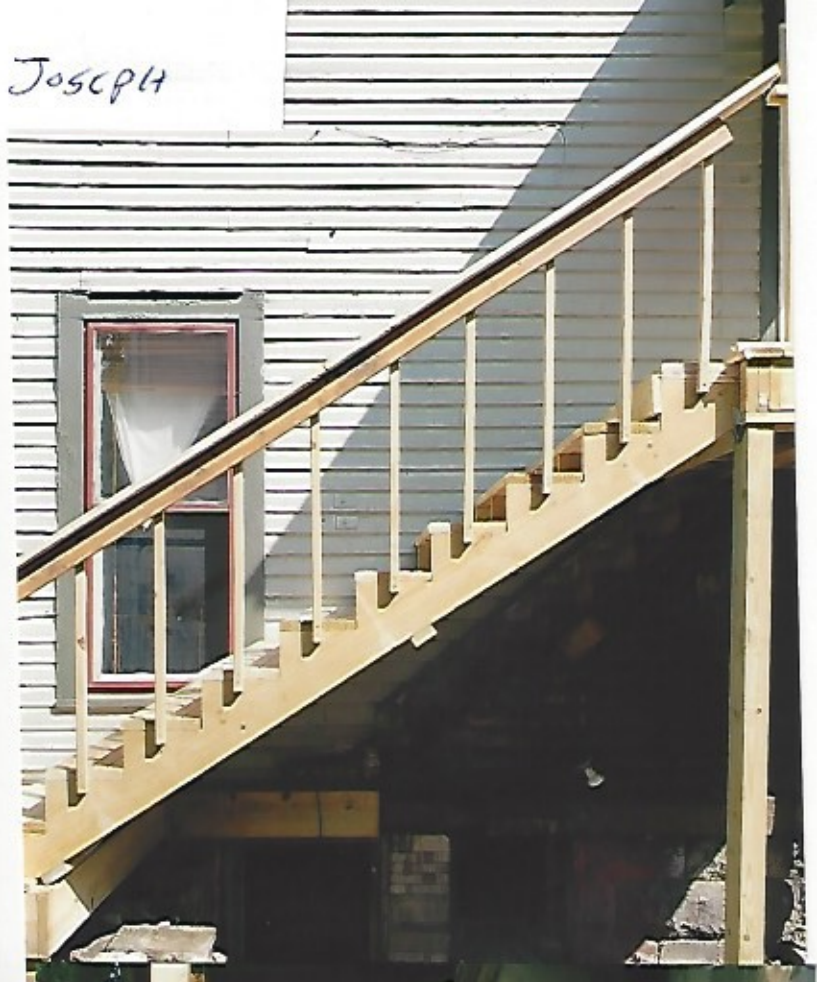
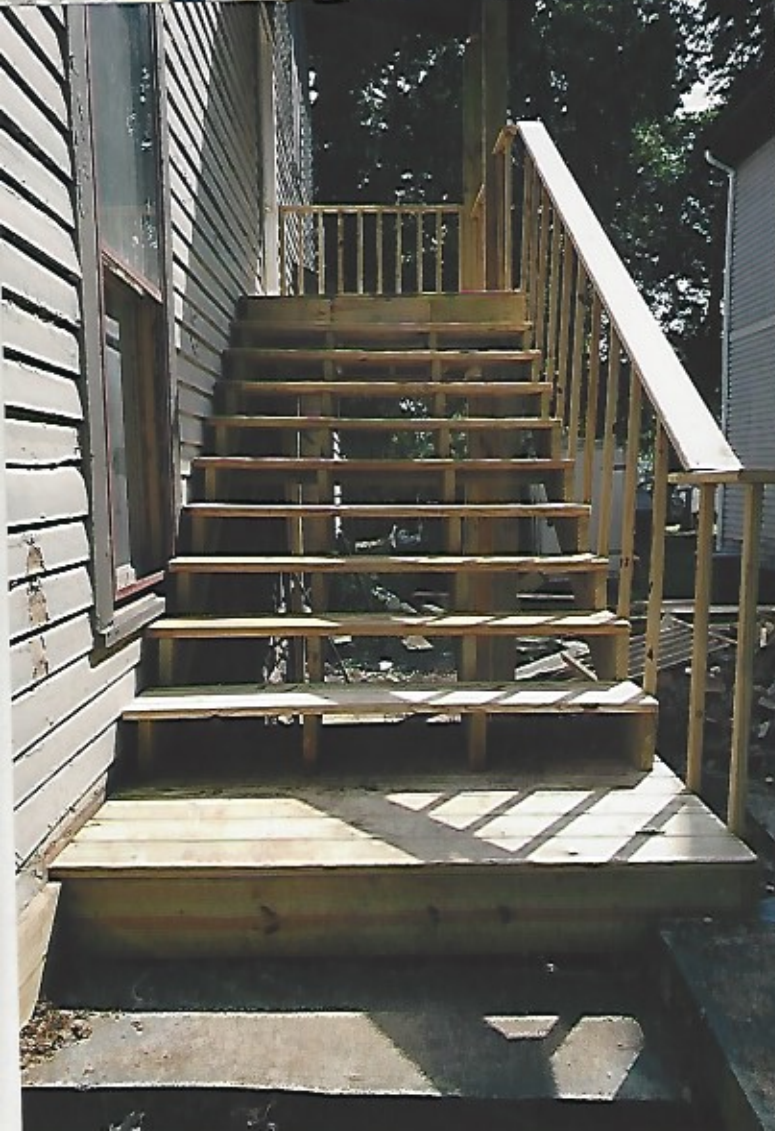
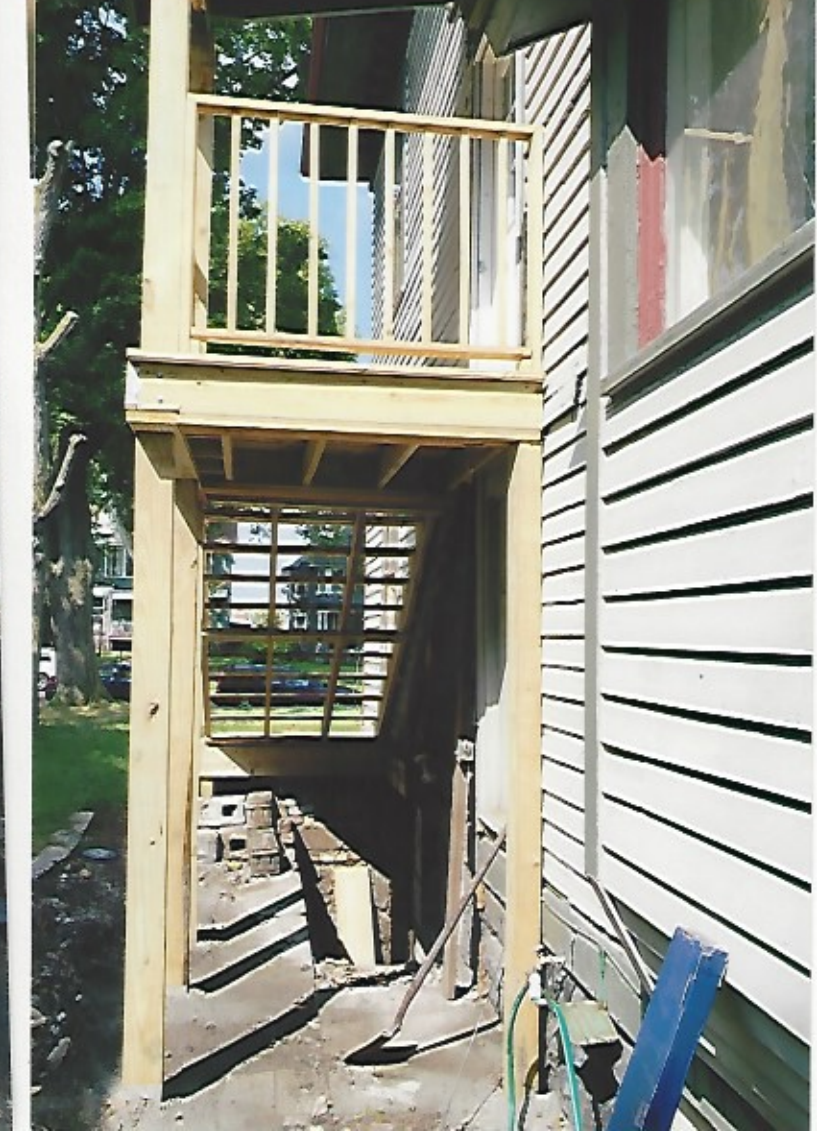
REPAIRED STOPS 510'S ST. JOSEPH

1. Outdoor Side Stair replacement. These stairs were failing and needed to be replaced. They were never installed properly and were attached to a stone and brick wall which was about to fail. We replaced the steps without approval, therefore we have pictures of the actual replacement step. I have included pictures of the new steps and the old steps from the street.

Regarding the external stairwell: in the period of time from the establishment of the district in 1998 until today, three out of the five Certificates of Appropriateness on file for this property have been received for projects related to the external staircases. As such, precedent has been established and staff recommends approval.

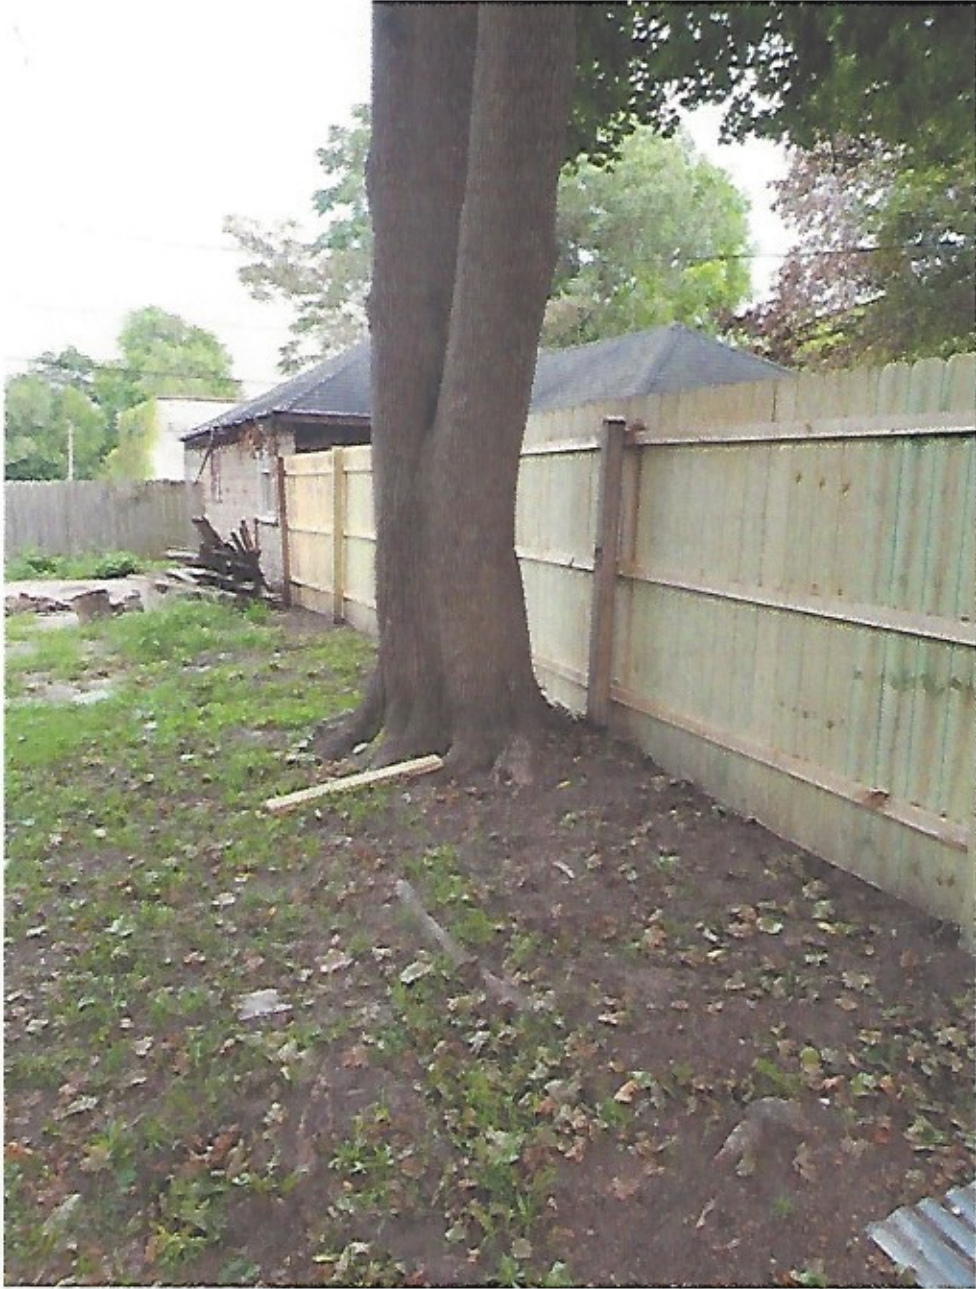
NEW FENCE

2. Replacement of fallen down fence. We have installed the fence in the back of the property. Included is a picture of the new fence.
3. Windows. We are requesting replacement of 7 windows on the west side of the house. These windows no longer have the weight system working. Since they are large windows they do not stay up and the wood is deteriorating. The current windows are wood and on the exterior there are aluminum storm windows. The storm windows are painted red. We are requesting the removal of both the wood windows and the storm windows. The new windows would be white and would be custom sized to fit exactly in the existing window frame. The windows we are planning to purchase are Jeld-Wen Best Series model JW1438. We would purchase from Menards. There are other windows in the house which were replaced with white vinyl windows. I have pictures of the windows we are requesting replacement and we purchased 1 custom window so you can see it has a similar sized frame as the original windows. Long term we would like to find a paint scheme which would incorporate white windows. We are open to any suggestions.

Regarding the retroactive reconstruction of the fence using the existing fence posts, staff recommends approval.
