STAFF REPORT CONCERNING APPLICATION FOR A CERTIFICATE OF APPROPRIATENESS

Application Number:2018-0727Property Location:417 W Navarre AvenueArchitectural Style/Date/Architect or Builder:Queen Anne / 1919Property Owner:BAC Home Loans Servicing LPLandmark or District Designation:Chapin Park Local (Ordinance #9574-05) and National Historic DistrictRating:Outstanding

DESCRIPTION OF PROPOSED PROJECT: Applicant seeks a *retroactive* Certificate of Appropriateness for changes on the structure:

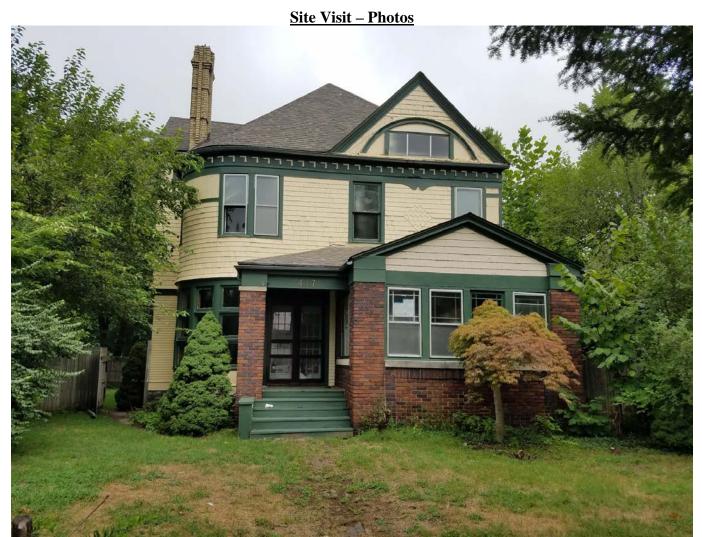
Figure 1 – 417 W Navarre from the street, looking north. The subject door is behind the storm doors.

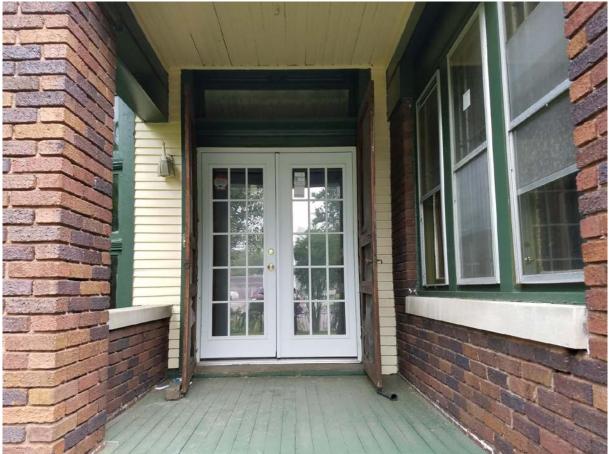
1. The replacement of the wood double-leaf multi-paned front doors with a Jeld-Wen Steel Door, "DG Full-Lite w/ Ext Grid WF", model number JEL-M-2-03808-00001.

Figure 2 -- Close-up of the replacement doors on the front porch of the structure.

Wood storm windows and doors painted or finished to match the original should be used but should not damage existing frames. If new sashes or doors are installed, the existing or original materials, design and hardware should be used. When metal storm doors are used, they should be painted, anodized or coated to match the existing. When awnings are used, they should be of canvas material. **<u>STAFF RECOMMENDATION</u>**: Staff recommends denial of new steel door and recommends replacement with new wood door to resemble original. If retroactive approval is given, Staff recommends painting door to coincide with existing color scheme of house.

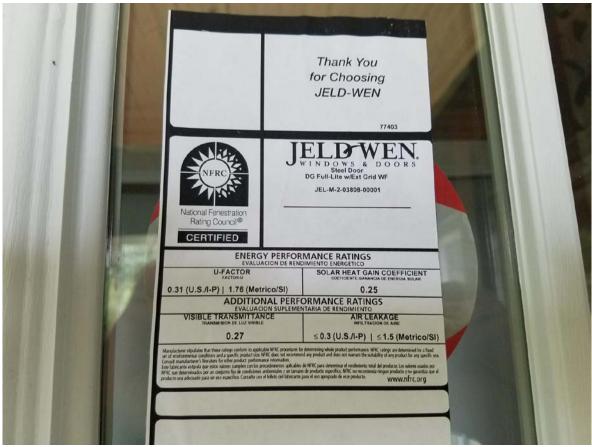
Figure 3 – Close-up of the manufacturer's label.

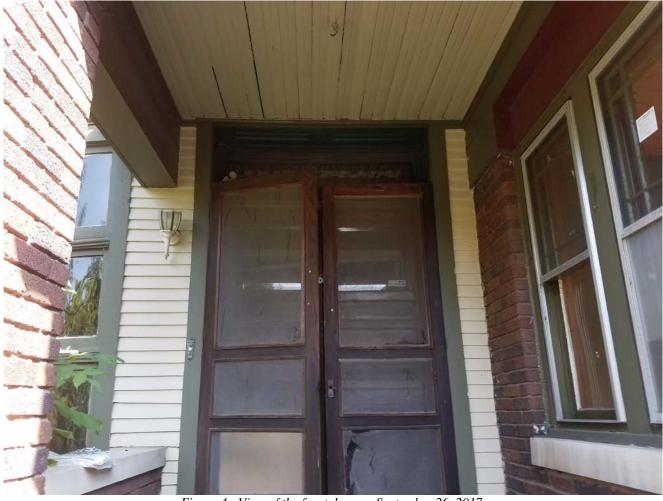
Figure 4 - View of the front door on September 26, 2017.

wood	wood
glass	glass
wood	wood

Figure 5 – Staff interpretation of original door (as depicted from above photograph)
