# STAFF REPORT

## CONCERNING APPLICATION FOR A CERTIFICATE OF APPROPRIATENESS

**Application Number:** 2018-0904A

**Property Location:** 237 N. Michigan Street

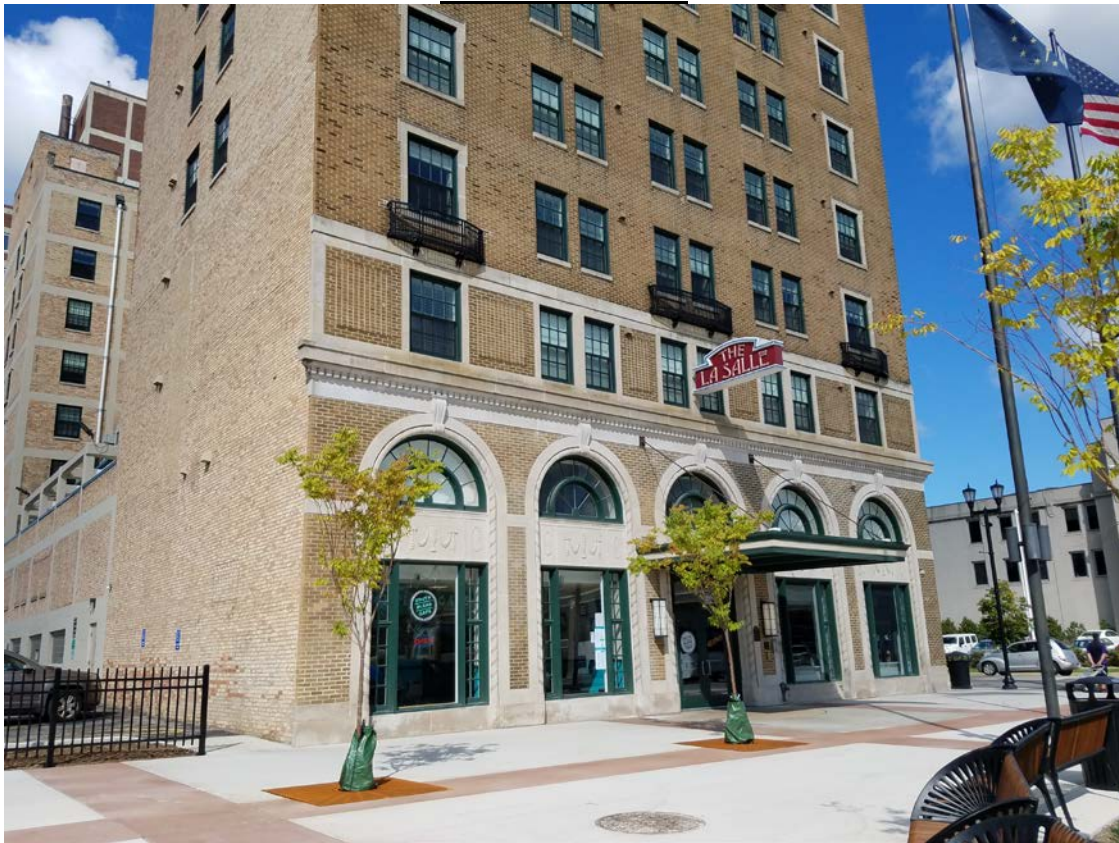
*Figure 1 – 237 N Michigan from the street, looking northwest. Two of the subject windows are at the right.*

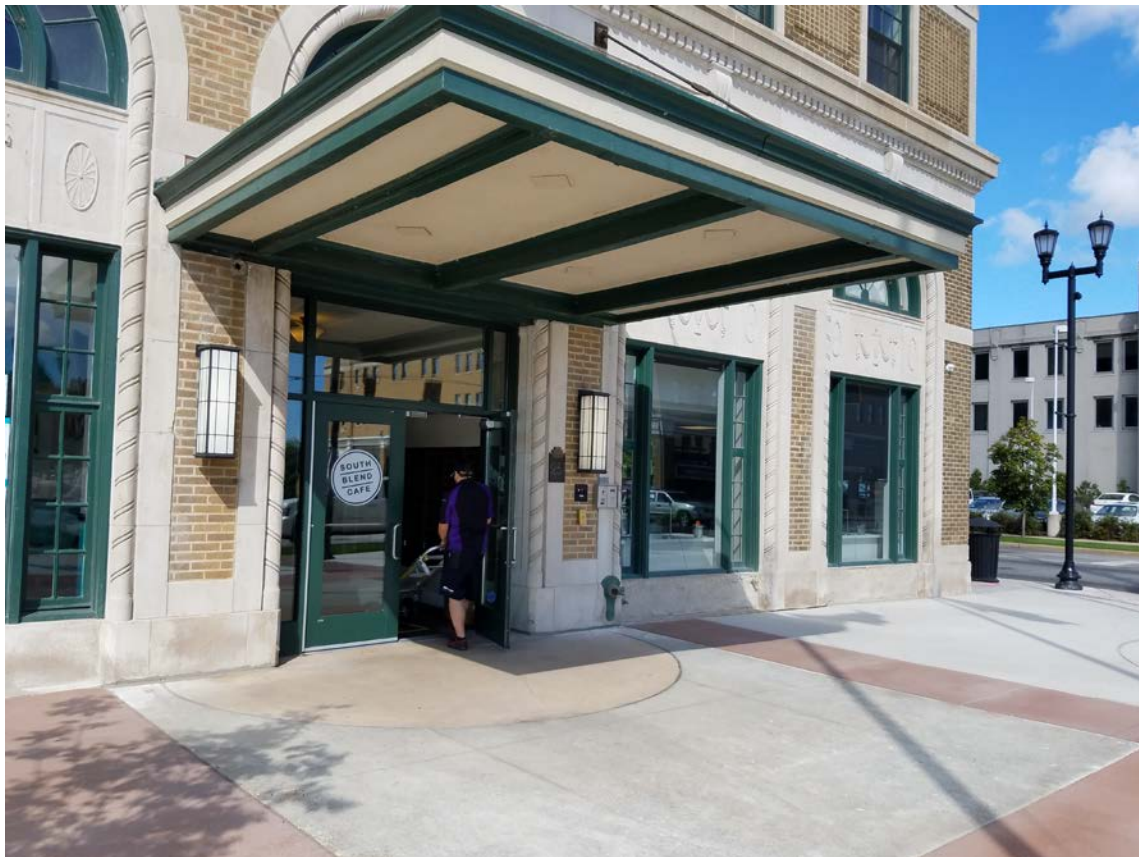
*Figure 2 - The east entrance to the Lasalle Building. Two of the subject windows, at right. Note "South Blend Cafe" signage on door.*

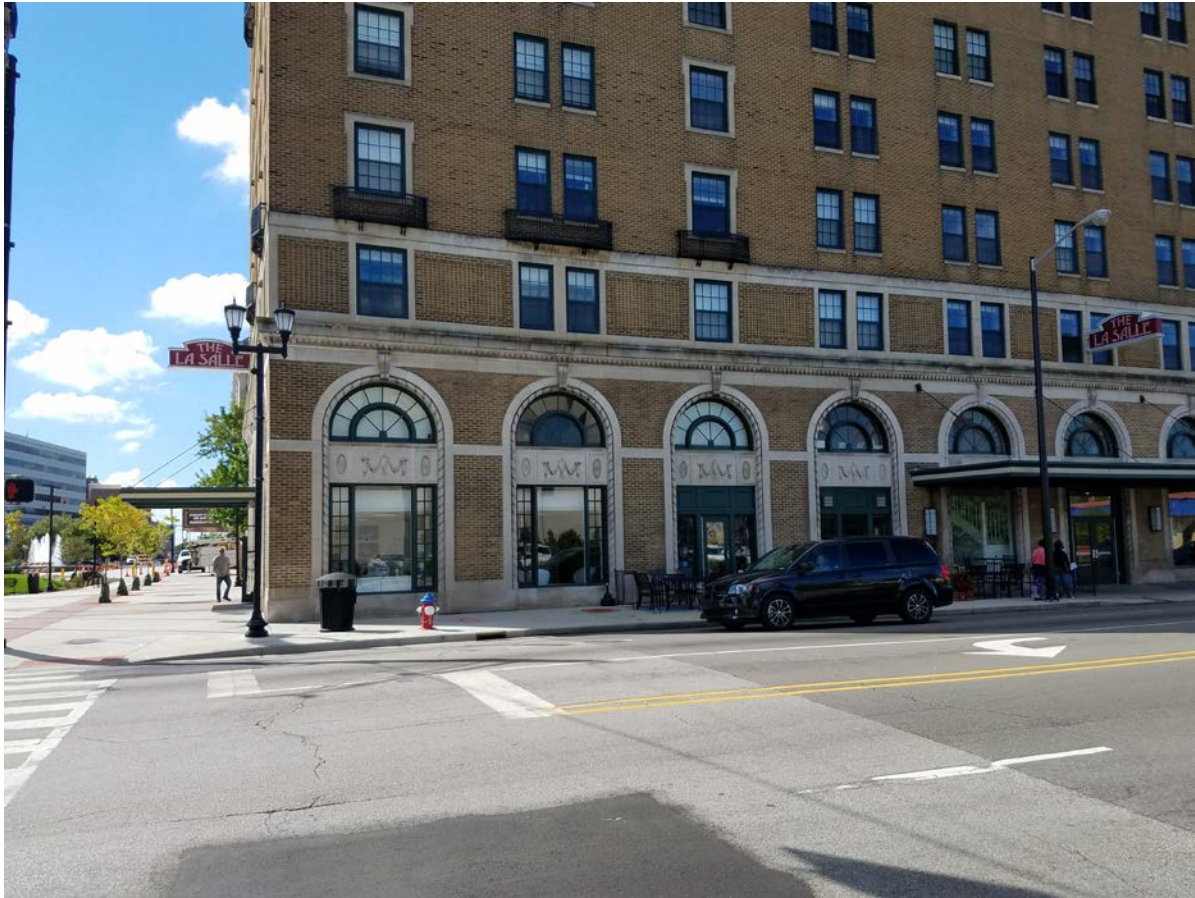
*Figure 3 - The LaSalle Building, looking south. The two ground-floor windows closest to the corner are also part of this application.*

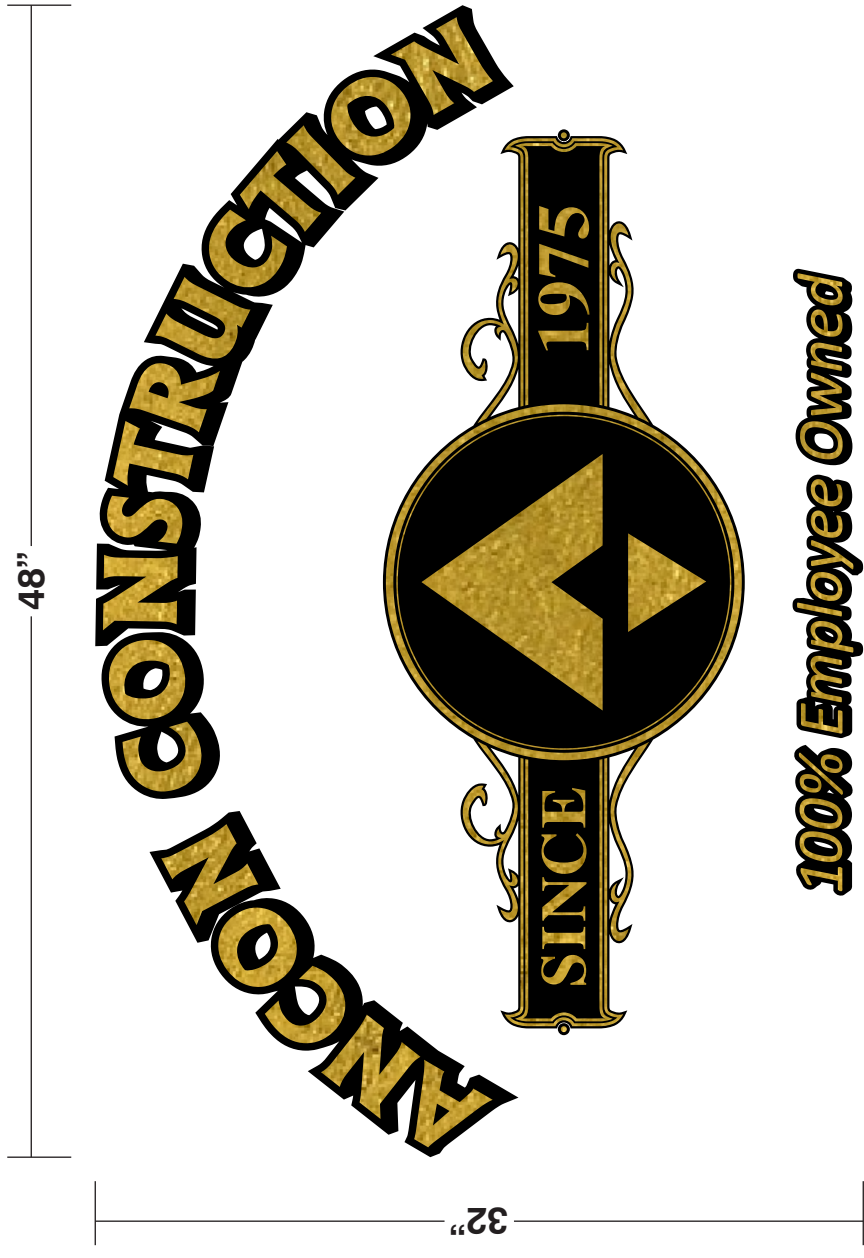
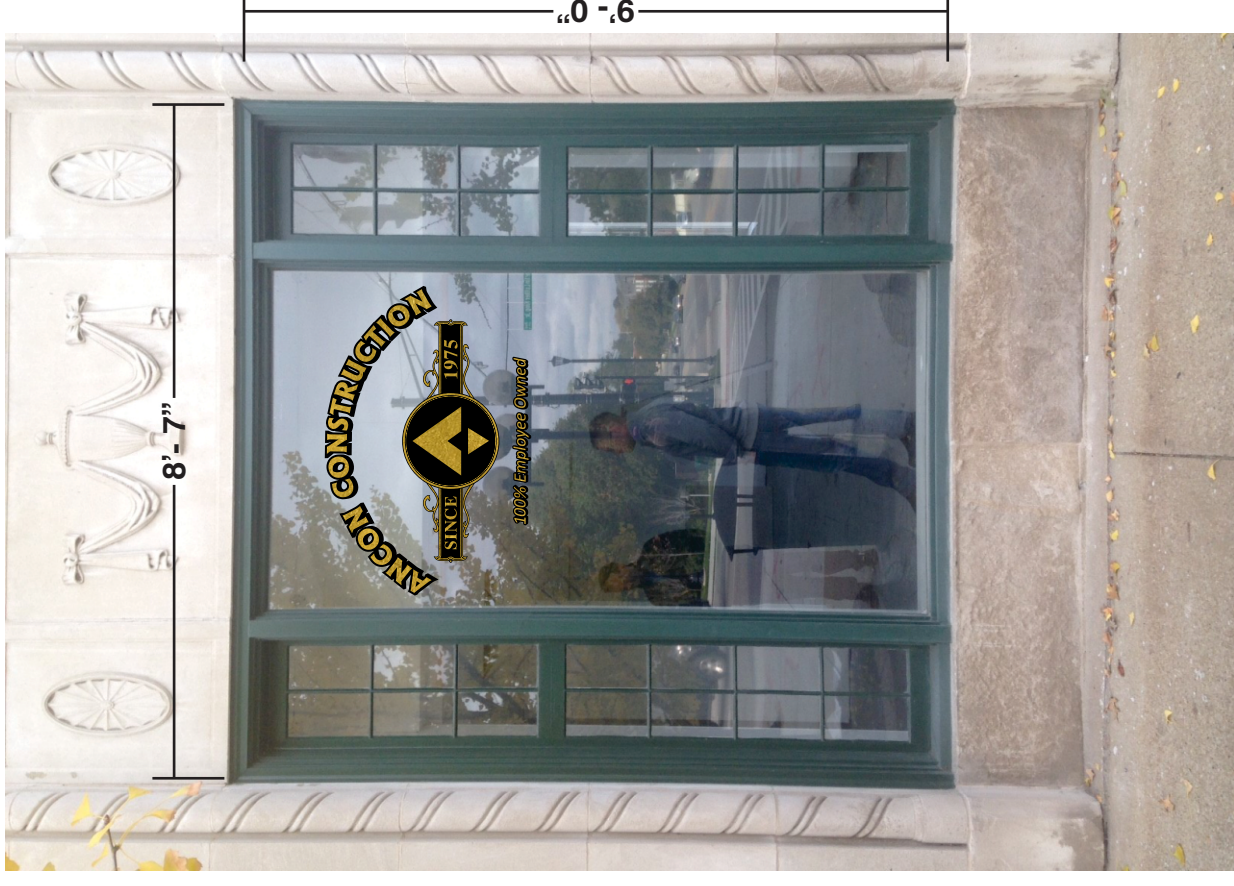
**FOUR (4) SETS OF 1st SURFACE WINDOW VINYL**

TWO (2) EAST WINDOWS  
TWO (2) NORTH WINDOWS  
\*MEASUREMENTS = SAME

SCALE: 1"=1'-0"

■ GOLD LEAF VINYL  
■ BLACK VINYL

1. The application of vinyl window signs for Ancon Construction, the tenant of the corner unit.
  - a. Vinyl appliques four windows of the office at the northeast corner of the building, two on the east face and two on the north face.
  - b. Overall dimensions: approximately 32” x 48”
  - c. Description of sign design: arched “ANCON CONSTRUCTION” text over the company logo and the text, “SINCE 1975”, with smaller text stating “100% Employee Owned”. All text in gold with black border.

The proposed design compliments the architectural elements of the building (mimicking the curvature of the windows), is a facsimile of the gold-leaf signage that was so prevalent in the late 19<sup>th</sup> and early 20<sup>th</sup> century, and is respectful to the size and scale of the windows themselves.

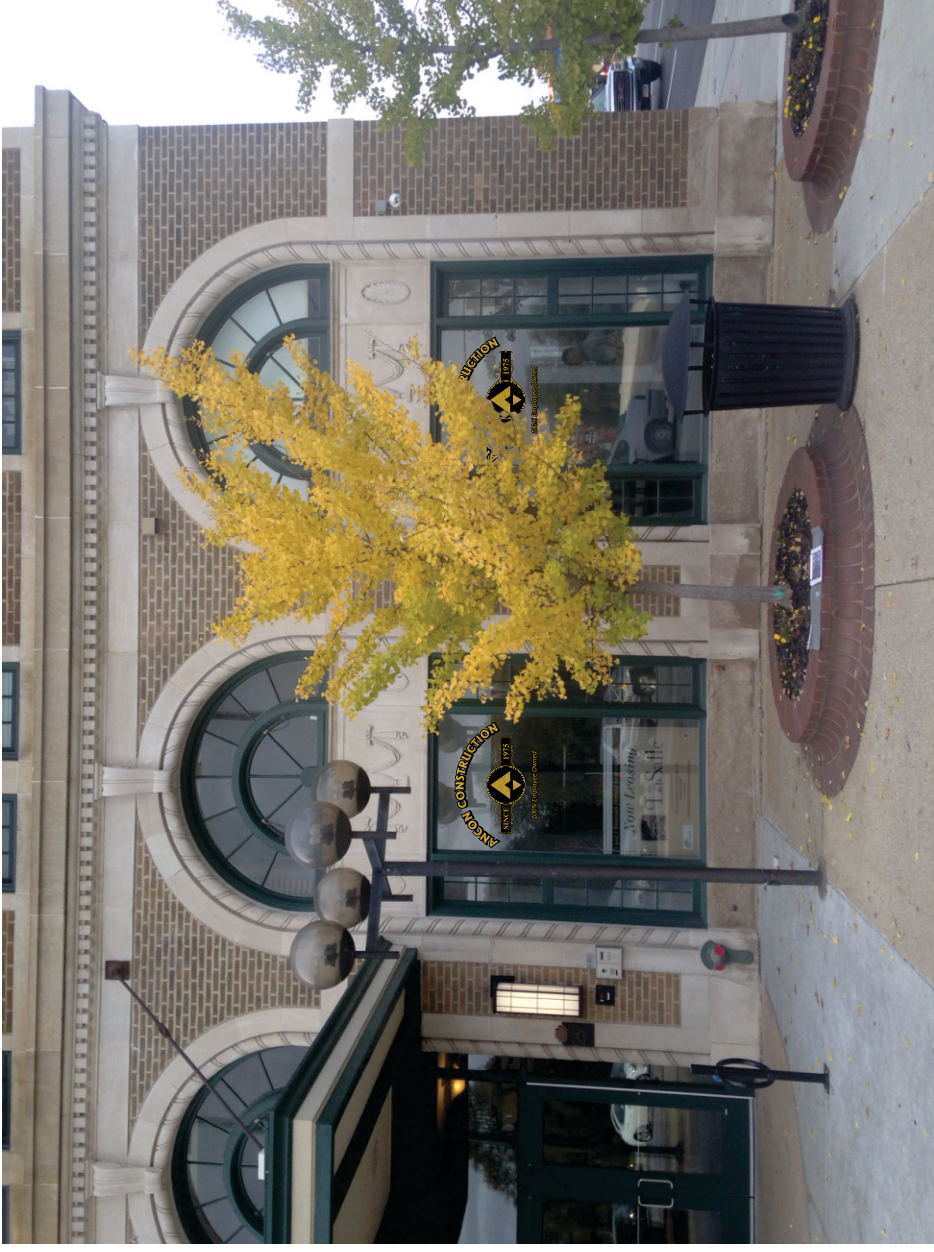
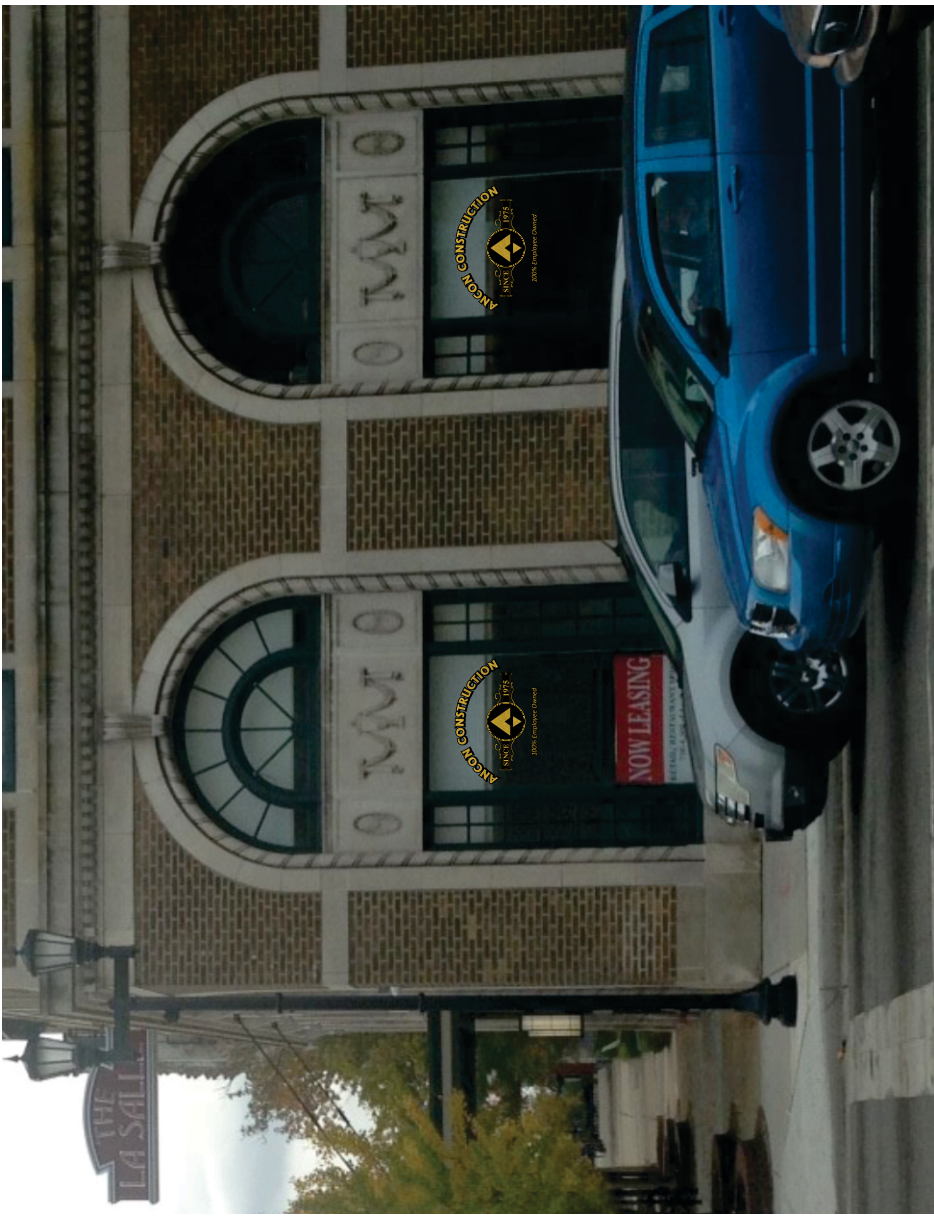
SCALE: 1"=1'-0"

GOLD LEAF VINYL

BLACK VINYL
