AMERESCO, INC.

**Re: UST Closure
Summary of Activities
Studebaker Phase IV
Project # - 11.2529.3**

Project Narrative

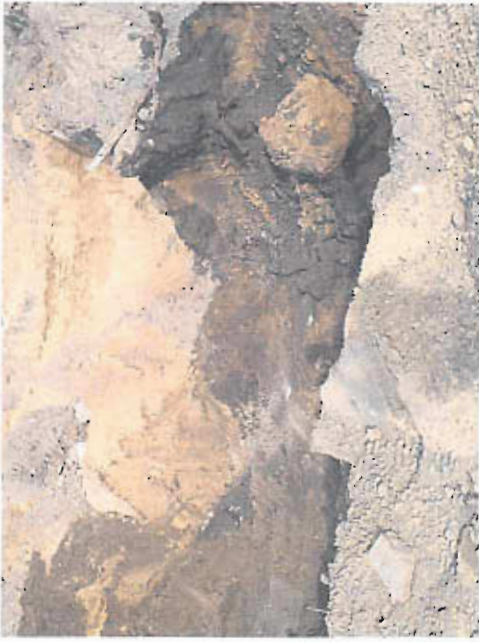
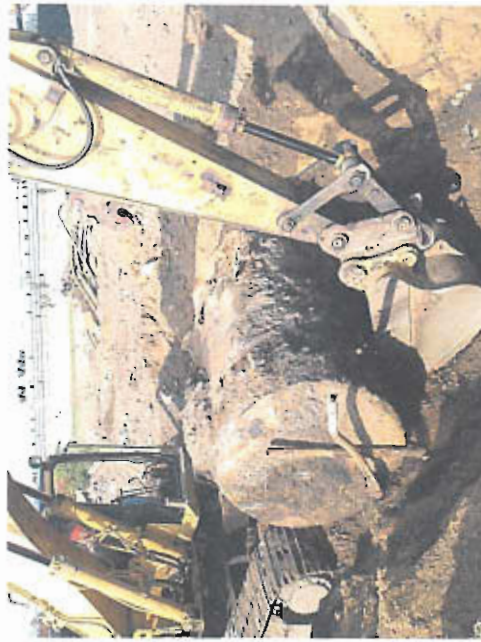
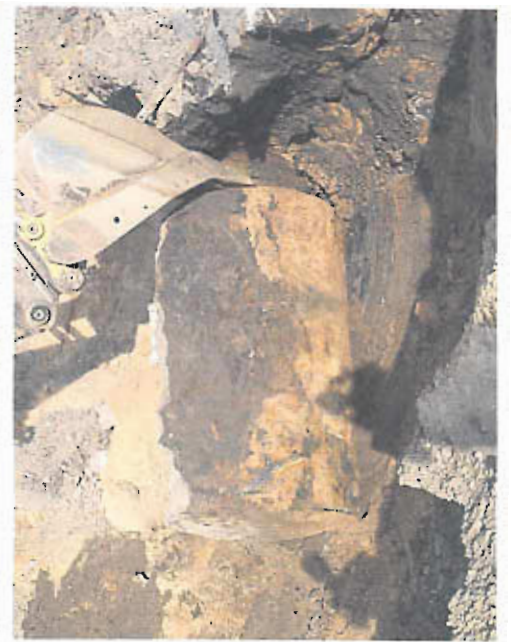
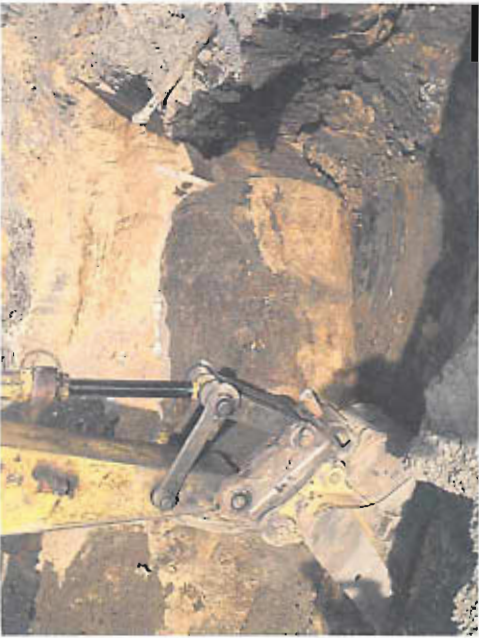
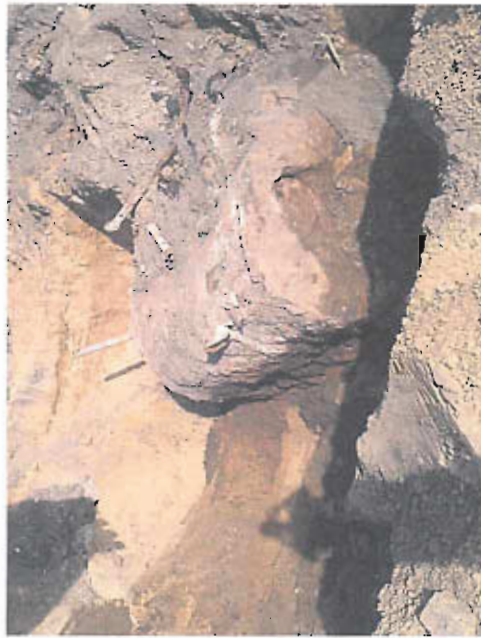
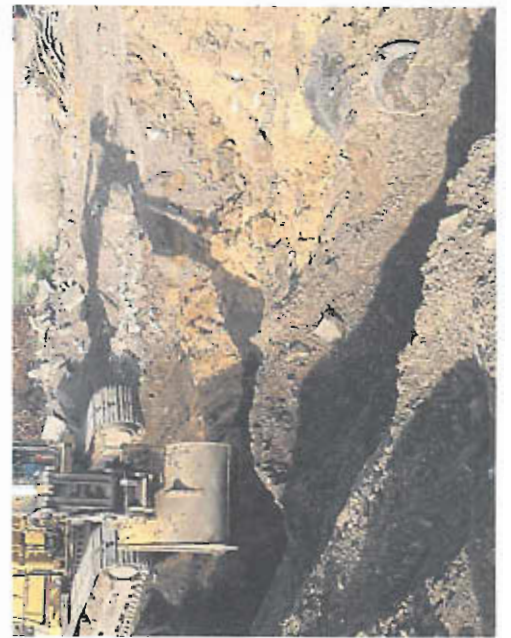
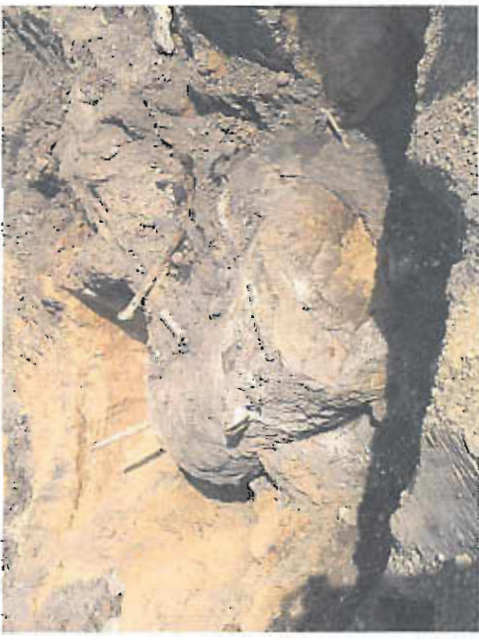
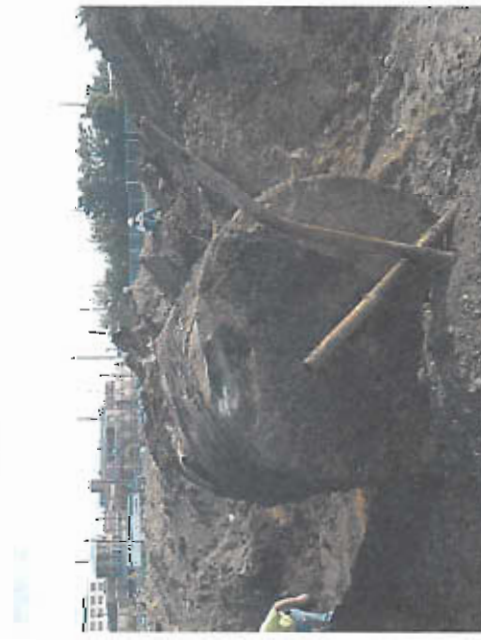
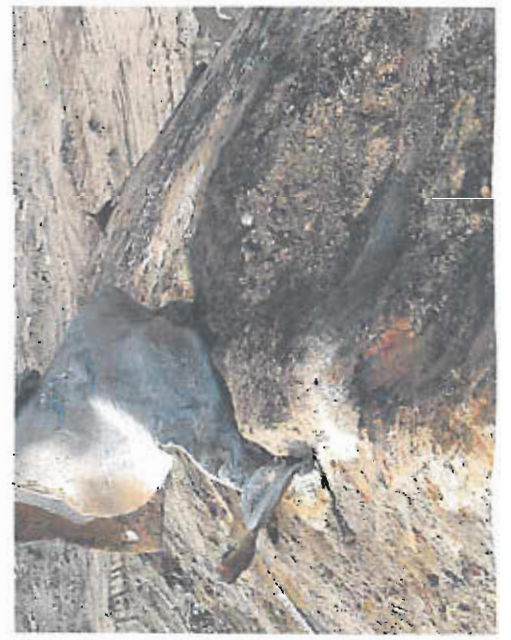
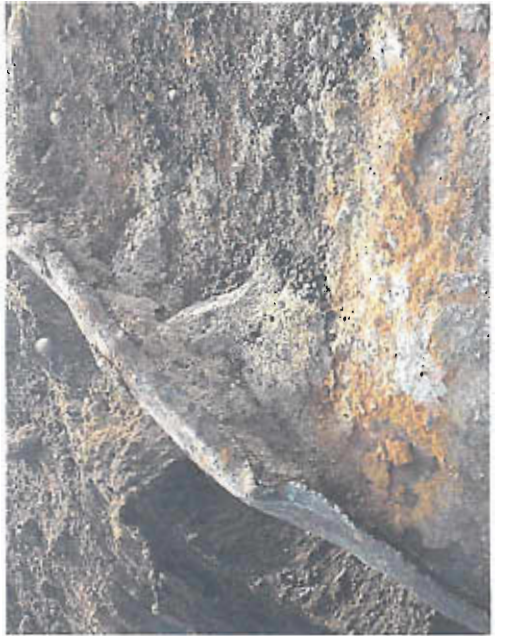
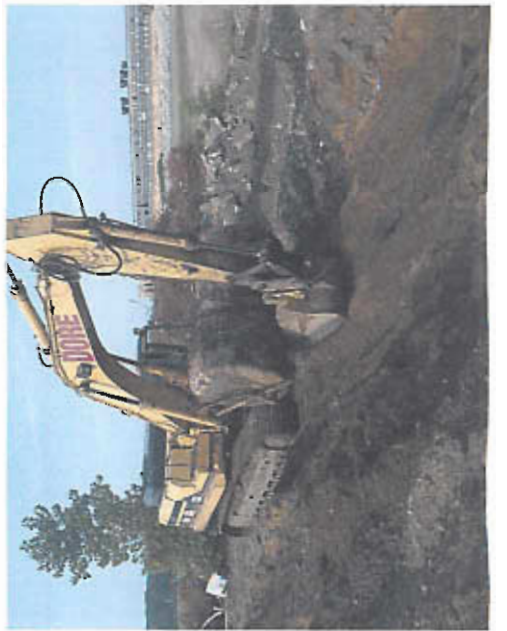
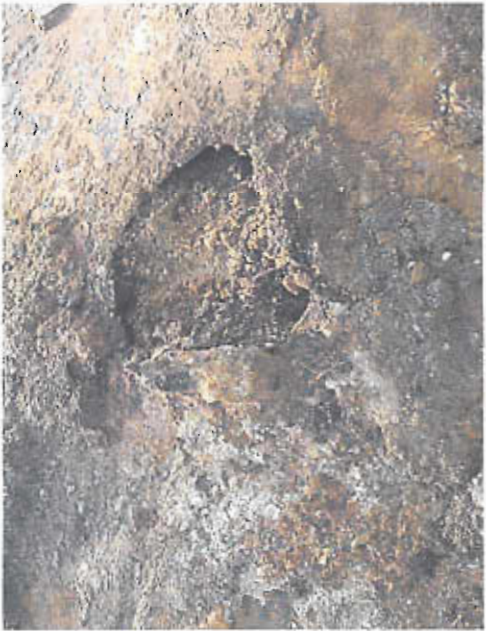
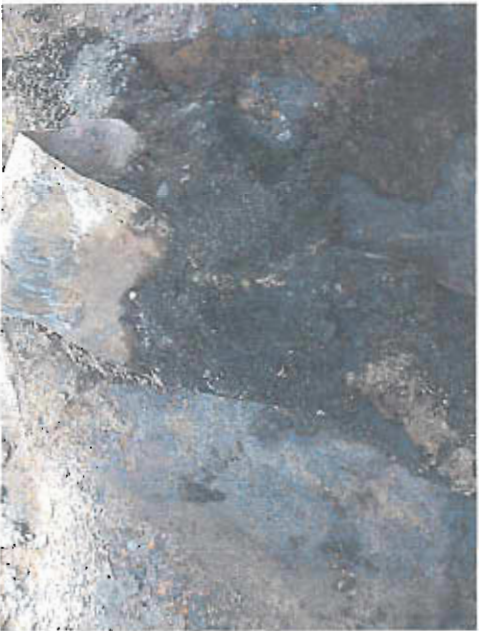
Ameresco oversaw the removal of the 1,500 gallon located at the Engineering Building. Dore and Associates removed this UST from the earth and staged/stabilized the UST for disposal. The UST had been previously filled with a lightweight concrete. The UST has several areas of damage, which all indicated the UST was completely filled with the lightweight concrete.

- 9:50 AM The UST is dislodge and is being pulled & carried out of the excavation.
- 10:00 AM UST is removed from excavation and staged in a stable manner. Holes are observed in various locations on the UST, varying in size from pinhole to 2 ft². All holes provide evidence that concrete is throughout UST.

Be advised that the USTs should be cut up, crushed, or removed from the site as promptly as possible. The lightweight concrete should be disposed at a licensed landfill or a sample should be collected to profile the material. It is unknown if the UST was cleaned properly before closure in place by concrete; therefore, it is unknown if the concrete is contaminated.

The UST is in a stable condition and has been rendered unusable. Therefore, the all that remains is disposal of the UST and concrete fill.
