STAFF REPORT
CONCERNING APPLICATION FOR A
CERTIFICATE OF APPROPRIATENESS

Application Number: 2018-1204

Property Location: 50106 Bittersweet Trail

Corn Crib Project – Reconstruction

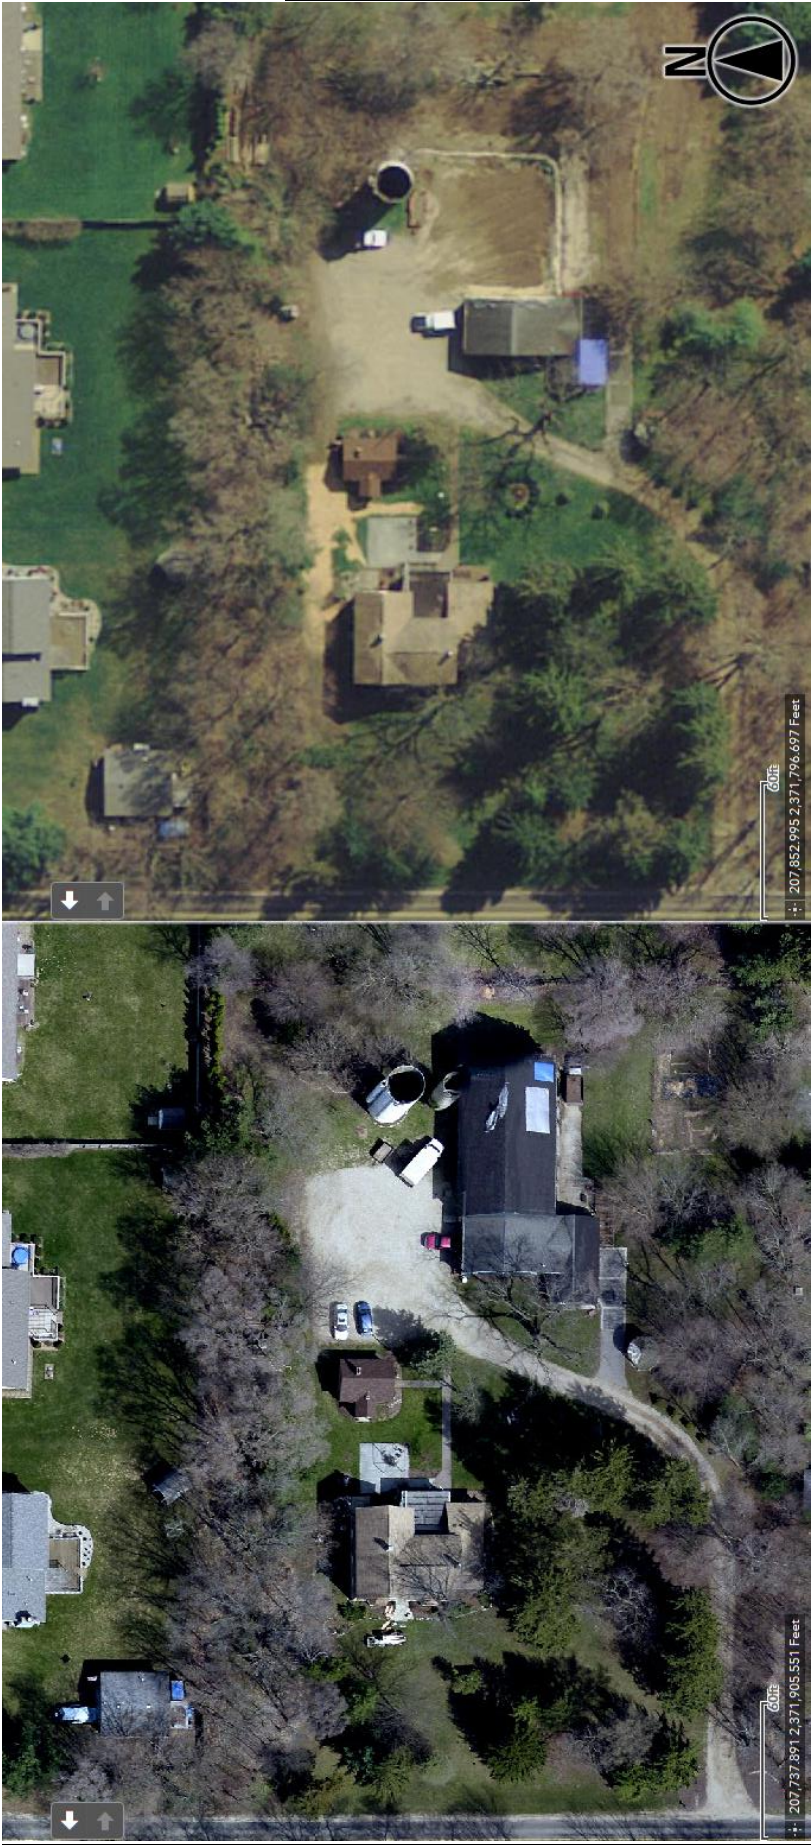
Diagram 1- 50106 Bittersweet Trail as seen in 2016 (top) and 2013 (bottom).

ALTERATIONS: Original bay windows roofs have been replaced with higher pitch and wood shakes. Aluminum storm windows have been added. There is a small addition to the rear of the house. Between May 2012 and December 2014, the front portico was removed without a COA. The barn was taken down in 2014 without a COA. Green space at site of former barn has been developed with a stone wall built of original barn foundation stones. COA 2017-0403A approved installation of egress window on north side of house and landscaping to screen window and adjacent A/C unit, creation of dumpster pad along south side of drive adjacent to road, to be enclosed with fence, gates, and evergreens, and extension of gravel driveway. COA 2017-0501 approved installation of 6'H dog-ear wood stockade panels along north property line. Appropriate shade tolerant plants and/or junipers to be installed as necessary. COA 2017-1204A was tabled indefinitely by the Historic Preservation Commission – the absence of a decision on the application resulted in the issuance of an approved COA on January 18, 2018. COA 2018-0306A allowed for the installation of a 40' windmill. COA 2018-1001C allowed for the deconstruction of the corn crib.

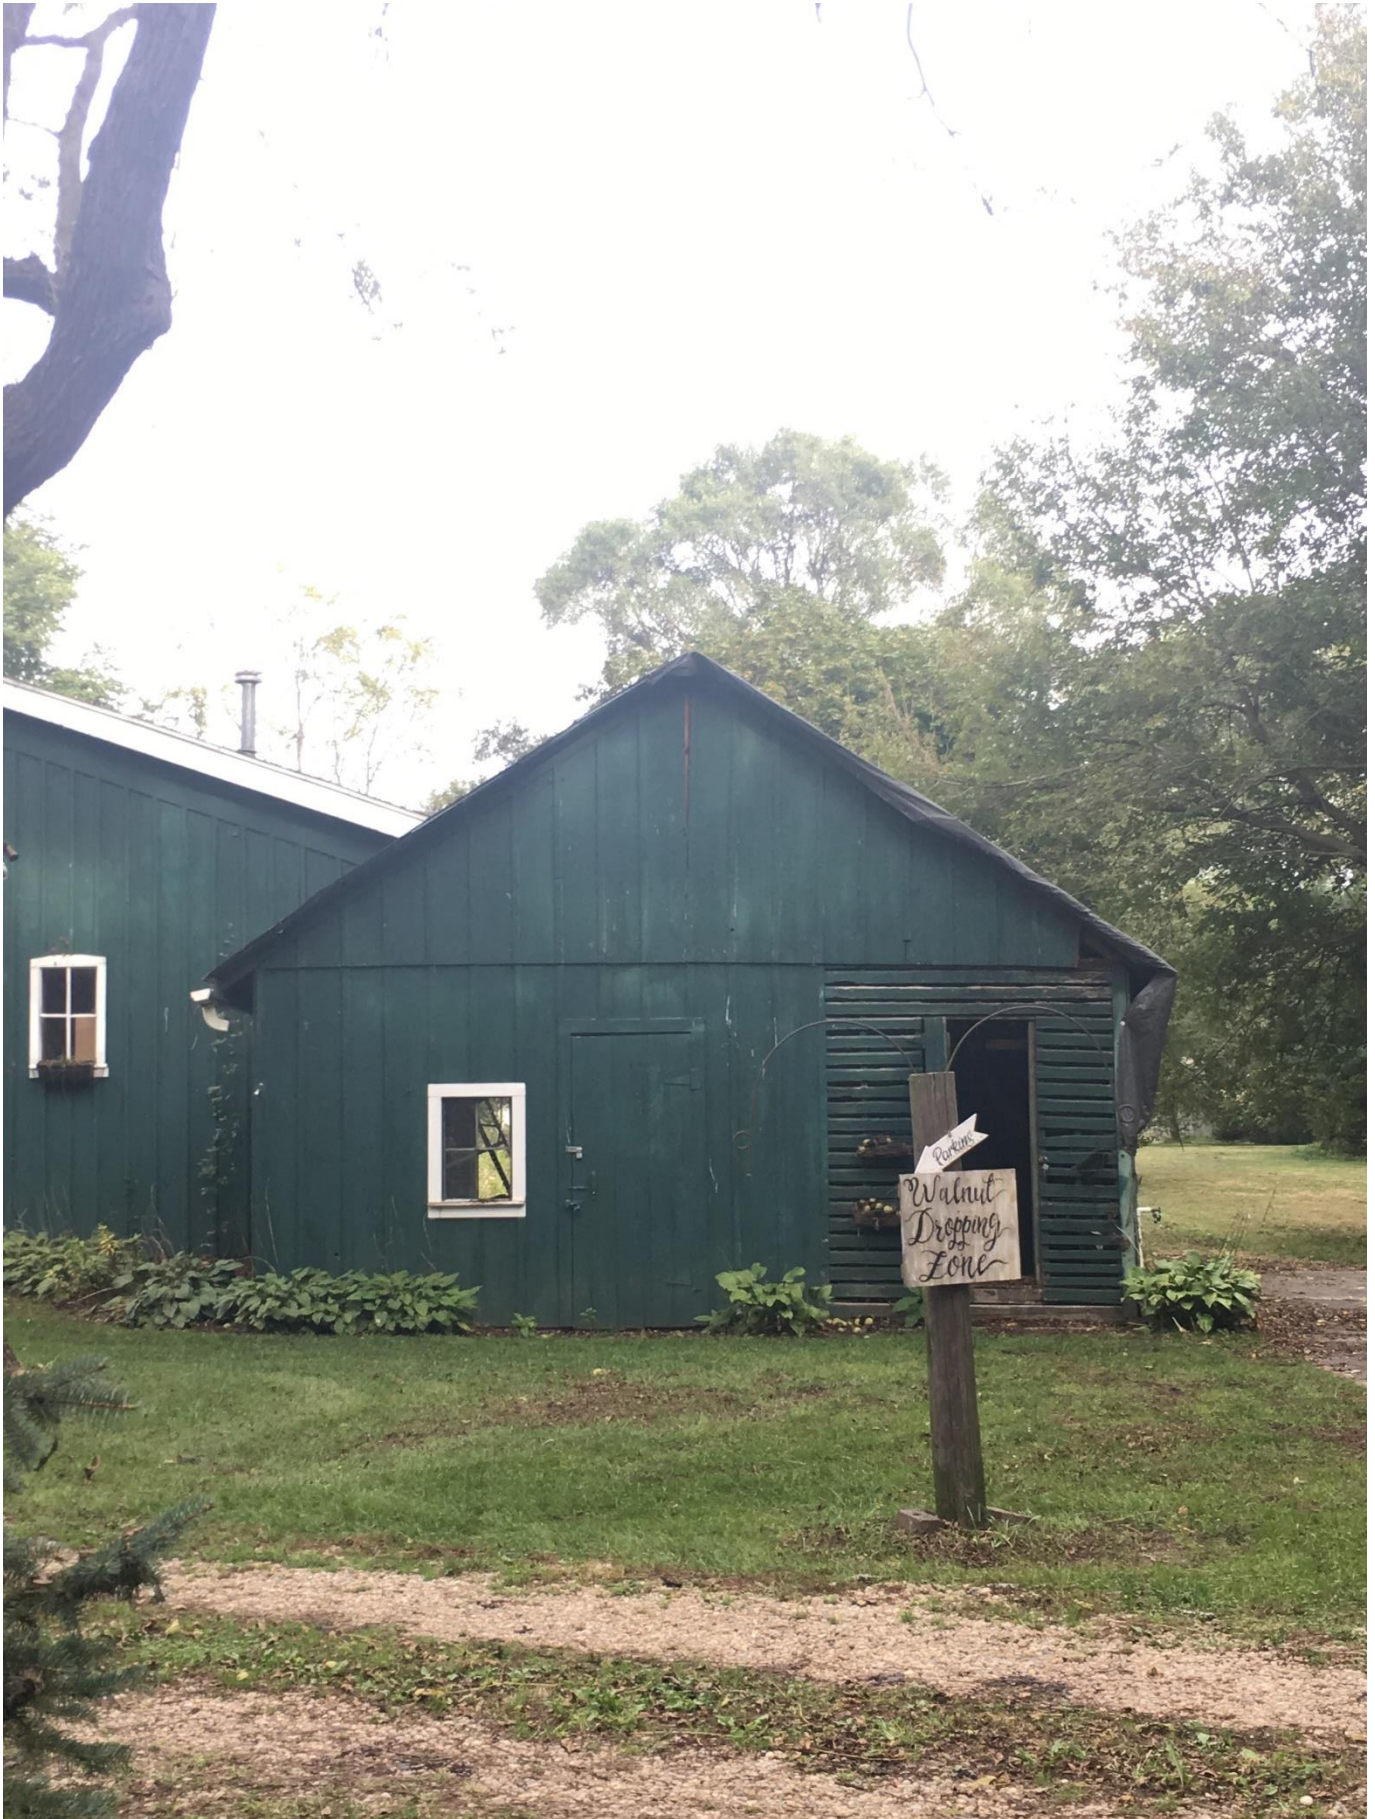
Figure 2 - Corn crib, west facade.

1. Replacement windows on the north and west faces,
 - a. Salvaged windows from the HPC inventory were being considered, although none are available,
 - b. Staff has suggested that the applicant pursue salvage windows from ReStore or other reclamation stores,

- c. Alternatively, new manufacture *Northview* wood barn sash windows have been approved in similar projects.
 2. Replacement man-door on the west face,

STAFF RECOMMENDATION: The submitted plan allows for the replicated corn crib to be built separately from the existing barn structure; this new construction will appear (from the street and approaching drive) to remain connected. Staff recommends approval of this proposed reconstruction, based upon the adherence of the project to the *Group B Standards and Guidelines*, specifically Section C, Renovations and Additions.

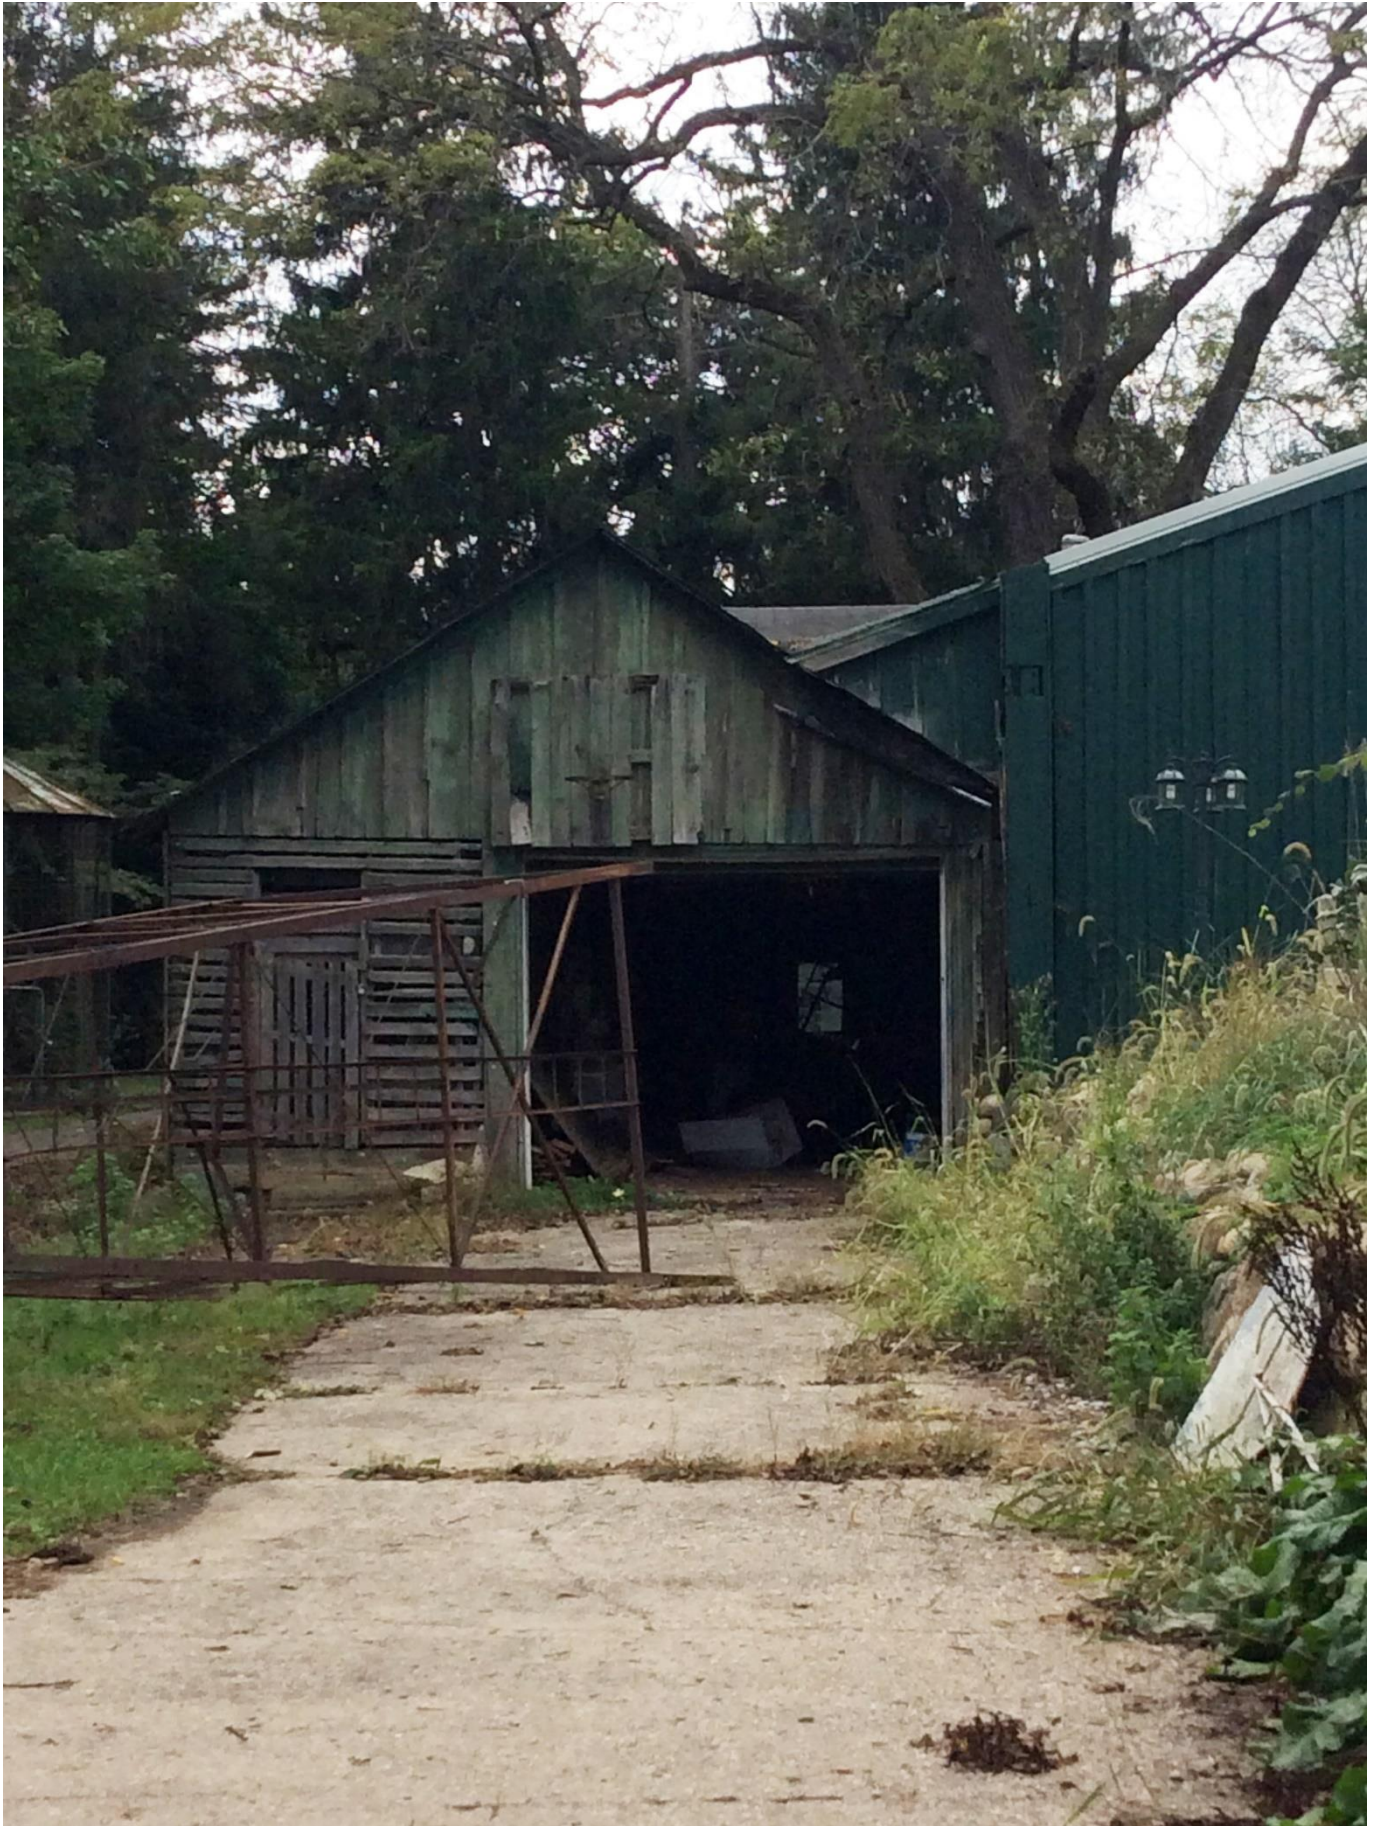
Figure 5 - Corn crib, east facade. Note roof eave.

3. Replacement garage door on the east face,
 - a. Applicant has expressed desire to utilize a 'barn door' garage door as opposed to the metal generic garage door as was previously found on the corn crib,

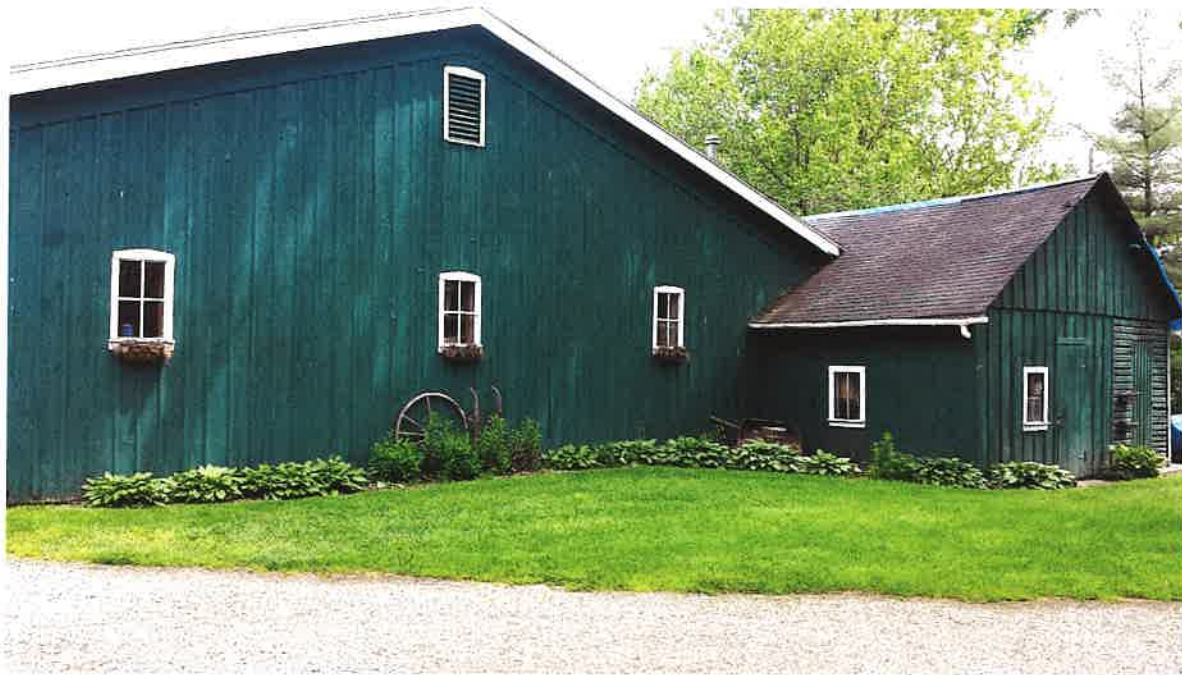
Original garage and corn crib building

The building referred to as the Corn Crib was attached to another building on the property that has been called a garage and also referred to as a barn. In any case, the corn crib is considered original or at least vintage, but the garage was added much later. The buildings had an awkward abutment that created water and ice retention and threatened both building structures. The external wall of the corn crib was suffering exposure from the elements in combination with disrepair over the years. The portion called the corn crib was deemed non-salvageable, and a CoA was approved previously to deconstruct the corn crib portion in conjunction with a to-be-clarified reconstruction plan.

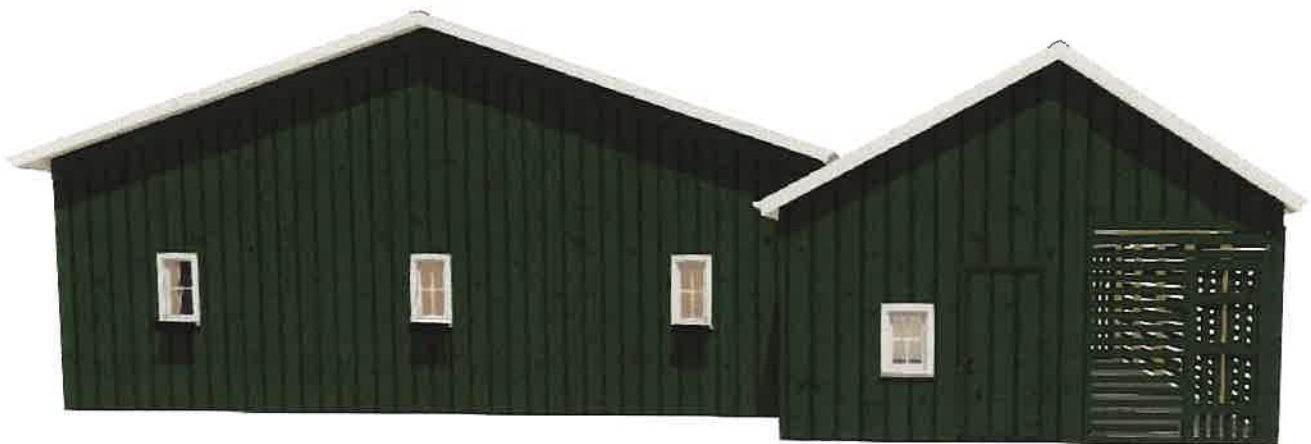
This CoA application is to describe and convey detail of the reconstruction of the corn crib in like fashion, with like elevations, however with one important exception exteriorly, and that is the creation of a 2' gap between the buildings for storm water and snow control.

Rendering of final reconstruction, maintaining west elevation view while creating gap between the buildings. (additional detail on next page)

Frame and finishing material shall be wood. We have a considerable amount of barn wood on site from the previous barn demolition. Structural members will need to be sound and new, but exterior pieces will be endeavored to include vintage wood where feasible. Roof shall be asphalt shingle as was previously on the corn crib building. Color selections will attempt to match garage and former corn crib structure. We plan to pour a cement floor inside the corn crib building. Eaves and downspouts that match those approved for the home, will be used to replace damaged ones on the garage, and will be installed on the edges of each roof between the garage and corn crib.

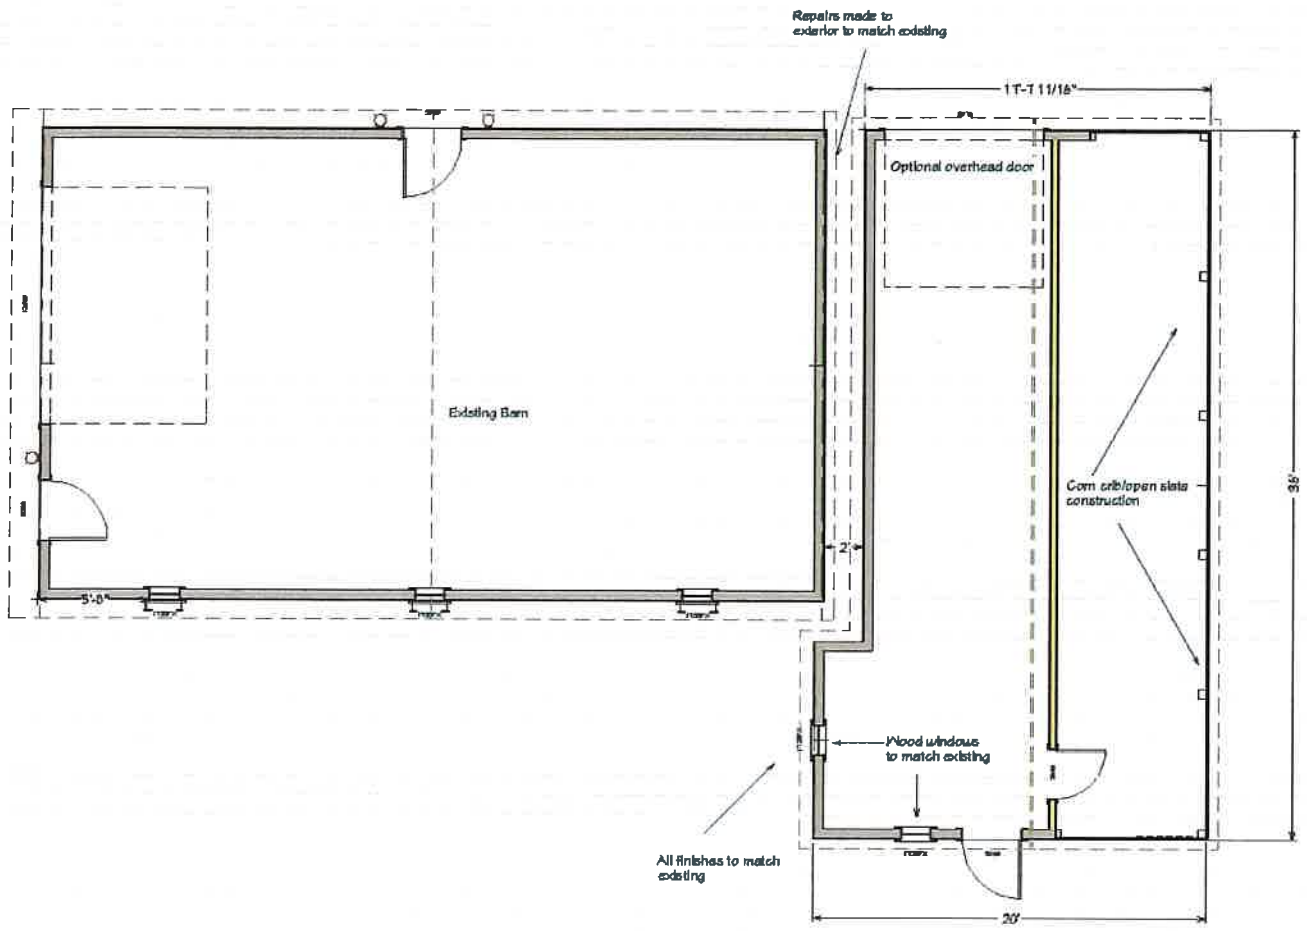
Photos on the ensuing pages show previous structure and proposed elevations. The final page shows the general architectural layout of the proposed structure.
